## *UST Removal and Validation Report*

Hornsby Kuring-Gai Hospital

UST Removal and Validation Report

**July 2009**

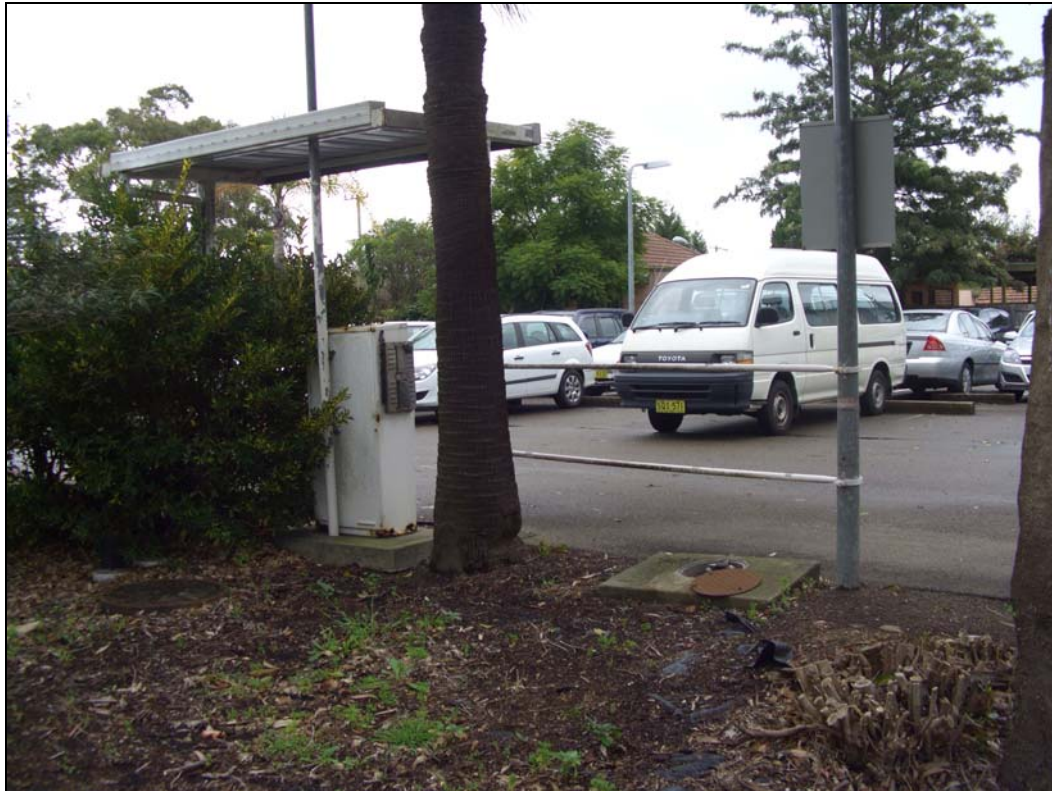
**Photograph 1: Fuel Dispenser, Canopy and Remote Fill Point – facing southwest**

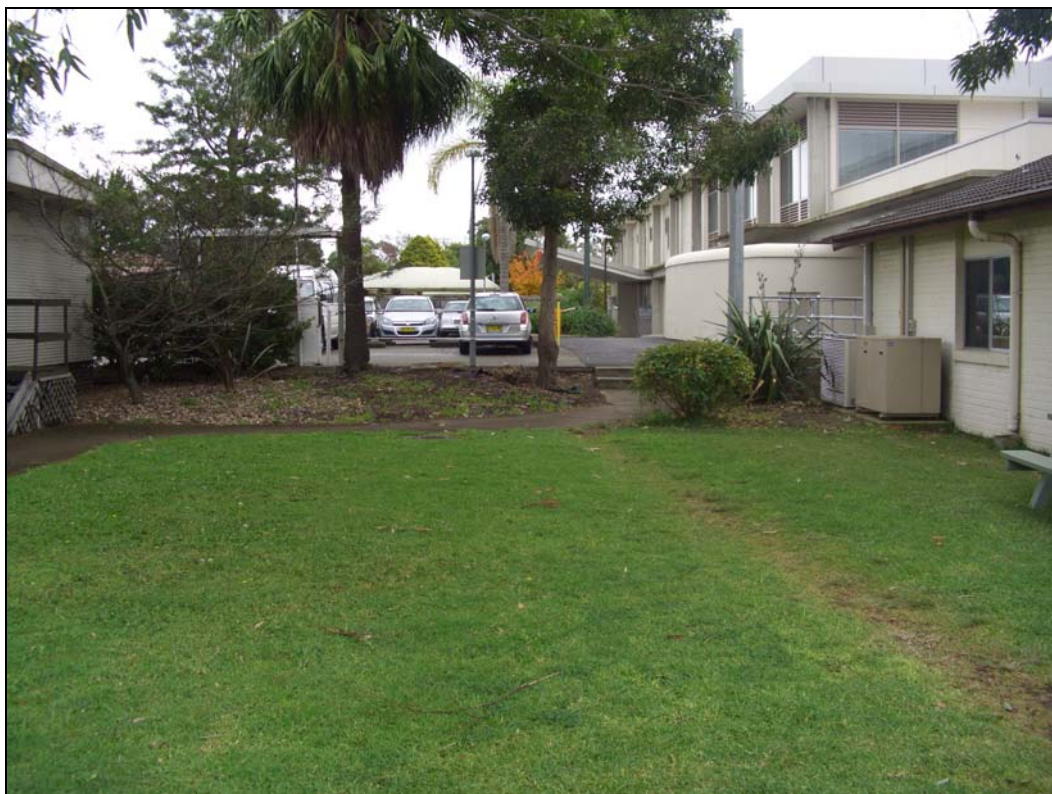
**Photograph 2: Area of UST – facing west**

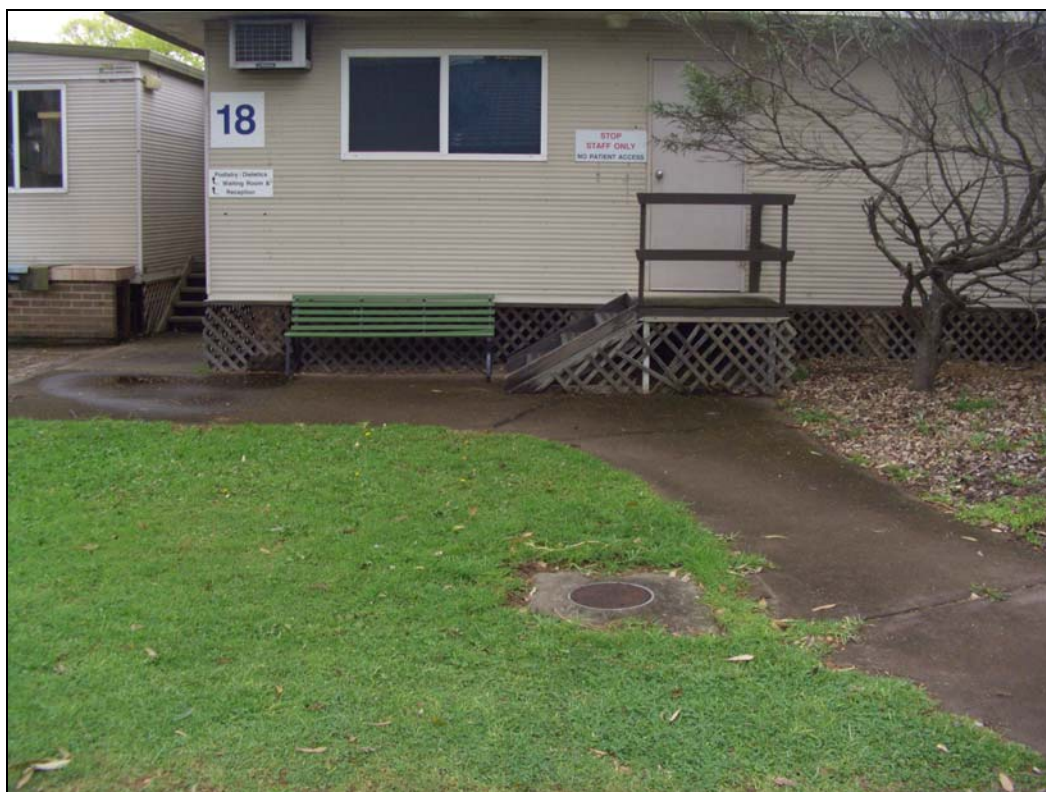
Photograph 3: UST Dip point – facing south

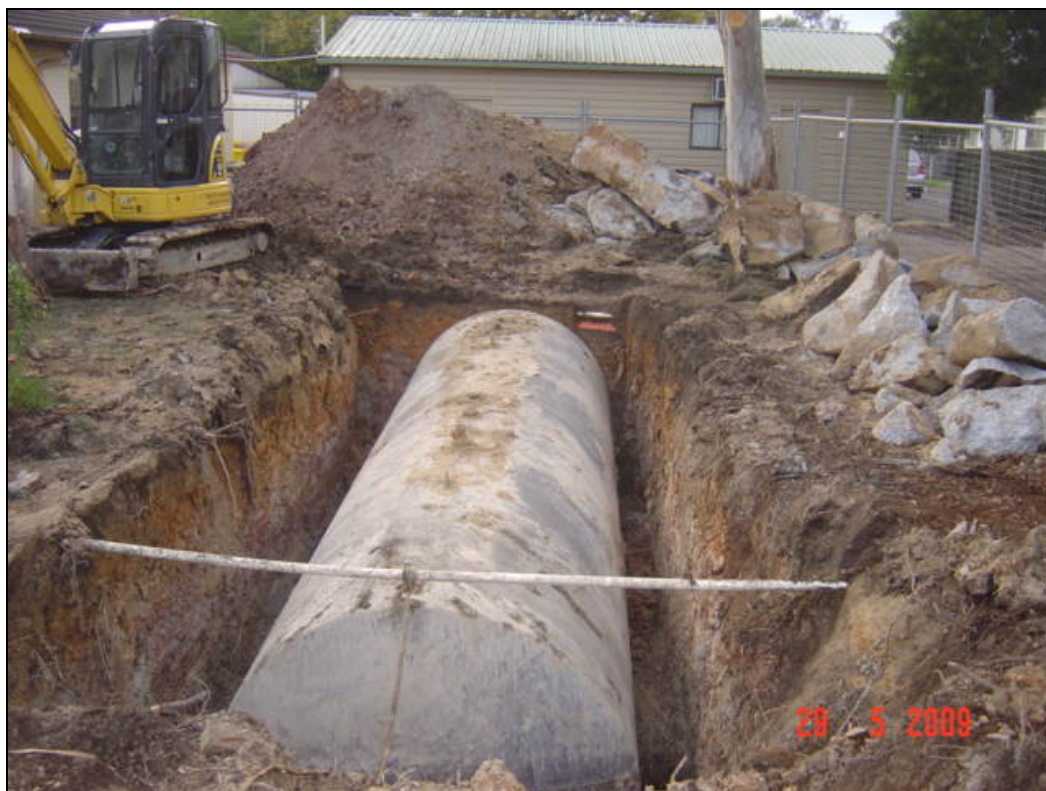
The 25,000 L UST and fuel lines were inspected upon removal and reported to be in good condition with no signs of corrosion apparent. The UST contained 11,900 L of 2-3 year old unleaded petrol, which was removed by a licensed liquid waste disposal contractor prior to appropriate decommissioning and removal of the UST.

Photograph 4: Exposed UST – facing east

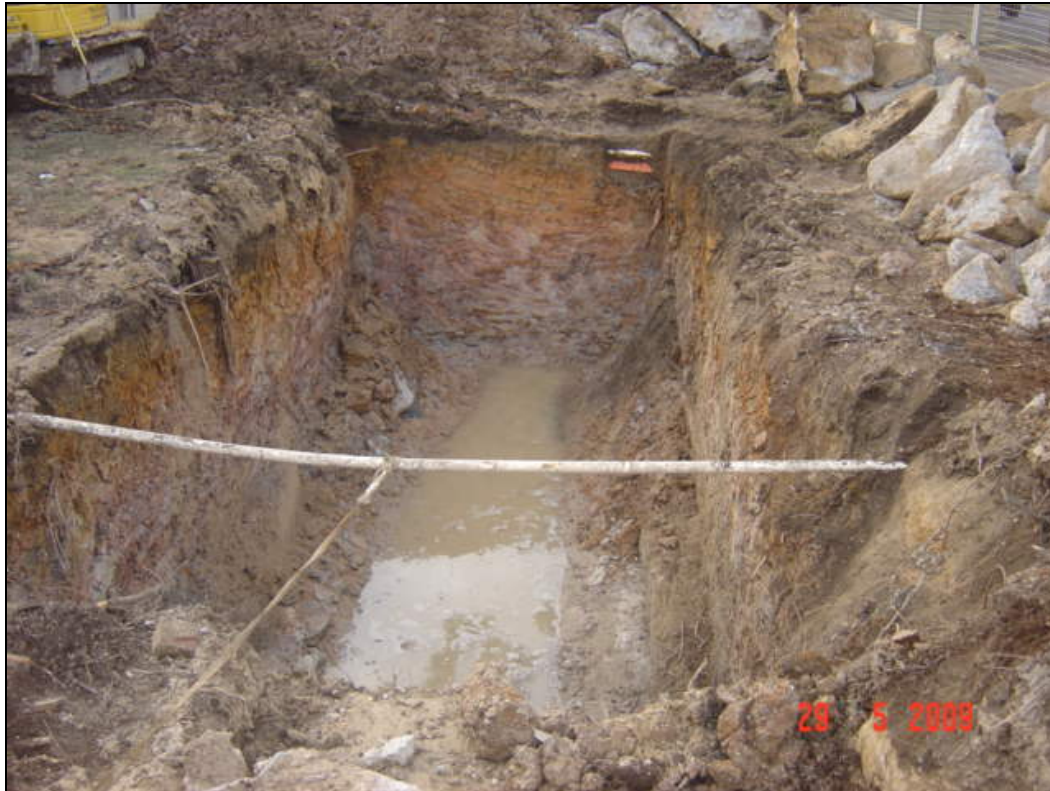
- 3.5m x 9.0m x 3.4m deep (UST excavation); and
- 0.5m x 0.5m x 2m (bowser/fuel transfer line trench)
- 0.5m x 0.5m x 2m (vent line trench).

**Photograph 5: UST Excavation- facing east**

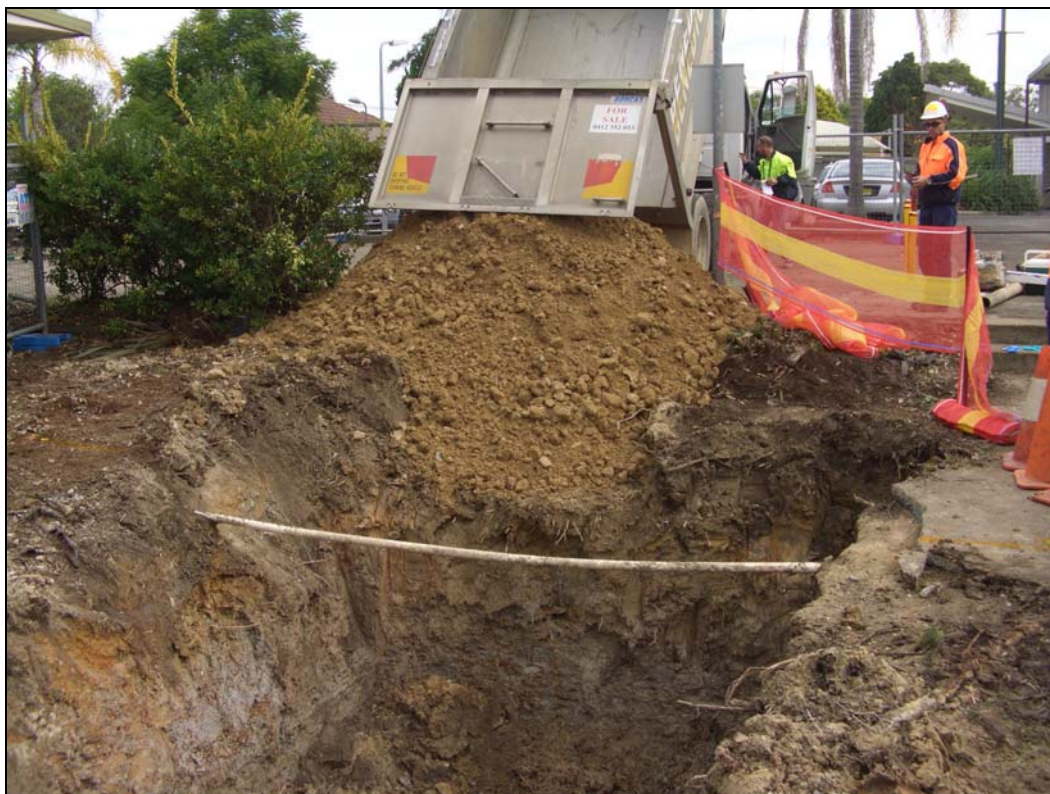
**Photograph 6: Reinstatement of Excavation with Imported VENM – facing west**

All excavations were reinstated with a combination of validated excavated soils and imported fill material. The soils were compacted using the excavator and track rolled. A layer of topsoil was placed over the imported fill to allow plantation of grass seed and to return the area to a similar condition prior to commencement of the works.

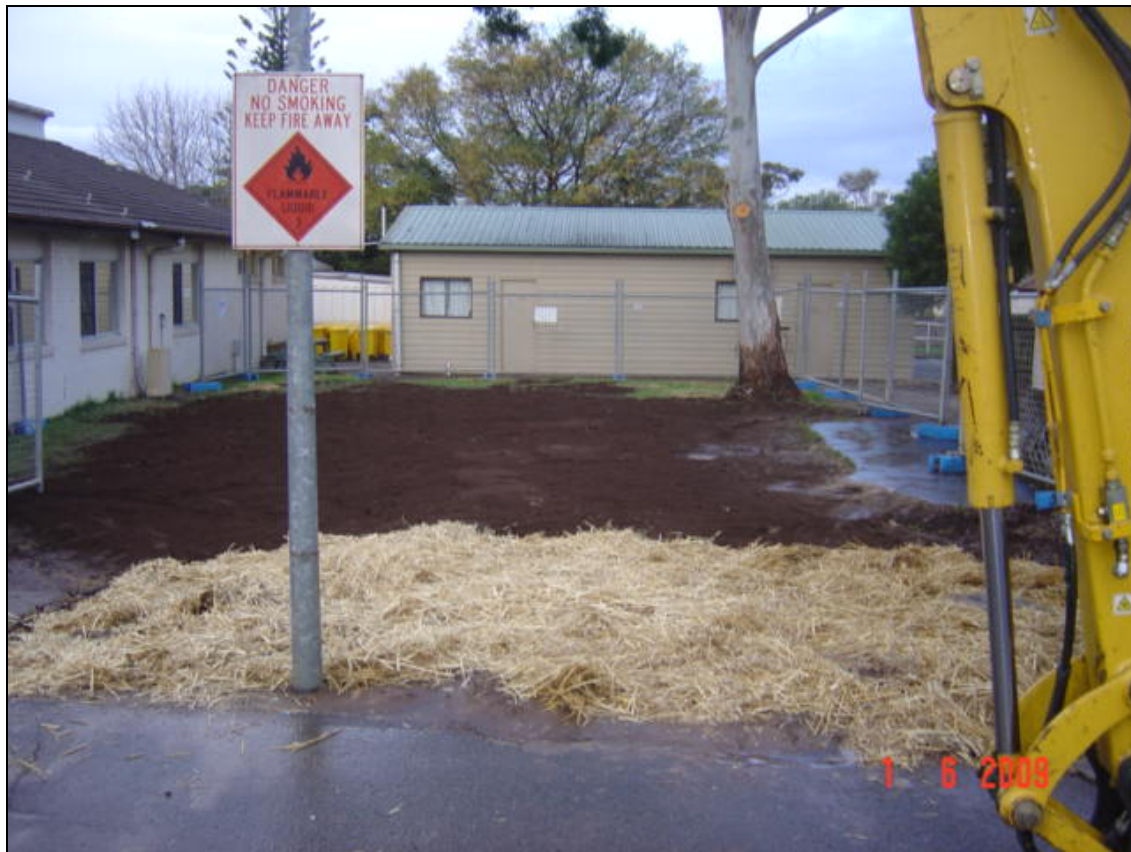
**Photograph 7: Completed UST Removal and Validation Site – facing east**
