Long Term Environmental Management Plan (LTEMP)

238-258 Captain Cook Drive, Kurnell NSW

Prepared for Dicker Data Limited

12 October 2020

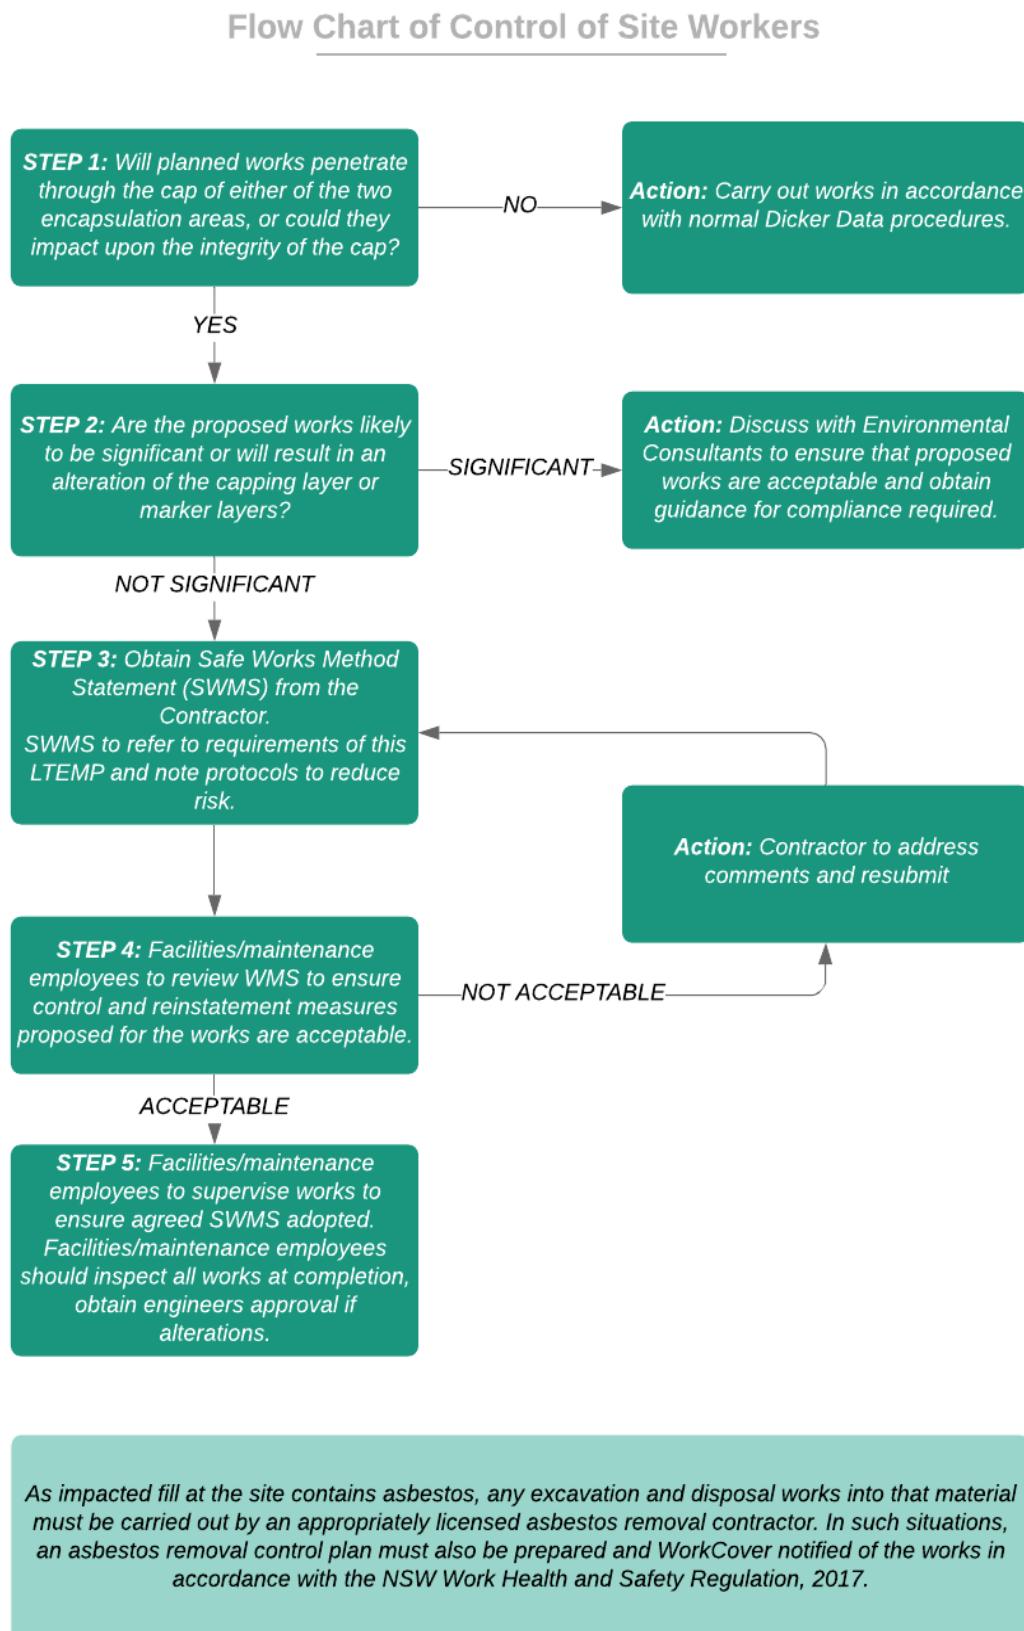
Diagram 4-4:

Future maintenance or contract works need to be assessed for the potential to damage or compromise the capping layers or marker layers. Any proposed works should be assessed by Dicker Data for the site using the following flow chart:

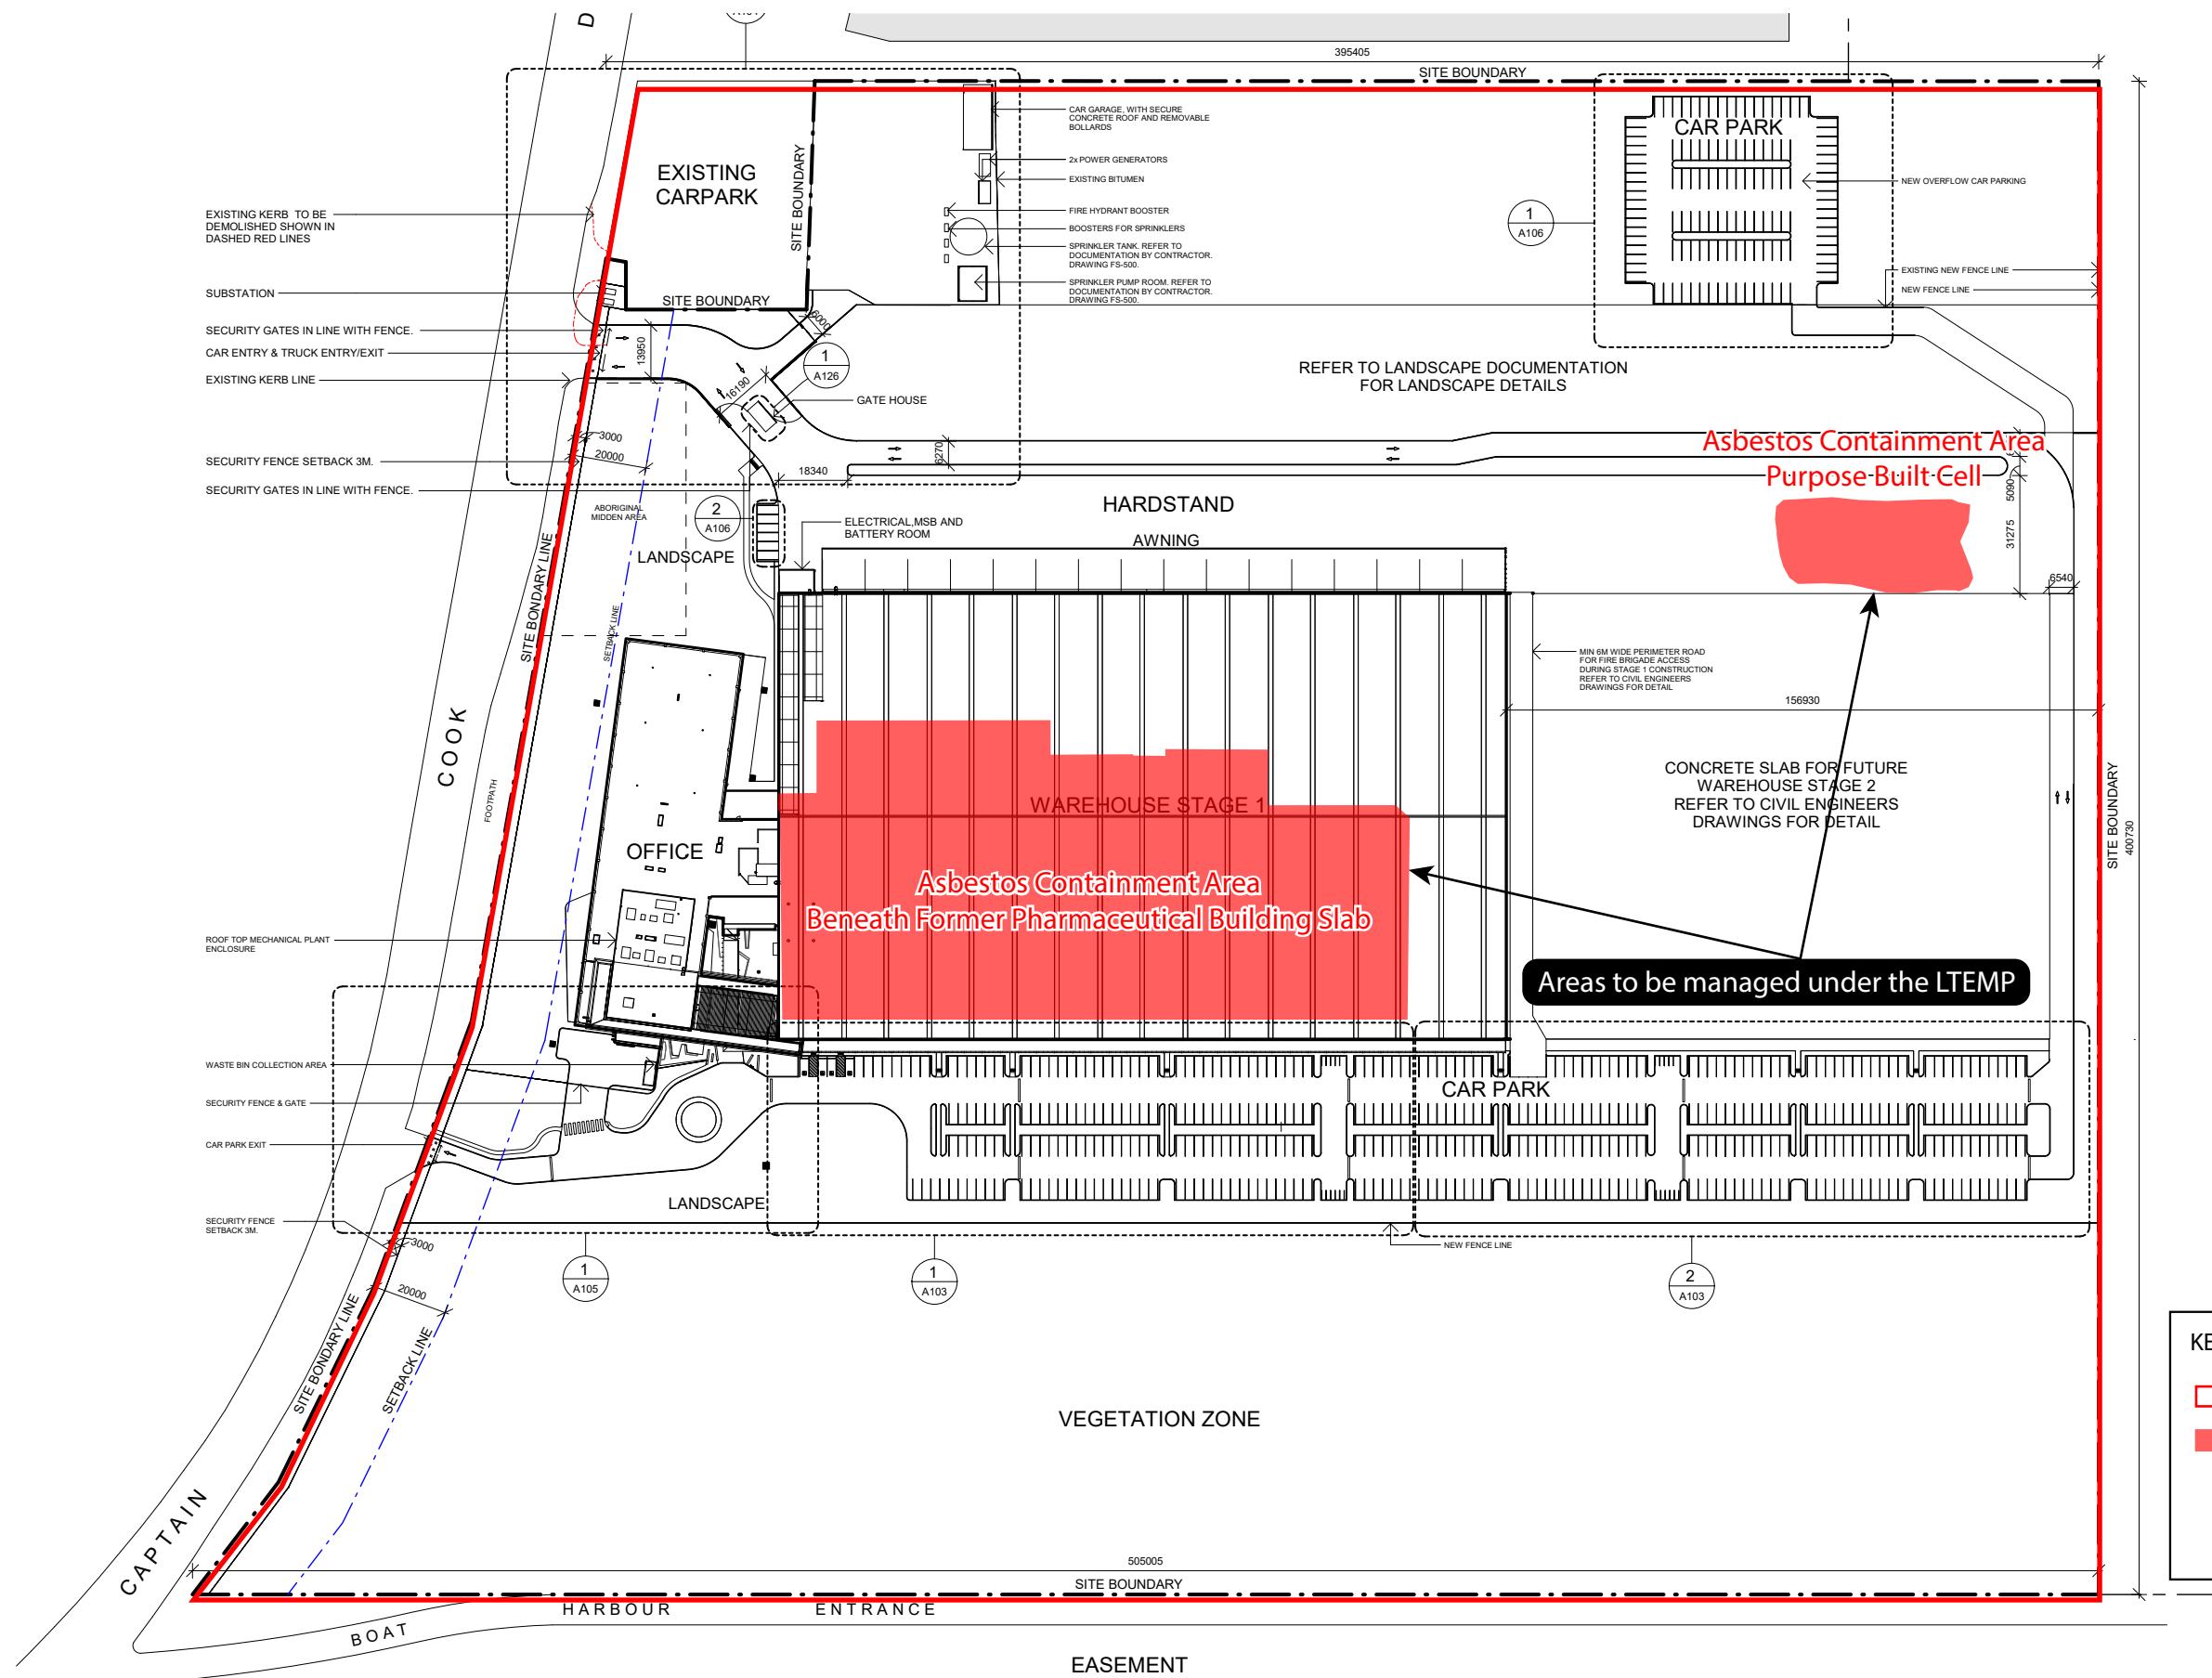
It should be noted that this LTEMP need only be applied if the soil beneath the site in the two designated areas is disturbed or exposed. The two containment areas are show in Figure 3, **Appendix A**.

Issue	Location	Monitoring Parameter	Monitoring Frequency	Performance Criteria/objective	Documentation
Integrity of the capping layer	illustrated in Figure 3, Appendix A	Visual inspection of the capping layer and geotextile marker integrity where applicable Obtain updated survey levels of capping areas to maintain updated capping thickness during works directly on or adjacent to the capping layer	Routine inspections by maintenance staff During and following any scheduled works	No significant damage / erosions to the capping layers reference levels indicate sufficient capping remains in situ to provide an effective barrier	Performance checklist/report Photographic records Survey data
Asbestos beneath the geotextile and capping layer	Excavation and stockpiling of waste spoil	Excavations and stockpiles or bins are not resulting in dust generation Public are excluded from the works area Asbestos waste with appropriate signage Sediment migration minimised No reuse of asbestos waste onsite Air monitoring	Daily during any intrusive works	Works in accordance with agreed S WMS	Performance checklist/report Air Monitoring results

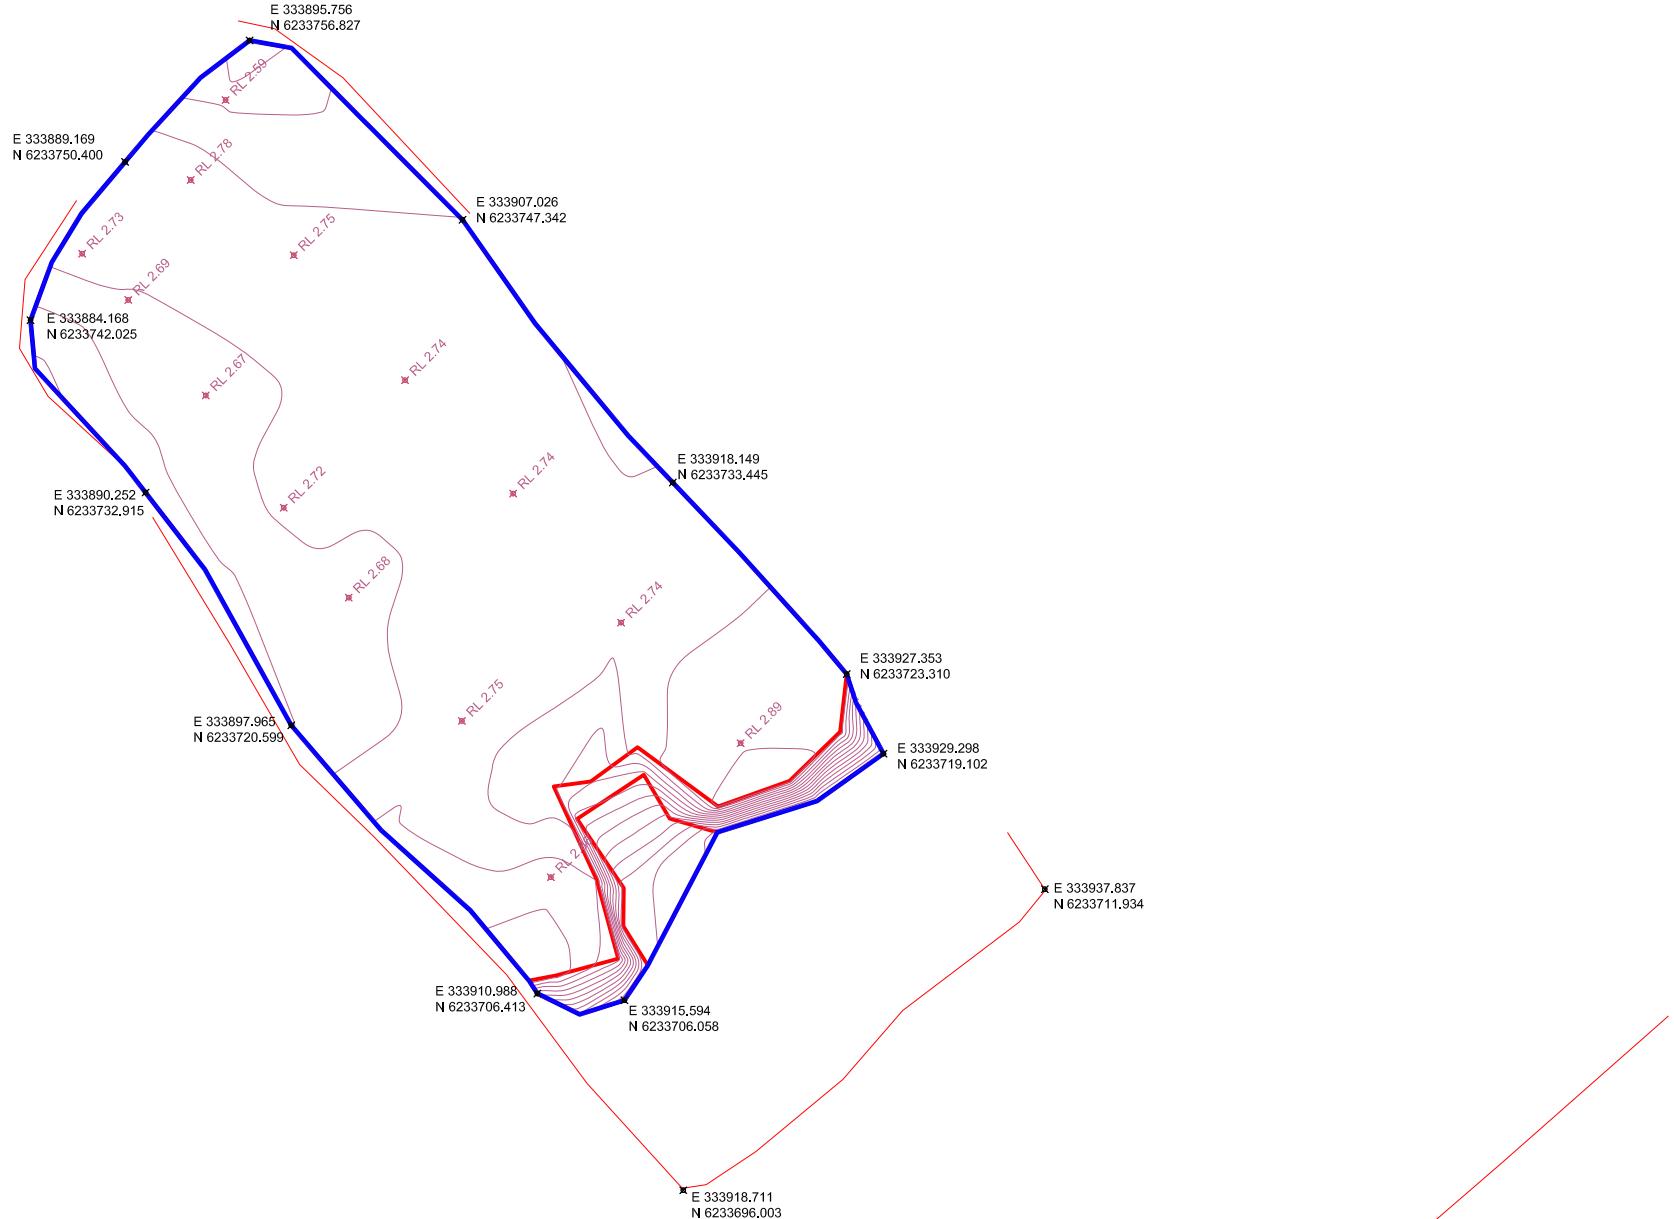
BORROW PIT CONTAMINATED
LAYER PICKUP 19-8-19
CUT = 0 Cu.m.
FILL = 1,306 Cu.m.

No bulking or compaction
factors have been applied

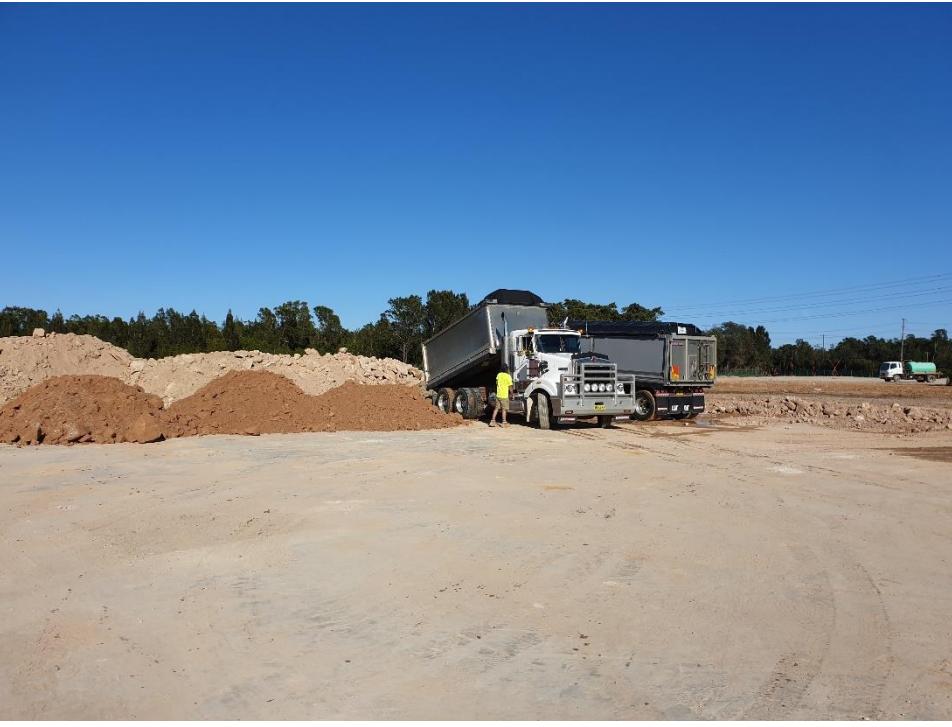
Photo No.	Date
1	18 Oct 2019
Description: VENM being unloaded onto main pharmaceutical slab for capping.

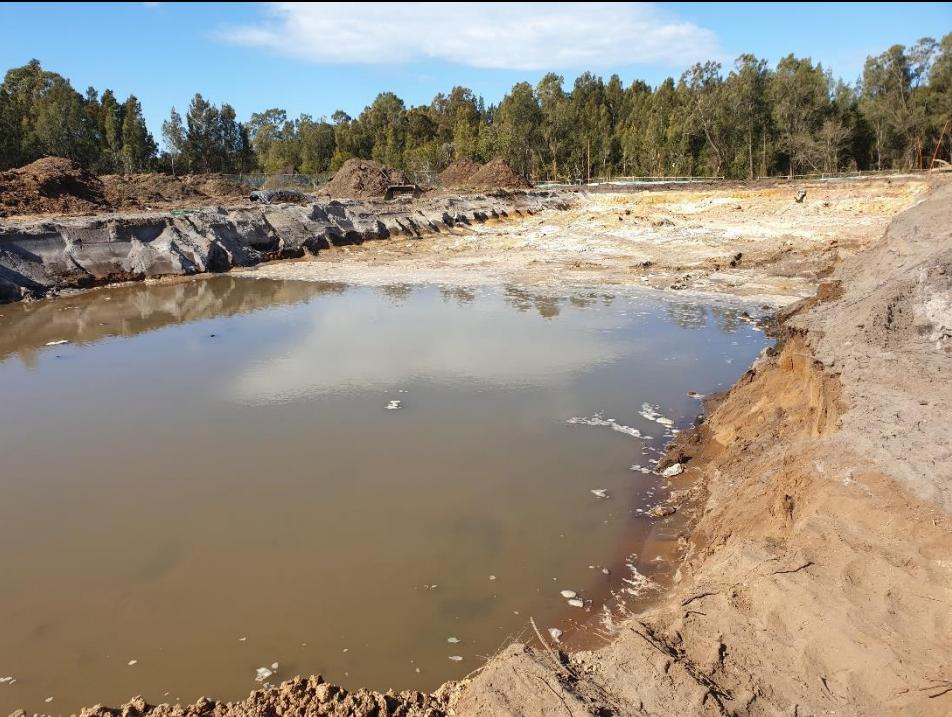
Photo No.	Date
2	27 Jul 2019
Description: Excavation of encapsulation cell at the south eastern end of the site.

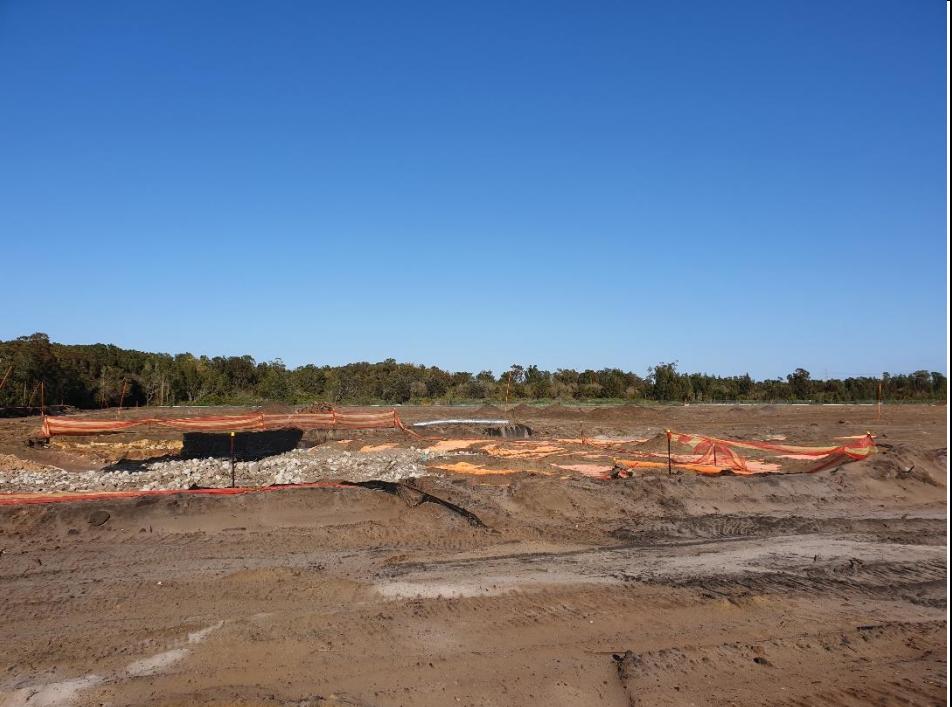
Photo No.	Date	
3	28 Aug 2019

Description: Cell filled with concrete and emu picked ACM. Lined with orange bidim marker layer and temporarily fenced with barrier fencing.

During removal of the building slabs (i.e former engineering building, fermentation building and chemical building) fragments of ACM were observed to be adhered to the underside of the slabs. The fragments appear to have been placed between the plastic/liner and the concrete during construction of the slabs. The pieces of demolished concrete slab and the administration building slab have been encapsulated within a purpose-built cell at the south eastern portion of the site and capped under approximately 0.4m of crushed sandstone VENM. The cell has an area of approximately 1,100m² and a volume capacity of approximately 1,300m³ and is lined with orange geofabric bidim ® marker layer.

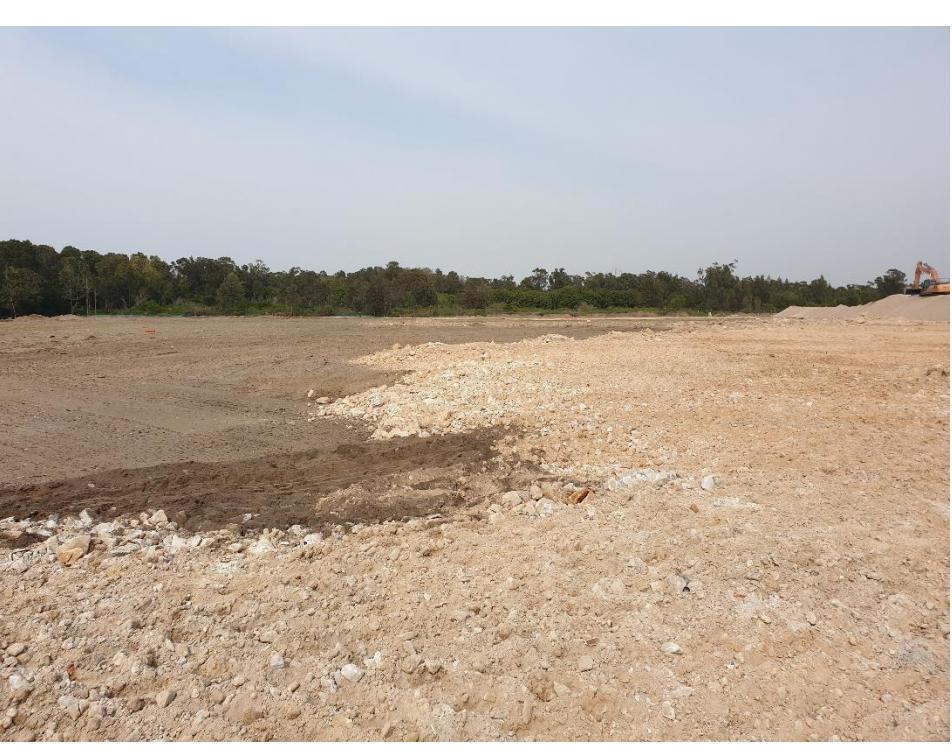
Photo No.	Date	
4	18 Oct 2019

Description: First lift of VENM being rolled onto surface to raise site levels and providing capping layer.

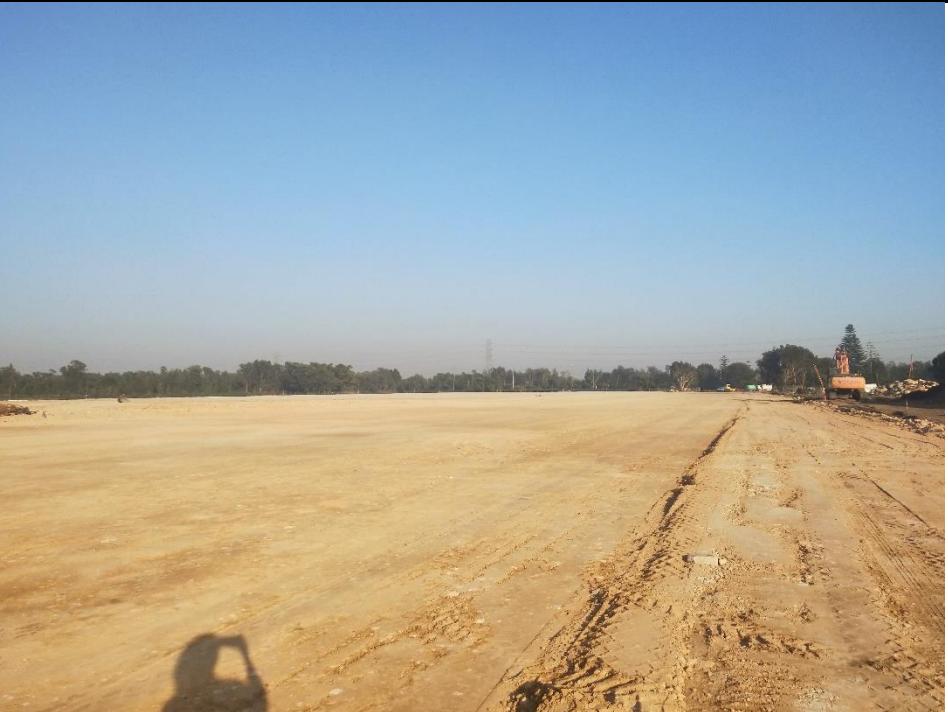
Photo No.	Date	
5	12 Nov 2019	
Description: Near final level after VENM placed and rolled over majority of site.
