# St Aloysius' College, Kirribilli

## SSD Masterplan

### Geotechnical Interpretive Report

**Date:**  
07 February 2018

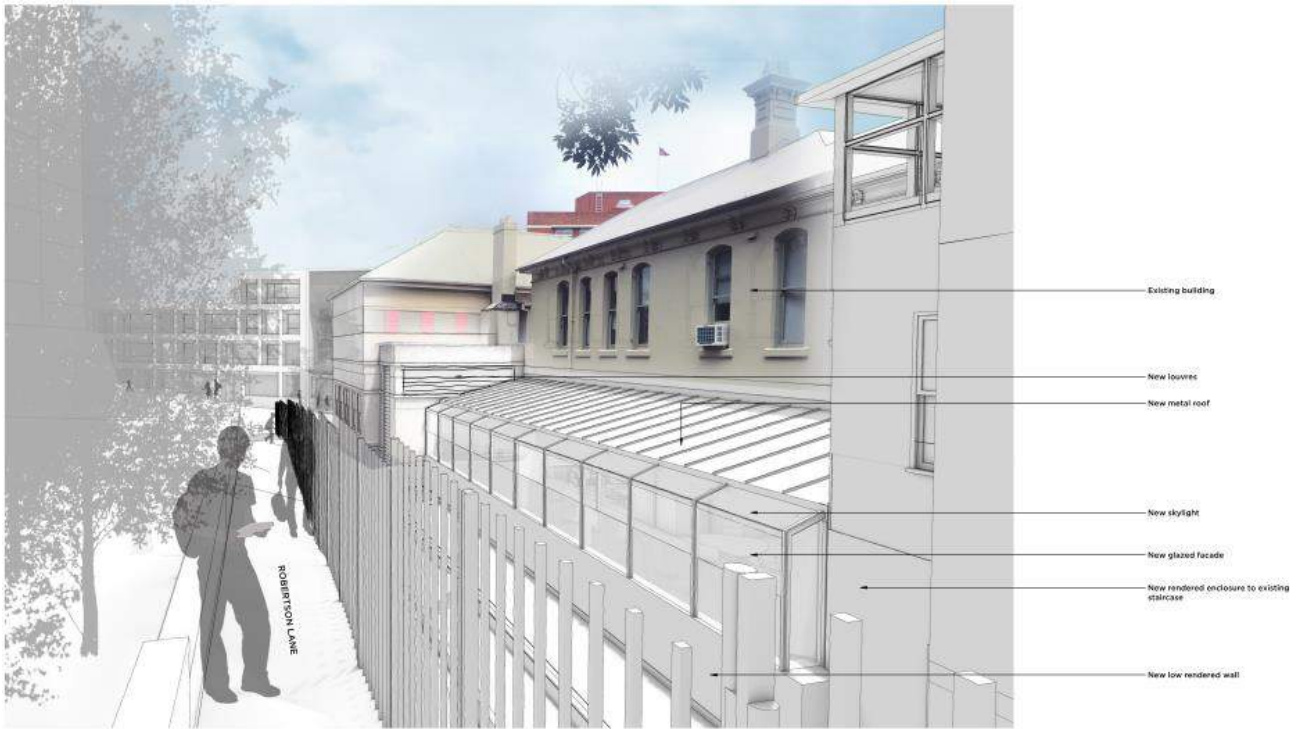
The proposed classroom extension is expected to be founded upon the underlying Sandstone formation (circa 900mm) with pumped concrete strip and pad foundations detailed to support the external masonry. Brick and blockwork cavity wall together with blockwork sleeper walls are provided to support a precast suspended floor slab. To allow for limiting handling requirements the proposed suspended floor is formed with precast beam elements supporting permanent form and insulation. The overlying pumped concrete slab is to be finished to reflect architects requirements.

Figure 2 Architectural Render of the proposed single storey structure

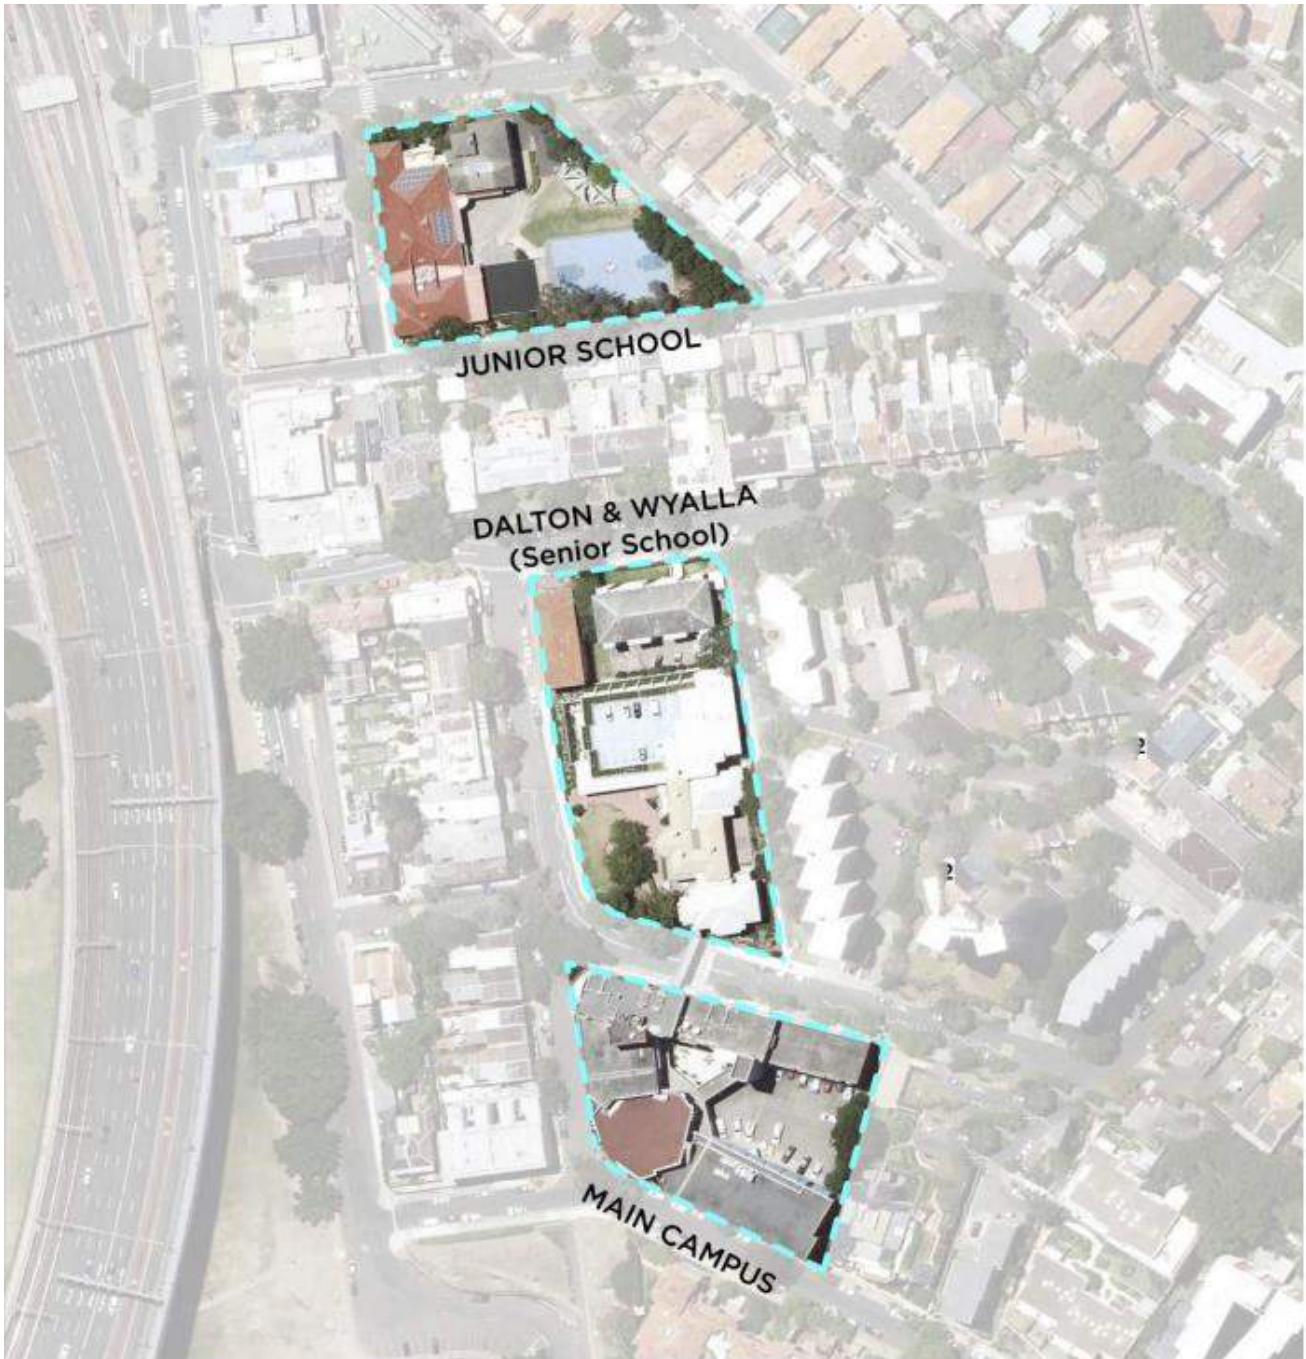
Figure 4 St Aloysius Site Overview

St Aloysius' College (the site) operations are located in Kirribilli, NSW and is located across three campuses. It is bisected by local roads and interspersed with light commercial and residential properties. All three campus sites were investigated for this project. For clarity the term "the site" will refer to the three sites, and where specific detail for a particular site we refer to the site by Junior School, Senior School and Main Campus.

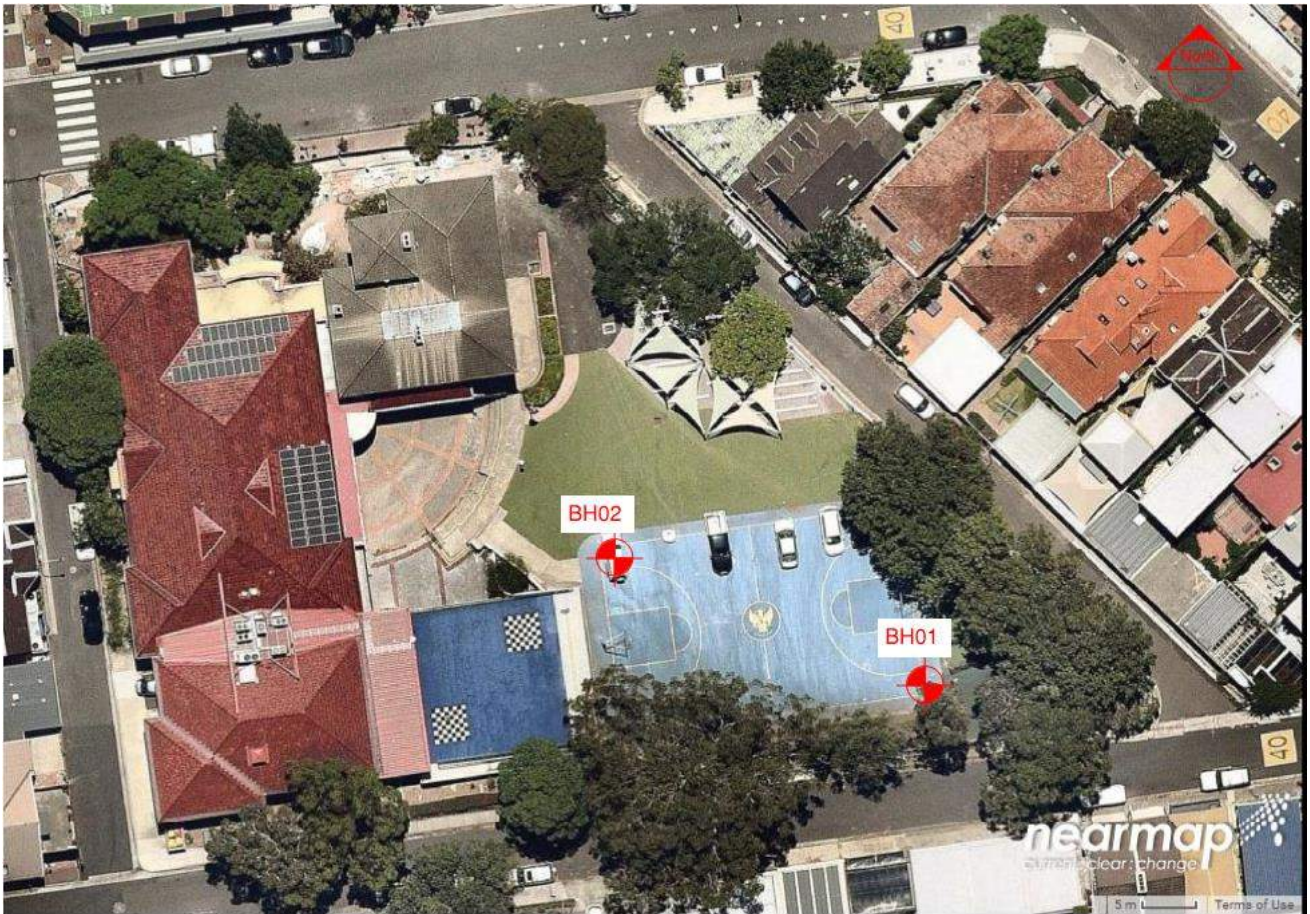
The Junior school is located on Burton Street Kirribilli. School buildings are present on the northern, western and southern boundary, the areas of the site investigated was the basketball court located in the south eastern corner (refer to the figure below). To the North of the basketball court a slope is present that falls to the north, the surface is artificial turf, and falls to a seating area and the north eastern boundary along Crescent Place.

Figure 5 Aerial Image of the Junior School Site and Borehole Locations (Source Nearmap)

The ground conditions at the junior school site indicate that the buried natural ground profile slopes to the north, to achieve the level surface for the existing basketball court fill comprising gravely sand has been placed (thickness increases from 0.30mbgl in BH01 to 1.80mbgl in BH02).

Ground water monitoring carried out in January indicates that the water depths in BH1 and BH2 range between 3.5m to 4.7m and 4.1m to 5.2m bgl respectively. These depths are consistent with stained and root bearing fractures observed during drilling. We note that ground water sampling was undertaken on 15/01/18 and subsequent monitoring visits show a lower groundwater depth on the 16/01/18 and 23/01/18 in BH1 suggesting that the wells may be recharging. Also the difference in depths between BH01 and BH02 is probably due to a northerly trending hydraulic gradient (i.e. in direction of topographical slope)

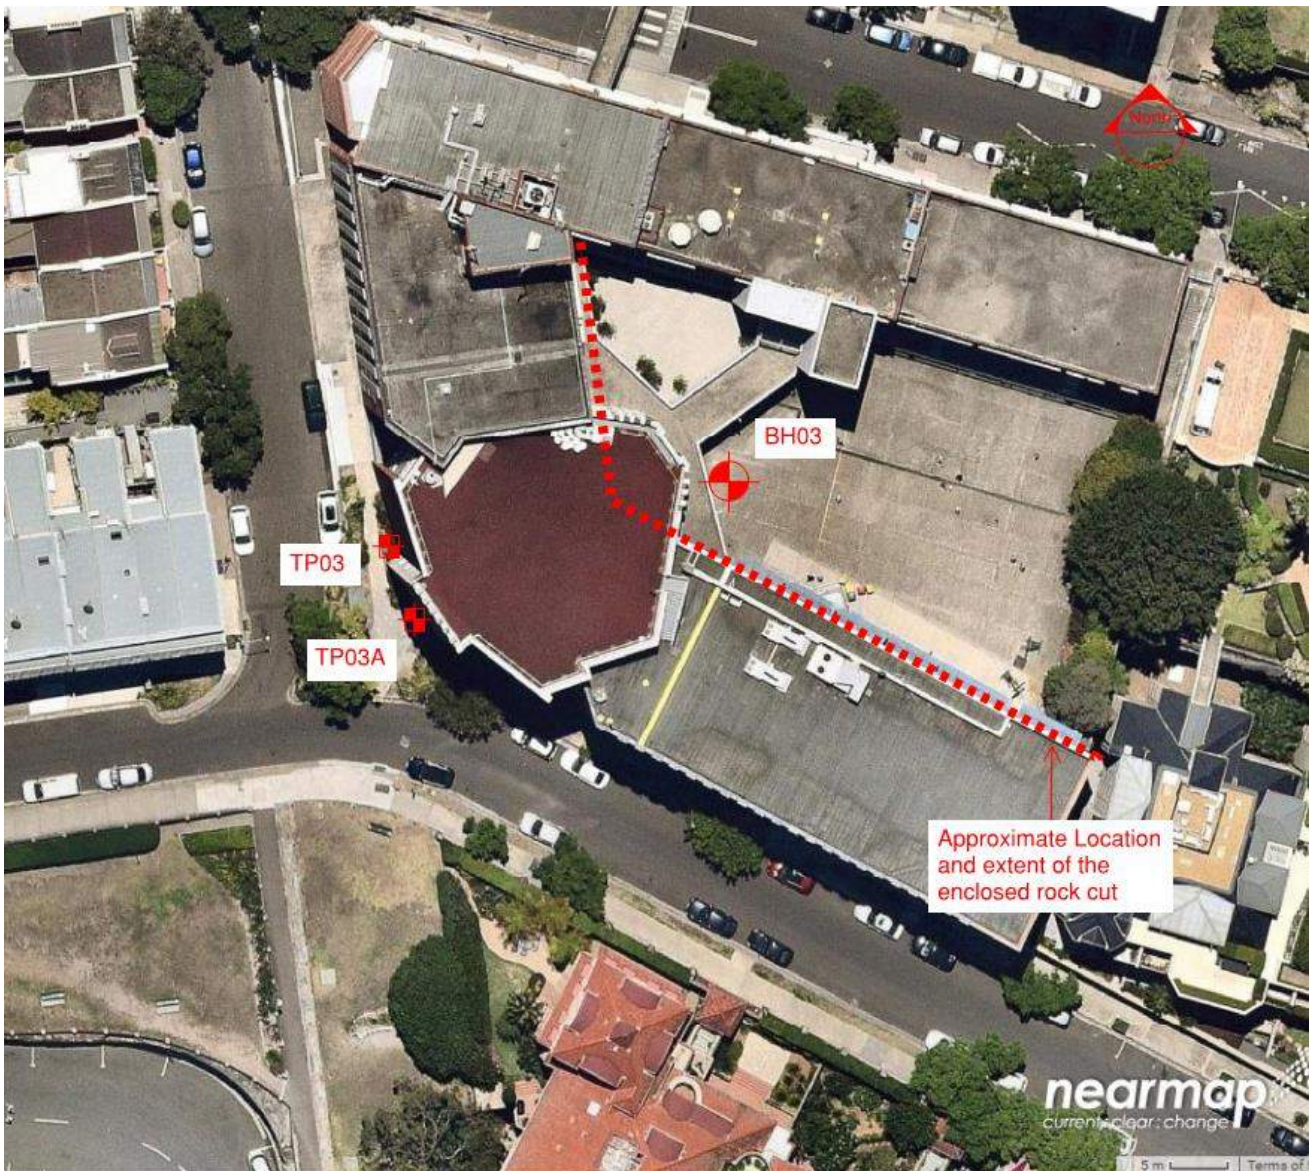
A rock cut is enclosed by the school buildings. The cut is accessed from the lower ground floor maintenance workshops and storage areas that are located on the western elevation at Jefferys St. The dashed line shown on figure 7 below indicates its approximate location and extents.

Figure 7 Main Campus Site and Exploratory Locations (Source Nearmap)

Rock mapping was carried out of the cutting and this corroborated the ground conditions encountered in the borehole. The existing excavated rock face approximately 6 to 8m high and approximately 80m in length generally comprised of massive Sandstone, medium to high strength with moderately to widely spaced defects, horizontal to sub-horizontal. The cutting was observed from the base, rock mesh was noted near the crest suggesting that the rock quality is in a poorer condition in the top 1 to 2 m. This would be expected due to the effects of weathering. It appears the means of excavation was by drill and blast techniques and pre-splitting was not carried, resulting in a more irregular and fractured surface. Localised spot bolting has been carried out to support wedge and block failures. Tensioned wire rope has also been adopted to provide additional support to localised areas. Ground water seepage was noted from localised joints at various locations across the face.

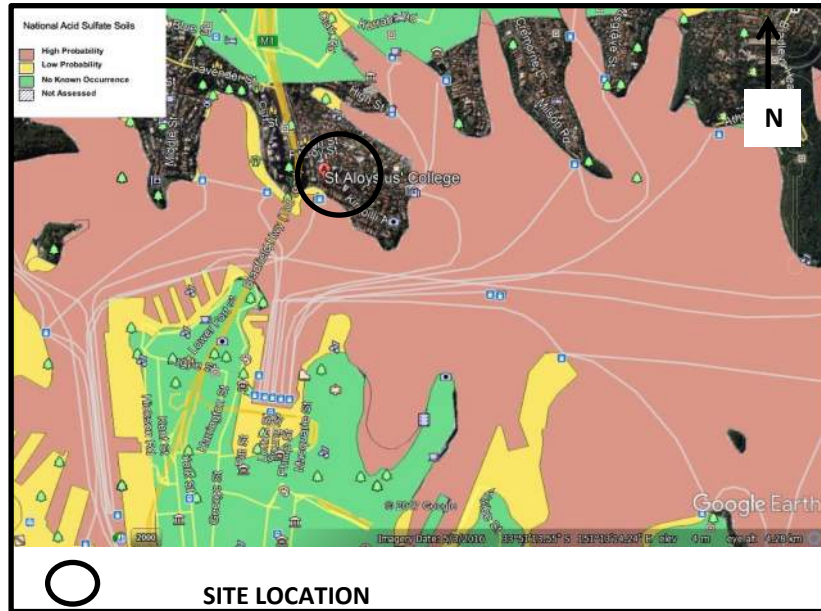
**Figure 3: Site Location with Acid Sulphate Map Overlay**

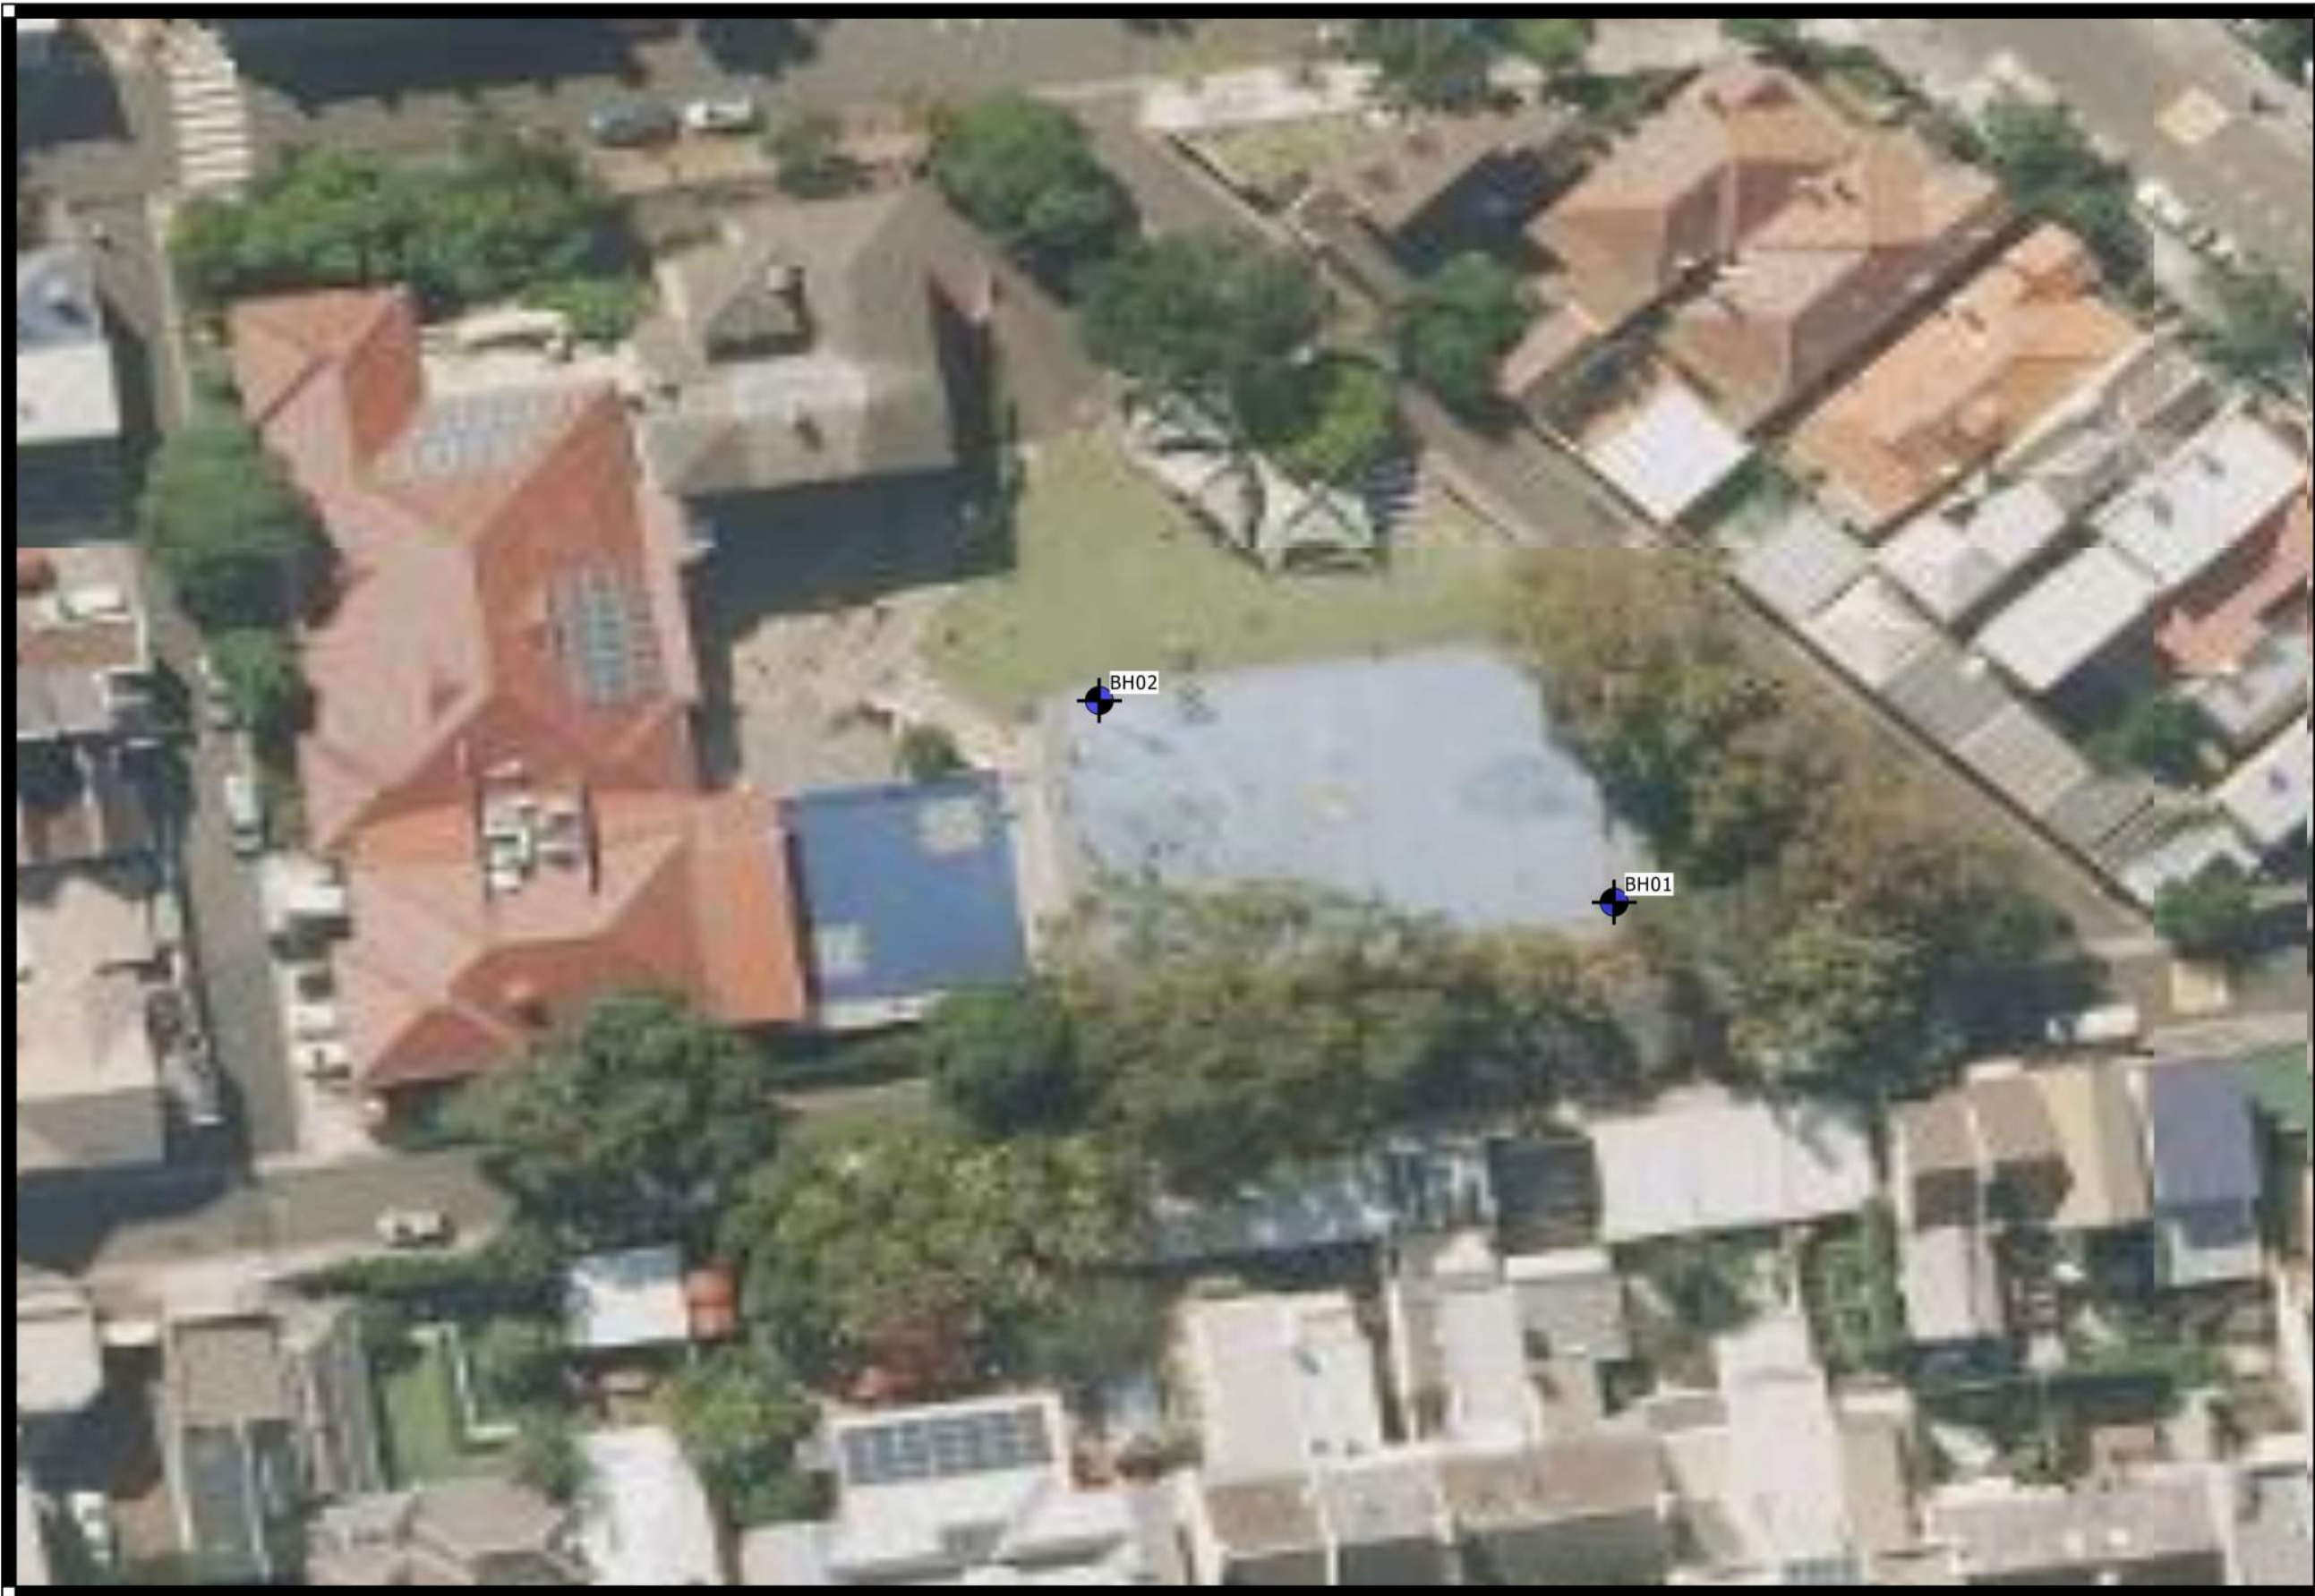
Drawing Number: B17550 St Aloysius College Geotechnical Investigation  
REV 0

Macquarie Geotechnical Ltd  
Geotechnical Investigation Locality Map

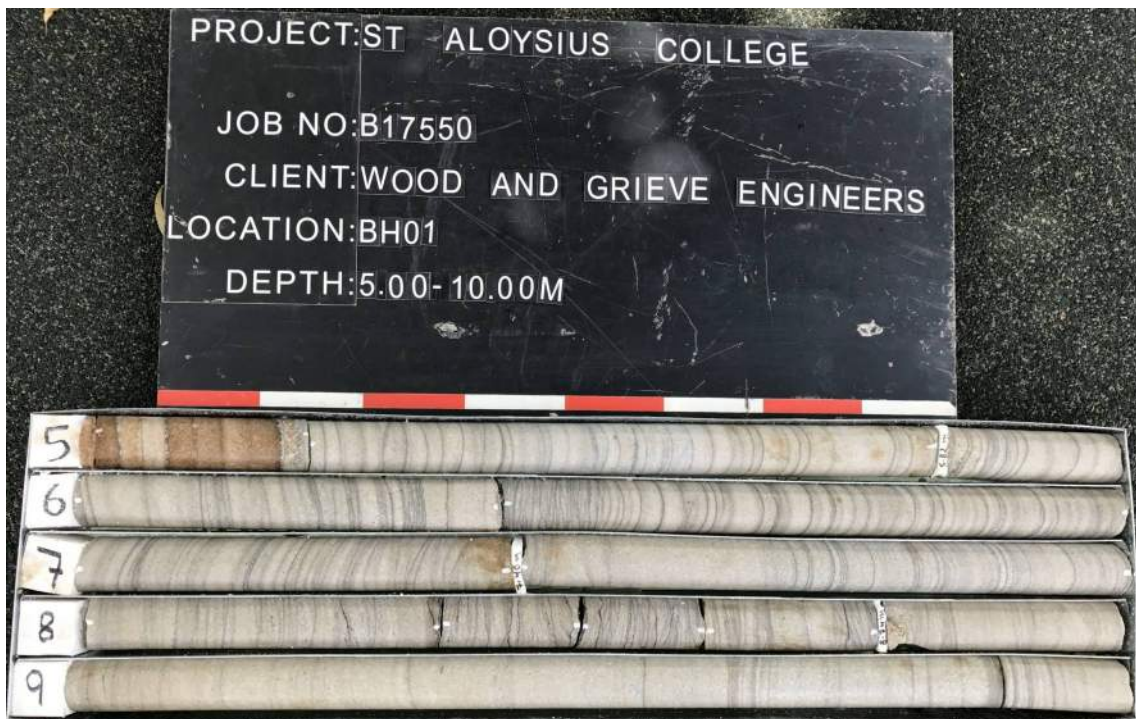
PointID : BH01 Depth Range: 1.10 - 5.00 m

**Engineering Log - Cored Borehole**

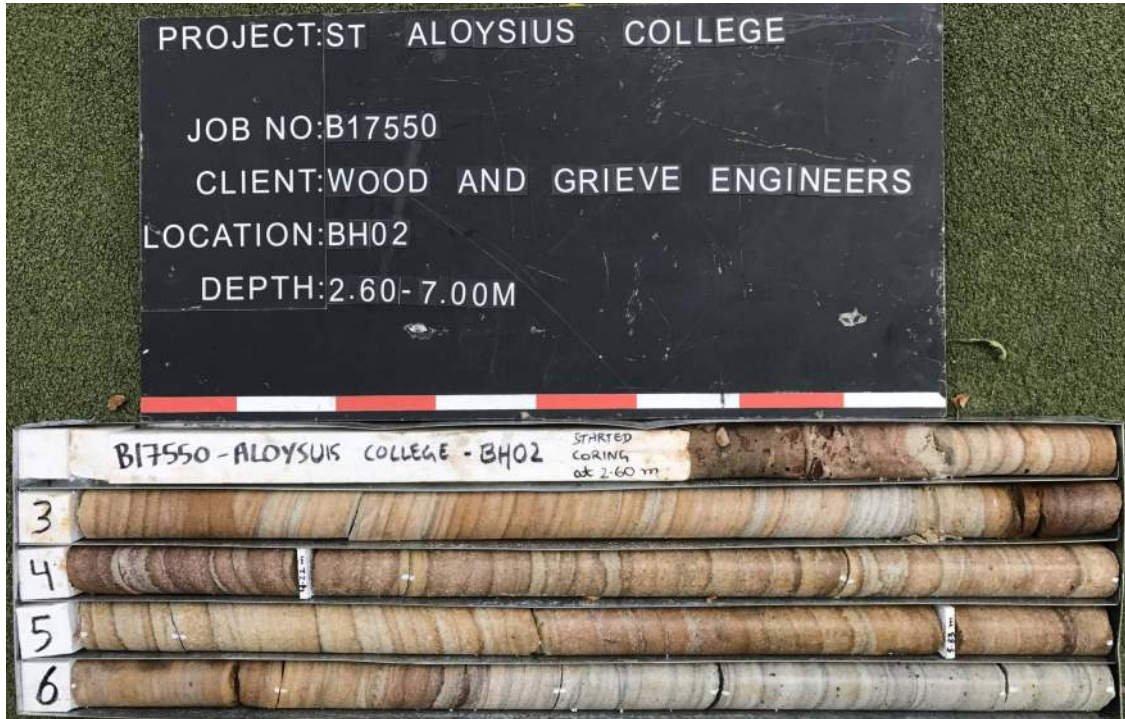
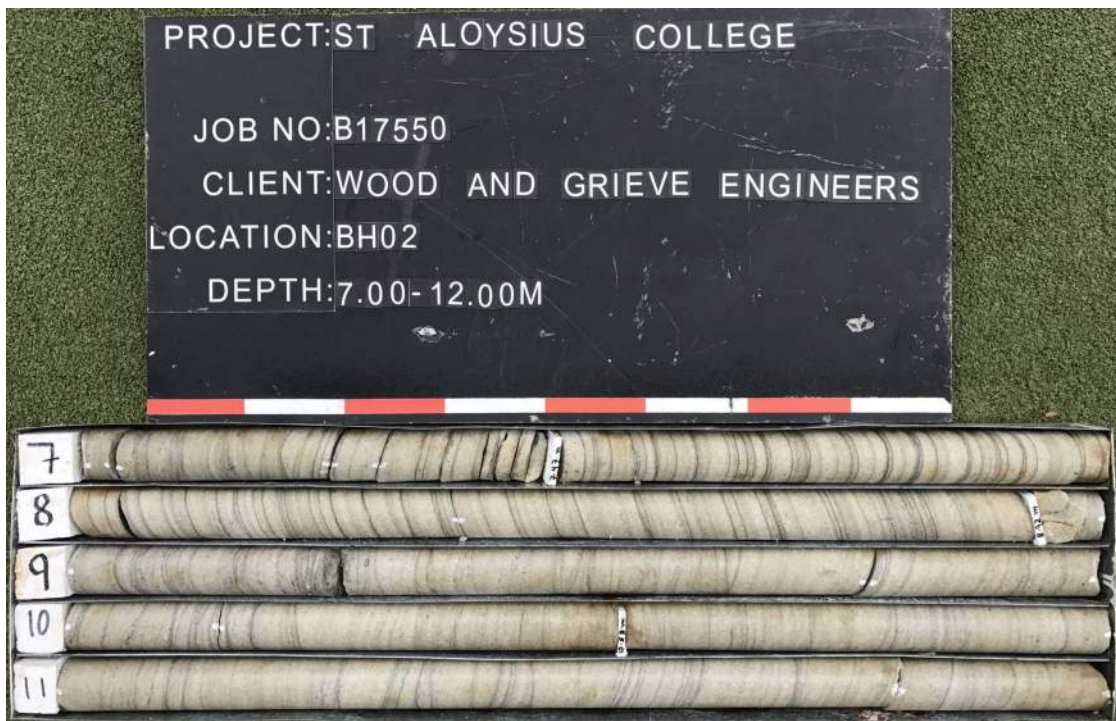
PointID : BH02 Depth Range: 2.60 - 7.00 m

**Engineering Log - Cored Borehole**

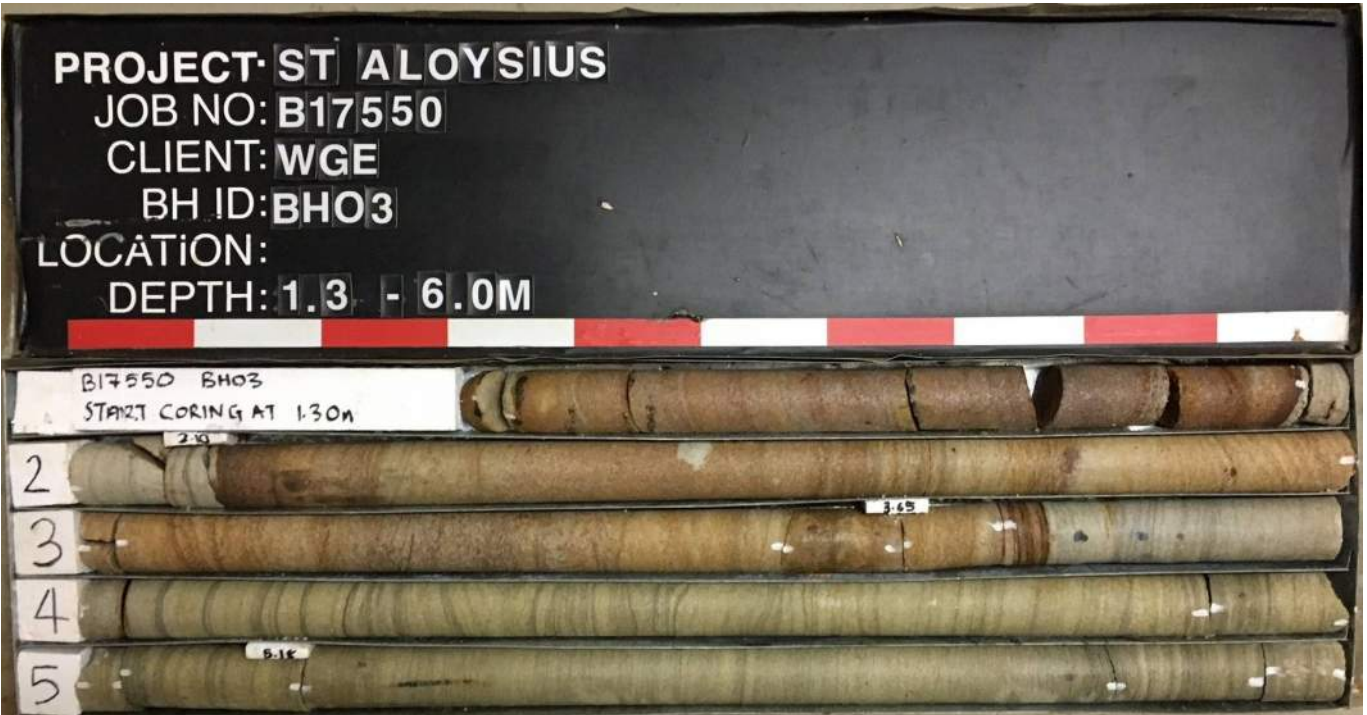
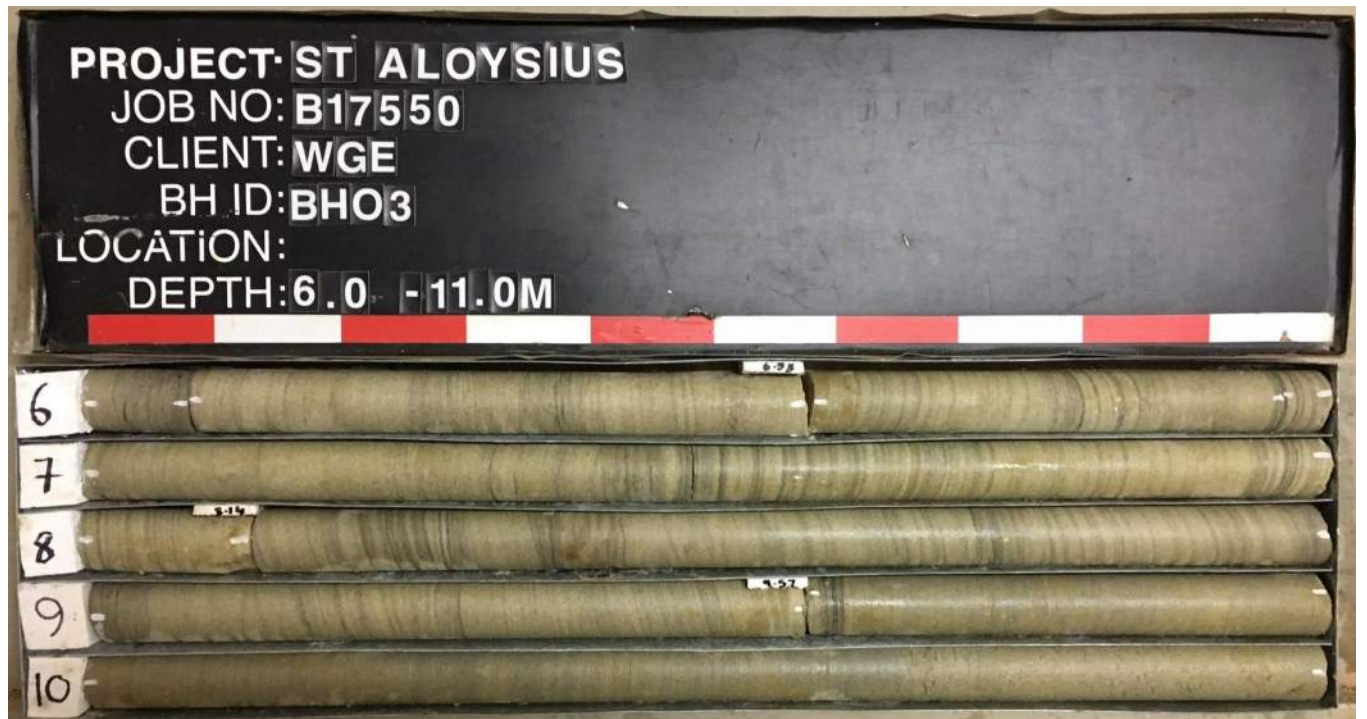
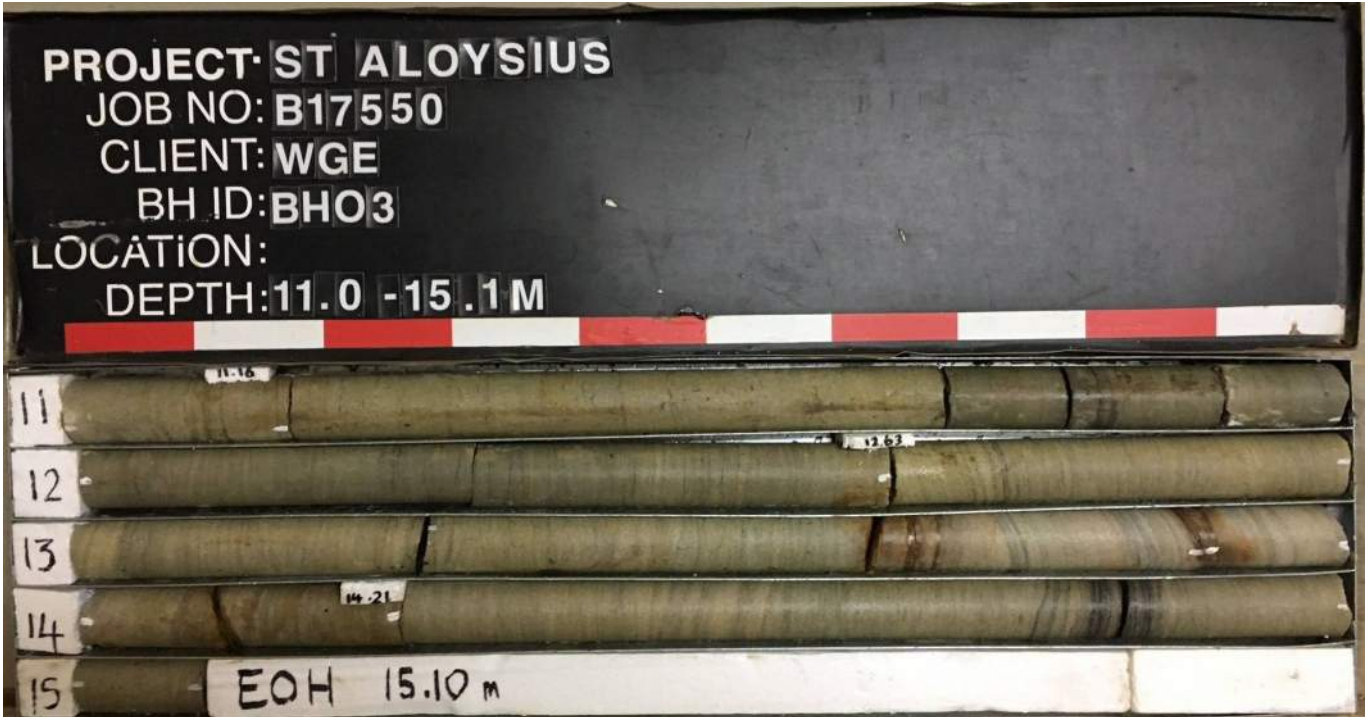
PointID : BH03 Depth Range: 1.30 - 6.00 m

**Engineering Log - Cored Borehole**

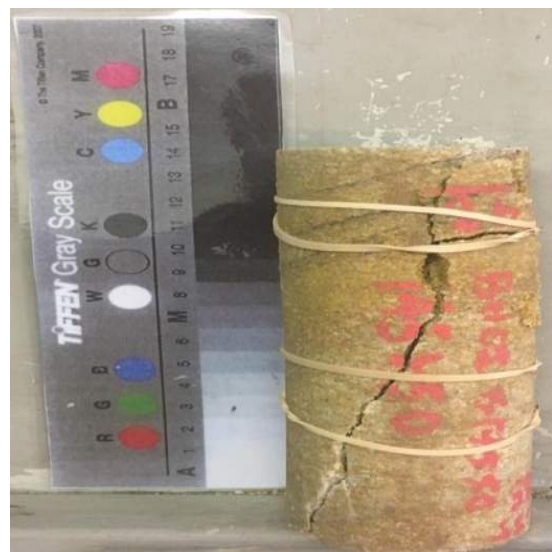
Before Test

After Test

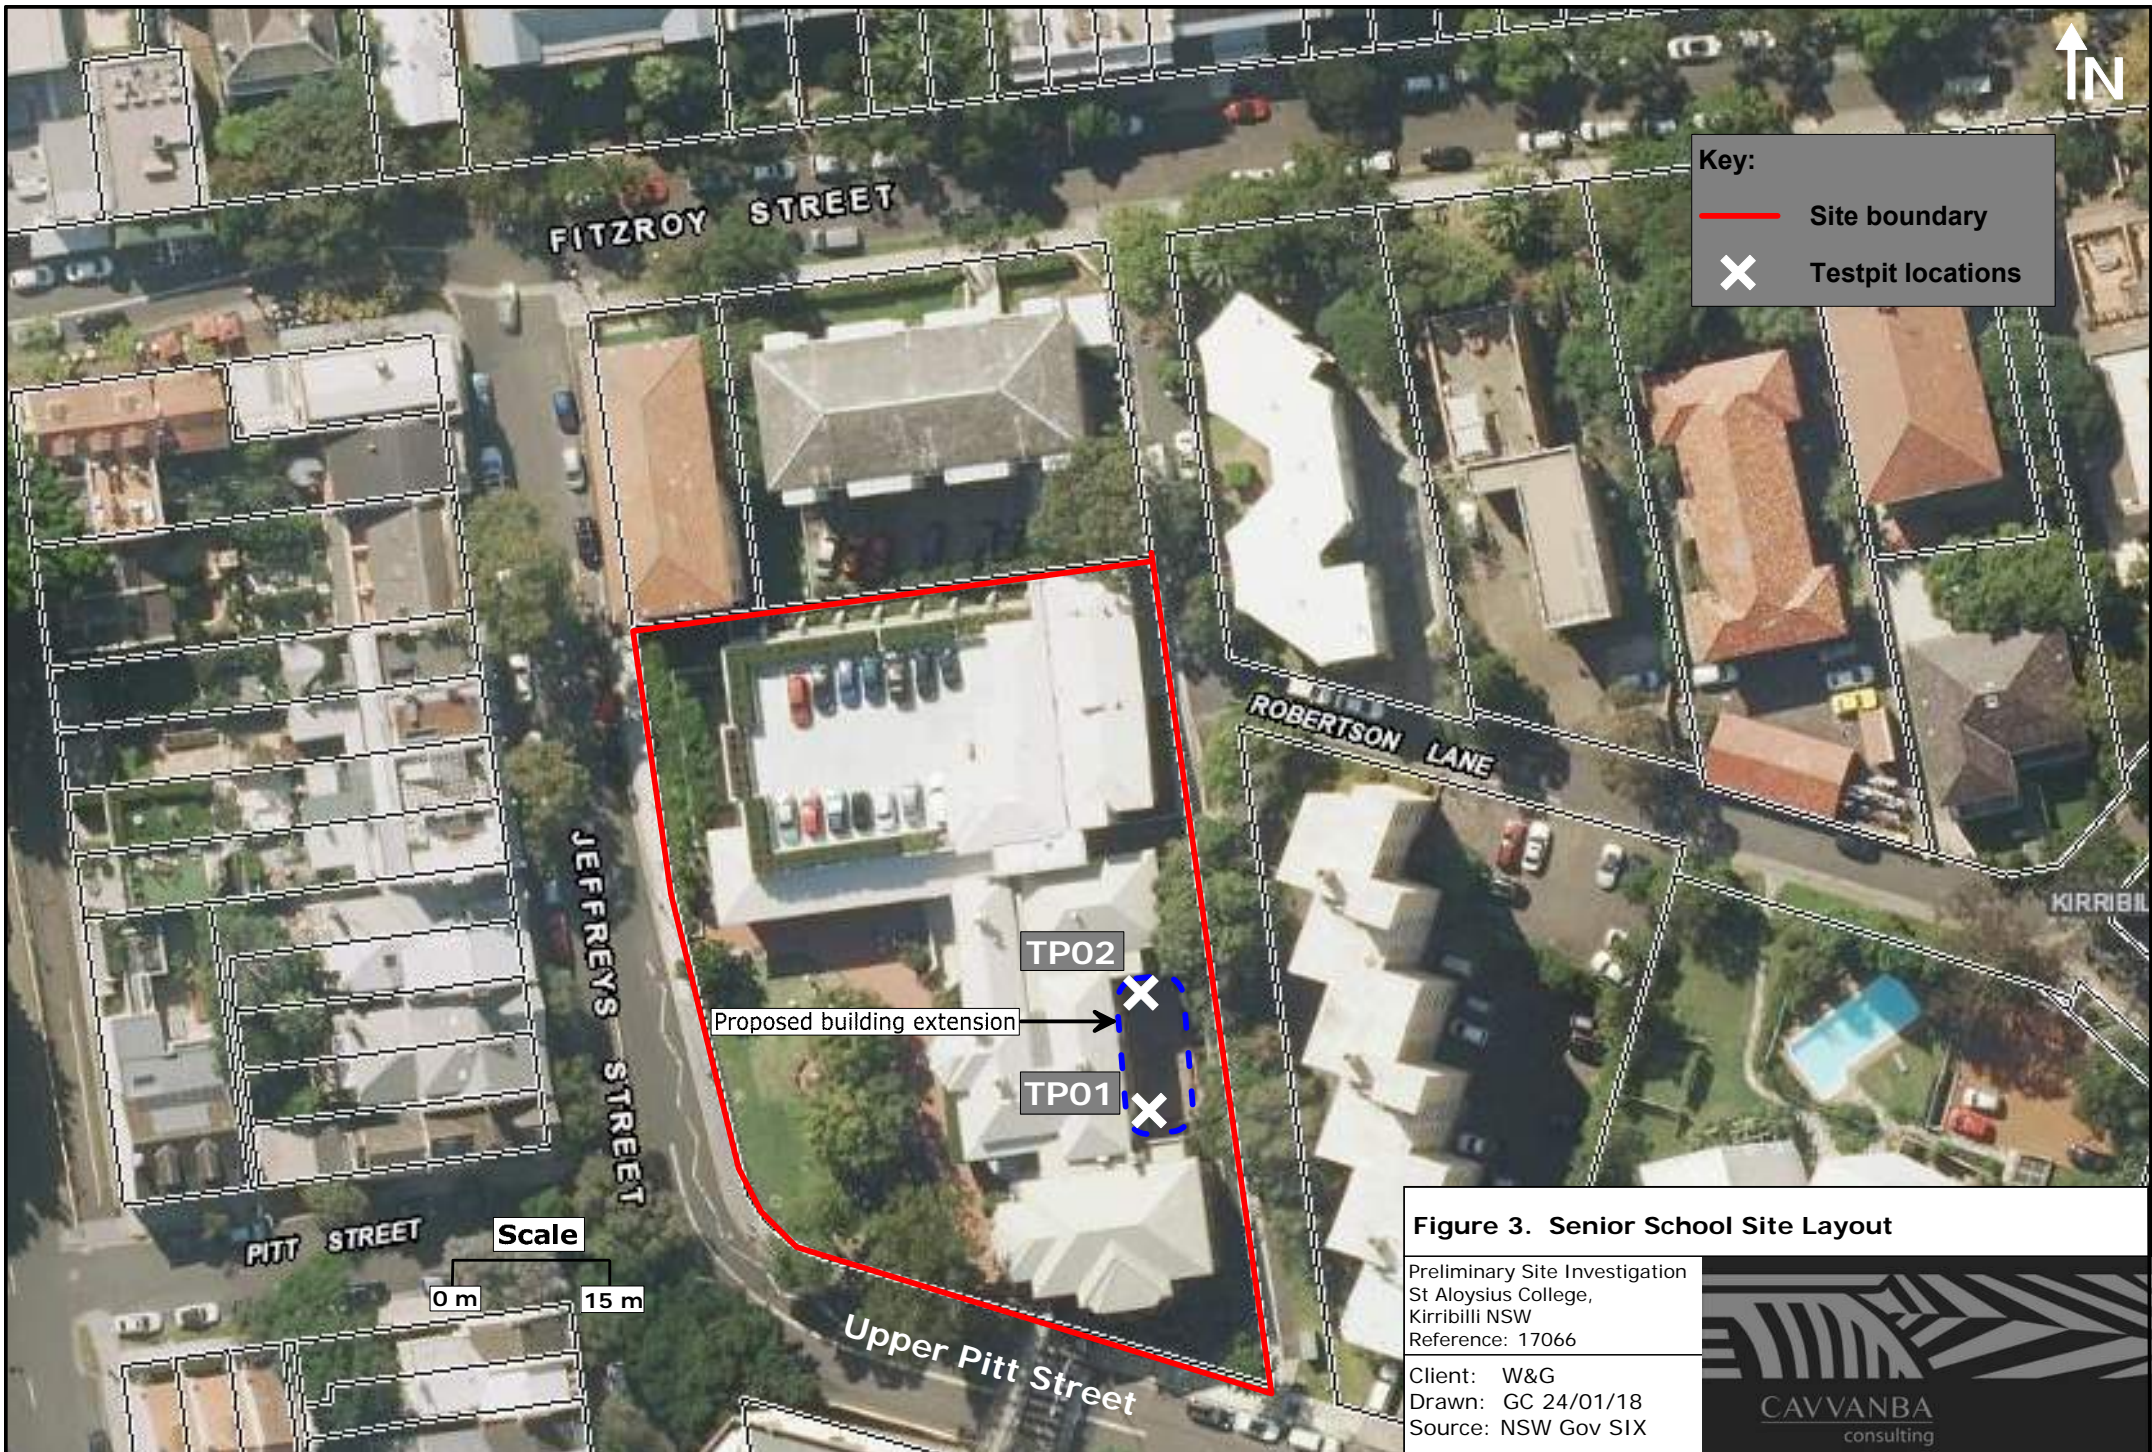
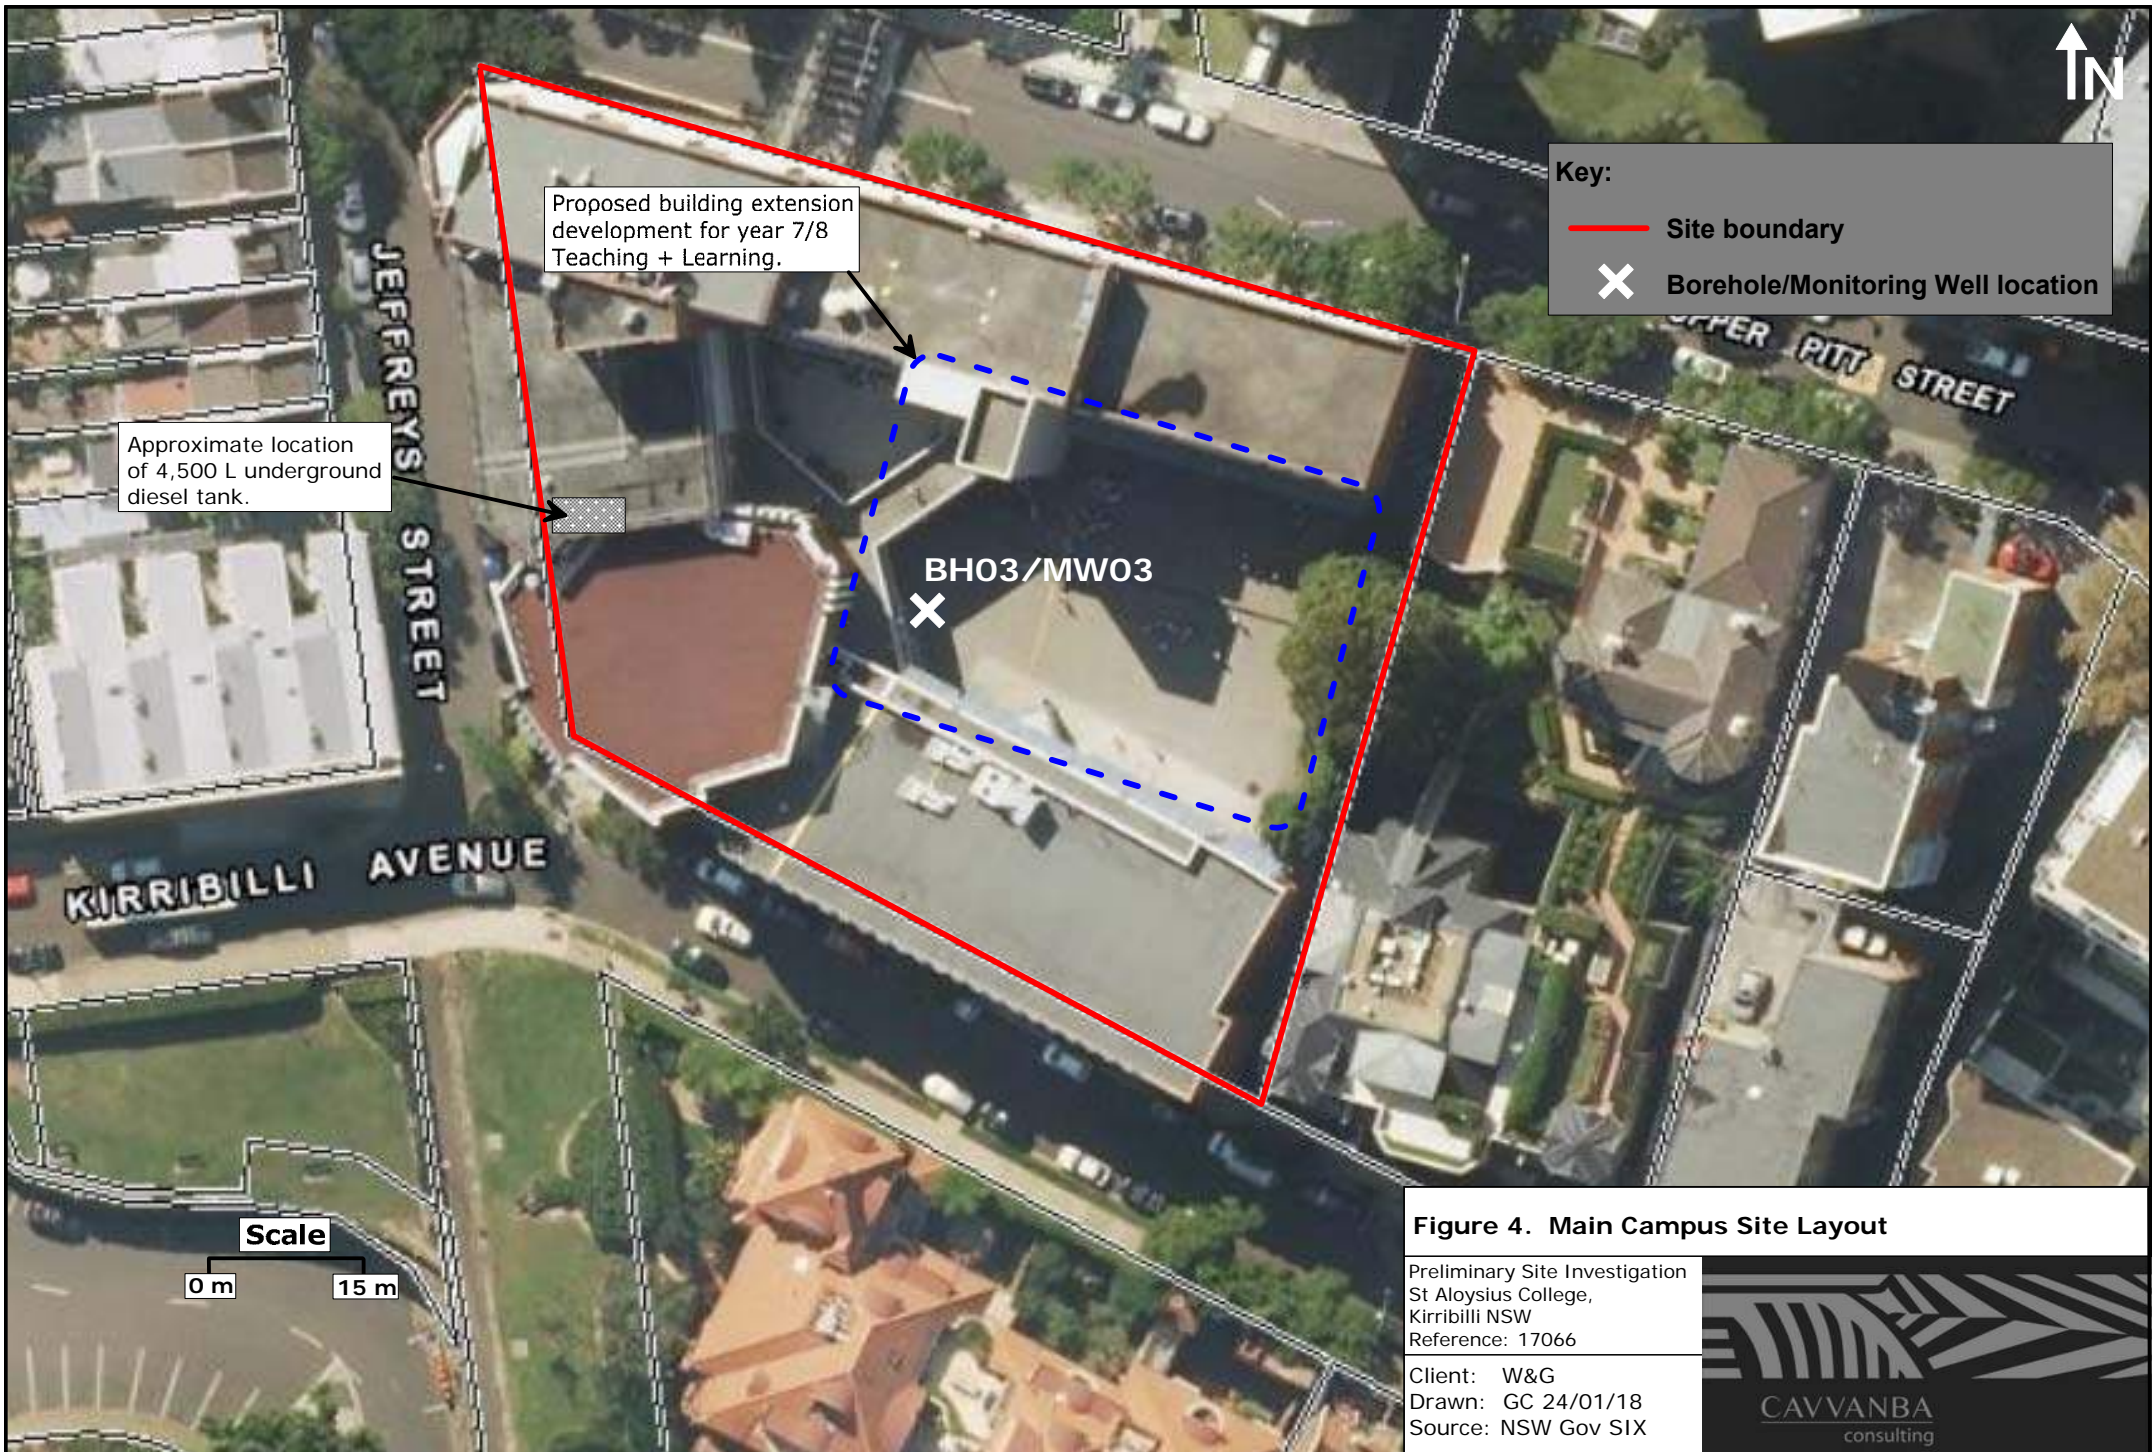
Figure 5: Conceptual Site Model Flow Chart

The conceptual site model (CSM) is a representation of site-related information regarding contamination sources, receptors and exposure pathways between those sources and receptors. The CSM for the site, following the soil investigation works is detailed in Table 11.1 and Figure 5 as a flow chart, attached.
