## Geotechnical Investigation

64 & 66 Lavender Street and 3, 5 & 7 Middlemiss Street, Lavender Bay, NSW 2060

RG1358-GR-1-1

**Report Type:** Geotechnical Site Investigation Report

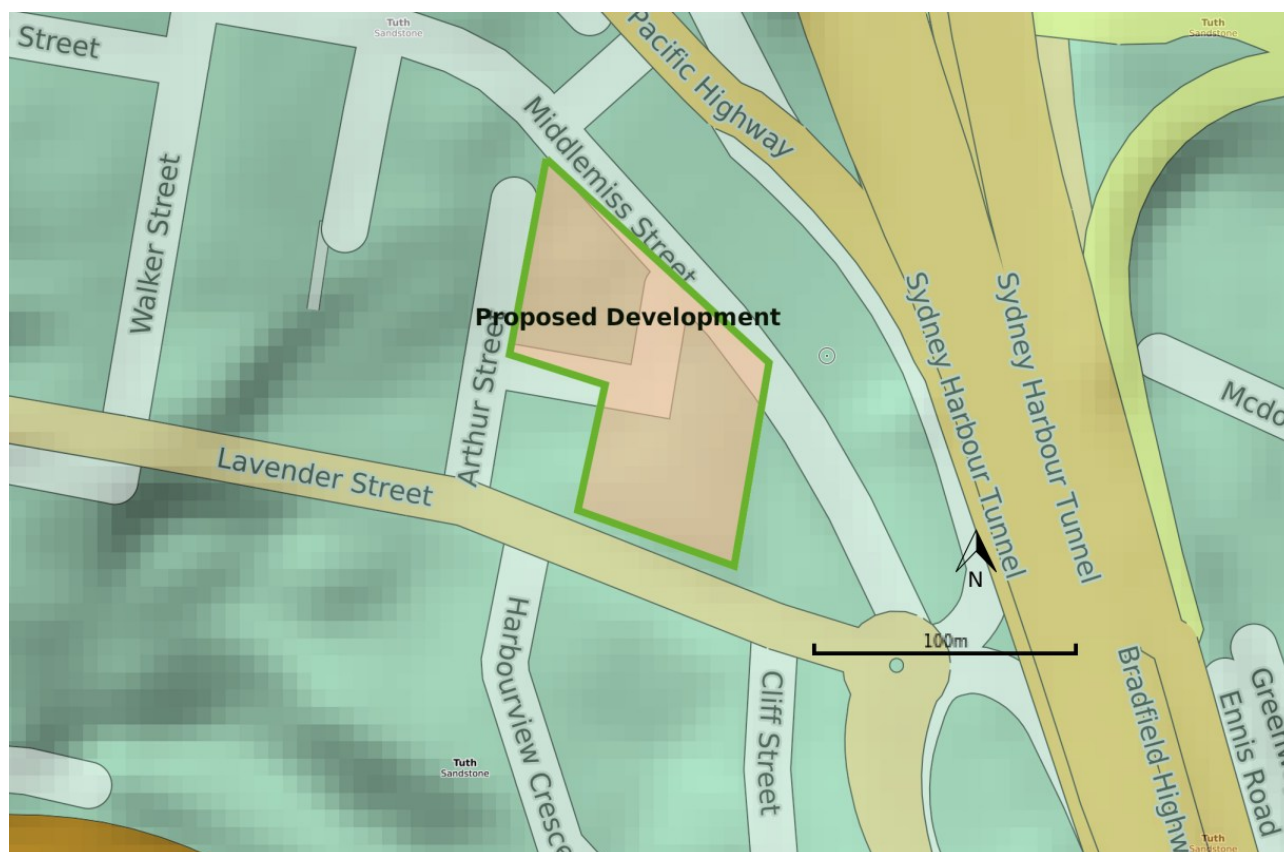
Figure 2 – Geological Features (Source: Minview Website)

The site is located within the Sydney Basin and is underlain by Middle Triassic sedimentary sequences. The local geology is defined by the Hawkesbury Sandstone, a major stratigraphic unit which dates to the Middle Triassic period with an estimated age range of 247.2 to 242.0 million years (Ma). The site-specific lithology comprises medium- to coarse-grained quartz sandstone exhibiting small- to large-scale, high-angle cross-bedding. The sandstone sequence is typically interspersed with minor shale and laminite lenses, which characterize the depositional environment of this unit.

**Figure 2** below provides an excerpt from the Minview geological mapping database.

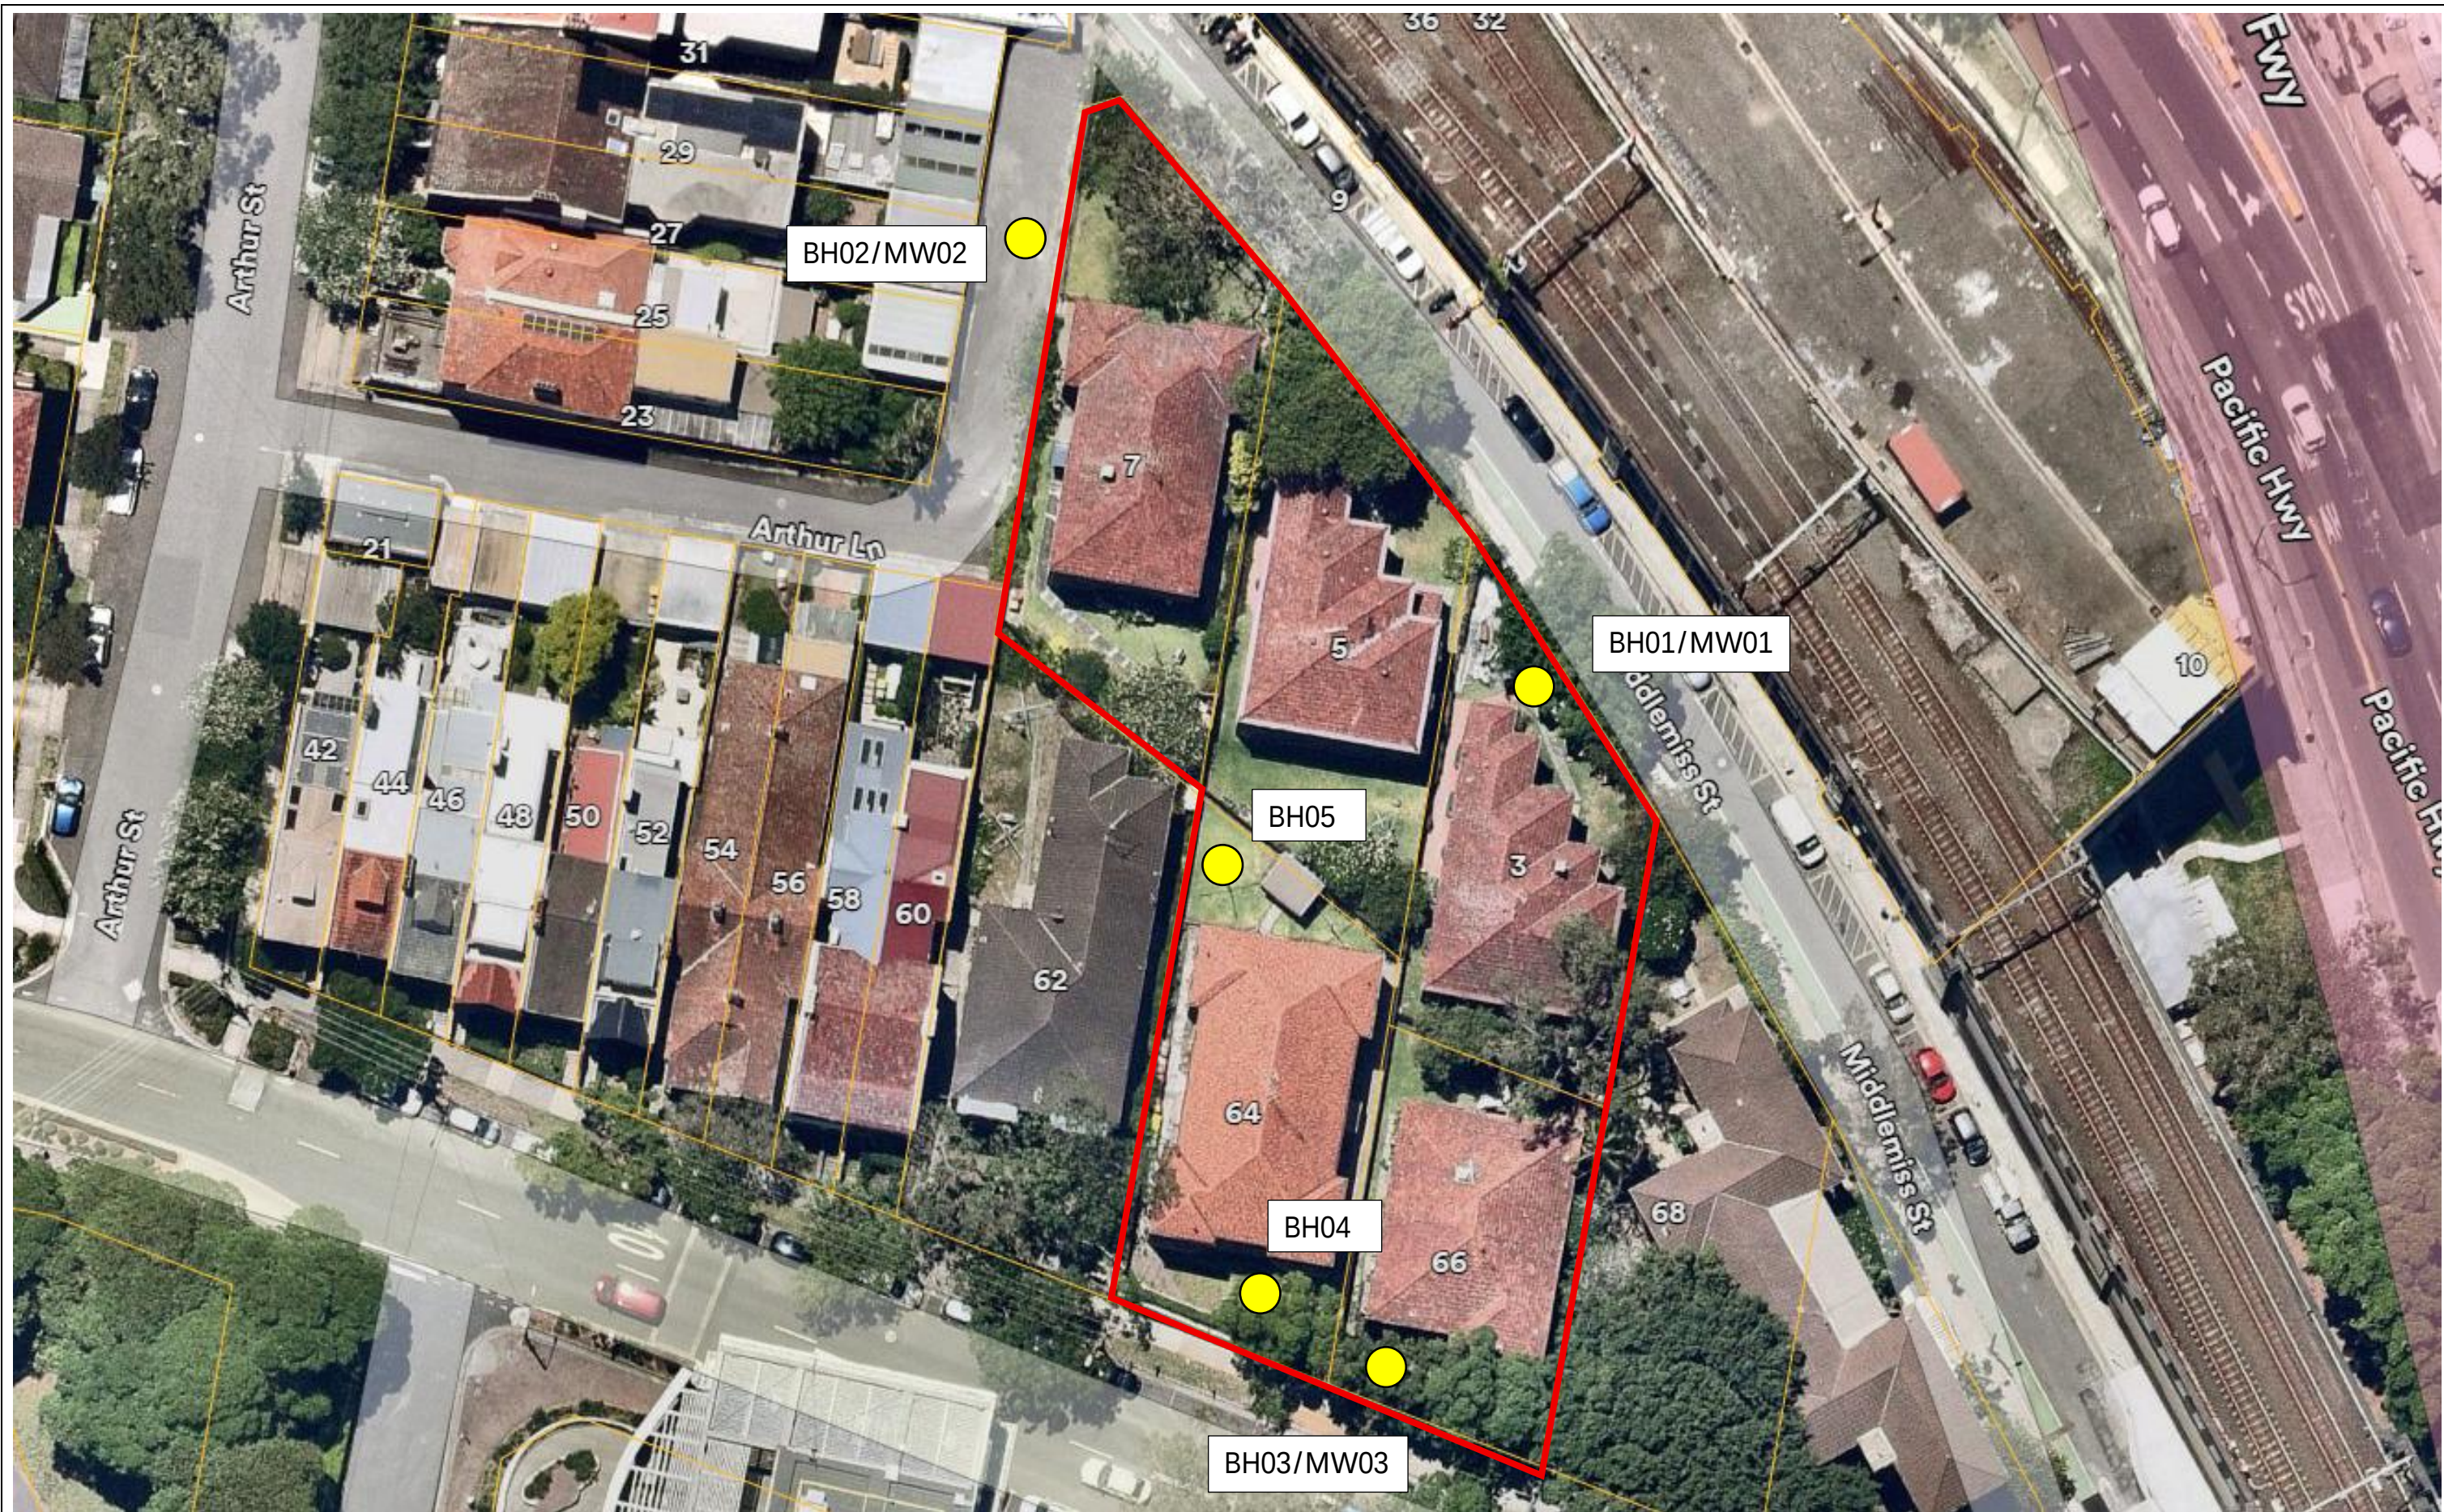
**Attachment A – Borehole Location Plan**

| Client Name: Central Element | Feature: | <div><div></div> Approximate Borehole Locations</div> <div><div></div> Site Boundary</div> |
| Project Name: Geotechnical Investigation | Figure Number: 1 | |

- Collection of disturbed soil samples and cored rock samples for laboratory testing and future reference.
- Recording of standing groundwater levels or seepage observed during and upon the completion of drilling.
- Installation of groundwater monitoring wells at two (2) borehole locations to facilitate ongoing level monitoring.
- The approximate locations of the investigation sites referred to above are shown on the Site Plan (**Figure A1, Attachment A**).

The subsurface ground conditions encountered in the boreholes are summarised in detailed logs provided in **Attachment B**. The boreholes' location is enclosed in **Attachment A**.
