### **The Harbour Rocks Hotel, 34 Harrington Street, The Rocks**

### **Aboriginal Archaeological Assessment**

**PREPARED BY:** Tory Stening  
**REPORT TO:** Welsh + Major  
**LGA:** City of Sydney  
**DATE:** October 2017  
**VERSION:** A.2017.1005

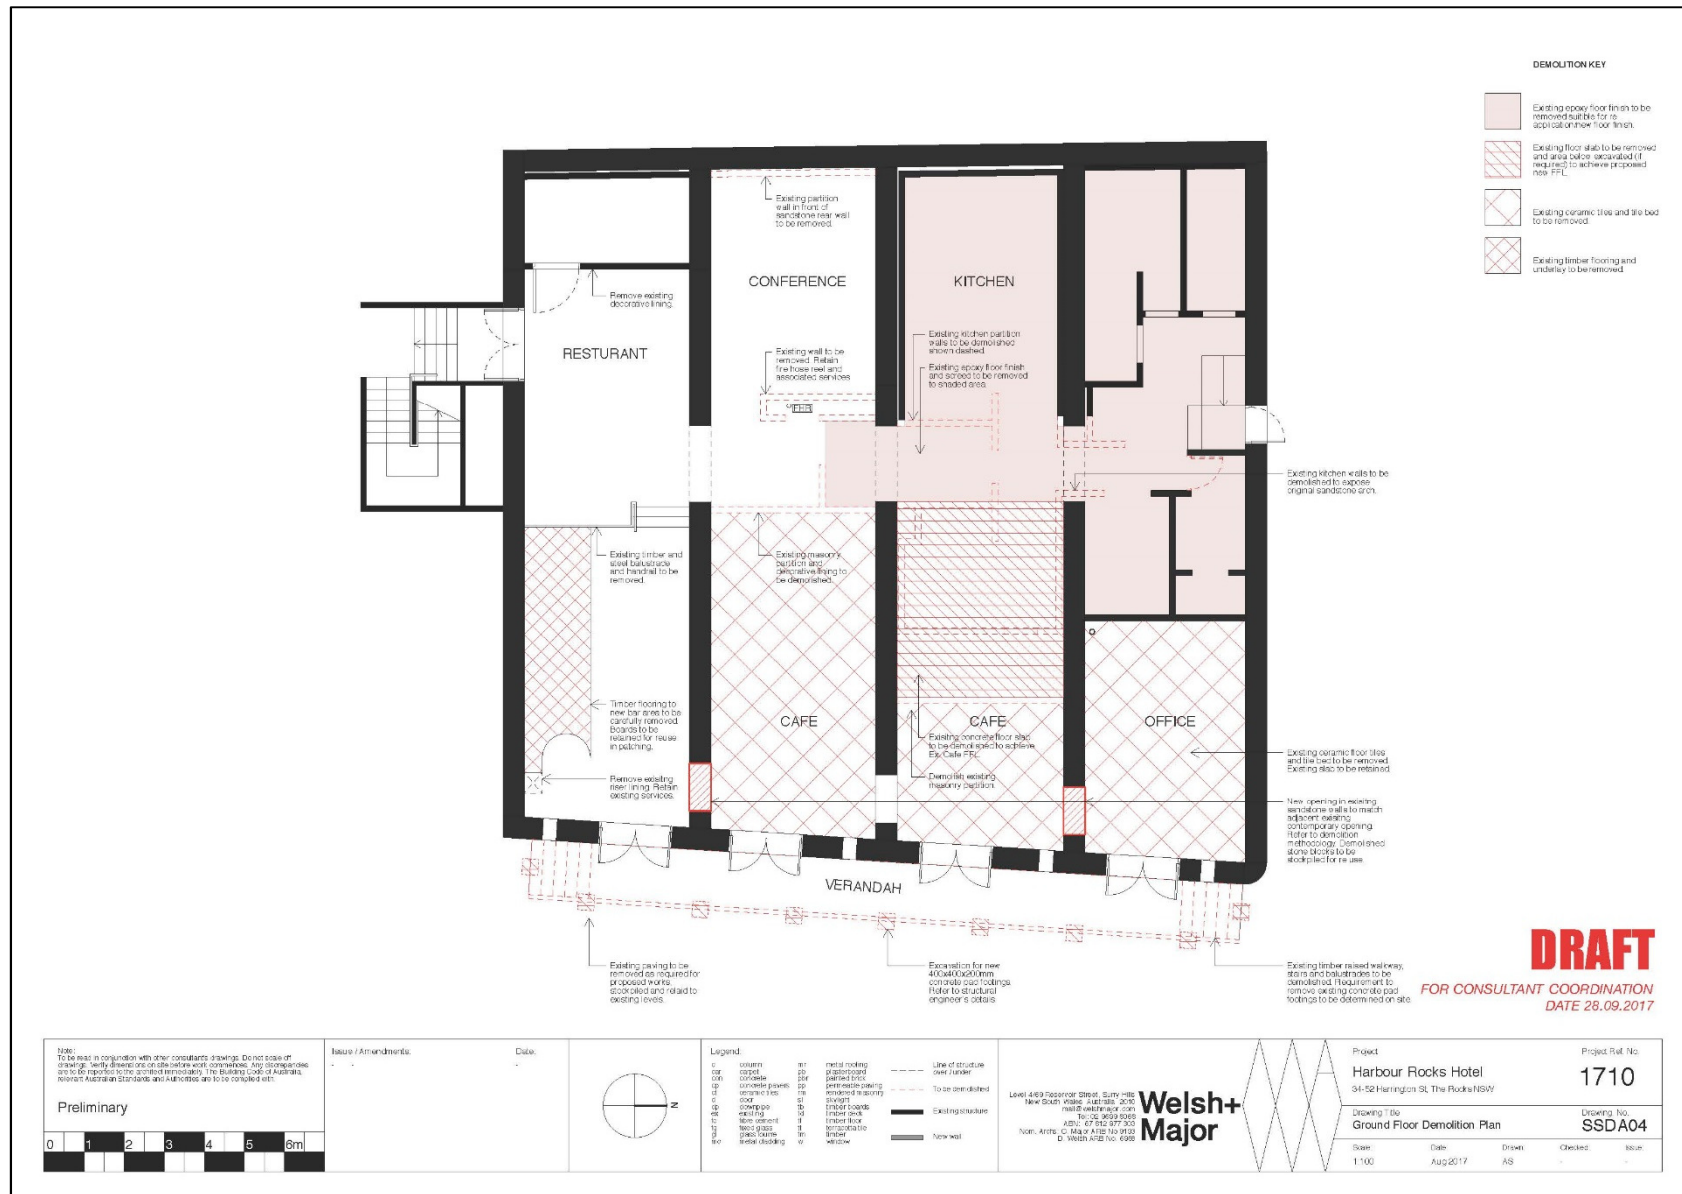
Figure 4: Showing the proposed ground floor layout of the proposed works.

Welsh + Major proposed the demolition of portion of the interior walls and floors for the construction of new facilities and to make all the floors level. Figure 4 below shows the proposed development.

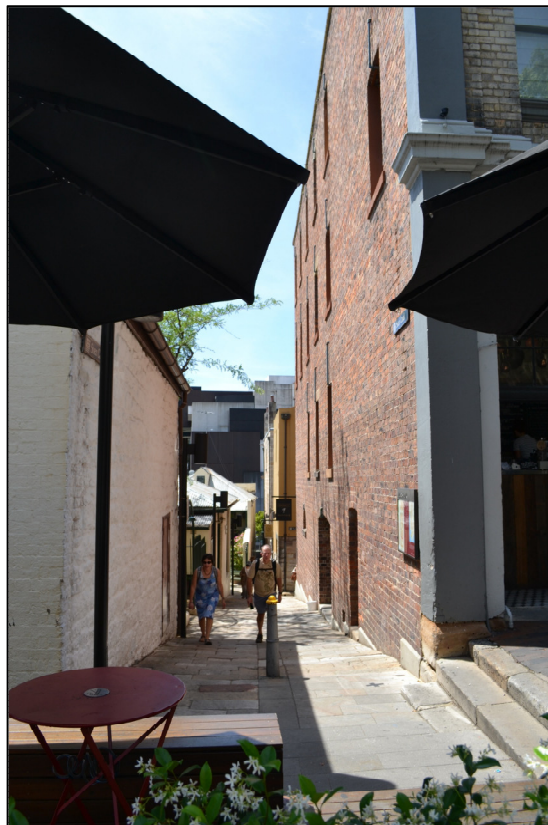
**Photograph 2:** Looking along Suez Canal towards George Street with Harbour Rocks Hotel on the right of the photo. This photograph shows the steeply sloping hillside of the study area.

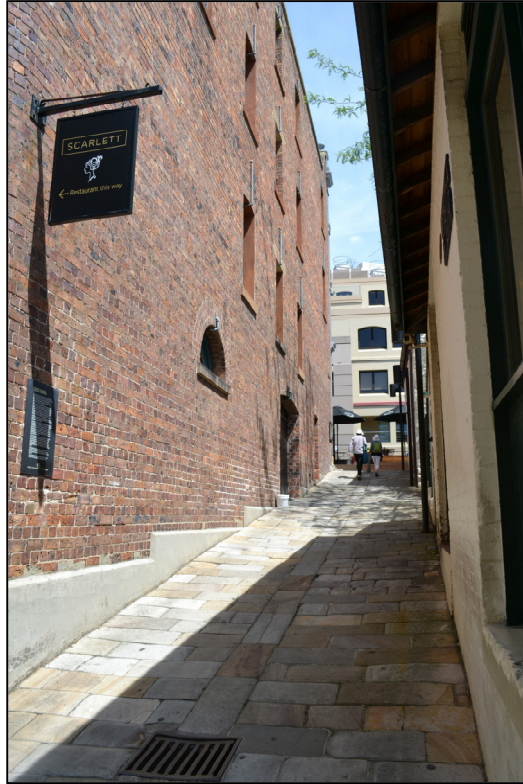
**Photograph 3:** Looking up Suez Canal toward Harrington Street and showing the Harbour Rocks Hotel cut into the steeply sloping hillside.

The present four storey brick store, formerly known as Evan's Store and presently known as the Harbour Rocks Hotel, has been constructed into the hillside. During the site inspection evidence this was observed along the Suez Canal side of the building where it is clearly visible that the building has been cut into the hillside. Along the Nurses Walk frontage of the building, the top of an archway could be seen just above the current footpath surface confirming that the building is cut into the steep slope. It is anticipated that the levelling and excavation of the site for the construction would have removed any evidence of Aboriginal occupation that may have existed in the study area. Therefore, it is not expected that any evidence of Aboriginal occupation or any Aboriginal objects exist within the study area.

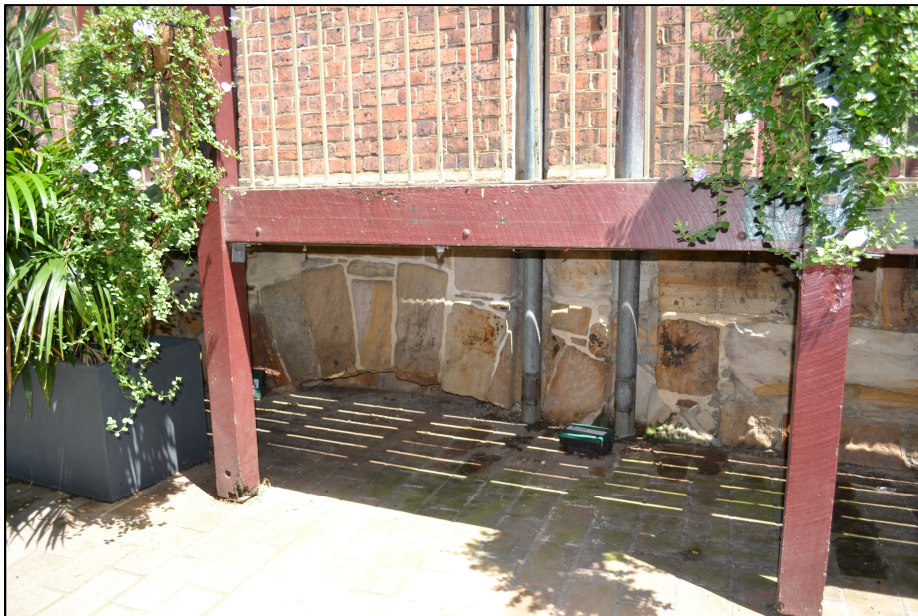
**Photograph 4:** Showing the rear of the Harbour Rocks Hotel along Nurses Walk. The top of an archway can be seen just above the current footpath surface indicating the building has been cut into the steeply sloping hillside of the study area.
