# St George Private Hospital Expansion at 119 – 129 Princes Highway and 2 Hogben Street, Kogarah, and 1 South Street, Kogarah

## Geotechnical Investigation Report

**Report reference number: SYDGE381816AA**

**Akalan Projects Pty Ltd**

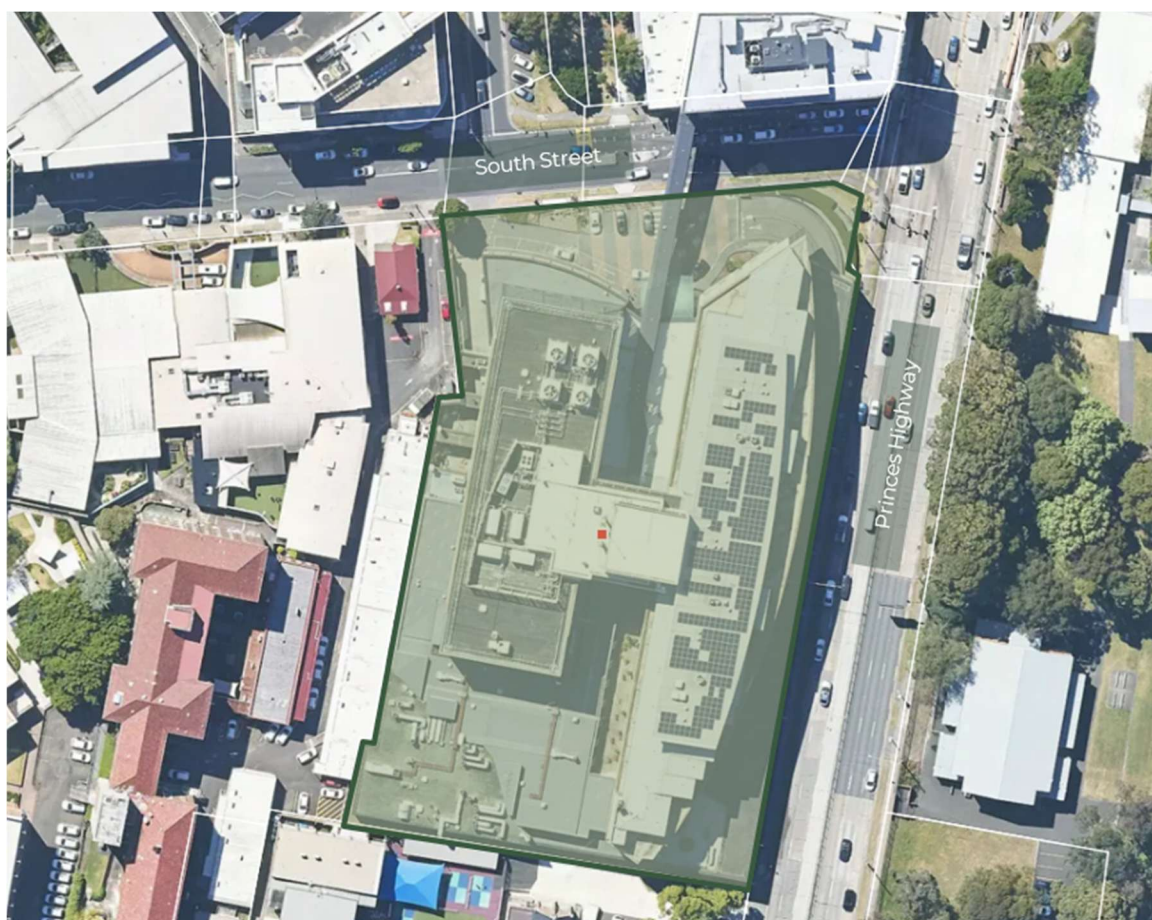
**Figure B: Main Hospital Site Aerial Extract (from Patch Planning and Development, 2025)**

The site accommodates the St George Private Hospital's main campus, with vehicular access provided off South Street. Refer to **Error! Reference source not found.** for a site aerial excerpt.

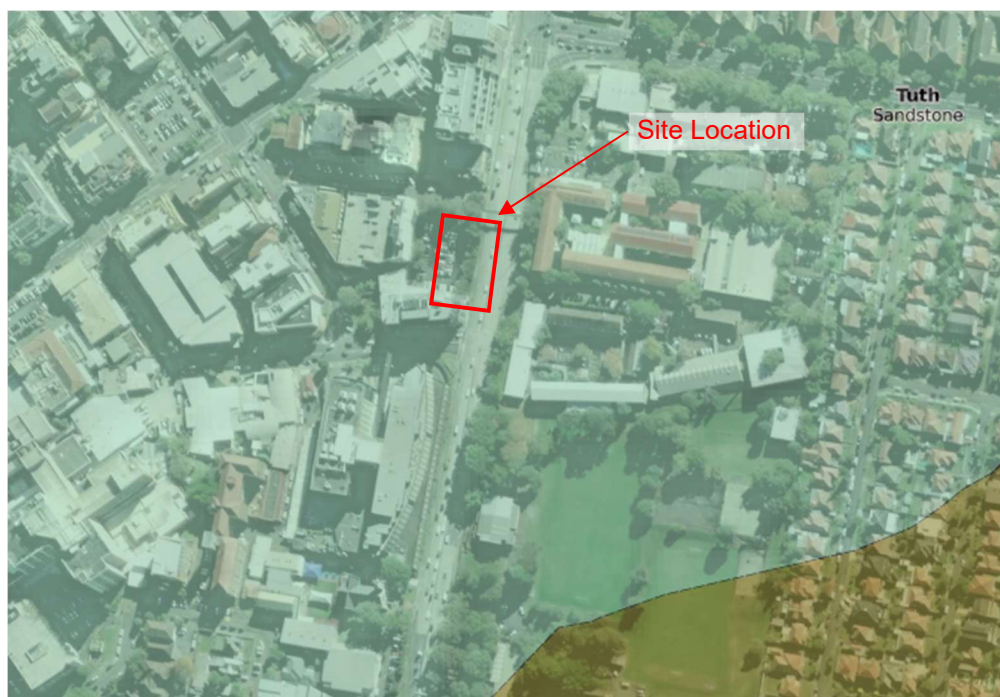
**Figure C: Regional geology of the site (Minview Surface Geological Map)**

Reference to the Minview Surface Geological Mapping date indicates that the site is underlain by Triassic age Hawksbury Sandstone. Hawksbury sandstone comprises medium to coarse grained quartzose sandstone displaying small to large scale, high angle cross bedding with minor shale and laminite lenses.

Our previous geotechnical investigations for St George Hospital, including the neighbouring property indicate that the subsurface conditions of the site comprise fill overlying residual soil, overlying sandstone, which is consistent with the conditions indicated on the geology map.

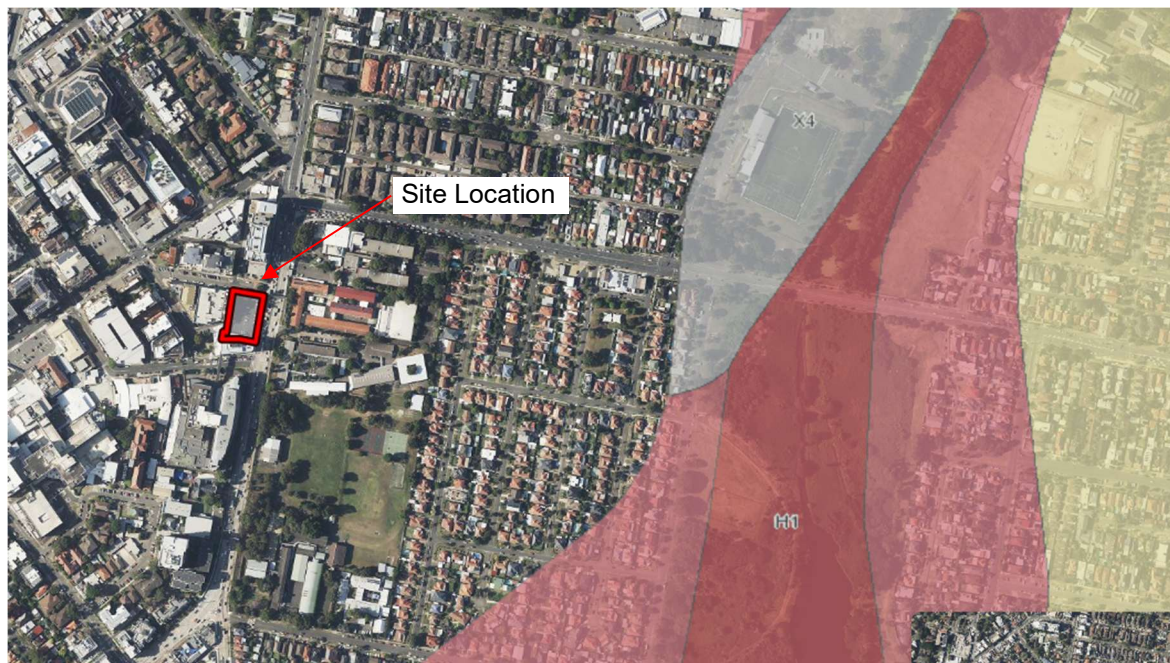
Figure D: SEED Acid Sulfate Hazard Map

With reference to the NSW government SEED (Sharing and Enabling Environmental Data) database, the proposed development is not located within the areas of the Acid Sulfate Soil Risk Map. The nearest known acid sulfate soils (Class H2) are located approximately 500m east of the subject site. Therefore any further requirements for production of an acid sulphate soils management plan is not considered to be required. See Figure D below for the site proximity to acid sulfate soil risk areas.

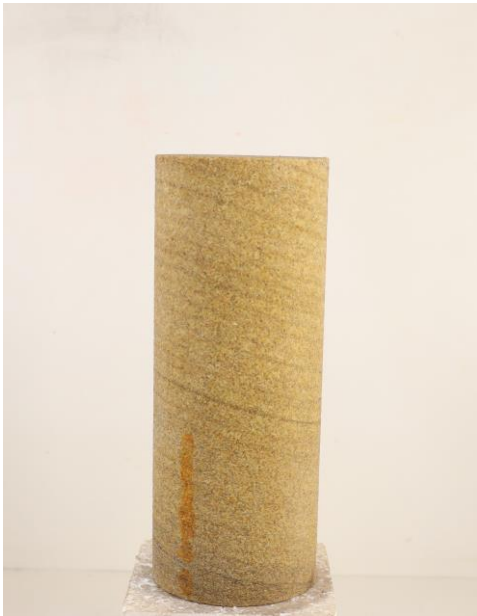
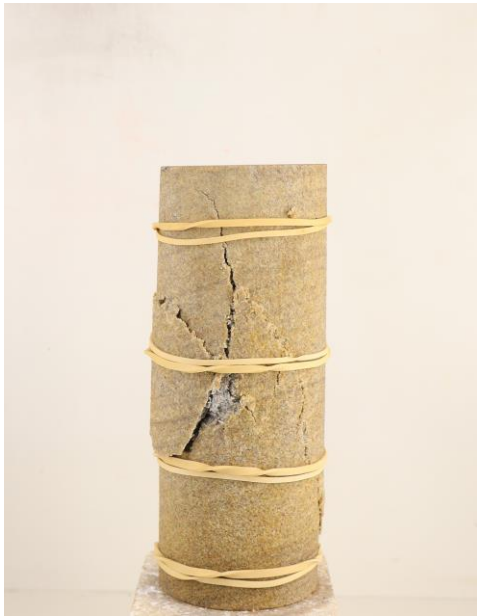
| Uniaxial Compressive Strength | | | |
|---|---|---|---|
| Sample Curing | - | Testing Machine | Matest 2000 kN Compression<br>Machine |
| Uniaxial Compressive Strength | | 19 | MPa |

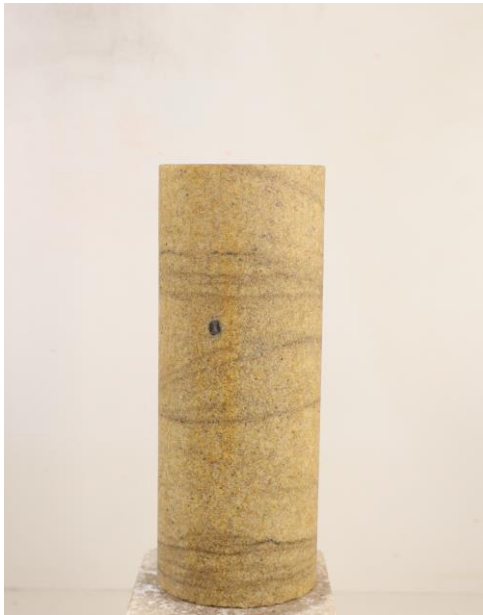
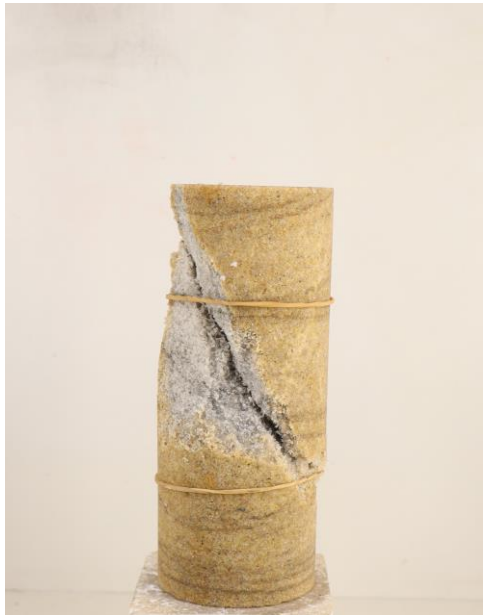
| Deformability of Rock Materials in Uniaxial Compression | | | |
|---|---|---|---|
| Mode of Failure | Single shear plane | Test Apparatus | Matest Compression Machine with Axial and<br>Circumferential Extensometers. |
| <div style="display: flex; justify-content: space-around; align-items: center;"> <div style="text-align: center;"> <p>Before Test</p> </div> <div style="text-align: center;"> <p>After Test</p> </div> </div> | | | |
| <b>Uniaxial Compressive Strength</b> | | <b>35 MPa</b> | |

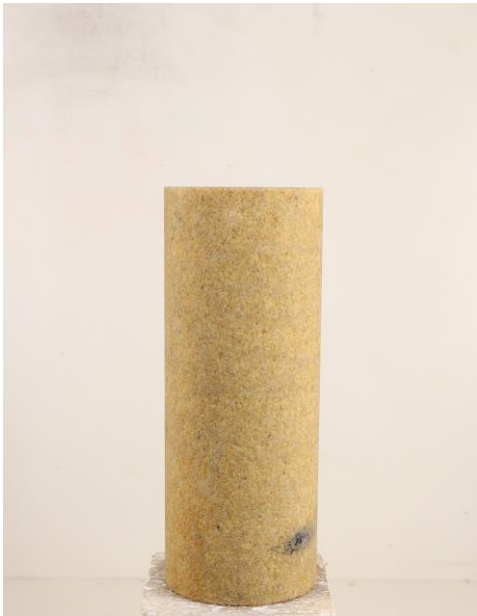
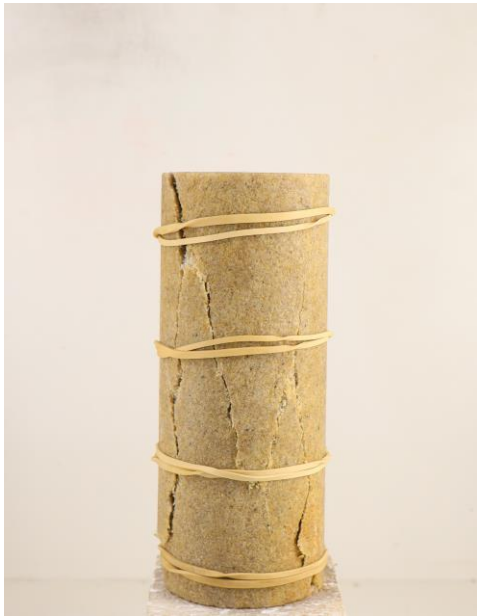
| Uniaxial Compressive Strength | | | |
|---|---|---|---|
| Sample Curing | - | Testing Machine | Matest 2000 kN Compression<br>Machine |
| Uniaxial Compressive Strength | | 42 | MPa |

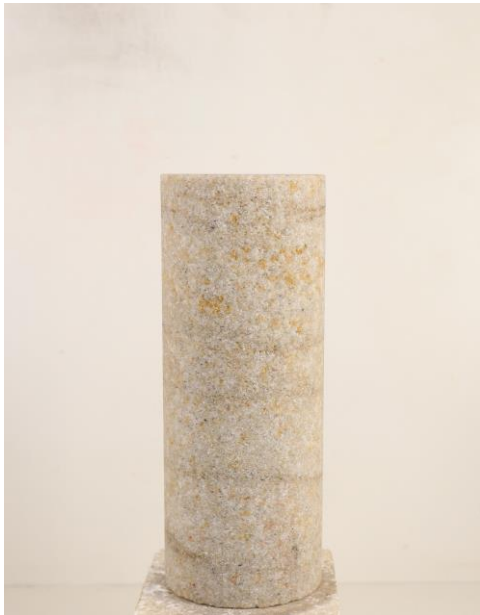
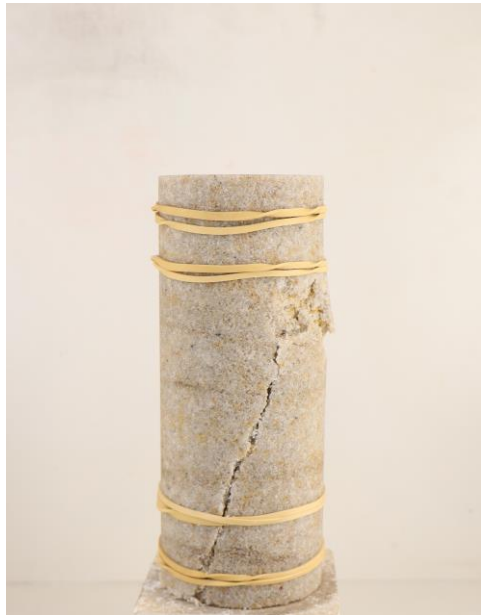
| Deformability of Rock Materials in Uniaxial Compression | | | | |
|---|---|---|---|---|
| Mode of Failure | | Single shear plane | Test Apparatus | Matest Compression Machine with Axial and Circumferential Extensometers. |
| <div><div></div><div>Before Test</div></div> <div><div></div><div>After Test</div></div> | | | | |
| Uniaxial Compressive Strength | | 26 | MPa | |

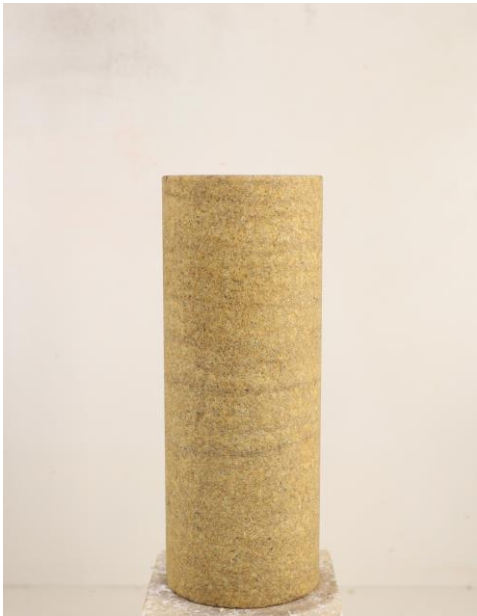
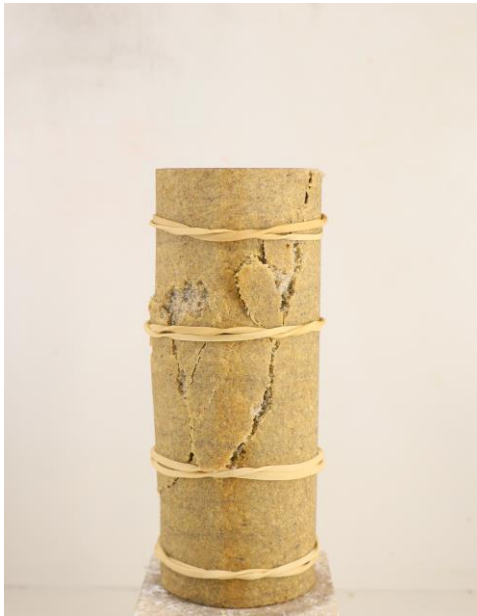
| Uniaxial Compressive Strength | | | |
|---|---|---|---|
| Sample Curing | - | Testing Machine | Matest 2000 kN Compression<br>Machine |
| Uniaxial Compressive Strength | | 22 | MPa |

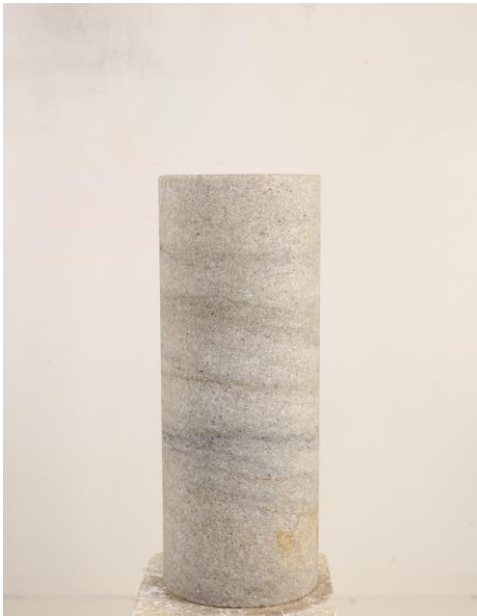
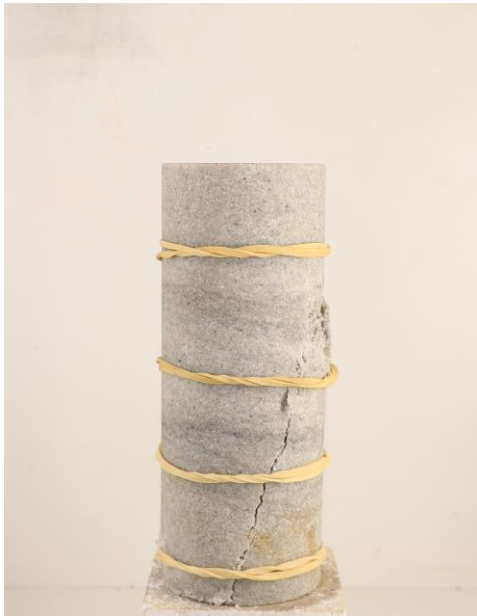
| Uniaxial Compressive Strength | | | |
|---|---|---|---|
| Sample Curing | - | Testing Machine | Matest 2000 kN Compression<br>Machine |
| Uniaxial Compressive Strength | | 28 | MPa |

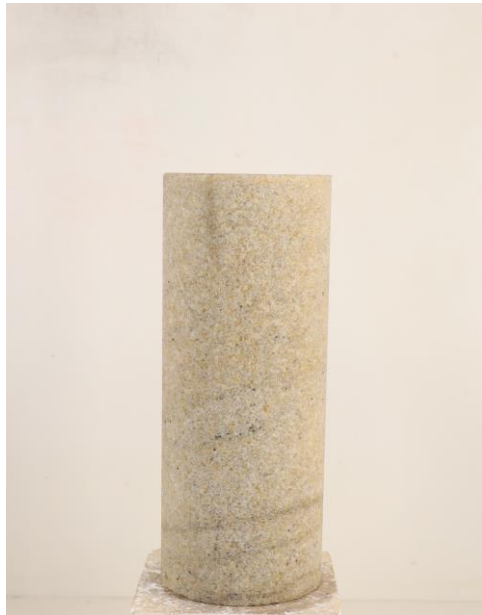
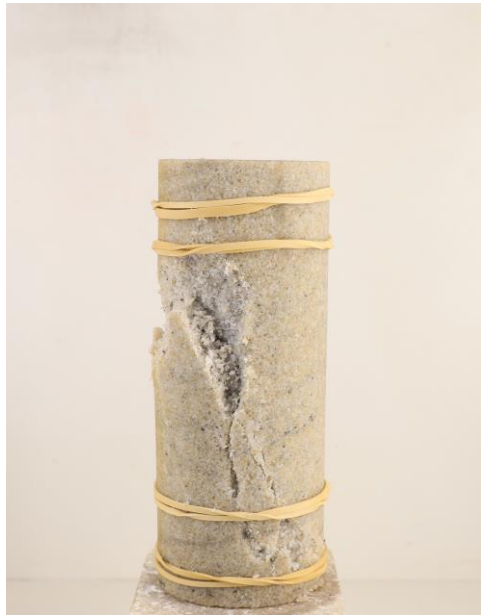
| Deformability of Rock Materials in Uniaxial Compression | | | | |
|---|---|---|---|---|
| Mode of Failure | | Single shear plane | Test Apparatus | Matest Compression Machine with Axial and Circumferential Extensometers. |
| <div><div></div><div></div><div><div>Before Test</div><div>After Test</div></div></div> | | | | |
| Uniaxial Compressive Strength | | 41 | MPa | |

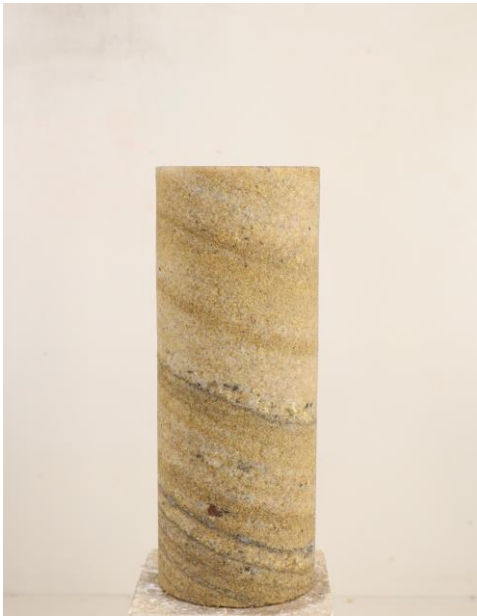
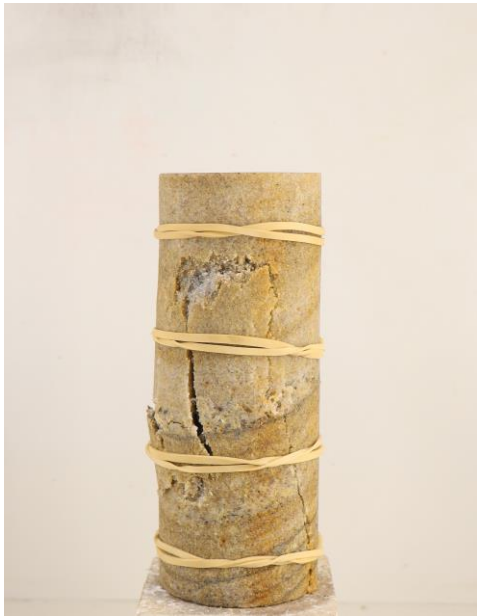
| Uniaxial Compressive Strength | | | |
|---|---|---|---|
| Sample Curing | - | Testing Machine | Matest 2000 kN Compression<br>Machine |
| Uniaxial Compressive Strength | | 34 | MPa |
