**RE: Greenwich Hospital Redevelopment – Pallister House  
Summary of Changes and Heritage Commentary**

## 1.0 APPENDIX A – FURTHER RESEARCH

### HISTORICAL NOTES – EARLY PATHS AND CARRIAGEWAYS AT 'STANDISH'

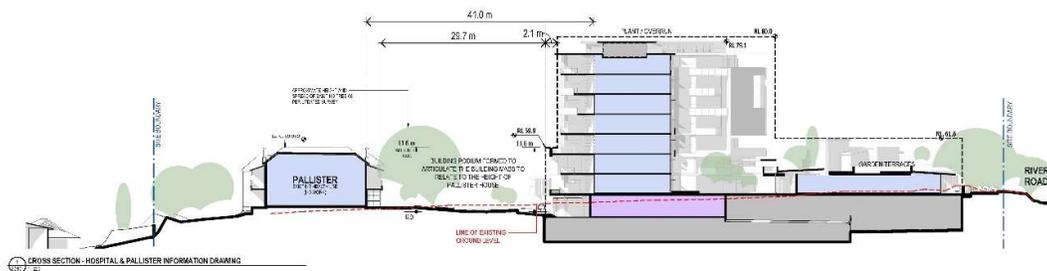
Figure 1 - Section showing the relationship between Pallister and the main building. (Source: Bickerton Masters Dwg 1213 IN.32 P5)

Modifications to the proposal described above have responded to the feedback by strengthening the relationship of the proposed hospital podium to the scale of Pallister and in reducing the bulk of the adjacent built form. Further articulation of the façade of the main building above the podium acts to soften the contrast in building forms. This is further supported through the development of an appropriate set back between the development and Pallister.

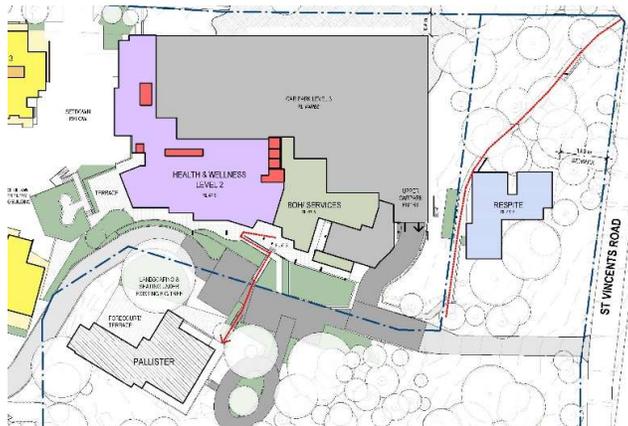
Figure 2 - Location of the existing path linking the corner of River Road and St Vincents Road shown in red. (Source: Bickerton Masters Dwg: 1213 IN.12 P6)

Appendix A of this report contains additional research text and images investigating further the area of the curtilage containing the path. The outcome is that it is reasonable to surmise that the main access from the east to the residence off River Road was along the curved carriageway visible in early 1890s photographs. The 1938 landscape drawings also confirm this location as a more formal driveway; the present-day path is located in the general area of these earlier accessways.

The proposal retains a pathway generally along the line of the existing path providing pedestrian access to Pallister, much in the same way as access is currently provided. The location of the Respite building has been determined in relation to the path as well as the existing trees to be retained.

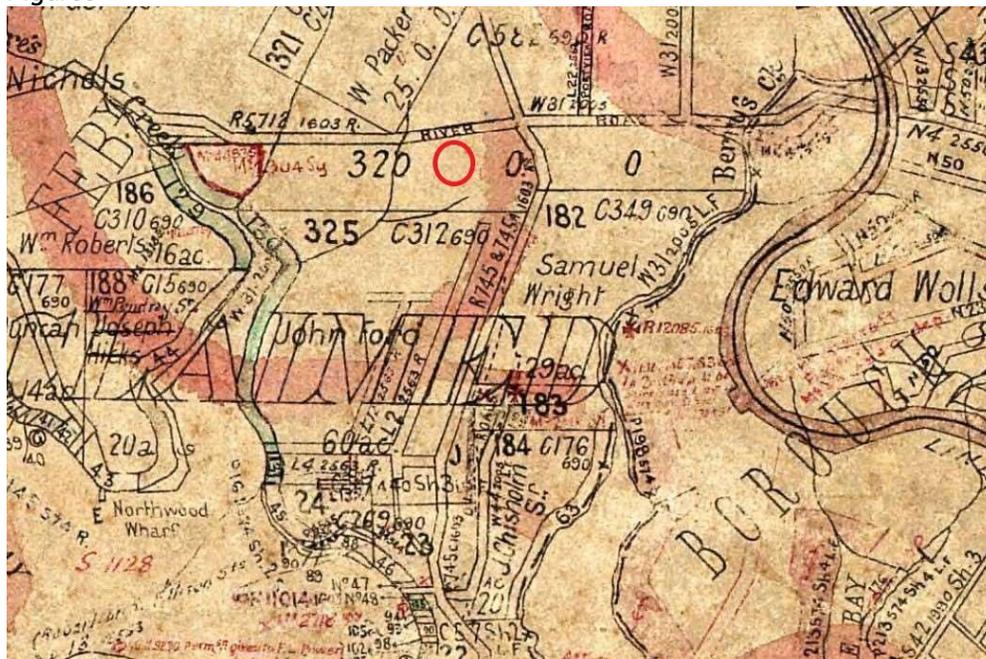
Figure 3: 1899 Historical Parish Map showing River Road at the top. The approximate location of 'Standish' is circled red. (Source: NSW Land Registry Services LRS, Historic Land Records Viewer HLRV, Parish Maps)

- River Road appears to have been the main access road to 'Standish', as noted on the 1899 parish map (Figure 3).
- Macdonald's thesis notes the following: *When the original land was purchased most of it was bushland. The paddock between River Road may have been cleared by the previous owner, or when Standish was built between 1890 and 1892. By 1894 this area had been completely cleared and fenced and was being used as a paddock. The clay driveway with its entrance from River Road and circular carriage loop in front of the house was one of the earliest things to be done. The driveway continued past the northern side of the house and the kitchen wing past the men's quarters and continued to the stables and garage area below. The drive then continued out onto River Road. The entrance had a large timber gateway for carriages and a smaller gate for pedestrians. There were timber fences to River Road and probably along the eastern boundary as well. Below the driveway on the eastern side was a drop and there were caves and grottoes. Much of the bushland to the east of the driveway was left.*<sup>2</sup>

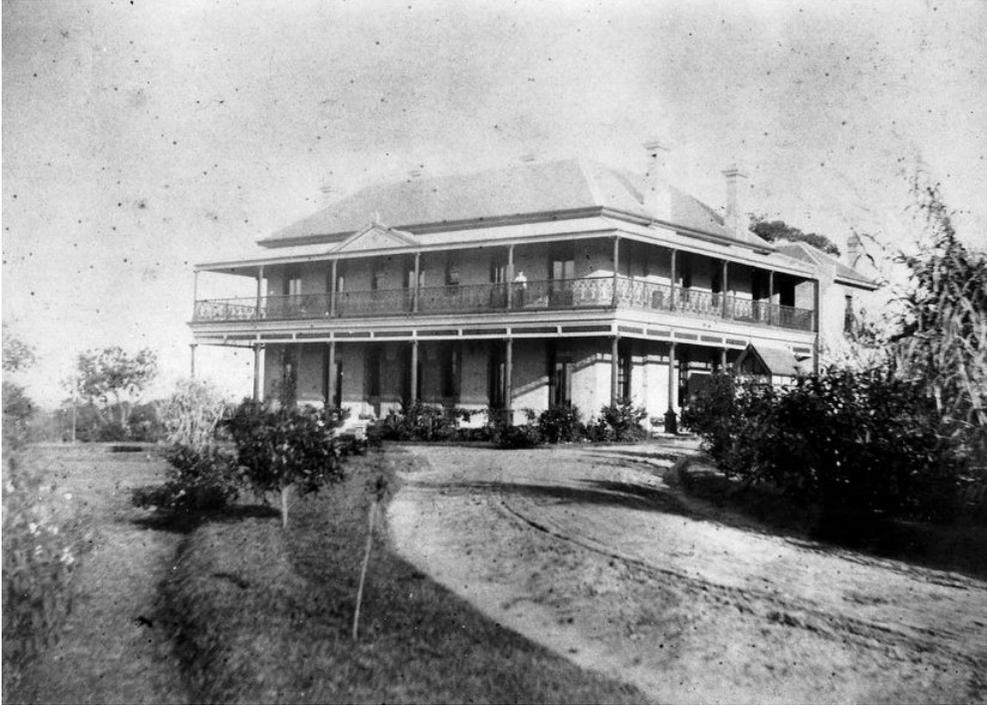
*Figure 4: Standish and its carriageway during the Welch family occupation. This photograph is said to be dated 1896. The smaller gabled structure is Emily St Vincent's bird cage. (Source: Lane Cove Library, Local History Collection, 'Stuart St Vincent Welch Photograph Collection')*

- A photograph, said by Macdonald to date from about 1896,<sup>3</sup> shows the carriageway to the northeast of the house (Figure 4). This appears to have included the carriage loop in front of the eastern elevation of the house and the continuation along the northern elevation of the residence, as described by Macdonald in her 1985 thesis.<sup>4</sup>

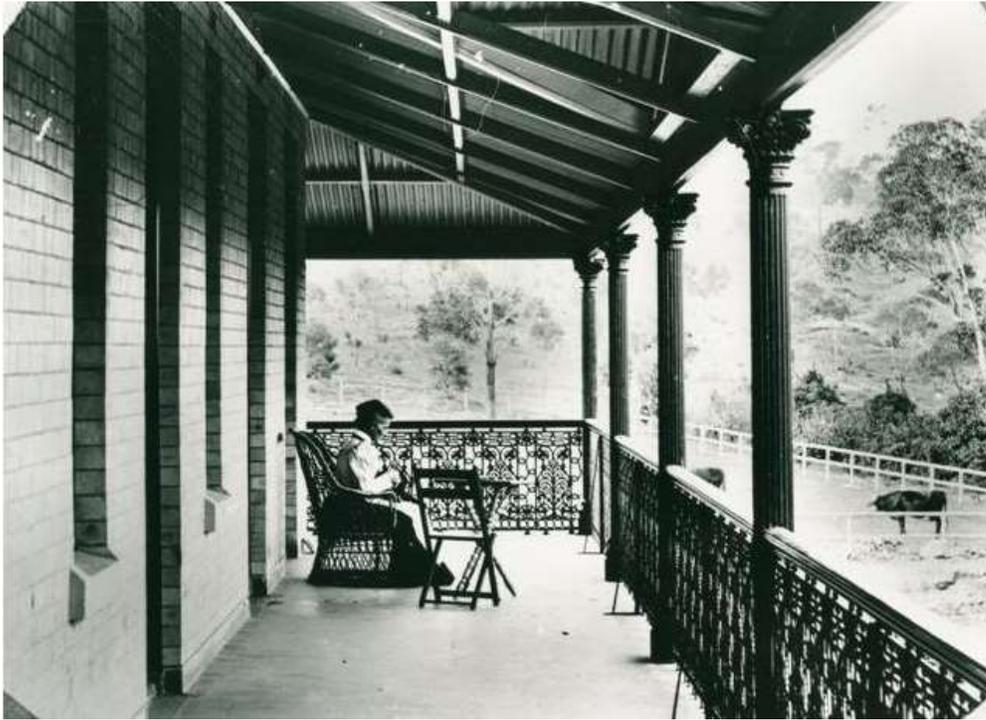
Figure 6: Photograph showing the northeast corner of the upper level verandah in 1894 (Macdonald Plat XXII). The garden to the north of the house was not established at this stage. The carriage loop appears to have been located on the right. (Source: Lane Cove Library, Local History Collection, 'Stuart St Vincent Welch Photograph Collection')

- The early paddock is shown in a photograph said by Macdonald to be dated 1894 (Figure 6) and in another photograph dated c1900 (Figure 8). It was fenced in and took up the area between River Road and the residence. The carriageway likely ran along the eastern side of the paddock.

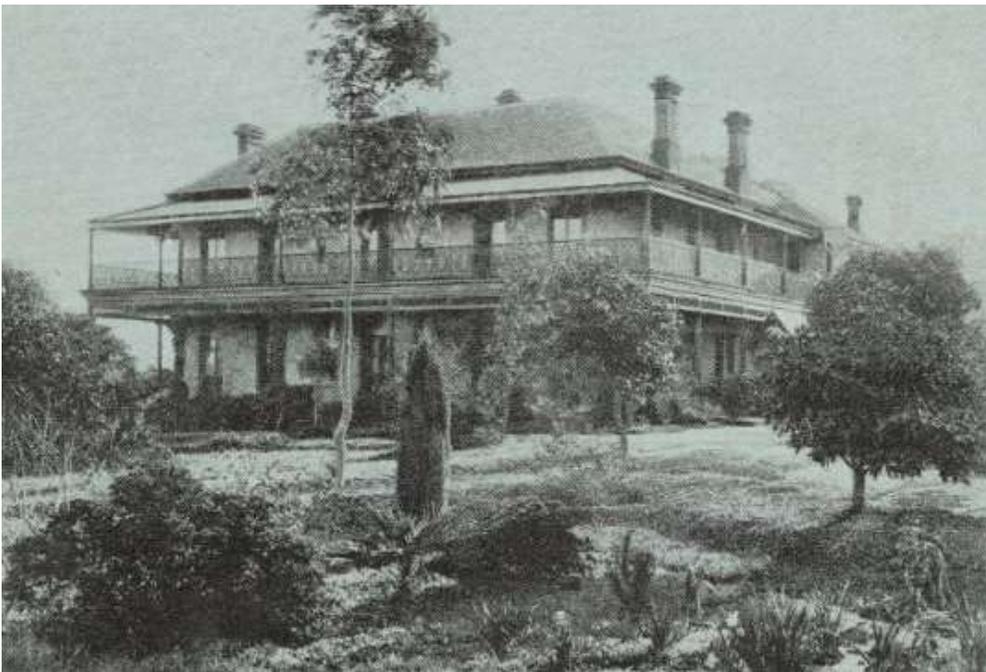
Figure 7: 1899 photograph of 'Standish'. No major access roads are shown in this image, however, this is likely due to the location from where the photograph was taken, further to the east from the carriageway which would have been located on the

far right hand side of the photograph. (Source: State Library of NSW, 'Greenwich Subdivision Plans', Call No. Z/SP/G12/19 – Heidelberg Heights)

- A photograph dated 1899 (Figure 7) shows the house within its grounds but does not appear to show the carriageway, which is likely due to the location where the photograph was taken.

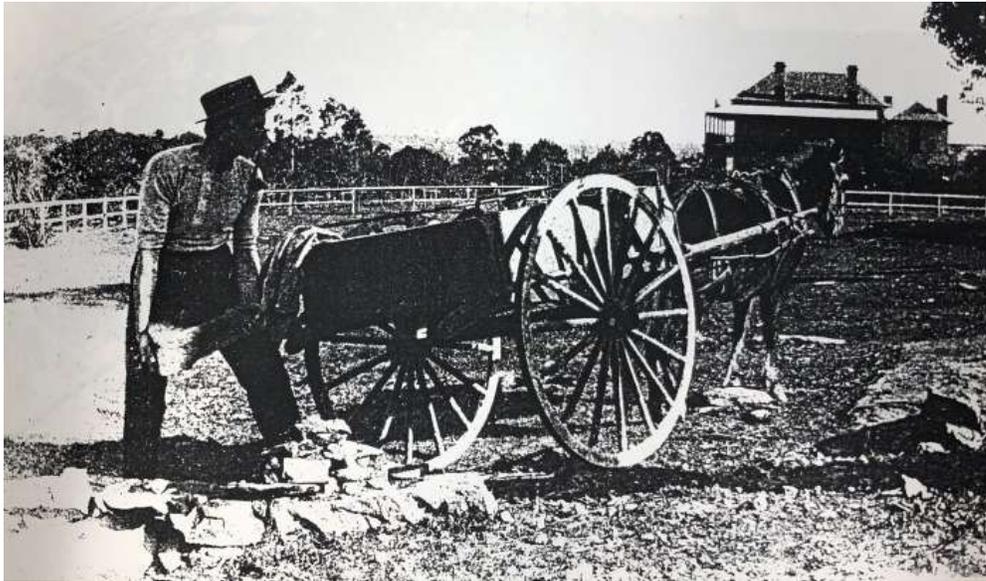
Figure 8: "...clearing stone from the grounds next to River Road (about 1900?). The garden to the north of the house is not yet established. This area is fenced off and used as a paddock. This is approximately the spot where the tennis courts were built." The carriageway would have run behind the timber fence visible in the background. (Source: Macdonald 1985, Plate XXXII, caption copied verbatim)

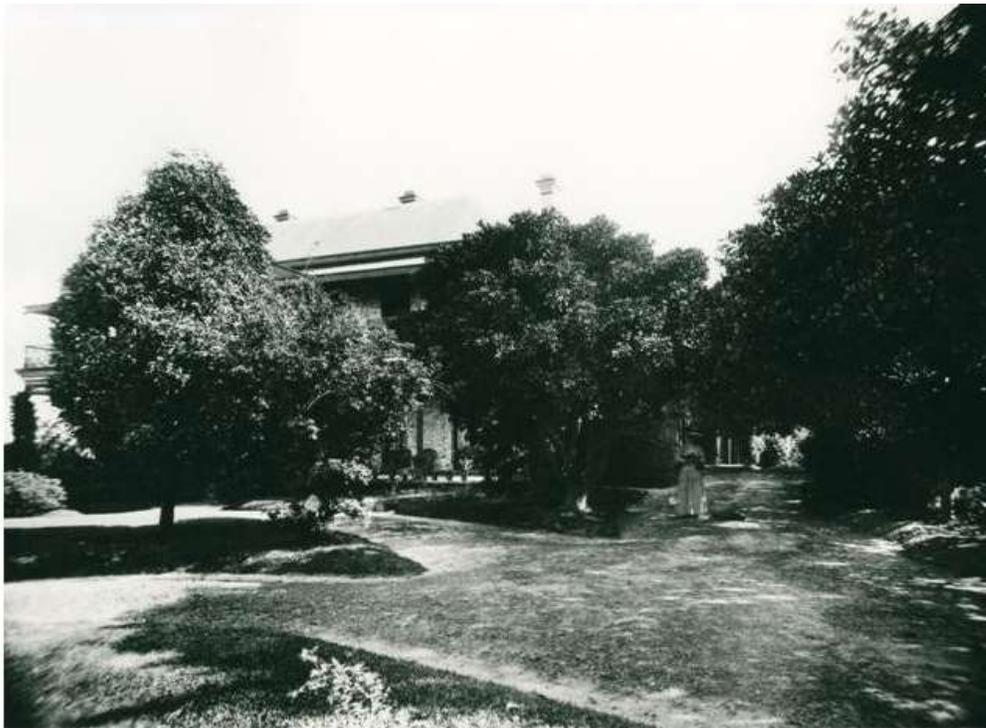
Figure 13: 'Standish in the early 1900s. Mrs Emily St. Vincent Welch stands on the driveway.' (Source: Lane Cove Library, Local History Collection, 'Stuart St Vincent Welch Photograph Collection')

- By around 1910, the trees and shrubs planted along the carriageway and in front of the house had grown into an established garden (Figure 13 and Figure 14).<sup>8</sup> Elms lined the carriageway. The area to the north of the house, previously used as a paddock, had also been transformed into a garden with a large bird cage, a pergola walkway (Figure 14), numerous paths, expanses of lawn, small clearings, large shrubs and trees with small clearings, and two clay tennis courts immediately south of River Road. The entrance gates were located adjacent to the tennis courts (Figure 15 - Figure 16). This is the situation largely as noted in the c1917 ‘reconstruction’ by Macdonald (Figure 17).<sup>9</sup>

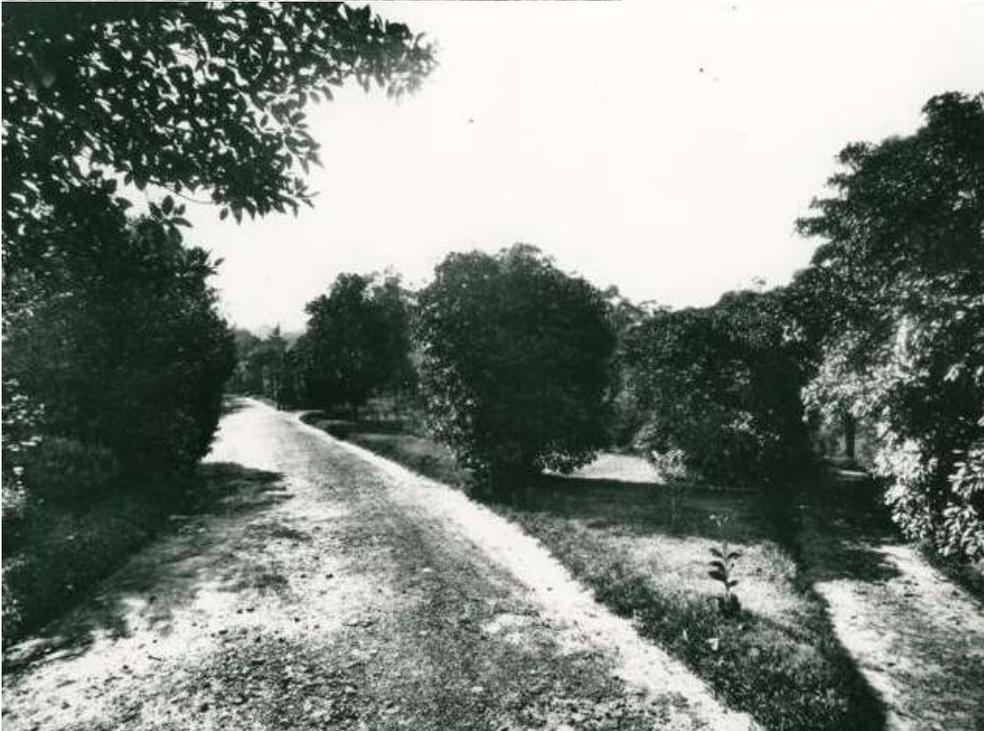
Figure 15: Clay paths at 'Standish', unknown location but possibly located near the entrance gates. The path on the right may have been for pedestrian access and that to the left for carriages. (Source: Lane Cove Library, Local History Collection, 'Stuart St Vincent Welch Photograph Collection')

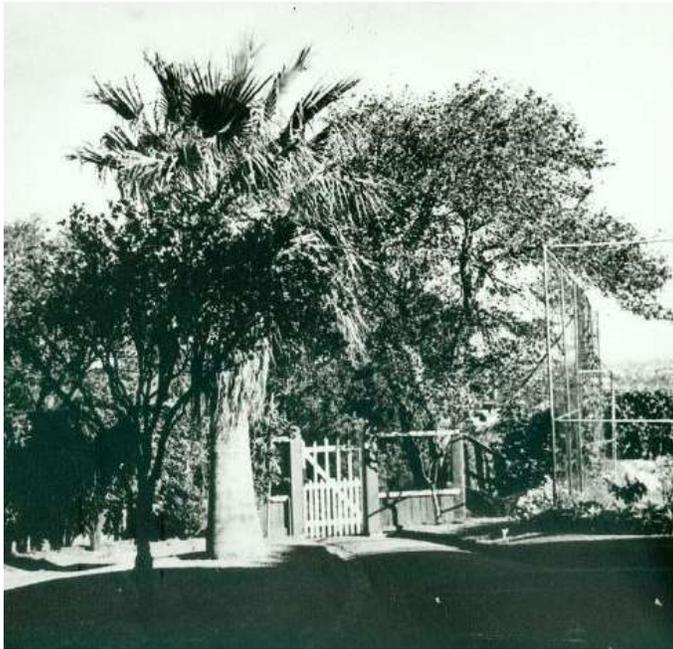
Figure 16: The pedestrian entrance gate to 'Standish' immediately adjacent to the clay tennis court. This photograph is undated. (Source: 2004 CMP, Figure 21)

- The c1917 'reconstruction' appears to contain some factual errors, including the following:
  - The entrance gates shown in Figure 16, clearly located next to the tennis courts, are not noted on the plan and the path which must have led from these gates to the south is not shown.

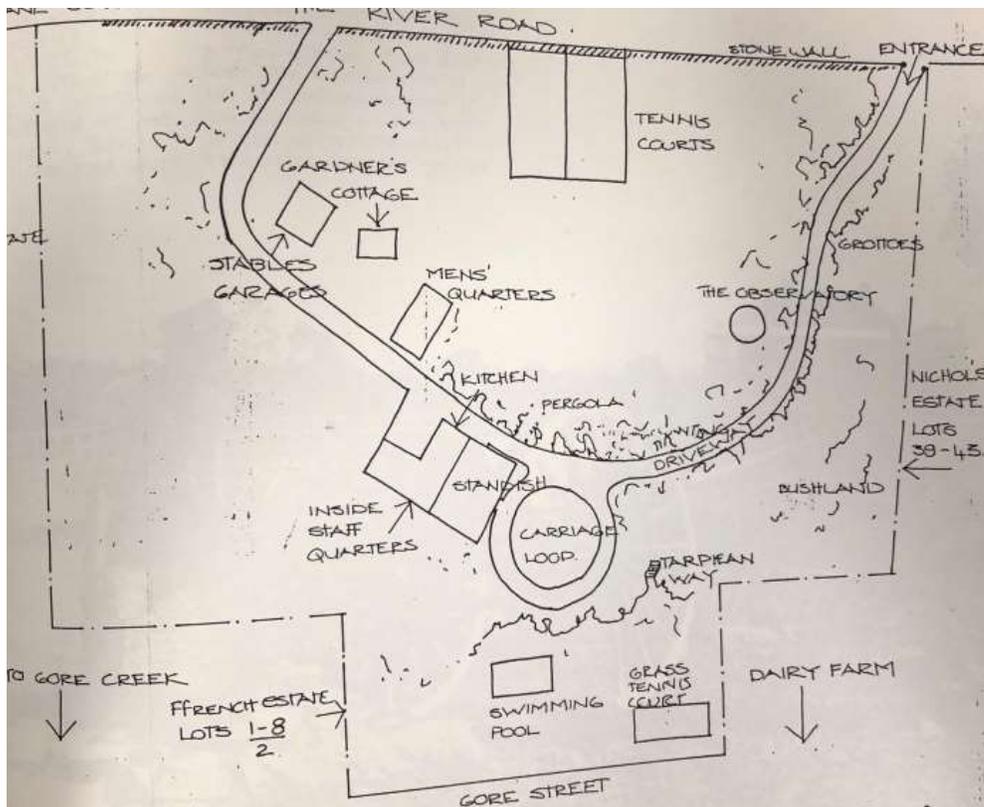
Figure 17: 'Reconstruction of the grounds, c1917' by Susan Macdonald. Note that it does not show a gate or path immediately adjacent to the clay tennis courts. It also omits a path leading towards the southeast from the carriage loop. (Source: Macdonald 1985, Figure 8)

- This ‘reconstruction’, included in Figure 8 of Susan Macdonald’s thesis (1985, see Figure 17) appears to be a conjectural plan that Macdonald prepared, likely based on the 1938 plan by Augustus Aley (Figure 20), and adding the information provided by the members of the St Vincent Welch family and other sources.

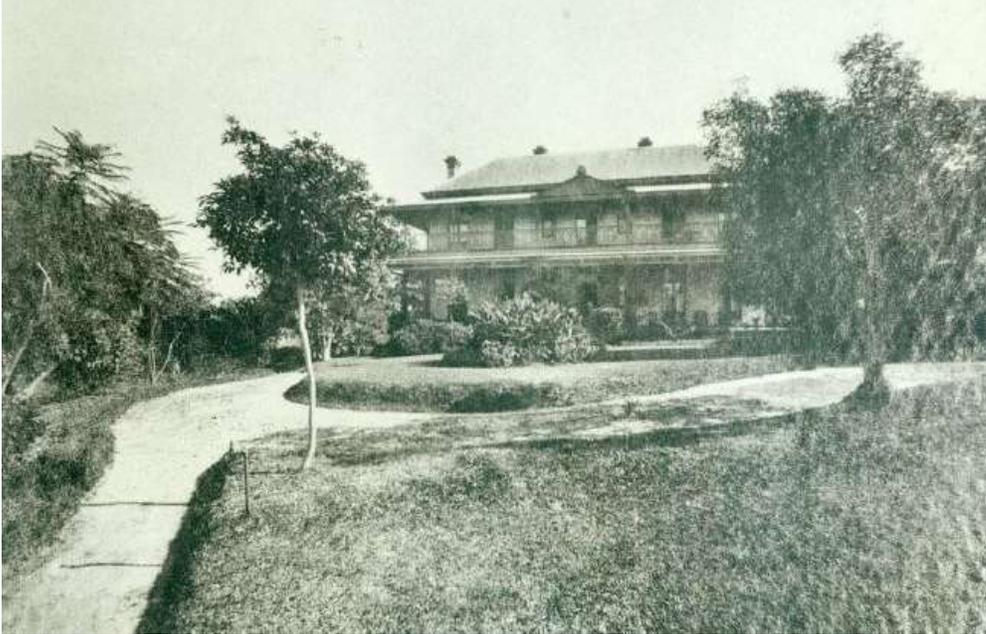
Figure 18: c1910s photograph of 'Standish' showing an additional clay path on an incline (on the left), potentially leading down to the lower grounds or Gore Street. (Source: 2004 CMP, Figure 23)

- A photograph dated c1910s shows what seems to have been an additional clay path leading down to the lower gardens (or Gore Street?) from the carriage loop in front of the house (Figure 18), potentially past the Tarpeian Way. Figure 19 shows that a path to the lower gardens indeed existed, however, its exact layout and location is unknown.

- Augustus Aley's 1938 plans for the SCEGGS school grounds refers to a 'new driveway' (Figure 20). Based on the photographic and written evidence this 'new' drive largely followed the line of the existing carriageway but likely included resurfacing of the clay path with a more durable surface. Aley's plan did not show the additional clay path down from the carriage loop which is clearly visible in a c1910s photograph (see Figure 18).

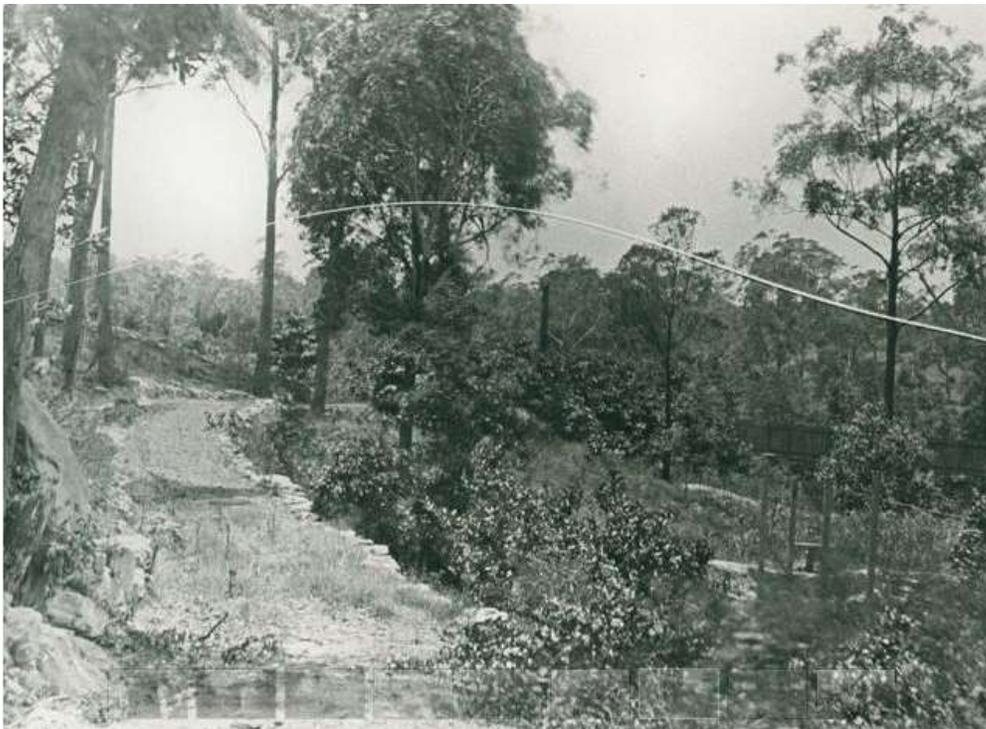
Figure 19: Lower grounds at 'Standish', showing a pathway from the upper level. (Source: Lane Cove Library, Local History Collection, 'Stuart St Vincent Welch Photograph Collection')

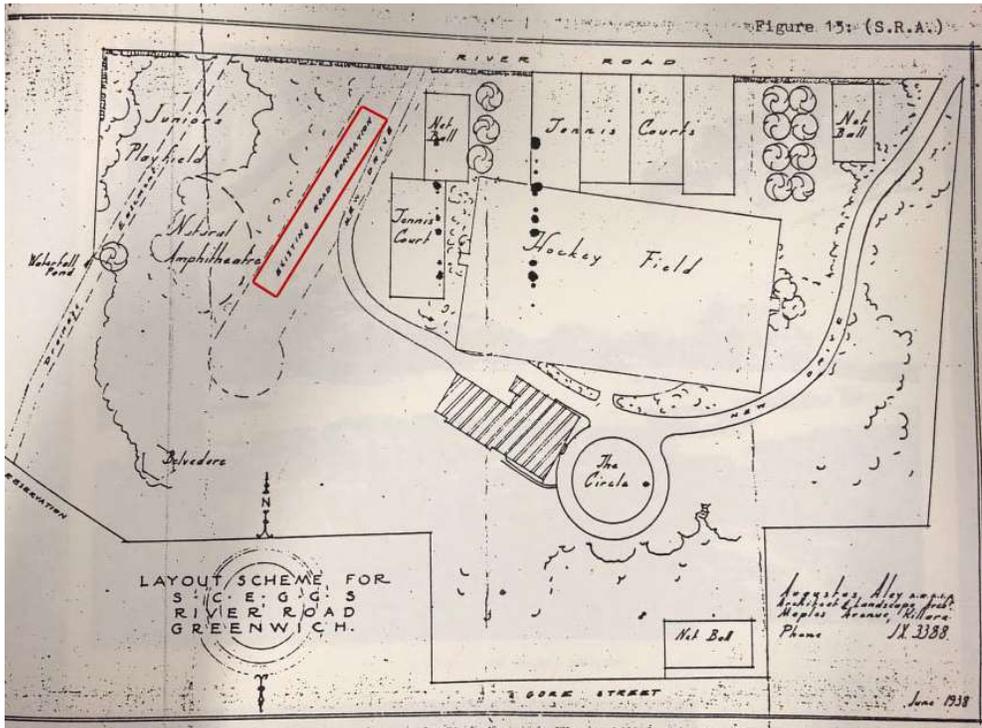
Figure 20: 1938 plan by Augustus Aley for the proposed layout for the new SCEGGS premises. Note his annotation for 'existing road formation', as outlined in red. This suggests an earlier road. (Source: Macdonald 1985, Figure 13)

- Augustus Aley's 1938 plan notes an 'existing road formation' to the northwest of the residence. This is not shown in the c1917 'reconstruction'. Macdonald 1985 does not provide any information on this. This road may have been part of the early layout or may have been added between 1917 and 1938.

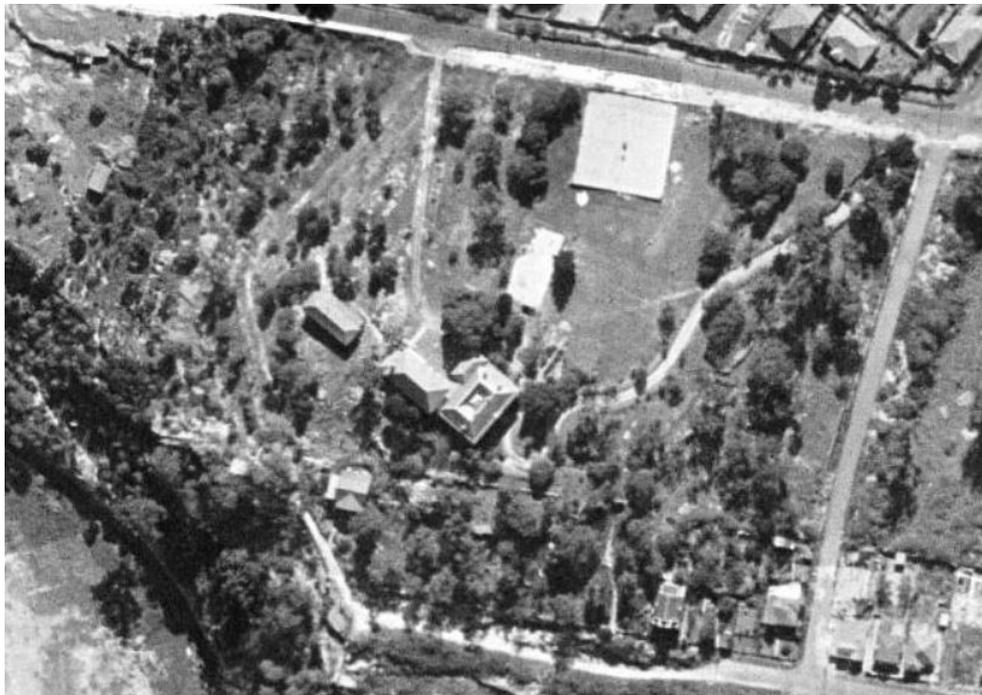
Figure 21: 1943 aerial photograph showing the grounds of the former 'Standish' property, with the main driveway and carriage loop clearly visible. (Source: NSW LRS, SIX Maps)

- An aerial photograph dated 1943 shows the grounds and its various elements, including paths and driveways. The path in the c1910s photograph is not visible and the western portion of the driveway also appears to have followed a different course than shown in the c1917 'reconstruction' and the 1938 plan by Aley. There appear to be several 'goat tracks' on the site, which may indicate the presence of earlier paths. The aerial suggests that Aley's 1938 plan was only carried out to a limited degree, with many of the playing fields proposed in 1938 not evident.

The 1943 aerial photograph is the earliest source that clearly shows paths and carriageways, however, the photograph shows the situation around 50 years after construction of 'Standish', i.e. after some considerable time had passed since the initial establishment of the grounds by the St. Vincent Welch family in the early 1890s.
