## **Additional Geotechnical Investigation**

13-17 Oxford Street and 2 Verona Street, Paddington, NSW

Report Title: Additional Geotechnical Investigation, 13-15 and 17 Oxford Street and 2 Verona, Paddington, NSW

Report No: E25559.G04

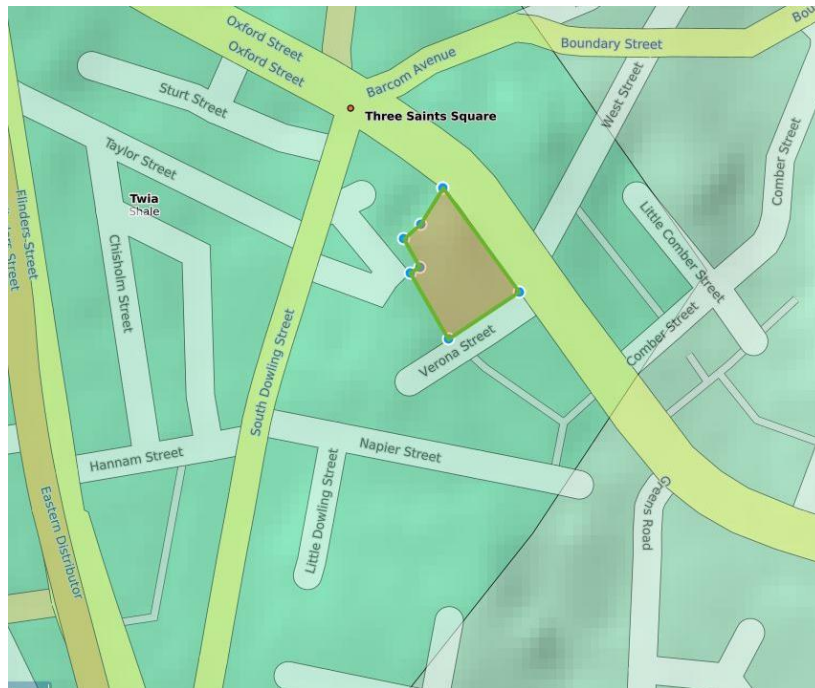
- **Plate 2:** Excerpt of geological map showing location of site.

| Attribute | Description |
|---|---|
| Regional Geology | Information on regional sub-surface conditions, referenced from the NSW Seamless Geology dataset (Colquhoun et al., 2024, corresponding to the Sydney 1:100,000 Geological Series Sheet) indicates the site to be underlain by Ashfield Shale, which consists of black to dark grey shale and laminite. |

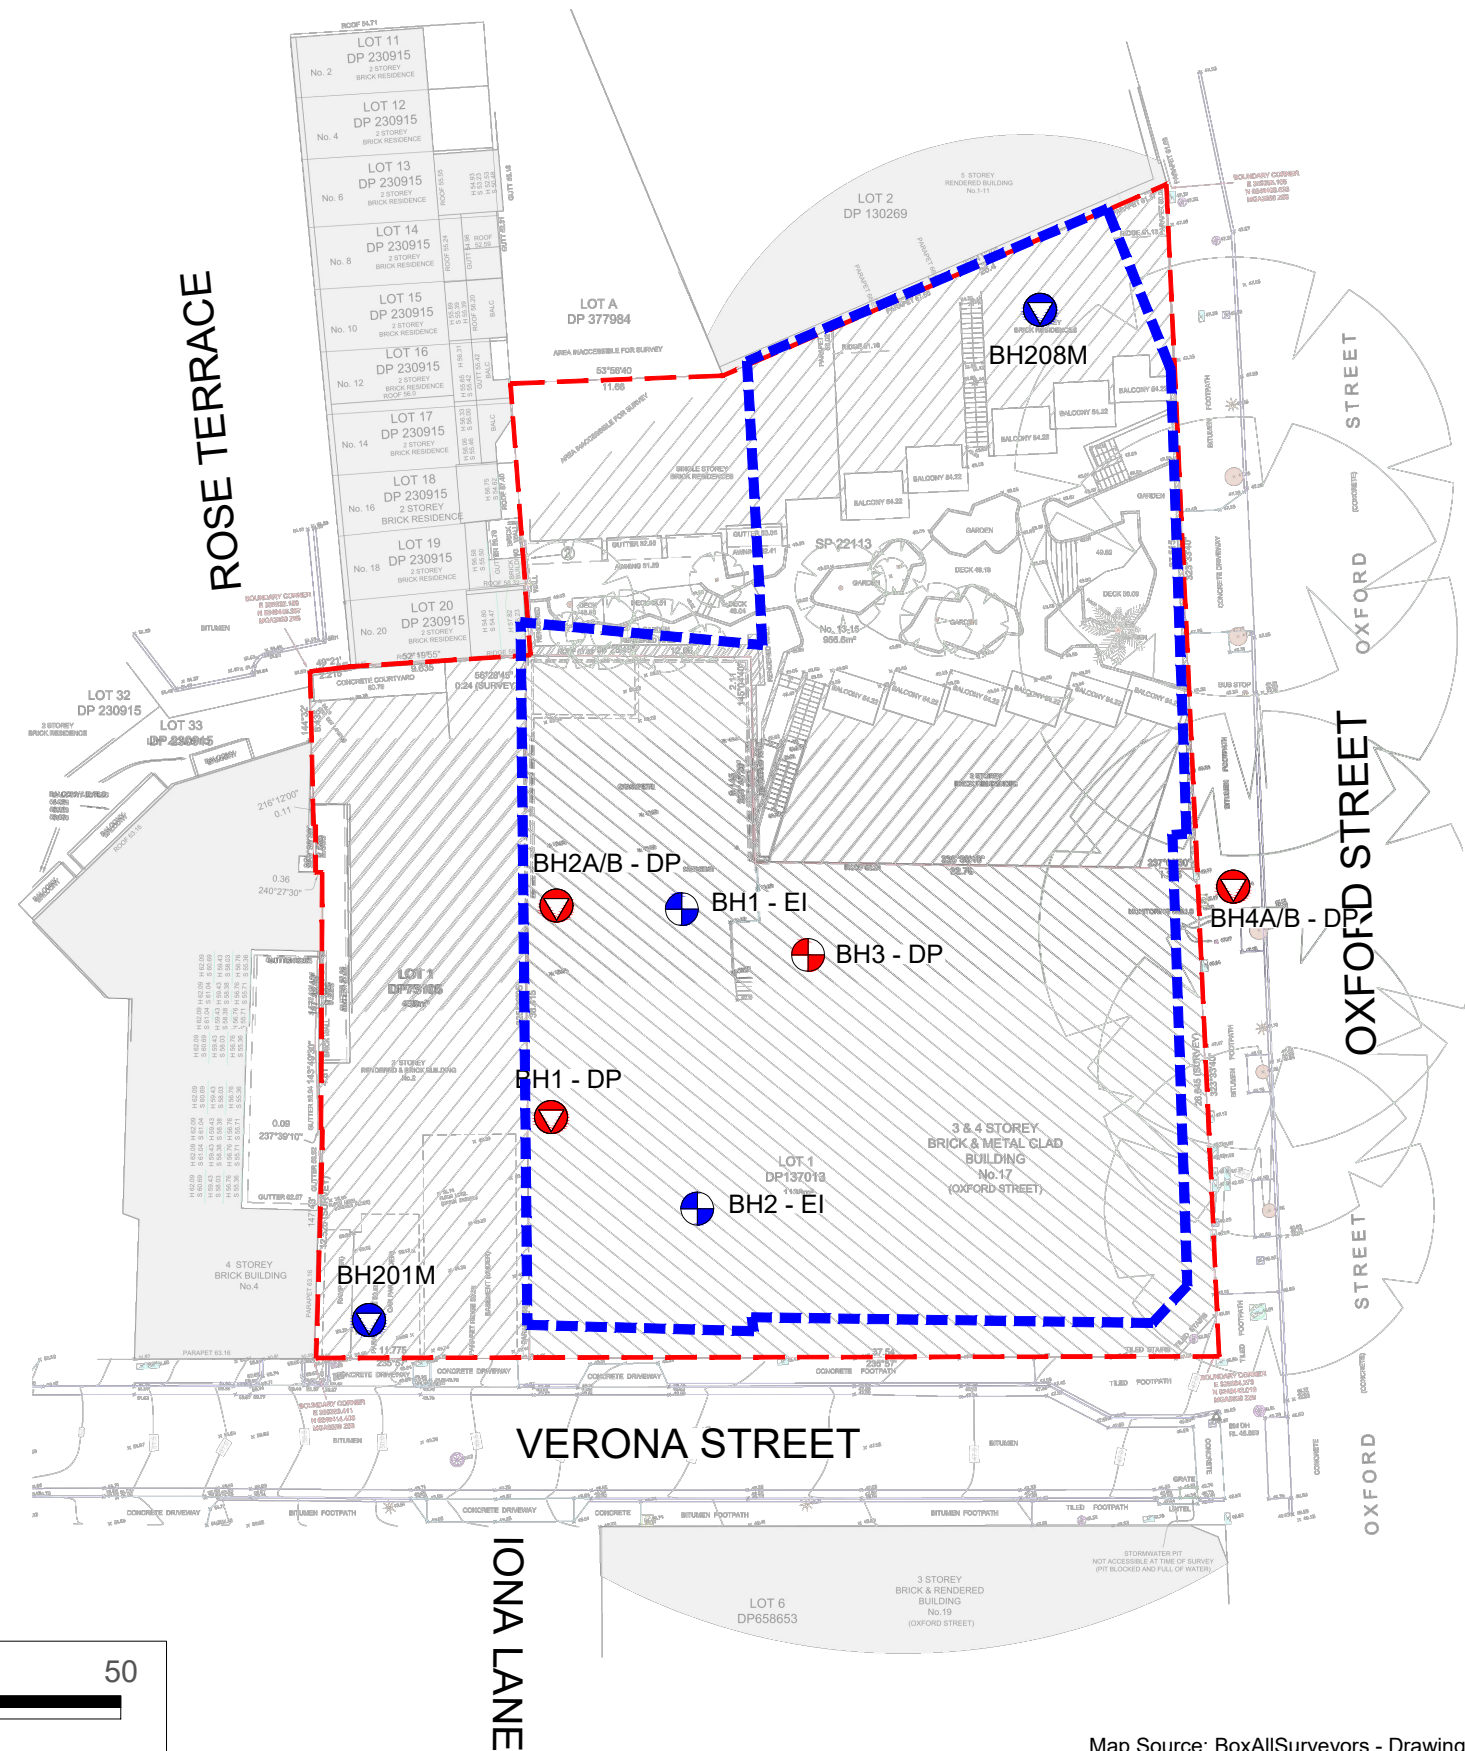
Figure 2      Borehole Location Plan

Map Source: BoxAllSurveyors - Drawing No. 11434-001, Sheet 1-2 of 4, Latest Revision F, Dated 18 October 2022

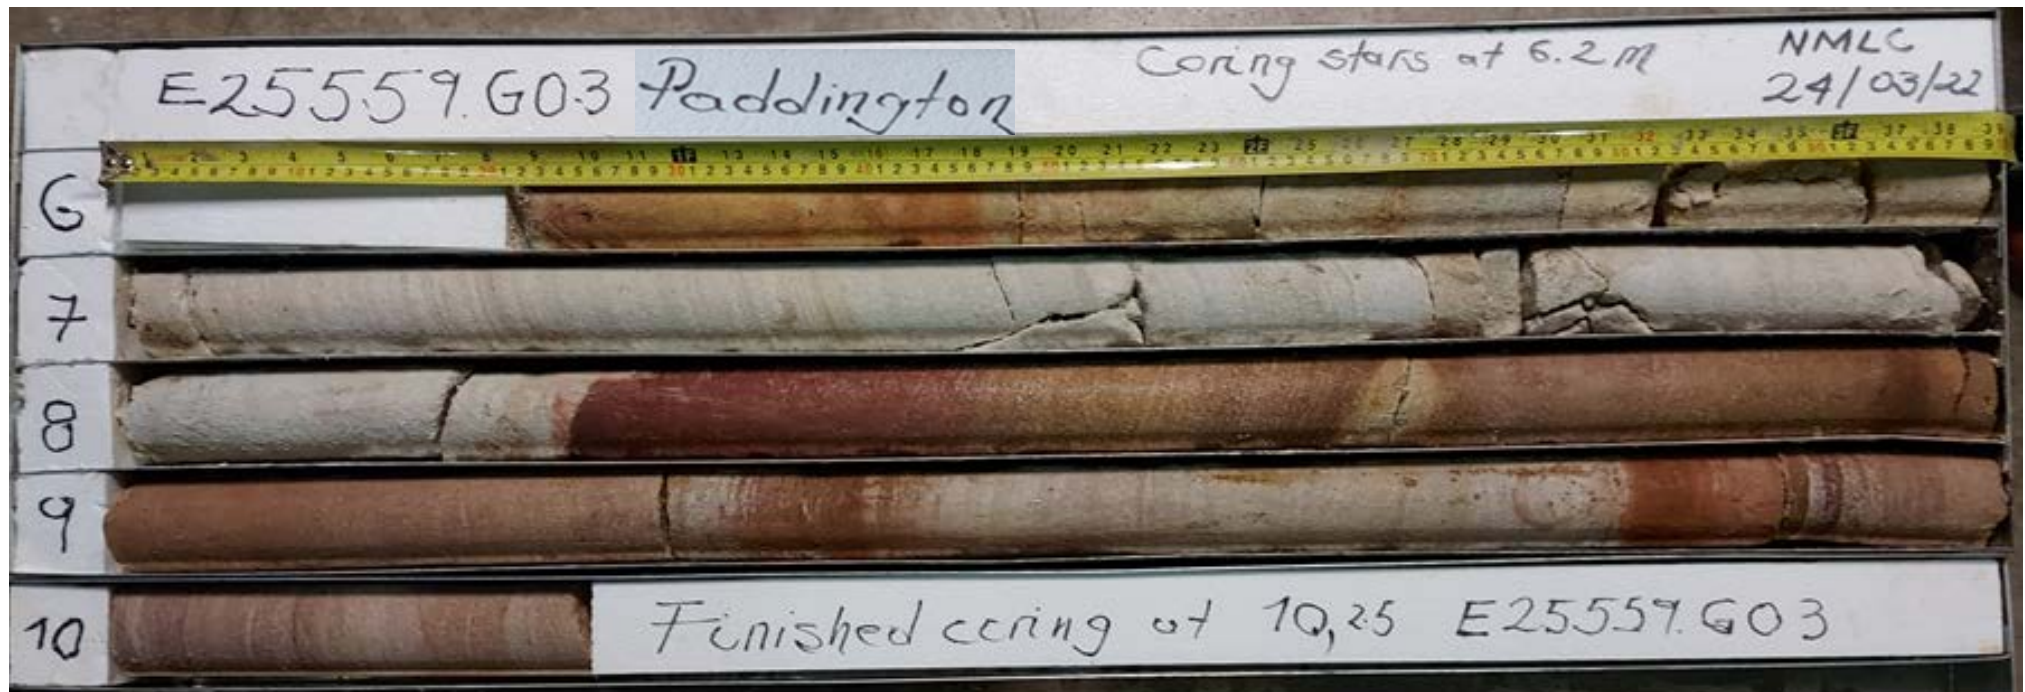
| <b>Job No.</b> | E25559.G03 | <b>Logged</b> | JS | <b>Date</b> 24 / 03 / 2022 |
| <b>Client</b> | Verona Co | <b>Box</b> | 1-2 of 2 | <b>Checked</b> DS <b>Date</b> 10 / 05 / 2022 |

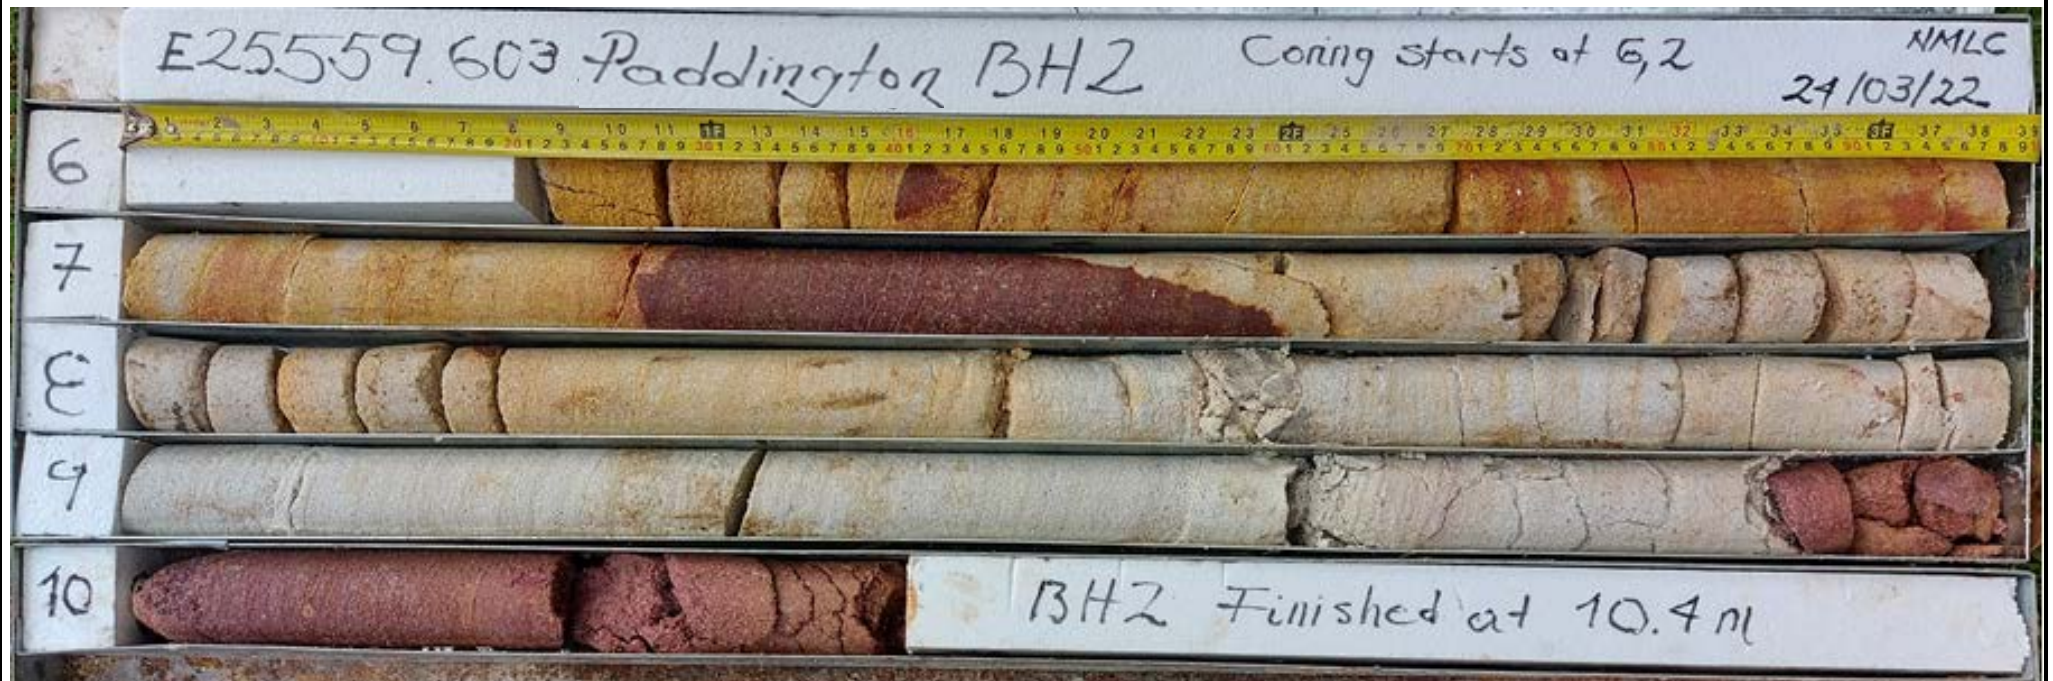
| | | <b>Box</b> | 1 of 1 | |
| | | <b>Checked</b> | DS | |

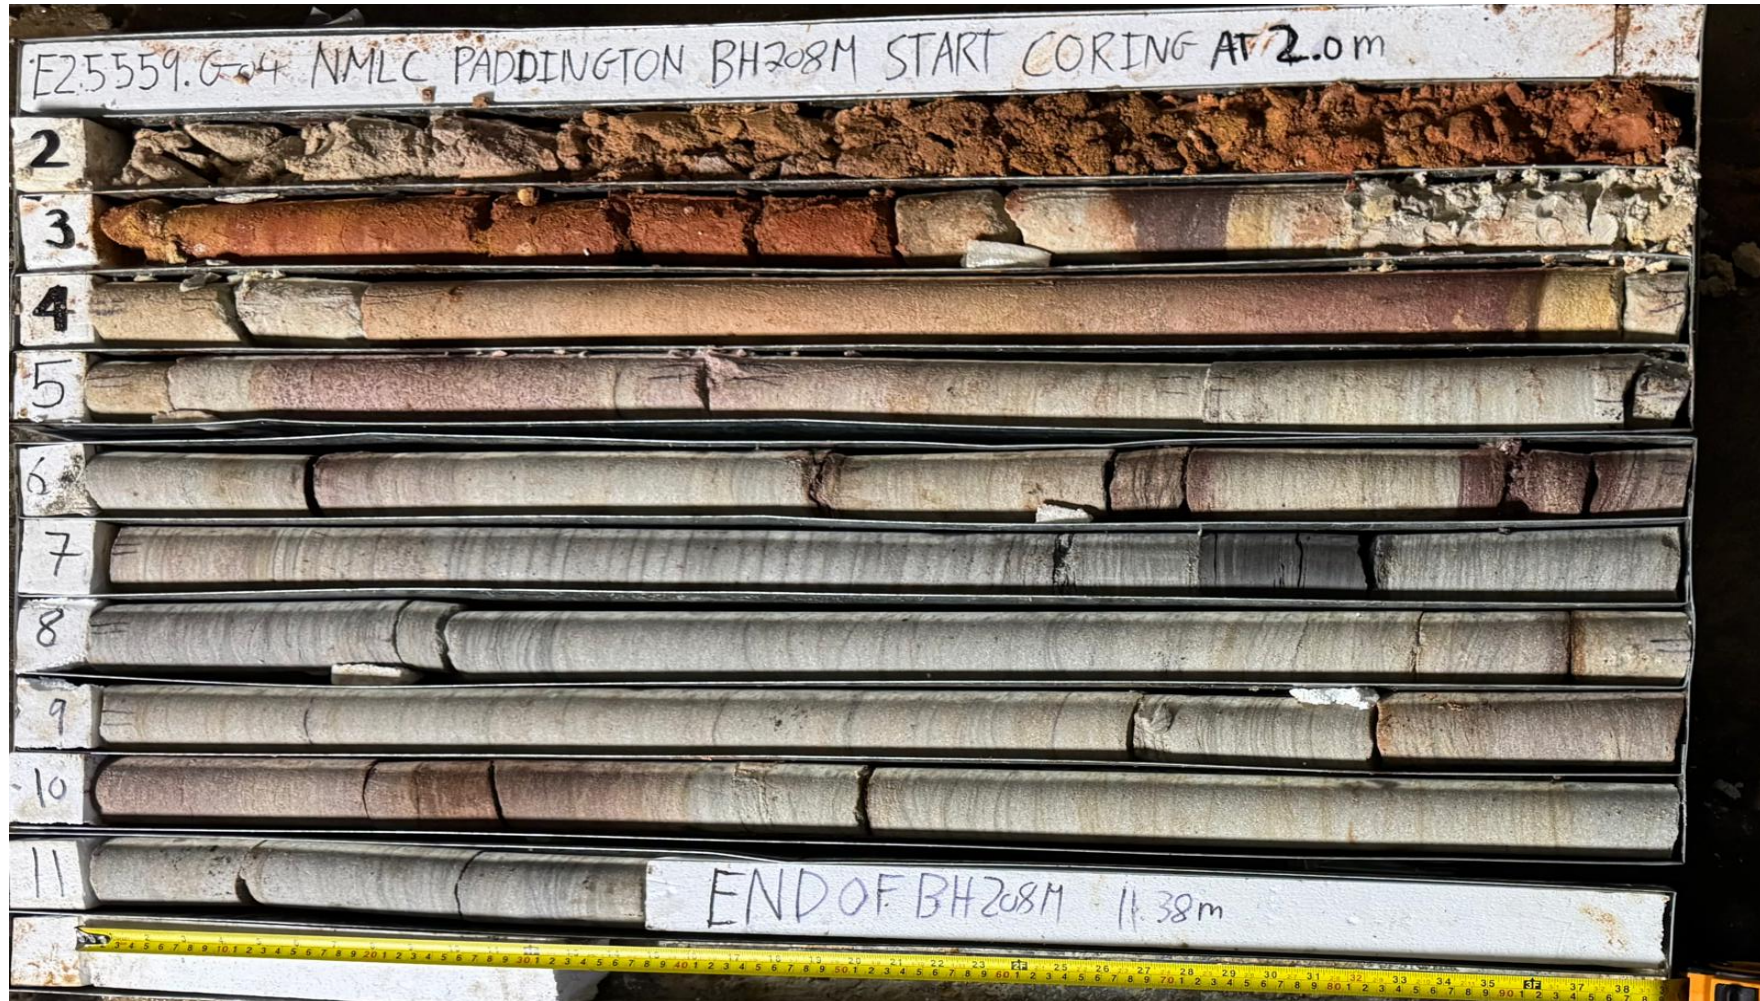
| <b>Job No.</b> | E25559.G04 | <b>Inclination</b> | -90° | <b>Logged</b> | S2 | <b>Date</b> | 08 / 10 / 2025 |
| <b>Client</b> | 17 Oxford Street Pty Ltd | <b>Box</b> | 1&2 of 2 | <b>Checked</b> | SK | <b>Date</b> | 15 / 10 / 2025 |
