# Remediation Action Plan

13-15 Oxford Street, 17 Oxford Street & 2 Verona Street,  
Paddington NSW

**Report No:** E25559.E06\_Rev1

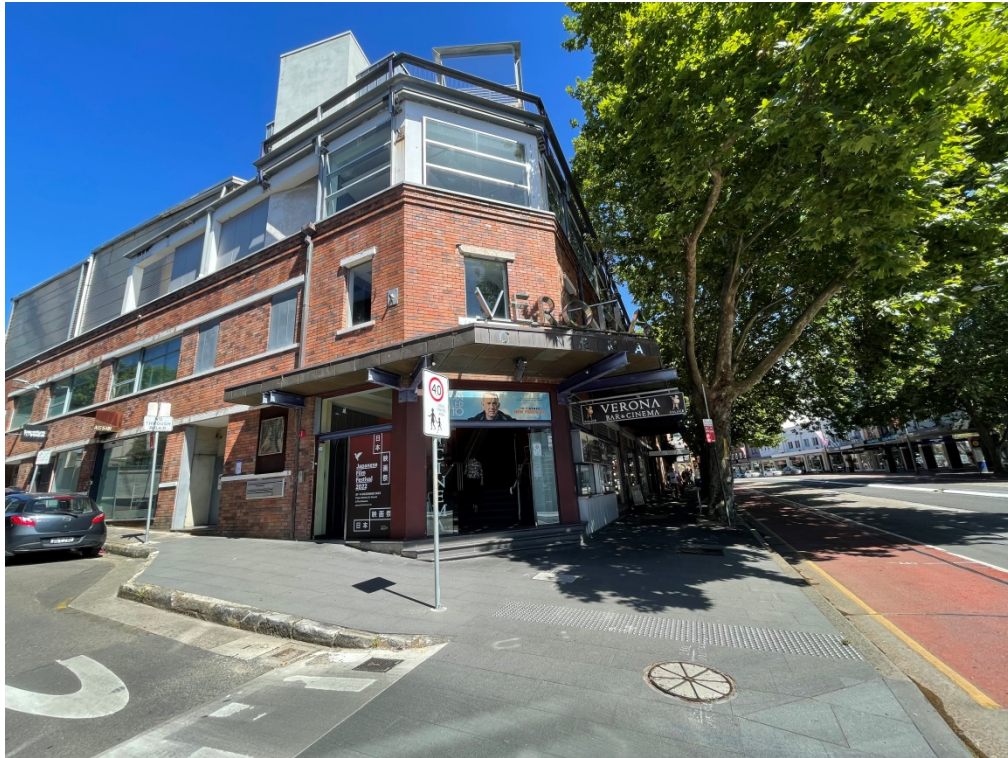
**Photograph 1:** General site conditions (23/11/2022.).

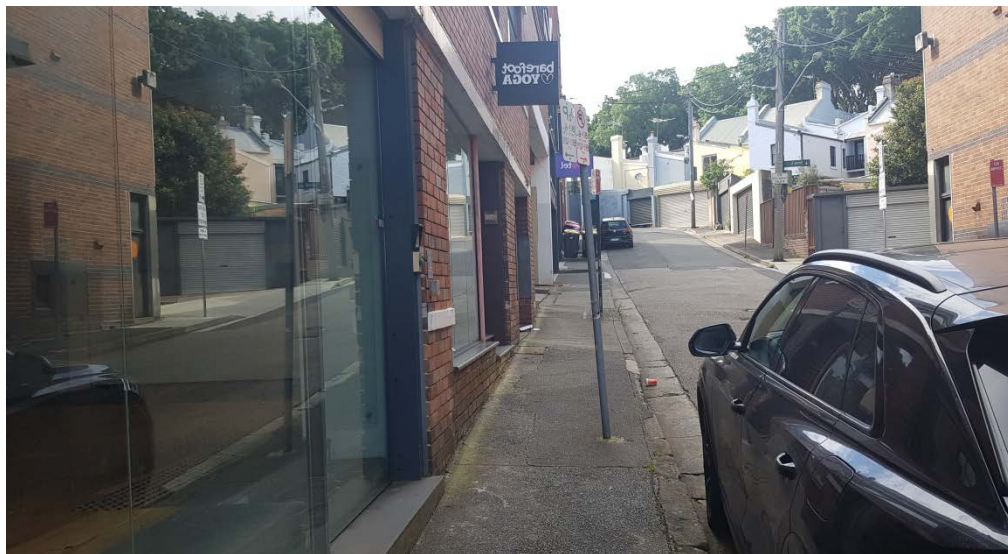
**Photograph 2:** General Site Topography (24/03/2022.).

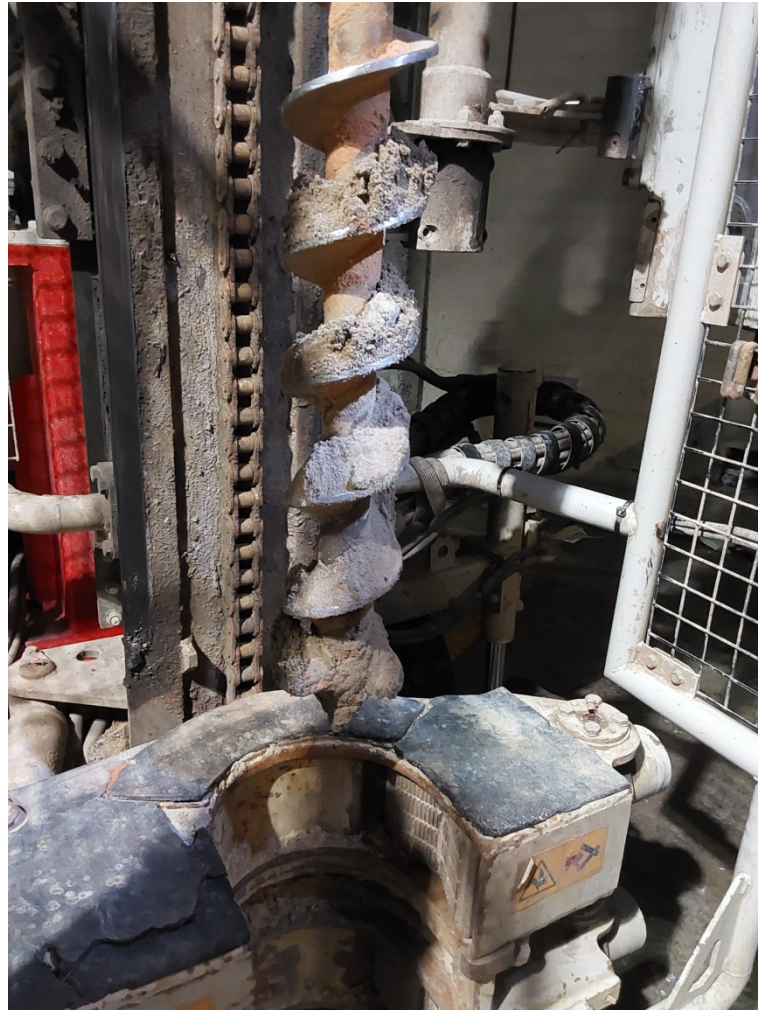
**Photograph 3:** Sandy Fill Material in BH103 (28/07/2023).

Based on the findings from the investigation phase, asbestos impacted fill soils were found in two locations BH103 and BH105 (17 Oxford Street).

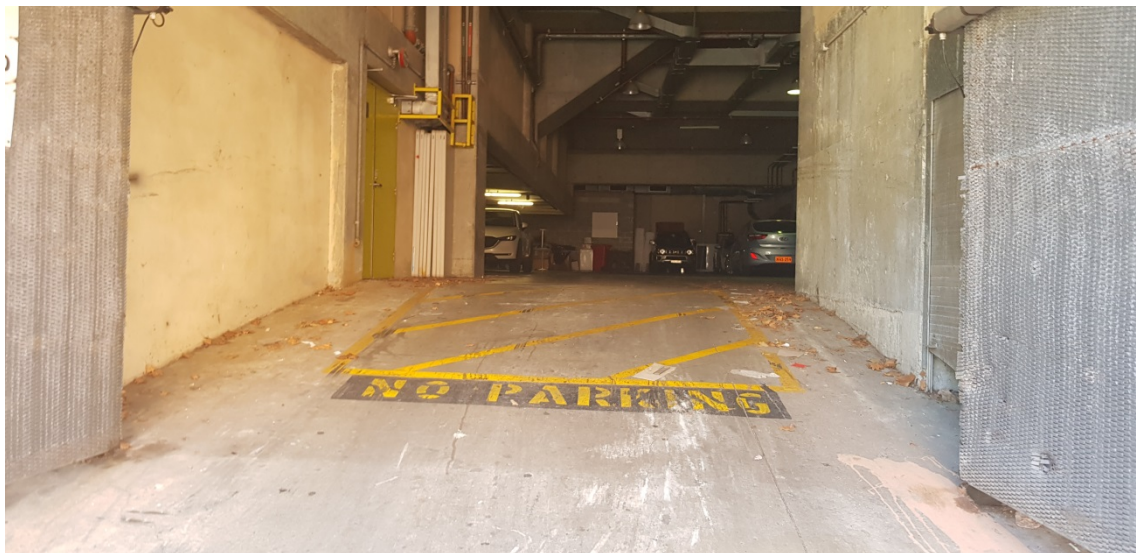
**Photograph 4:** Existing on-grade carpark on site (10/03/2022).
