## Detailed Site Investigation

13-15 Oxford Street, 17 Oxford Street & 2 Verona Street,  
Paddington NSW

**Report Title:** Detailed Site Investigation; 13-15 Oxford Street, 17 Oxford Street & 2 Verona Street, Paddington NSW

**Report No:** E25559.E02.002\_Rev0

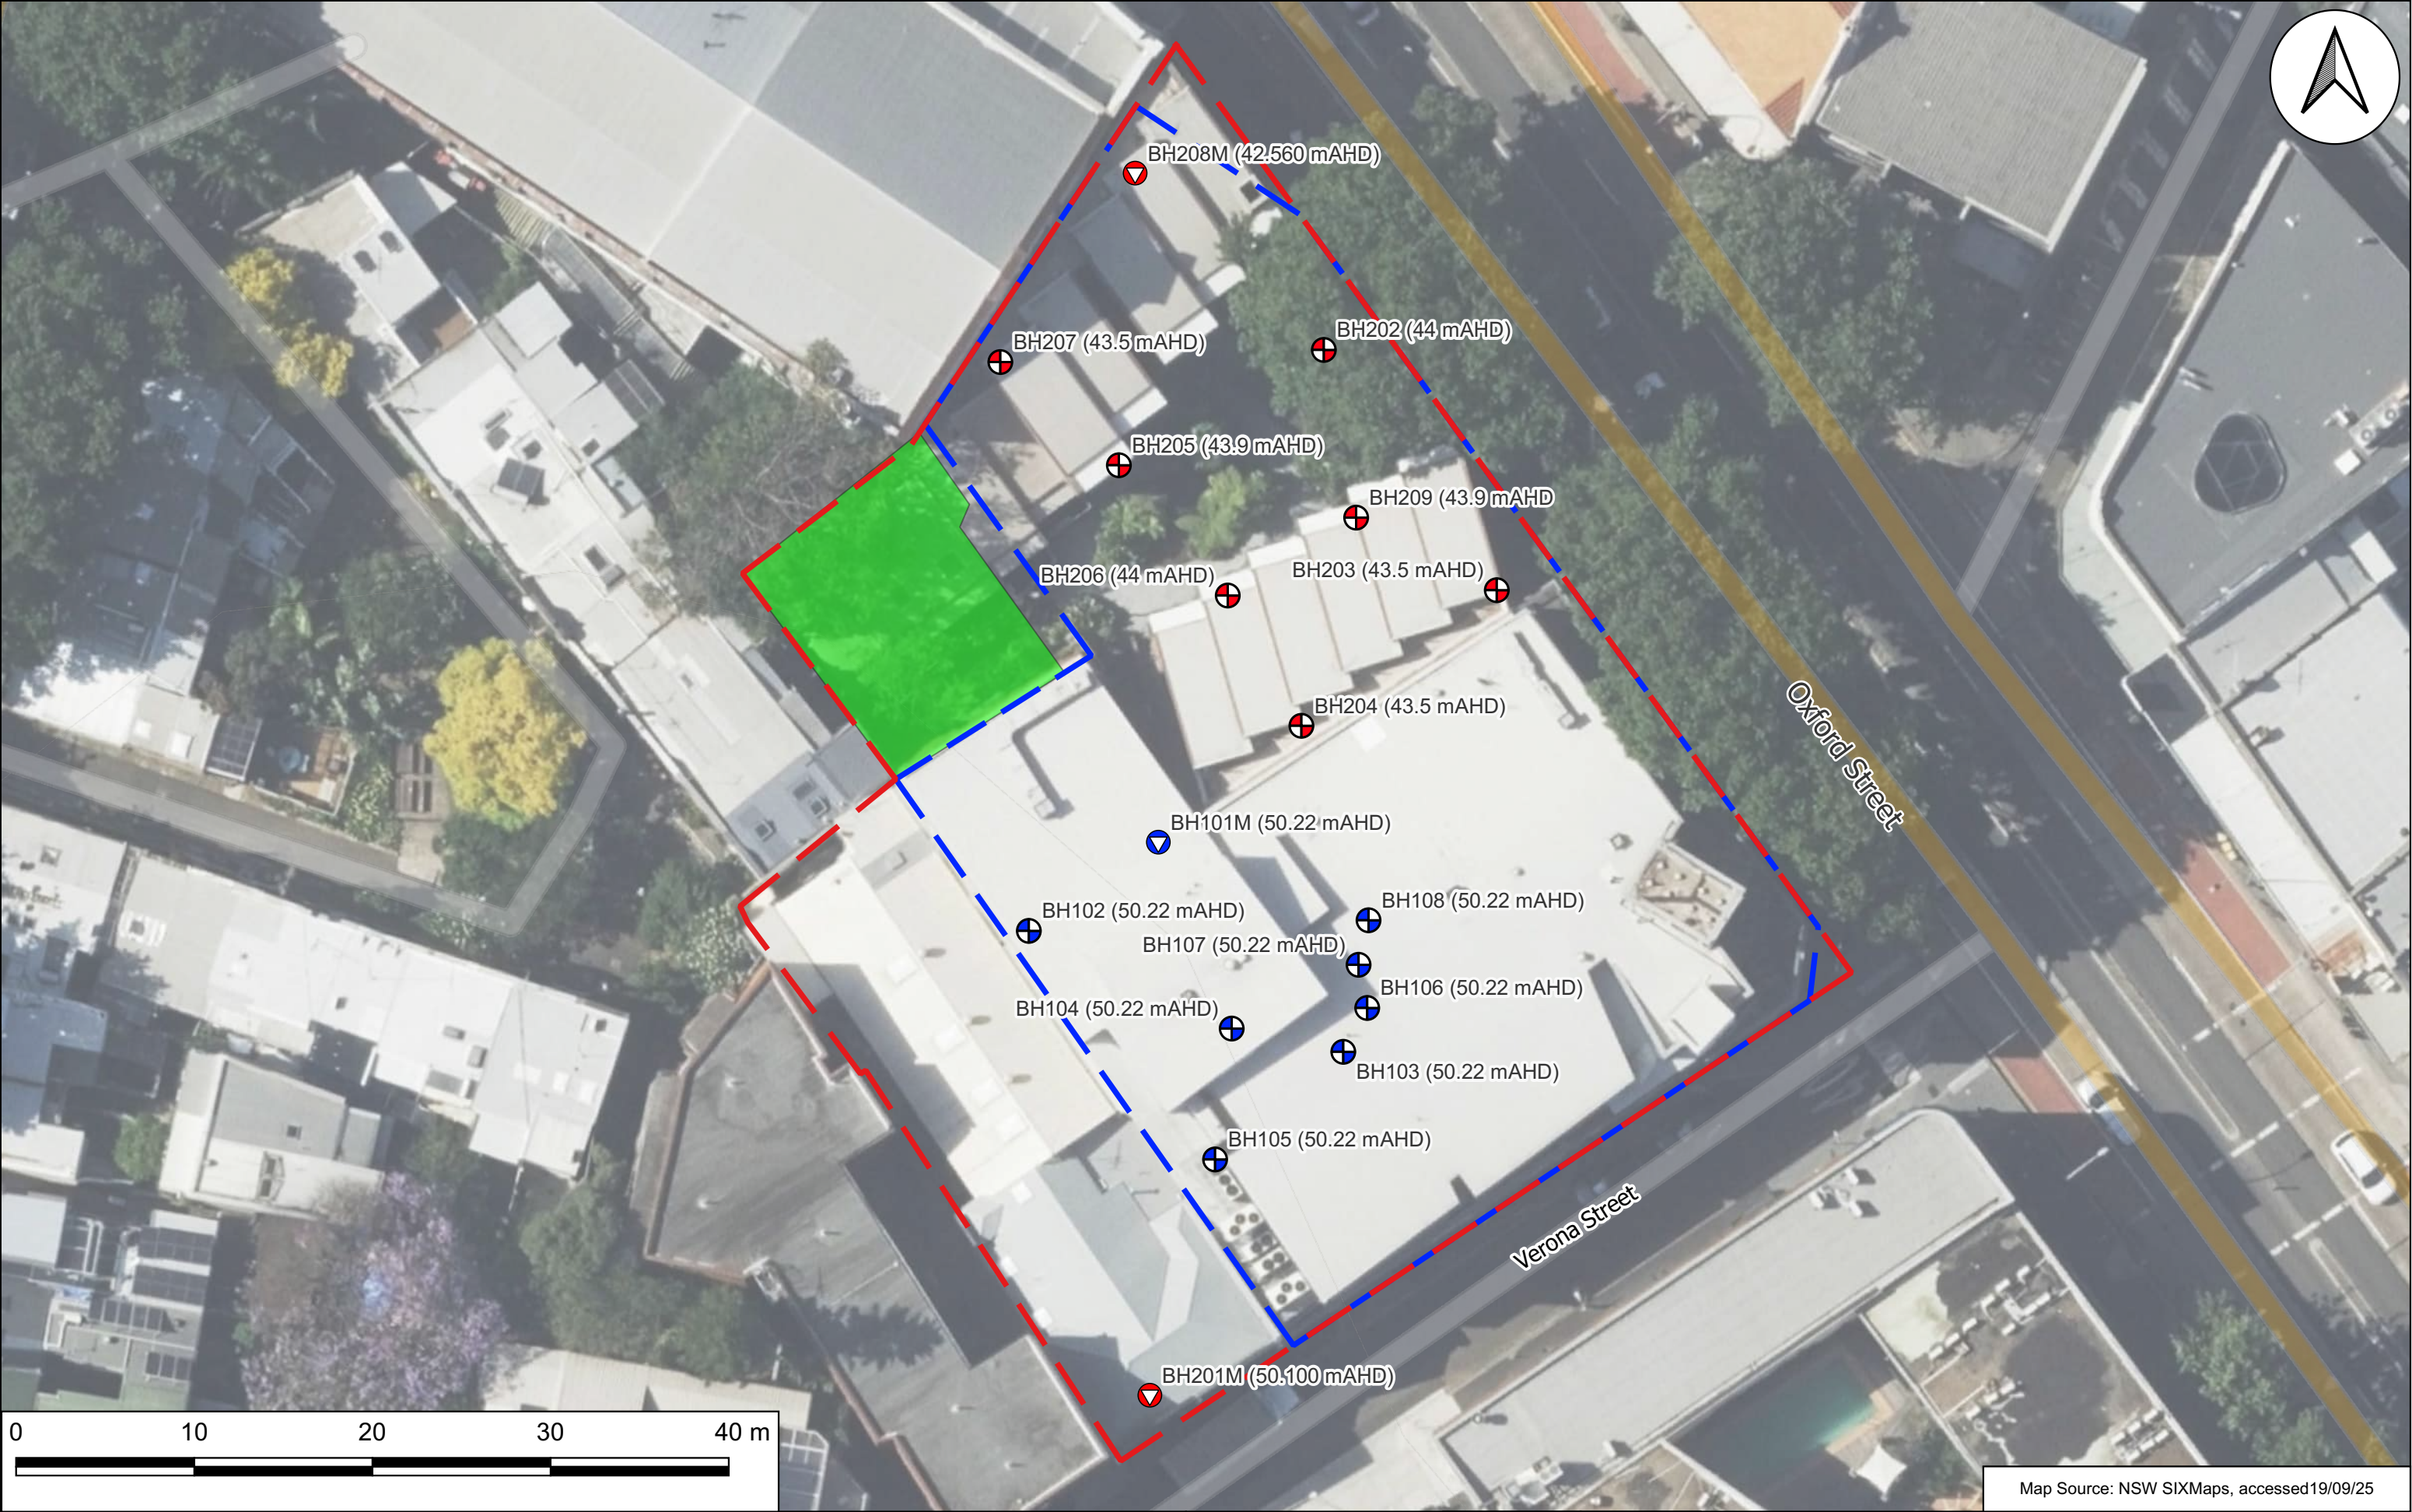
- Soil sampling was conducted at nine (9) boreholes (BH201M to BH209, including BH208M), placed in accessible parts of the site. Previous investigation of soil at 17 Oxford Street was conducted at eight borehole locations BH101M, BH102 to BH108. The total area of the proposed development is 2,533 m<sup>2</sup>. This complies with the minimum density recommended under the NSW EPA (2022) *Sampling Design – Part 1, Table 2*, which recommends 9 systematic sample locations for areas up to 0.3 ha; and
- Groundwater monitoring event (GME) at three monitoring wells;
- Laboratory analysis of representative samples for the identified contaminants of concern.

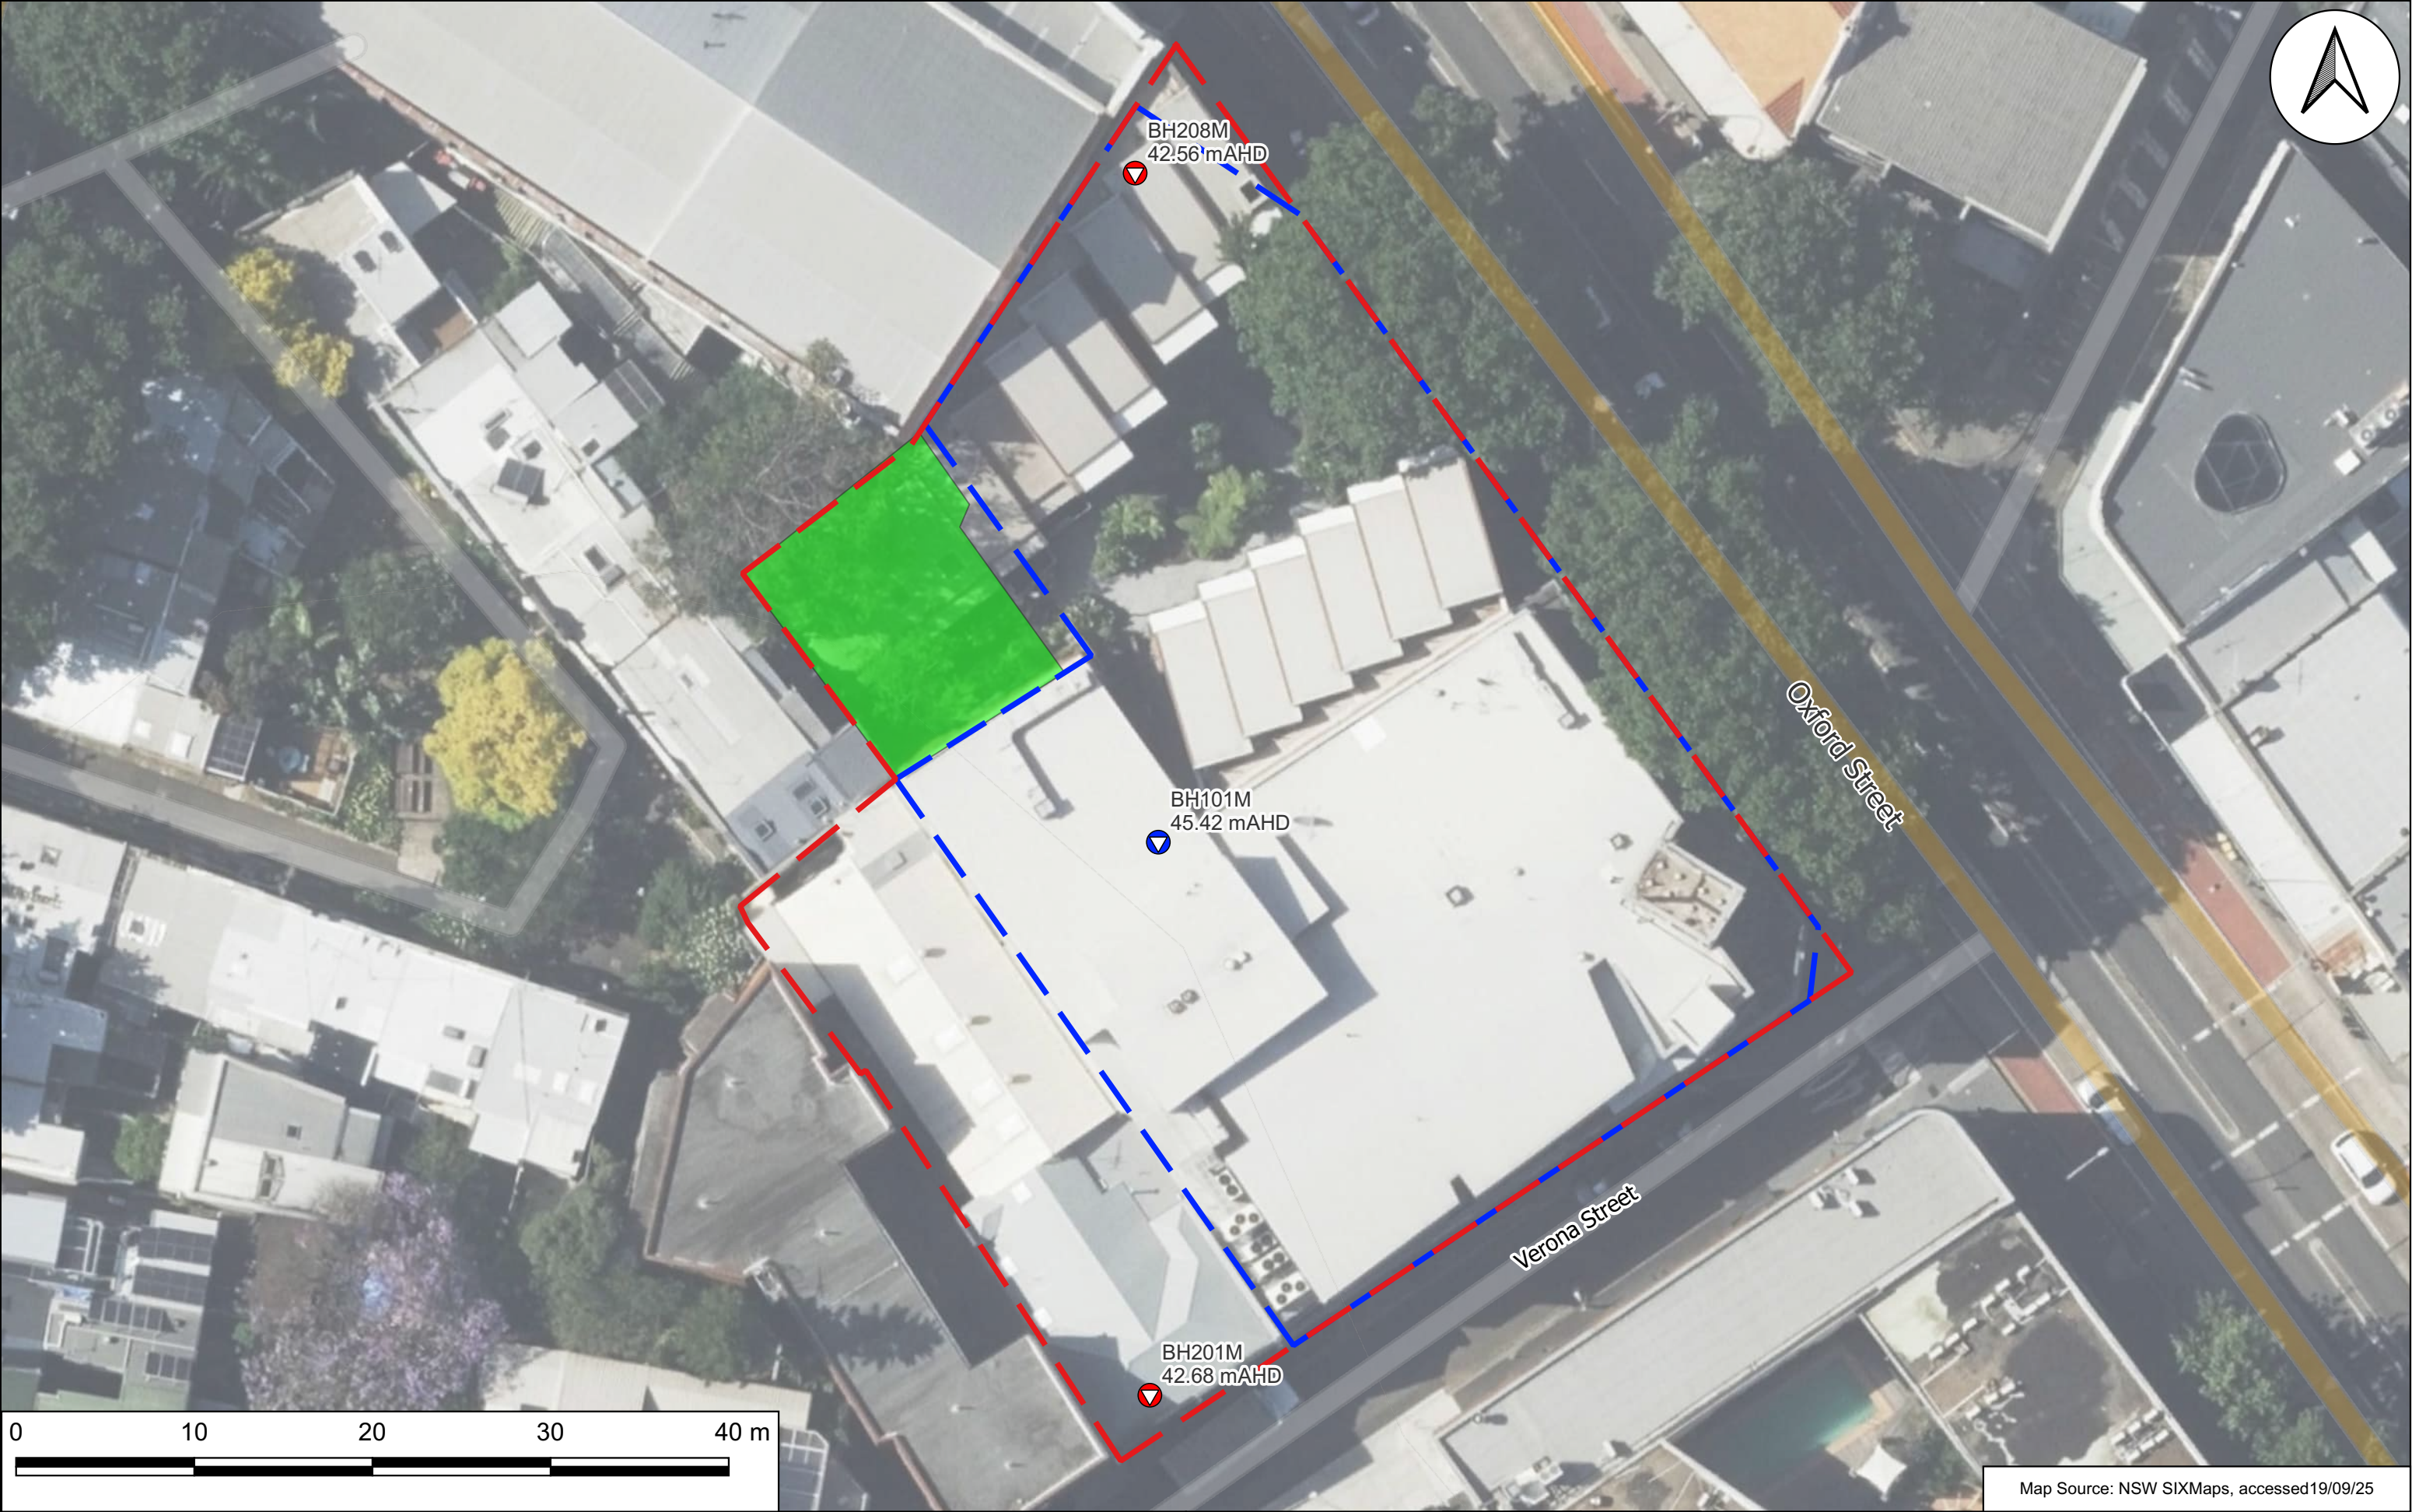
- Friable asbestos was identified in fill at locations BH103\_1.8-1.9 and BHB105\_1.3-1.4 at 17 Oxford Street.
- Groundwater was gauged at three monitoring wells and was found to occur at elevations of 42.68 mAHD (BH201M), 45.42 mAHD (BH101M) and 42.56 mAHD (BH208M). The potentiometric slope was anticipated to be north-easterly.

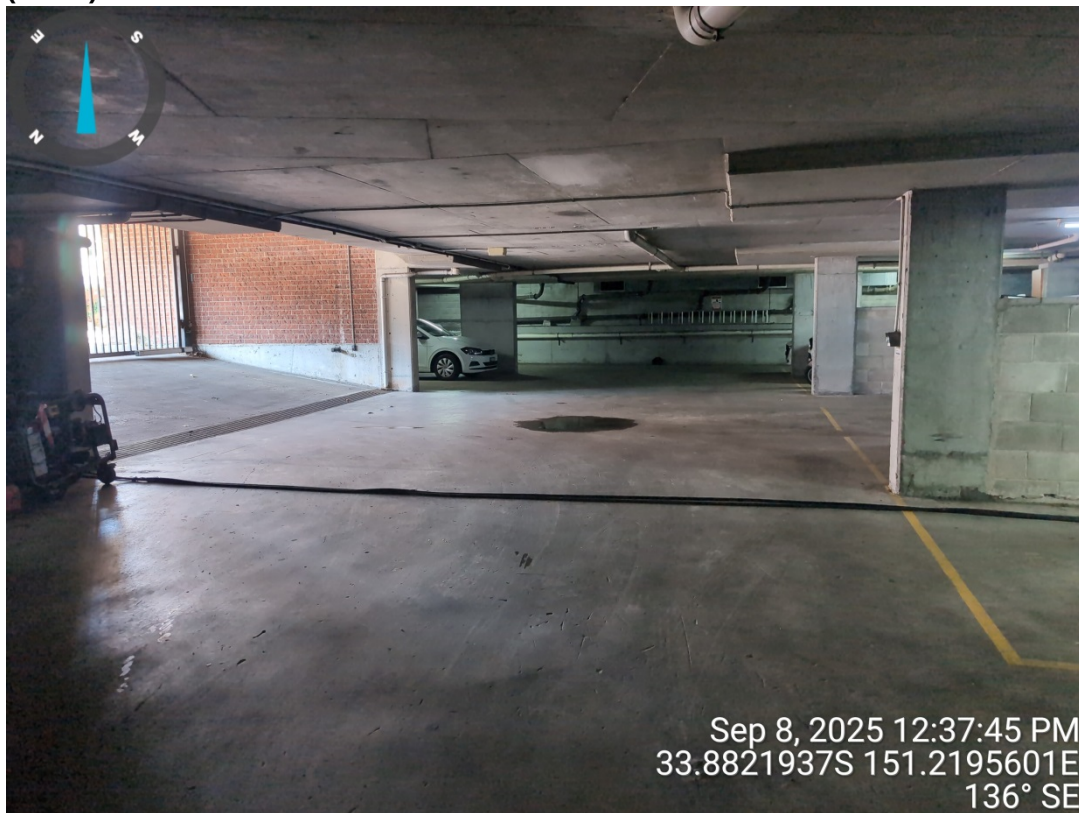
- No landscaped areas were observed within the entirety of the site;
- Concrete was observed across the entirety of the site and was in mostly good condition, with some rising damp and efflorescence was observed within the basement level of 13-15 Oxford Street.

**Photograph 4: View within basement 1 carpark of 13-15 Oxford Street, facing south-east (8/9/25).**

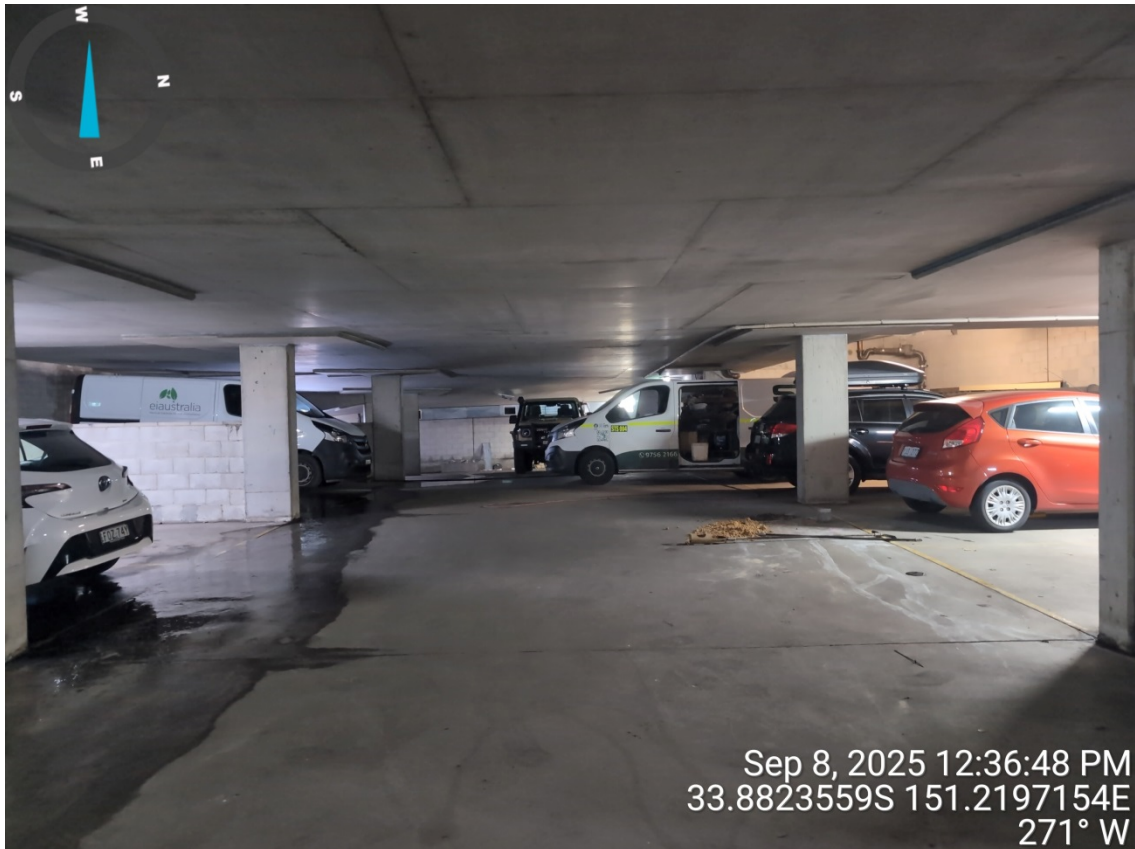
- 13-15 Oxford Street: A residential apartment complex overlying a two-level basement carpark. The basement was observed to occupy the majority of the site footprint. The lowest basement is at a floor level of approximately 4m below the surrounding ground level (i.e. RL 43.6 mAHD). The elevation of the surrounding ground level on Oxford Street was approximately RL 47 mAHD

**Photograph 5: View of basement 2 carpark 13-15 Oxford Street, facing west (8/9/25)**

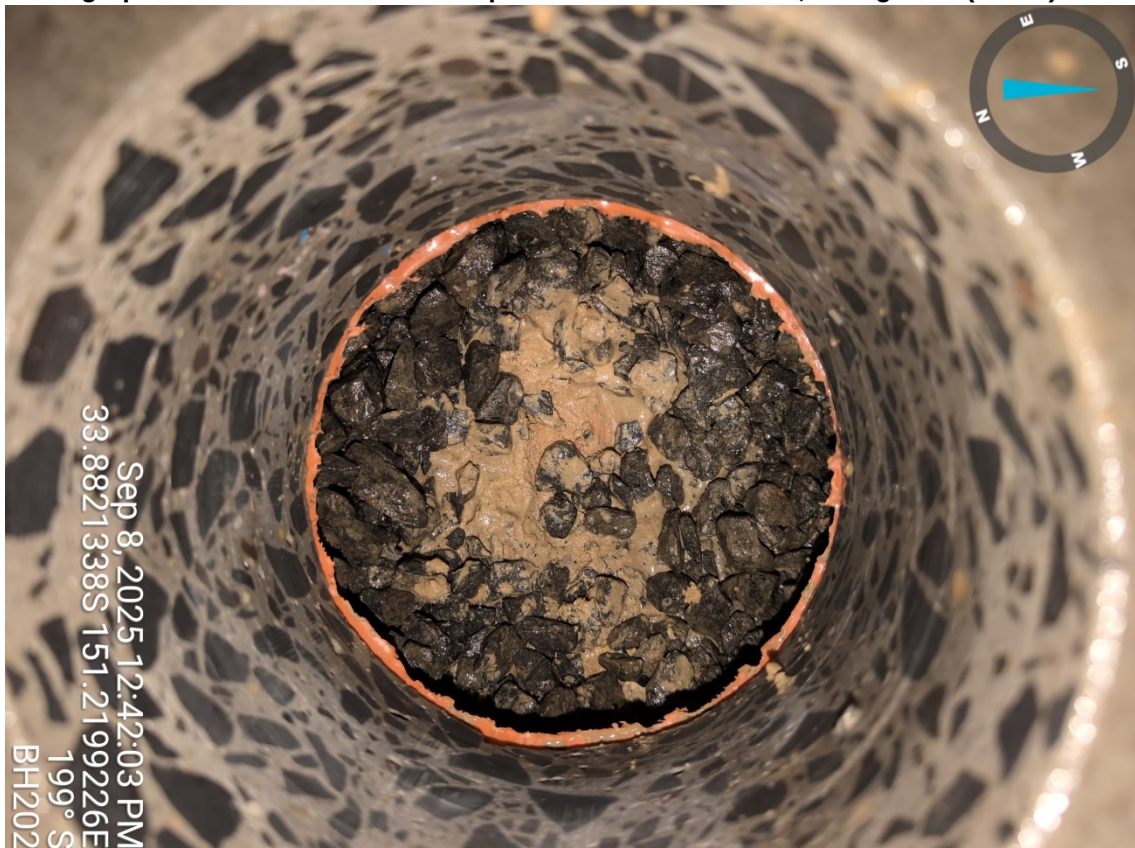
Soil samples were obtained and analysed from bores at various depths ranging between 0.15 to 1.0 mBGL. All soil samples collected were evaluated on a qualitative basis for odour and visual signs of contamination (e.g. hydrocarbon odours, oil staining, petrochemical filming, fragments of fibre containing substance (FCS), ash, slag and charcoal) and the following observations were noted:

**Photograph 6: Representative soil material within BH202 (8/9/25) .**
