The asbestos issue

Asbestos Management Plan

2. Window Asbestos Mastic Procedure (WAMP)

WINDOW ASBESTOS PUTTY PROCEDURE

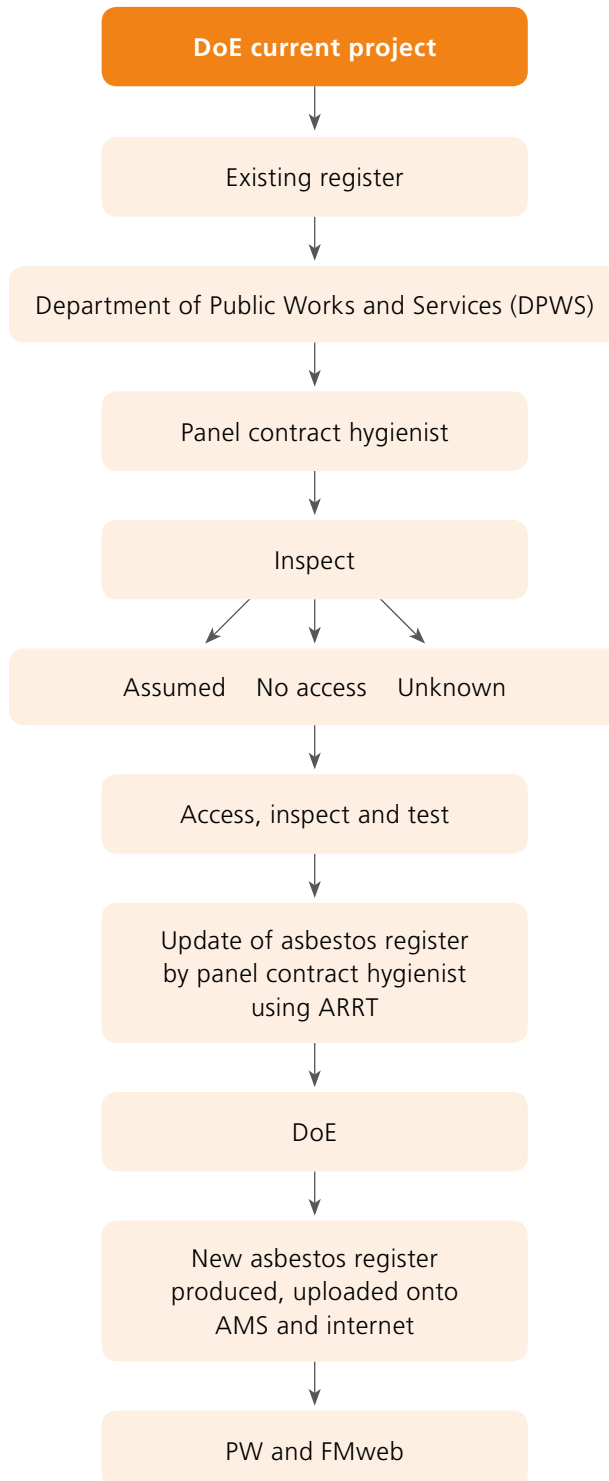
Figure G.1: Example flow chart – updating of register by panel contract hygienist

The following flowchart is provided as an example and explains maintenance of an asbestos register via a panel hygienist and their subsequent use of the Asbestos Register Review Tool (ARRT) prior to a project commencing. It does not aim to show all stakeholders and steps.

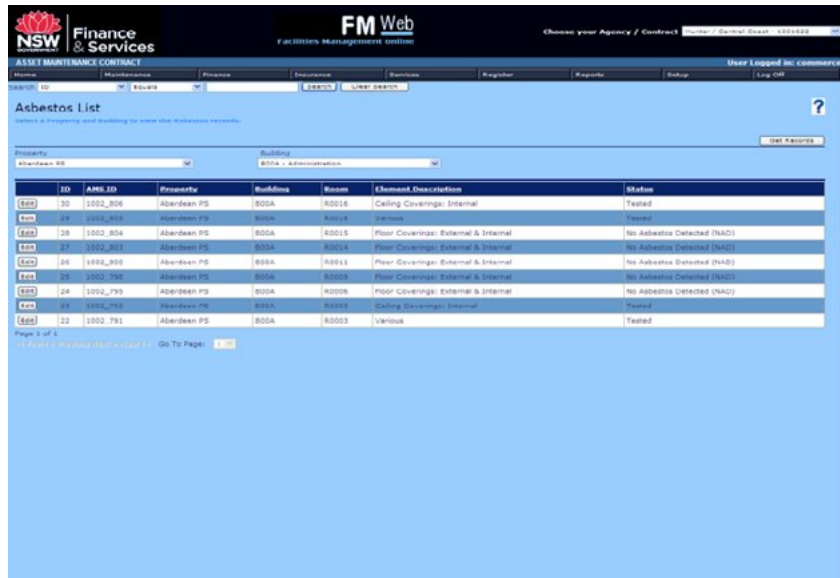
- Log in using user name and password in FMweb.
- Click on 'Register' >> 'Asbestos list' from FMweb main menu to go to the asbestos list screen.
- Asbestos asset list screen shows important fields like asbestos asset ID, AMS ID, property name, building, room, element and status details for the selected property and building.
- To get the asbestos asset list, user must select property and building.

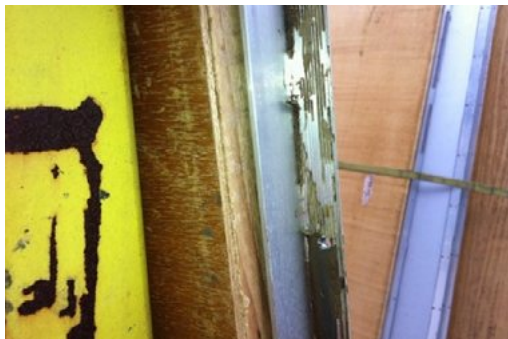
Photograph 04:
Typical panels showing location of asbestos containing mastic on aluminium frame

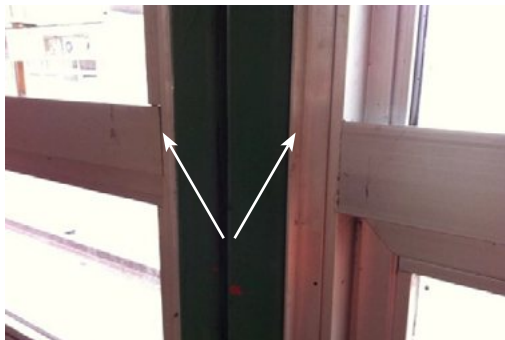
Photograph 06:
Position where asbestos containing mastic is
used to seal the join between the steel frame
of the demountable and the aluminium frame
of the windows / panels

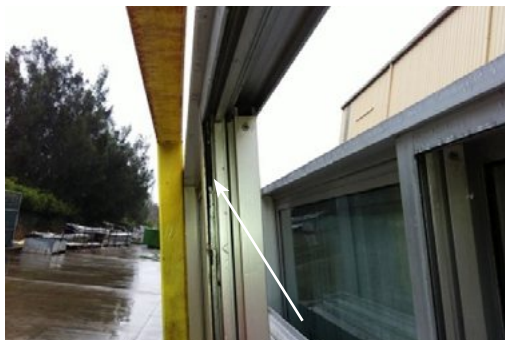
Photograph 07:
Asbestos containing mastic in the groove of
the window where the glass pane is inserted
