Report on
Preliminary Geotechnical Investigation and Acid
Sulfate Soils Assessment

Proposed School Structures,
High School, 33 Oxford Street, Kingscliff

Prepared for
School Infrastructure NSW/ Department of Education

Project 98084.00
April 2020

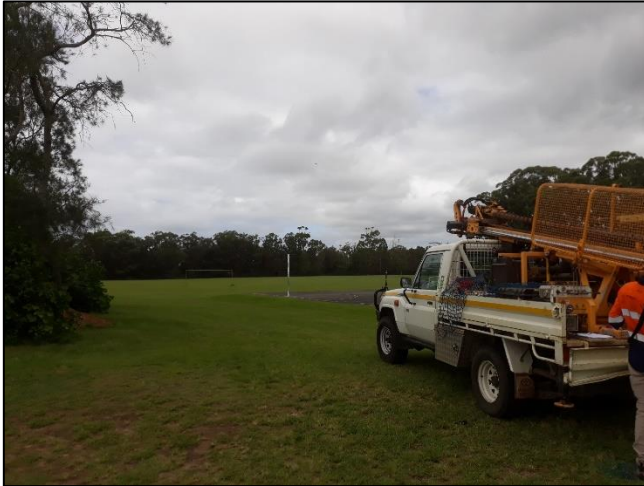
Figure 1: Typical site conditions looking southward from Bore 8.

Figures 1 and 2 indicate typical site conditions encountered at the time of the investigation.

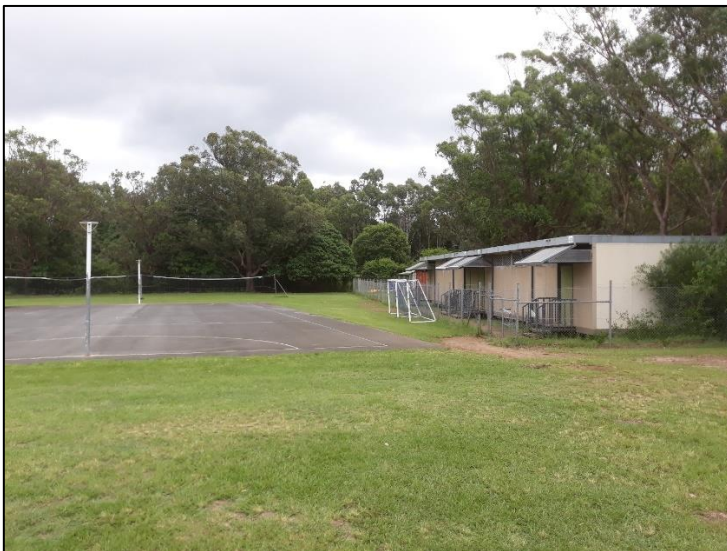
Figure 2: Typical site conditions looking westward from Bore 8.

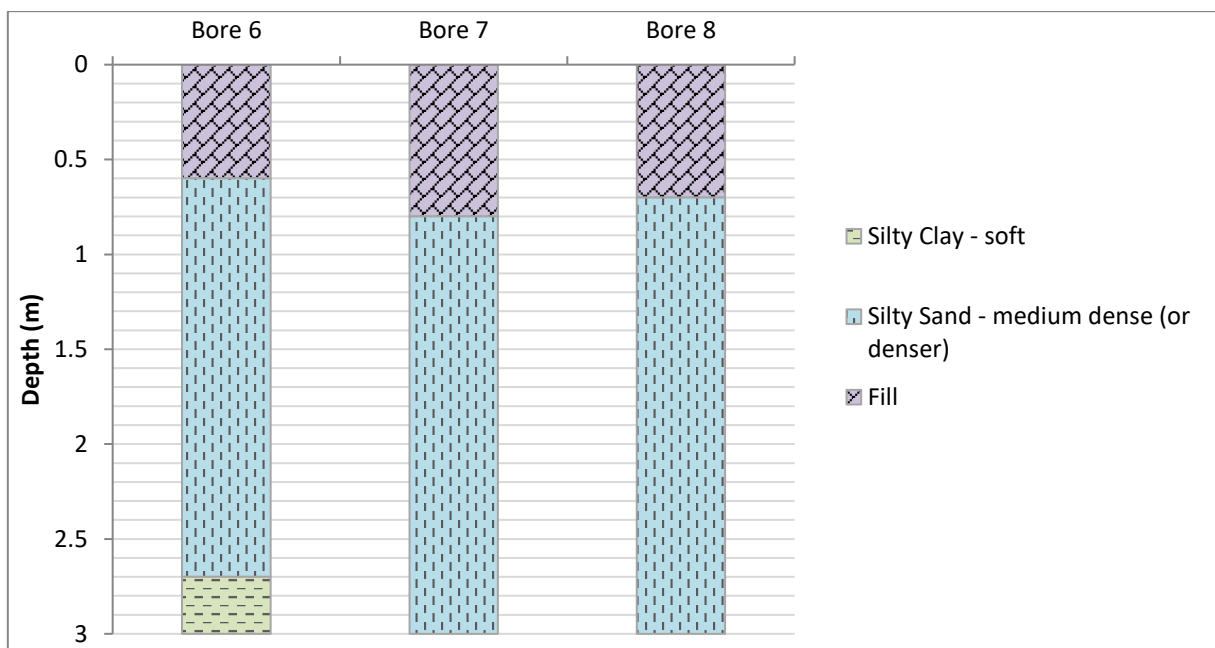
Figure 3: Graphical summary of subsurface conditions.

The subsurface conditions encountered in the bores are described in detail on the borehole logs in Appendix C, and are summarised in Table 1 and shown graphically in Figure 3.

The fill encountered in Bore 6 comprised pavement gravel and sandy gravel to 0.6 m depth, whilst clayey/silty sand fill was encountered at Bores 7 and 8. It is probable that the fill at Bore 6 was placed under ‘controlled’ conditions as part of the existing pavement construction, and the fill encountered at Bores 7 and 8 appears moderately well compacted. However, in the absence of documentation to confirm the fill was engineered and placed under ‘controlled’ conditions and meets the requirements of structural fill as defined in AS 3798 (2007), it must be deemed ‘uncontrolled’.

Groundwater was encountered within all bores during auger drilling at depths between 0.8 m and 1.8 m. It should be noted that groundwater depths and ground moisture conditions are affected by climatic conditions and tidal influences (which may be present at this site) and will therefore vary with time. Seepage may also occur along the fill/natural and the sand/clay interface during and after periods of wet weather.

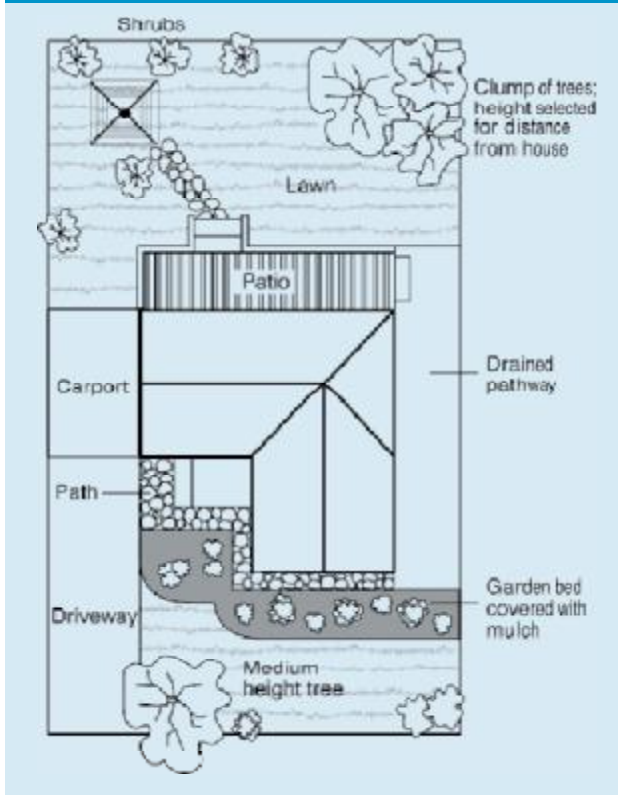
Gardens for a reactive site

should extend outwards a minimum of 900 mm (more in highly reactive soil) and should have a minimum fall away from the building of 1:60. The finished paving should be no less than 100 mm below brick vent bases.
