ABORIGINAL OBJECTS DUE DILIGENCE ASSESSMENT

20-22 Atchison Street
St Leonards, NSW
Cammeraygal Land

Prepared for
SETIA SYDNEY PTY LTD
16 September 2025

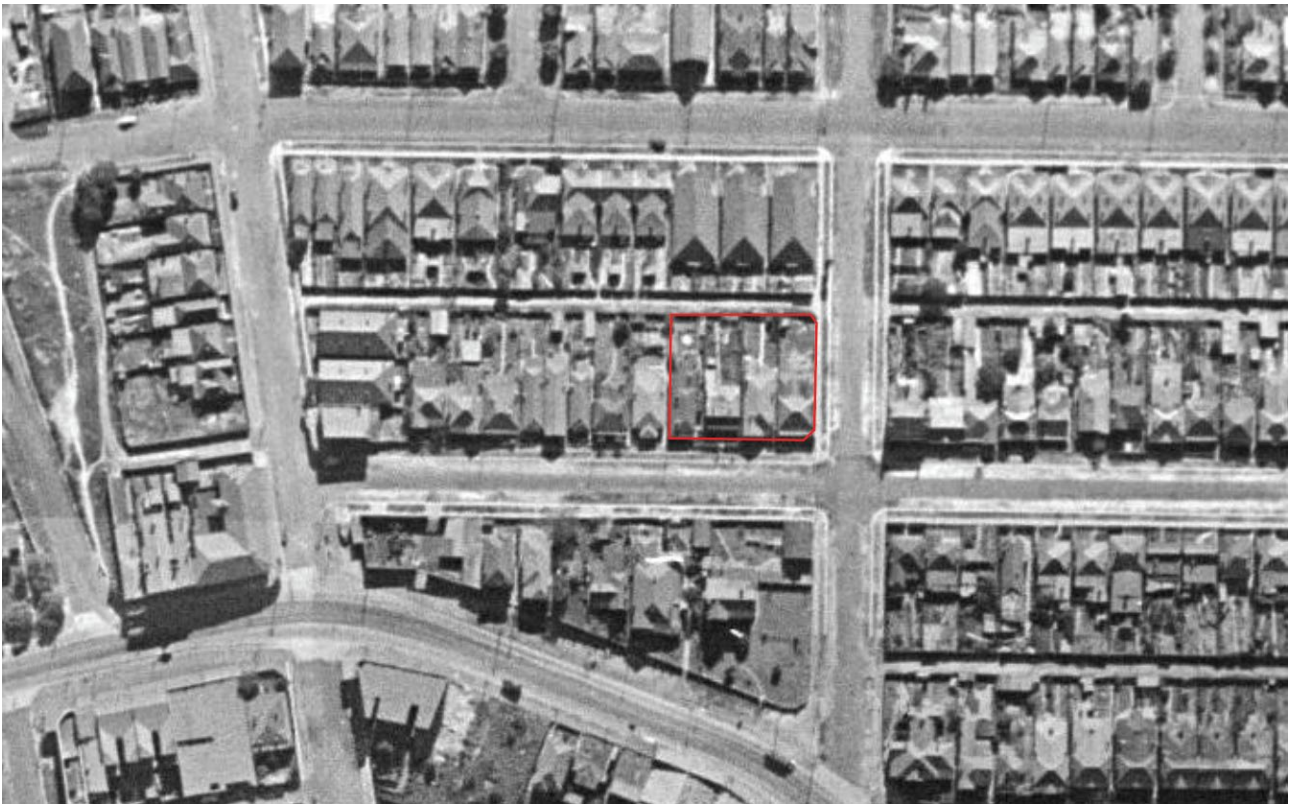
The next visual representation of the study site is the 1943 aerial photograph (Figure 11). In this aerial there is a dwelling on each of the four allotments. It is unclear whether the buildings on Lots 1 and 4 are the same from the 1890s crown plan or new buildings. Each of the four houses has a backyard and associated outbuildings. By the 1965 aerial only the house on Lot 4 is still standing (Figure 12). A new building is on Lot 3 and what appears to be a warehouse with a central yard has been constructed across Lots 1 and 2. On the 1986 aerial all of the buildings from the 1965 aerial have been replaced with the two buildings that currently occupy the site (Figure 13).

Figure 10 – 1943 aerial photograph – subject area outlined in red.
Source: NSW Historical Imagery

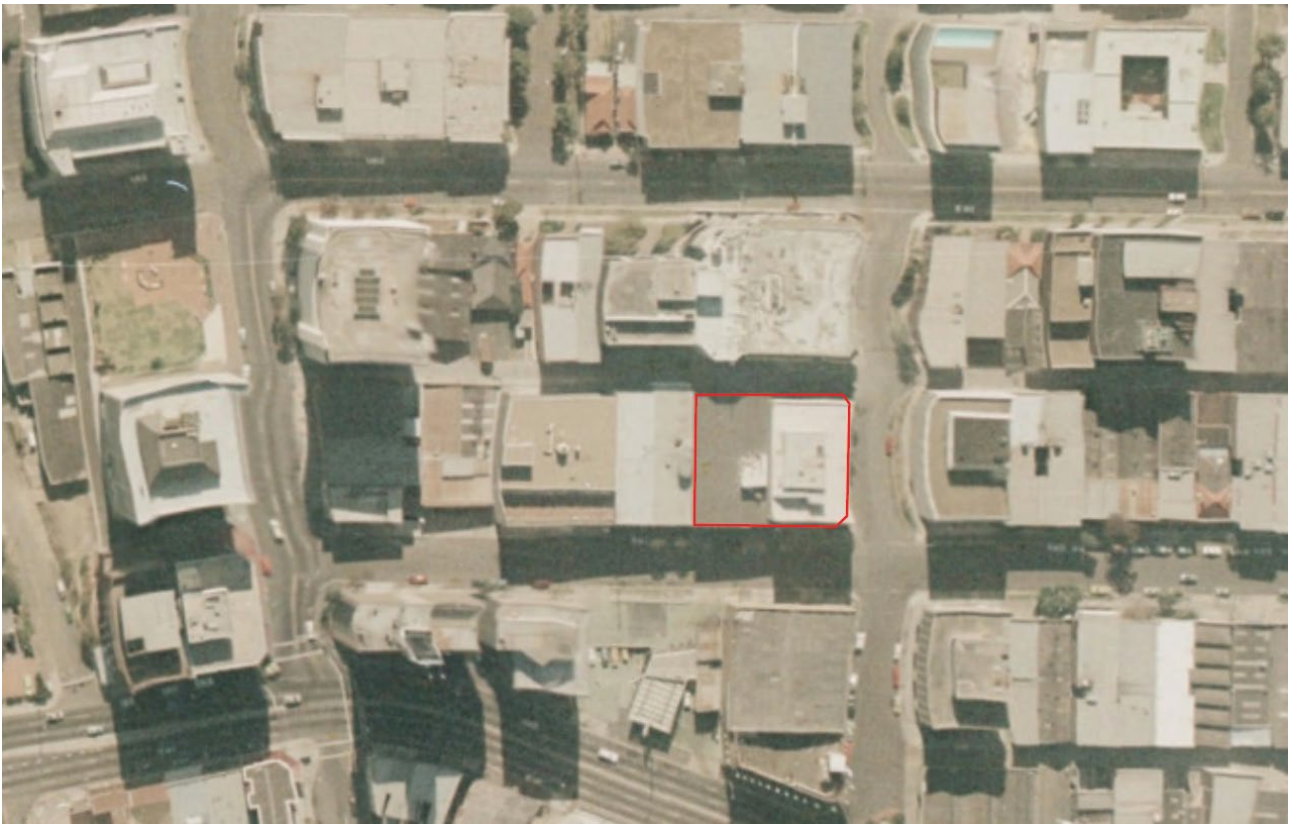
Figure 12 – 1986 aerial photograph – subject area outlined in red.
Source: *NSW Historical Imagery*

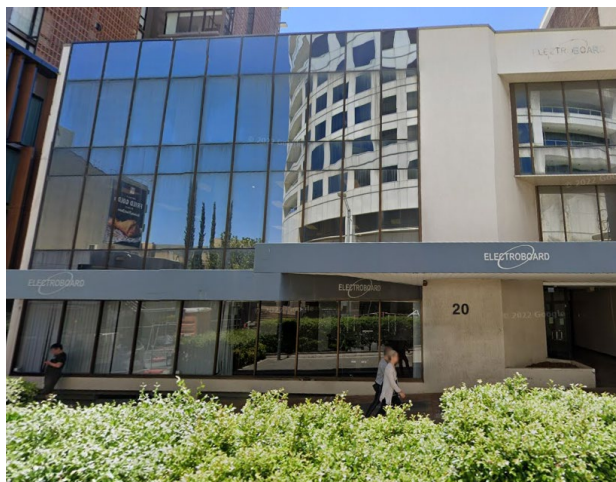
The visual inspection was undertaken in sunny conditions. Ground Surface Visibility (GSV) was estimated to be 0%, with the majority of the subject area taken up by the two office buildings (Figure 14 & Figure 15). Hardstand covered the remainder of the ground surface on all sides.

Figure 13 – Atchinson Street frontage, No. 20.

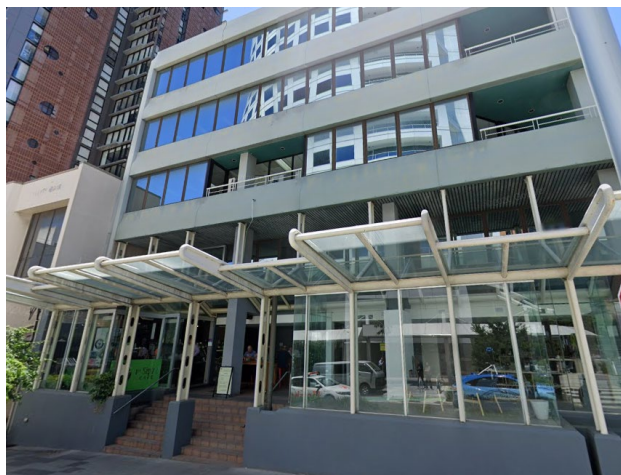
Figure 14 – Atchinson Street frontage, No. 22.

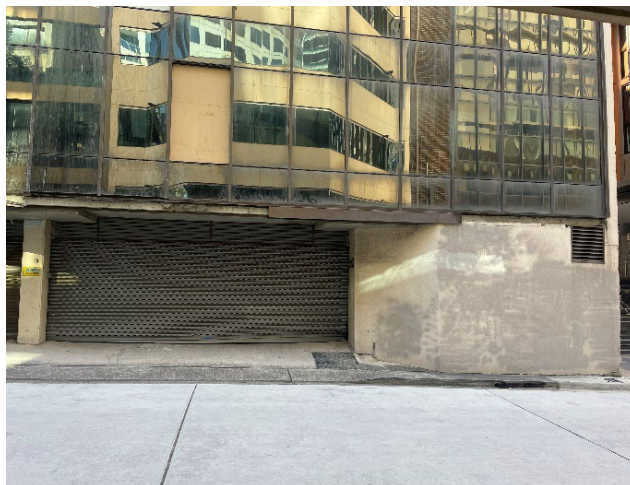
The visual inspection confirmed significant levels of ground disturbance across the entirety of the subject area. Basement carparking and underground drainage were observed to the rear of both office buildings (Figure 16 & Figure 17). These basement carparks were not accessible during the site visit but appeared to extend from boundary to boundary within the subject area. The level of Atchinson Street to the north of the subject area was observed to be significantly higher than the level of Atchinson Lane to the rear (Figure 18). A fire exit leading to the basement carpark of No. 20 indicated that the basement parking level was cut into the ground surface below the level of Atchinson Street (Figure 19). The basement carpark of No. 22 was observed to extend below street level at Mitchell Street and Atchinson Lane entrances and remained at depth as the street level rose towards Atchinson Street cutting into the sloped terrain (Figure 20 & Figure 21).

Figure 15 – Entrance to basement carpark to the rear of No. 20, showing drainage.

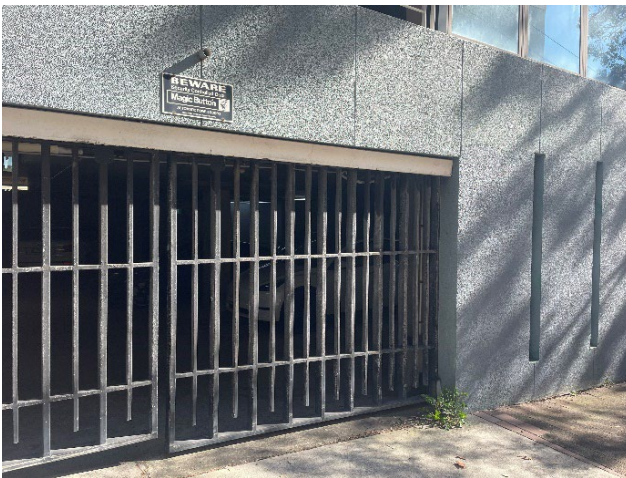
Figure 19 – Mitchell Street entrance to basement carpark of No. 22.
