**Report on Groundwater Impact
Assessment**

Proposed Mixed Use Development

20-22 Atchison Street, St Leonards, NSW

Project 73262.05

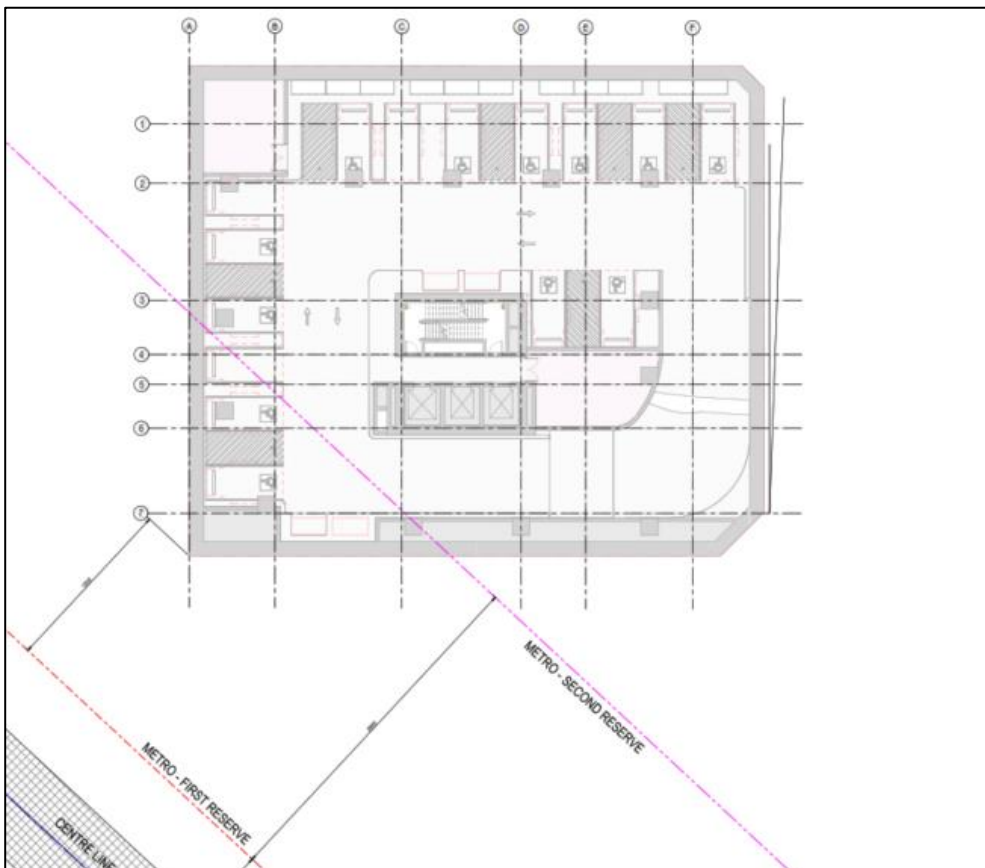
It is noted that the site is partially located over the second protection reserve of Sydney Metro, with a minimum set back of about 12.1 m from the first protection reserve approximately, as shown in Figure 1 below.

Figure 1: Approximate location of the site in relation to Sydney Metro line and protection reserves (ref: 131713_Atchison St_Metro_Tunnels - Meinhardt)

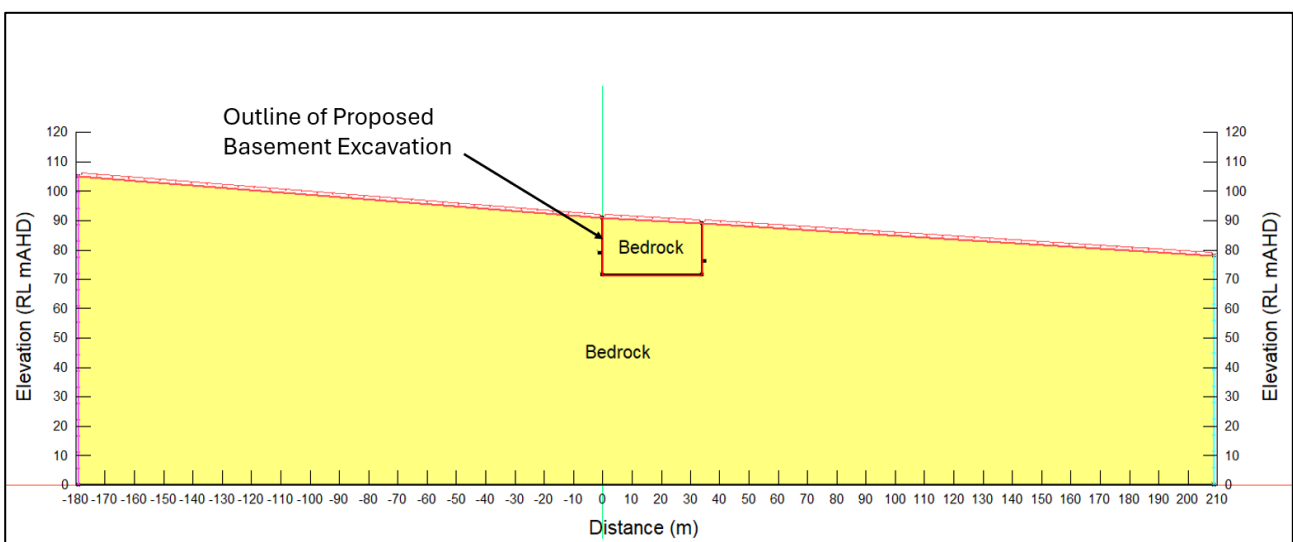
Douglas selected a single vertical cross-section in a roughly north to south direction, intercepting the basement footprint through the centre of the excavation, as shown in Figure 3. The ground surrounding the proposed basement was simulated as being a single-layered numerical model to represent the general subsurface conditions to allow the vertical flow components to be simulated more accurately.

Bulk Excavation Level (BEL) for the model was assumed to be at RL 71.5 m AHD, which is 0.35 m below FFL of the lowest basement.

Figure 3: SeepW model of site showing layer strata and boundary conditions

As the groundwater was observed only within the bedrock profile, the surficial soils were excluded from the model and considered negligible for the purpose of this assessment. The horizontal permeability value adopted for the bedrock (Table 4) were taken as the geometric mean of the testing results for the bedrock.

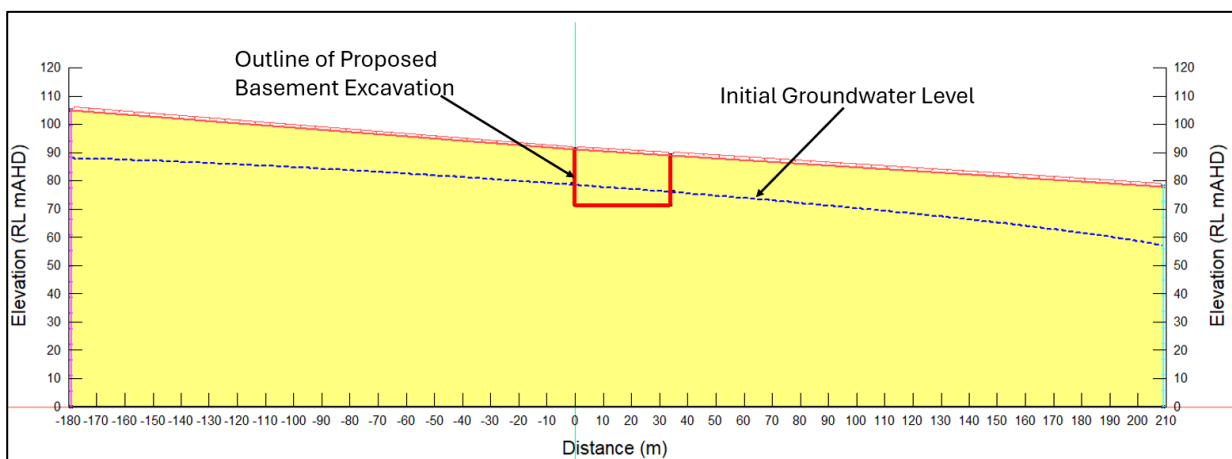
Groundwater levels were established in the model by setting constant head conditions at the lateral extents and applying a surface flux along the upgradient ground surface. The model was calibrated to roughly match the hydraulic gradient (effective total head) observed within the groundwater monitoring. The initial groundwater head levels prior to dewater are presented in Figure 4 below.

Figure 4: Simulation of initial groundwater levels prior to dewatering

An infiltration flux rate of $7.6 \times 10^{-10} \text{ m}^3/\text{s}/\text{m}^2$, which is 2% of an average annual rainfall of 1.2 m in Sydney, was adopted to simulate infiltration and seepage from rainfall and other potential sources (i.e. leaking services) to the model surface.

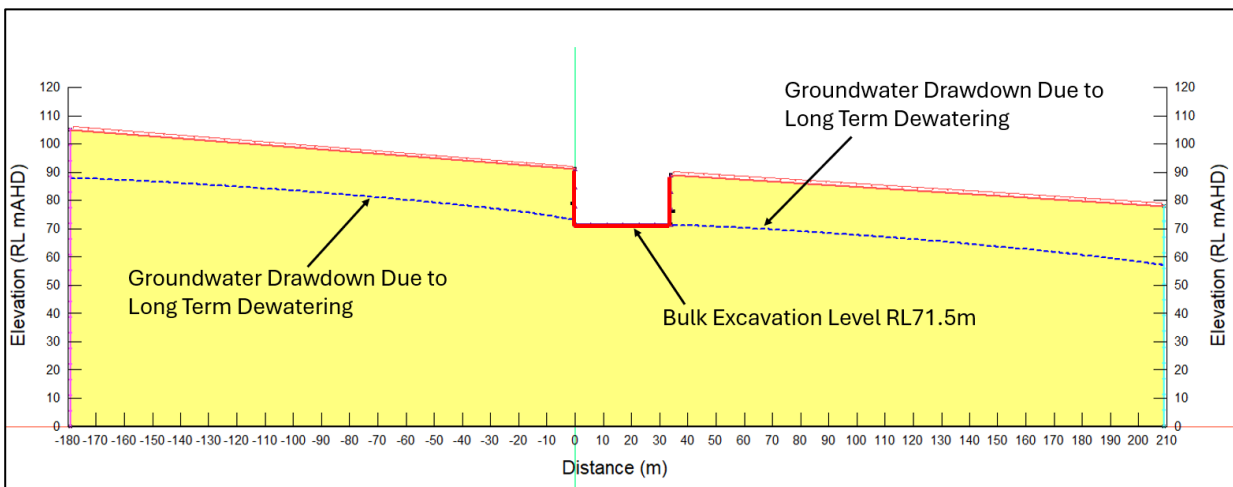
Groundwater levels immediately outside the basement excavation are expected to be drawdown to BEL and by up to approximately 3 m at a distance of 40 m (upstream) from the excavation as shown in below. As the basement is drained, there will be no mounding occurring. There are negligible impacts expected to surrounding properties and infrastructure from drawdown as the groundwater is contained within and flowing through the fractured bedrock profile with high deformation moduli.

Figure 5: Simulation of excavation with drawdown
