DISCHARGE VERIFICATION AND MITIGATION PLAN

Concrush Resource Recovery Facility

Prepared by
Umwelt (Australia) Pty Limited
on behalf of
Concrush Pty Ltd

Project Director: Chris Bonomini
Project Manager: Chris Bonomini
Report No. 4987/R03
Date: February 2021

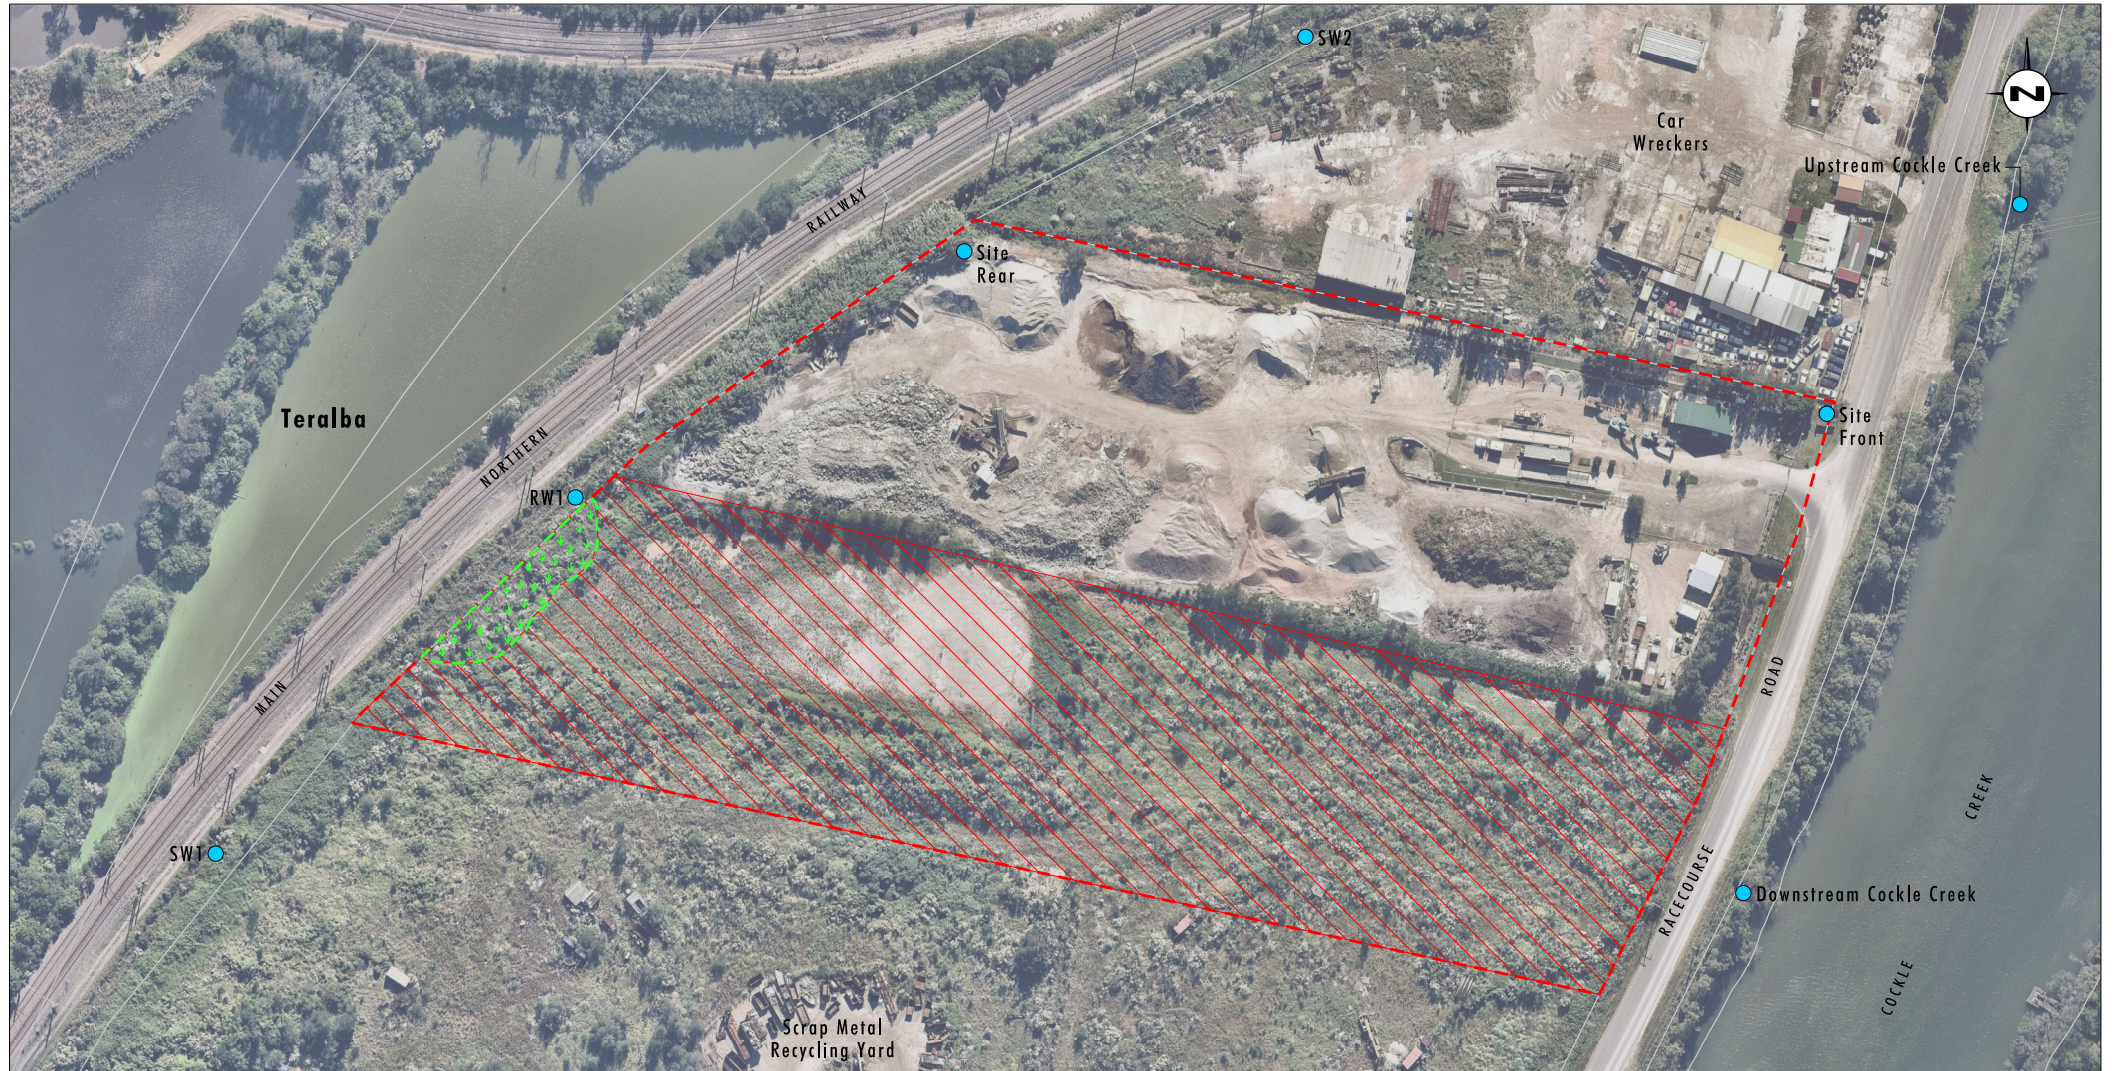
Baseline water quality monitoring has been undertaken for receiving waters potentially impacted by spills from the Project WMS and site water quality at the locations presented in **Figure 2.2**. Note that **Figure 2.2** also shows the Project receiving water quality monitoring locations SW1 and SW2 (refer to **Section 5.1**). **Sections 2.3.1, 2.3.2 and 2.3.3** provide a summary of the baseline water quality results for pollutants detected at non-trivial levels for the expanded water quality monitoring program undertaken during the approvals stage of the Project.

Two rounds of water quality monitoring were undertaken in Cockle Creek upstream and downstream of Concrush (refer to **Figure 2.2**) for the expanded water quality monitoring program and the results are presented in **Table 2.3**. It should be noted that the downstream water quality monitoring location is only downstream of the stormwater discharge point from the relatively small section of catchment draining to the front of the Concrush site.

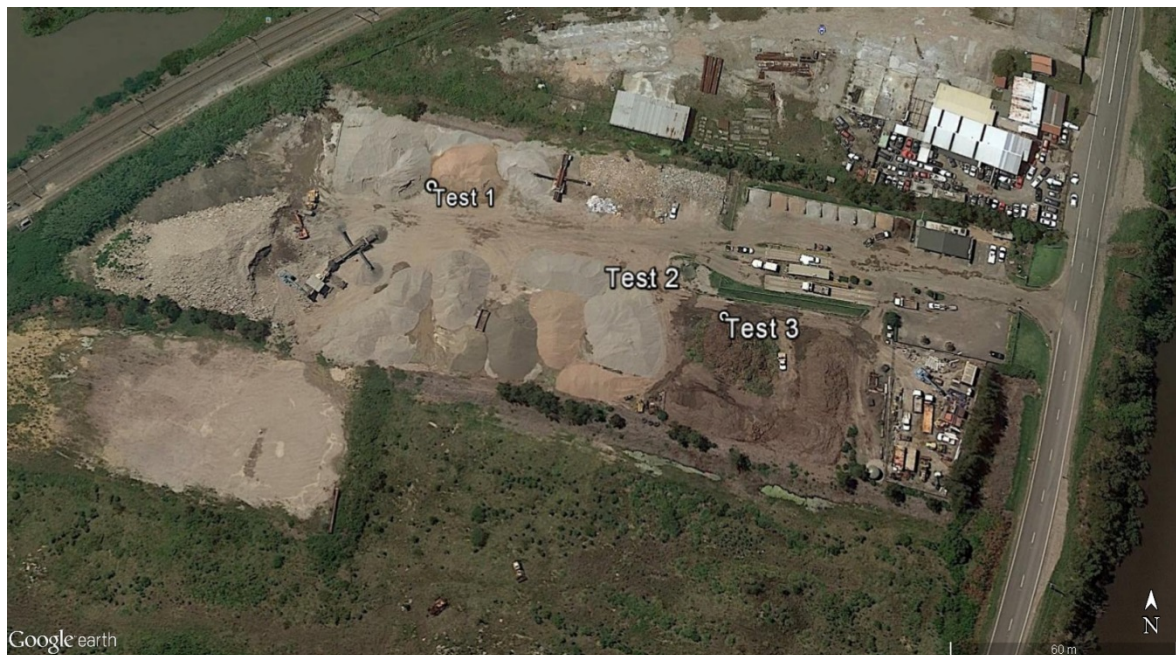
Figure 1. Approximate Infiltration Test Locations

- Infiltration testing using a double ring infiltrometer was undertaken within the existing hardstand at three (3) locations across the site.
- Two (2) bulk samples were collected from stockpiled materials for the purpose of laboratory permeability testing, comprising the following:
 - One (1) sample was collected from the recycled/crushed 'concrete base' material.
 - One (1) sample was collected from the recycled/crushed 'blended base' material.

Approximate test locations are shown below in **Figure 1**.
