**REPORT  
TO  
HEALTH INFRASTRUCTURE  
ON  
ADDITIONAL GEOTECHNICAL INVESTIGATION  
FOR  
NEPEAN HOSPITAL AND INTEGRATED  
AMBULATORY SERVICES REDEVELOPMENT  
SSDA  
AT  
NEPEAN HOSPITAL  
DERBY STREET, KINGSWOOD, NSW**

**19 March 2018  
Ref: 29845L2rptRev1**

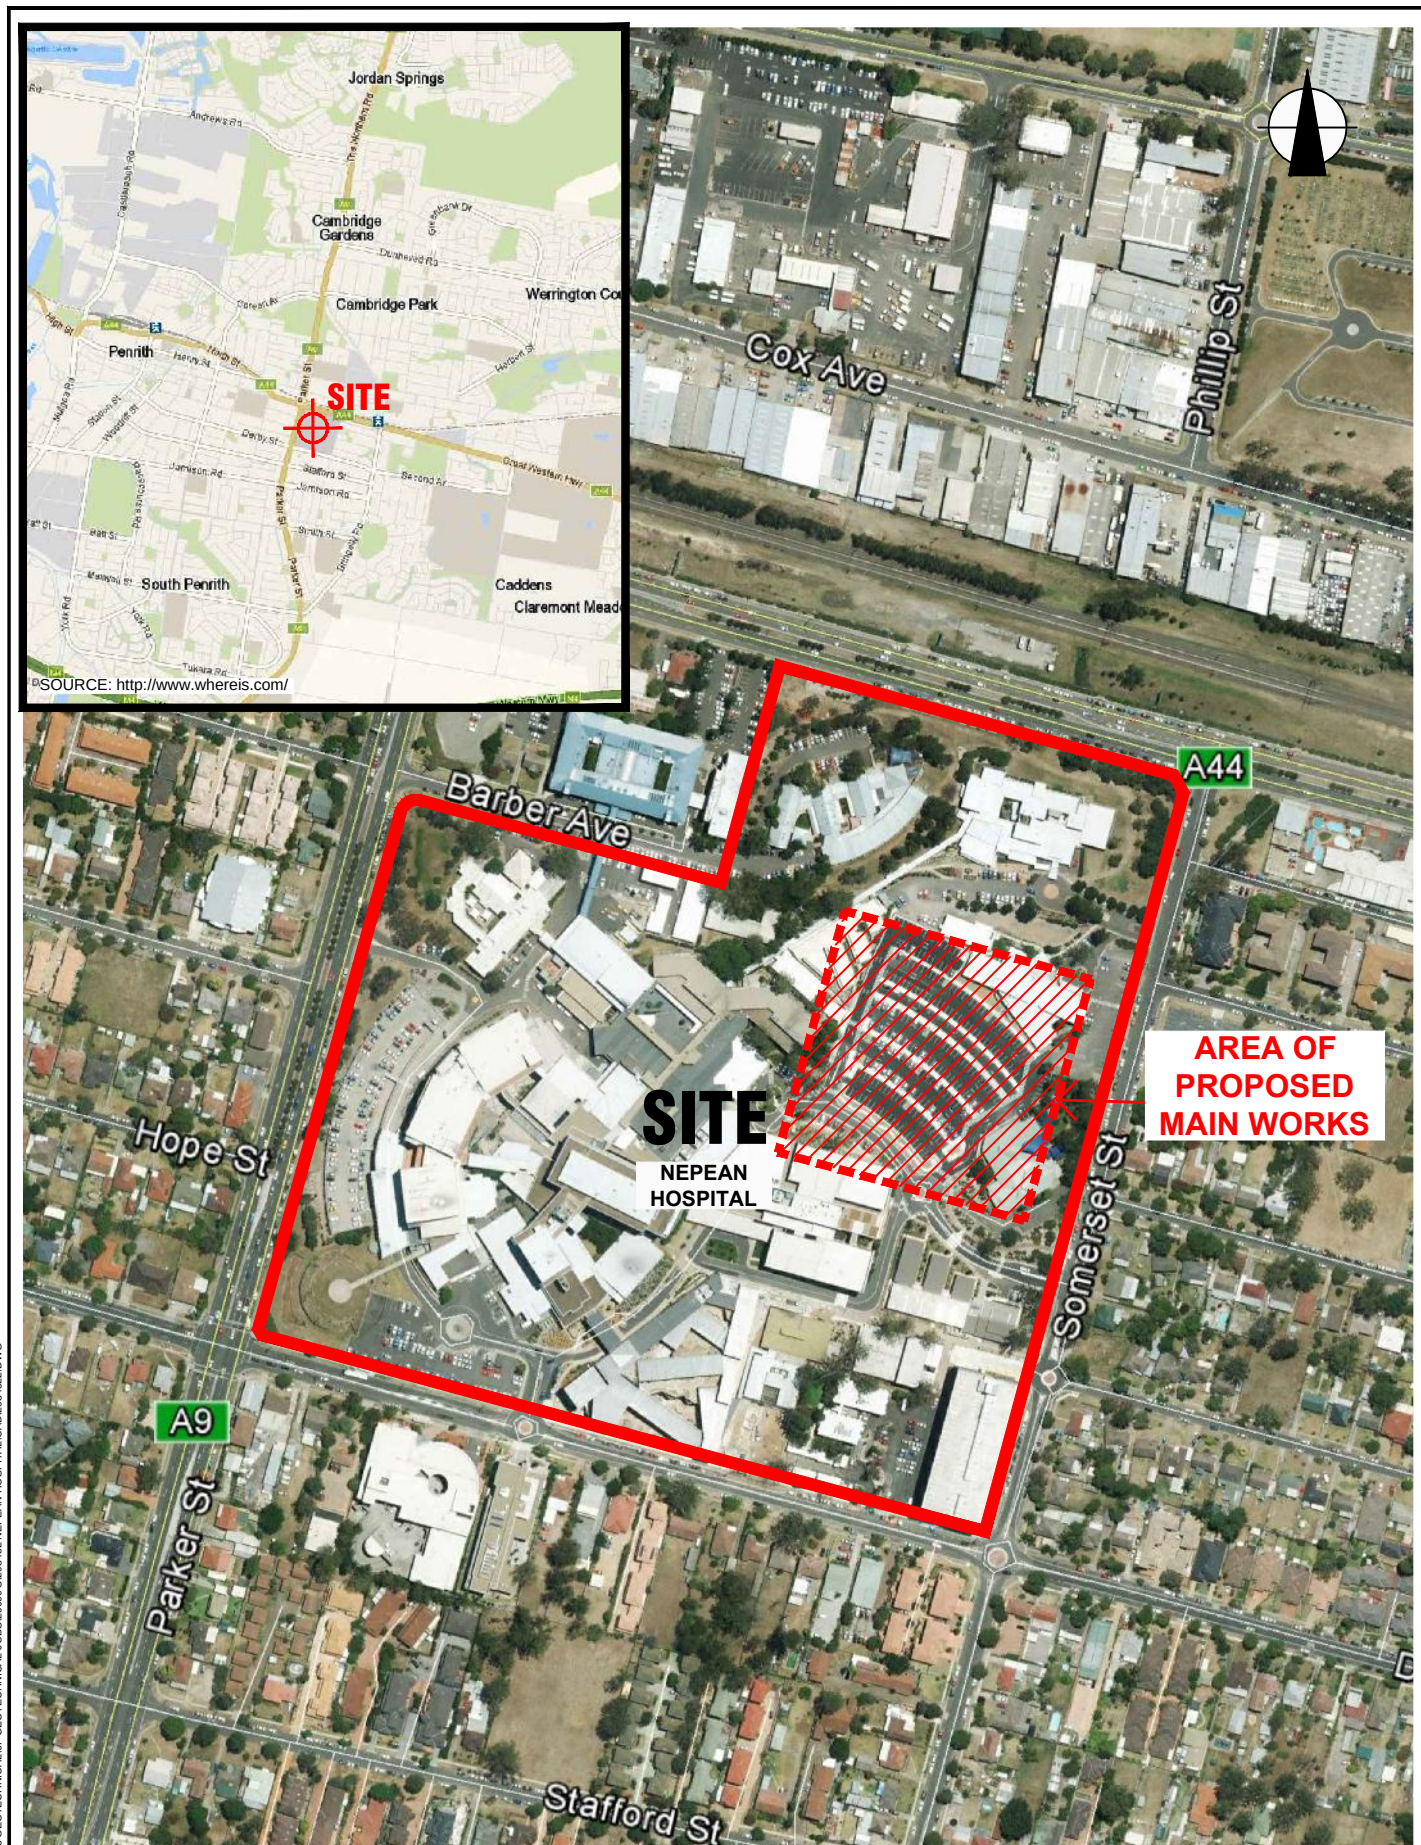
**FIGURE 1: SITE LOCATION PLAN**

AERIAL IMAGE SOURCE: GOOGLE EARTH PRO 7.1.5.1557  
AERIAL IMAGE ©: 2015 GOOGLE INC.
