**PRELIMINARY STAGE 1/STAGE 2 CONTAMINATION  
ASSESSMENT AND PRELIMINARY SALINITY  
ASSESSMENT**

**PROPOSED ALTERATIONS AND ADDITIONS**

**GREYSTANES PUBLIC SCHOOL,  
781 MERRYLANDS ROAD, GREYSTANES, NSW**

**REF: E30431KPrpt**

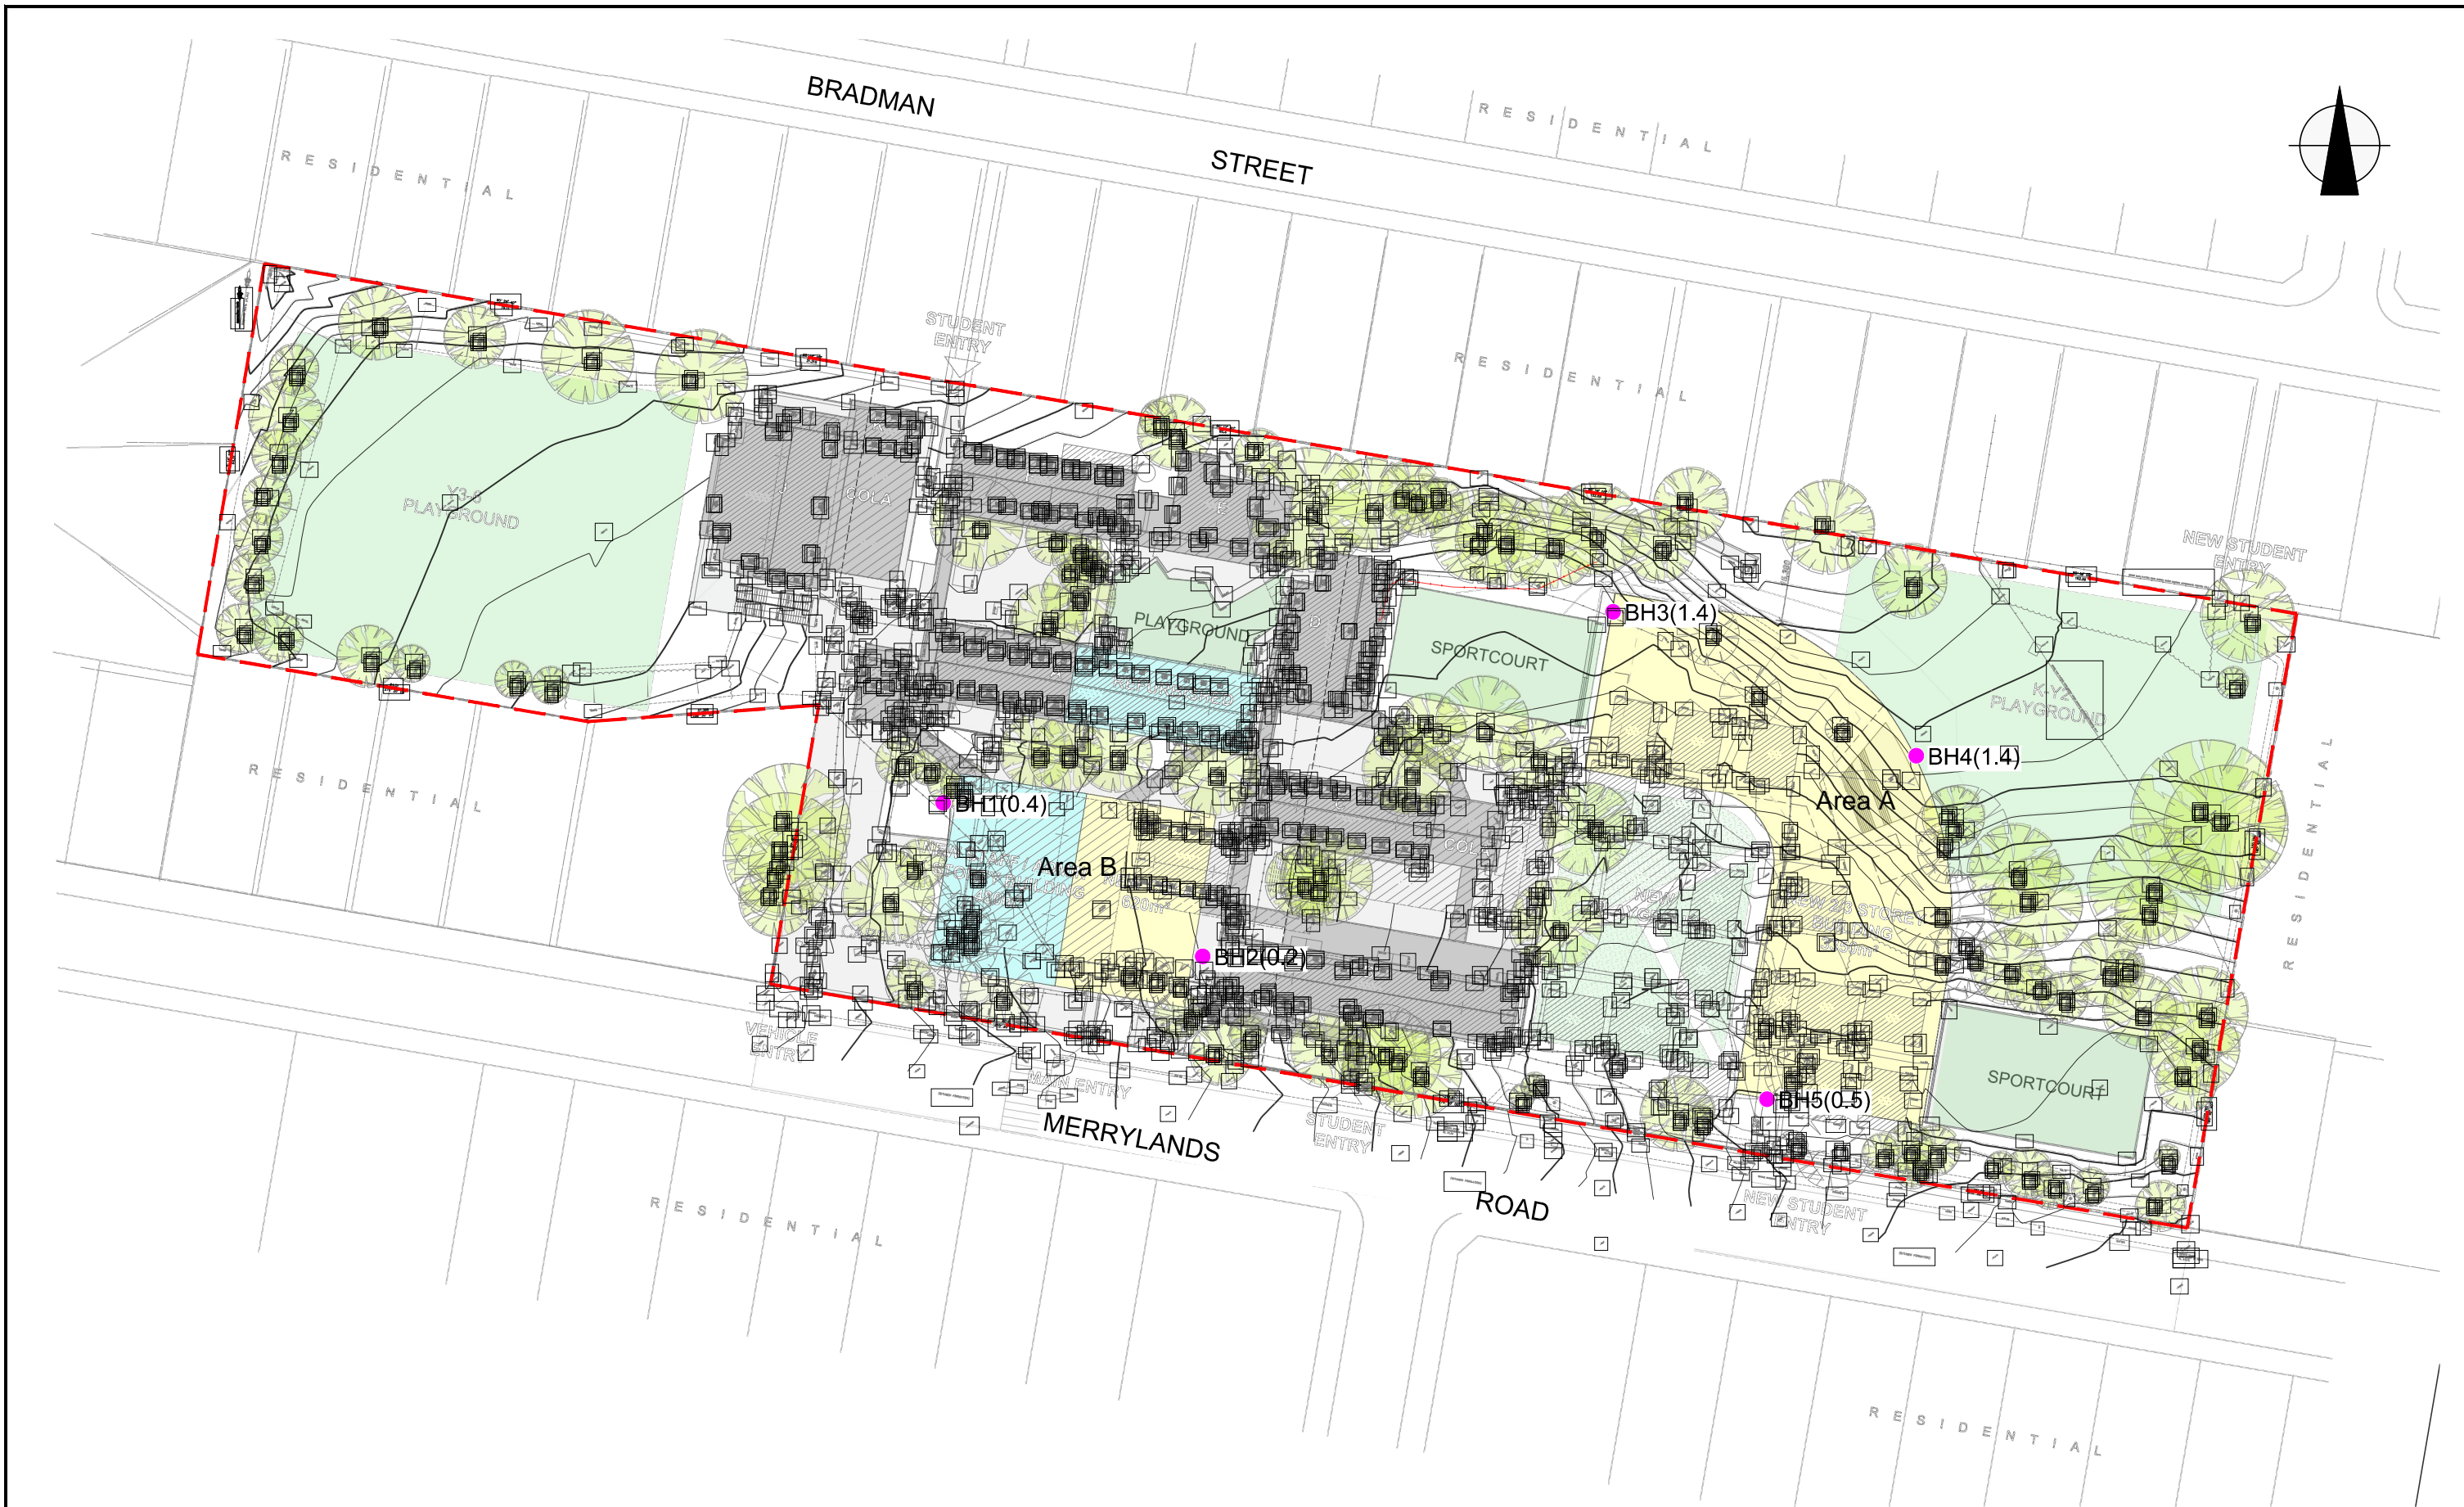
- - - - - APPROXIMATE SITE BOUNDARY
- BH (Fill Depth) BOREHOLE LOCATION, NUMBER AND DEPTH OF FILL (m)
