**REMEDIATION ACTION PLAN**

**PROPOSED DEVELOPMENT**

**PARRAMATTA WEST PUBLIC SCHOOL, CRIMEA  
STREET, PARRAMATTA, NSW**

**REF: E31425KPrpt-RAP**

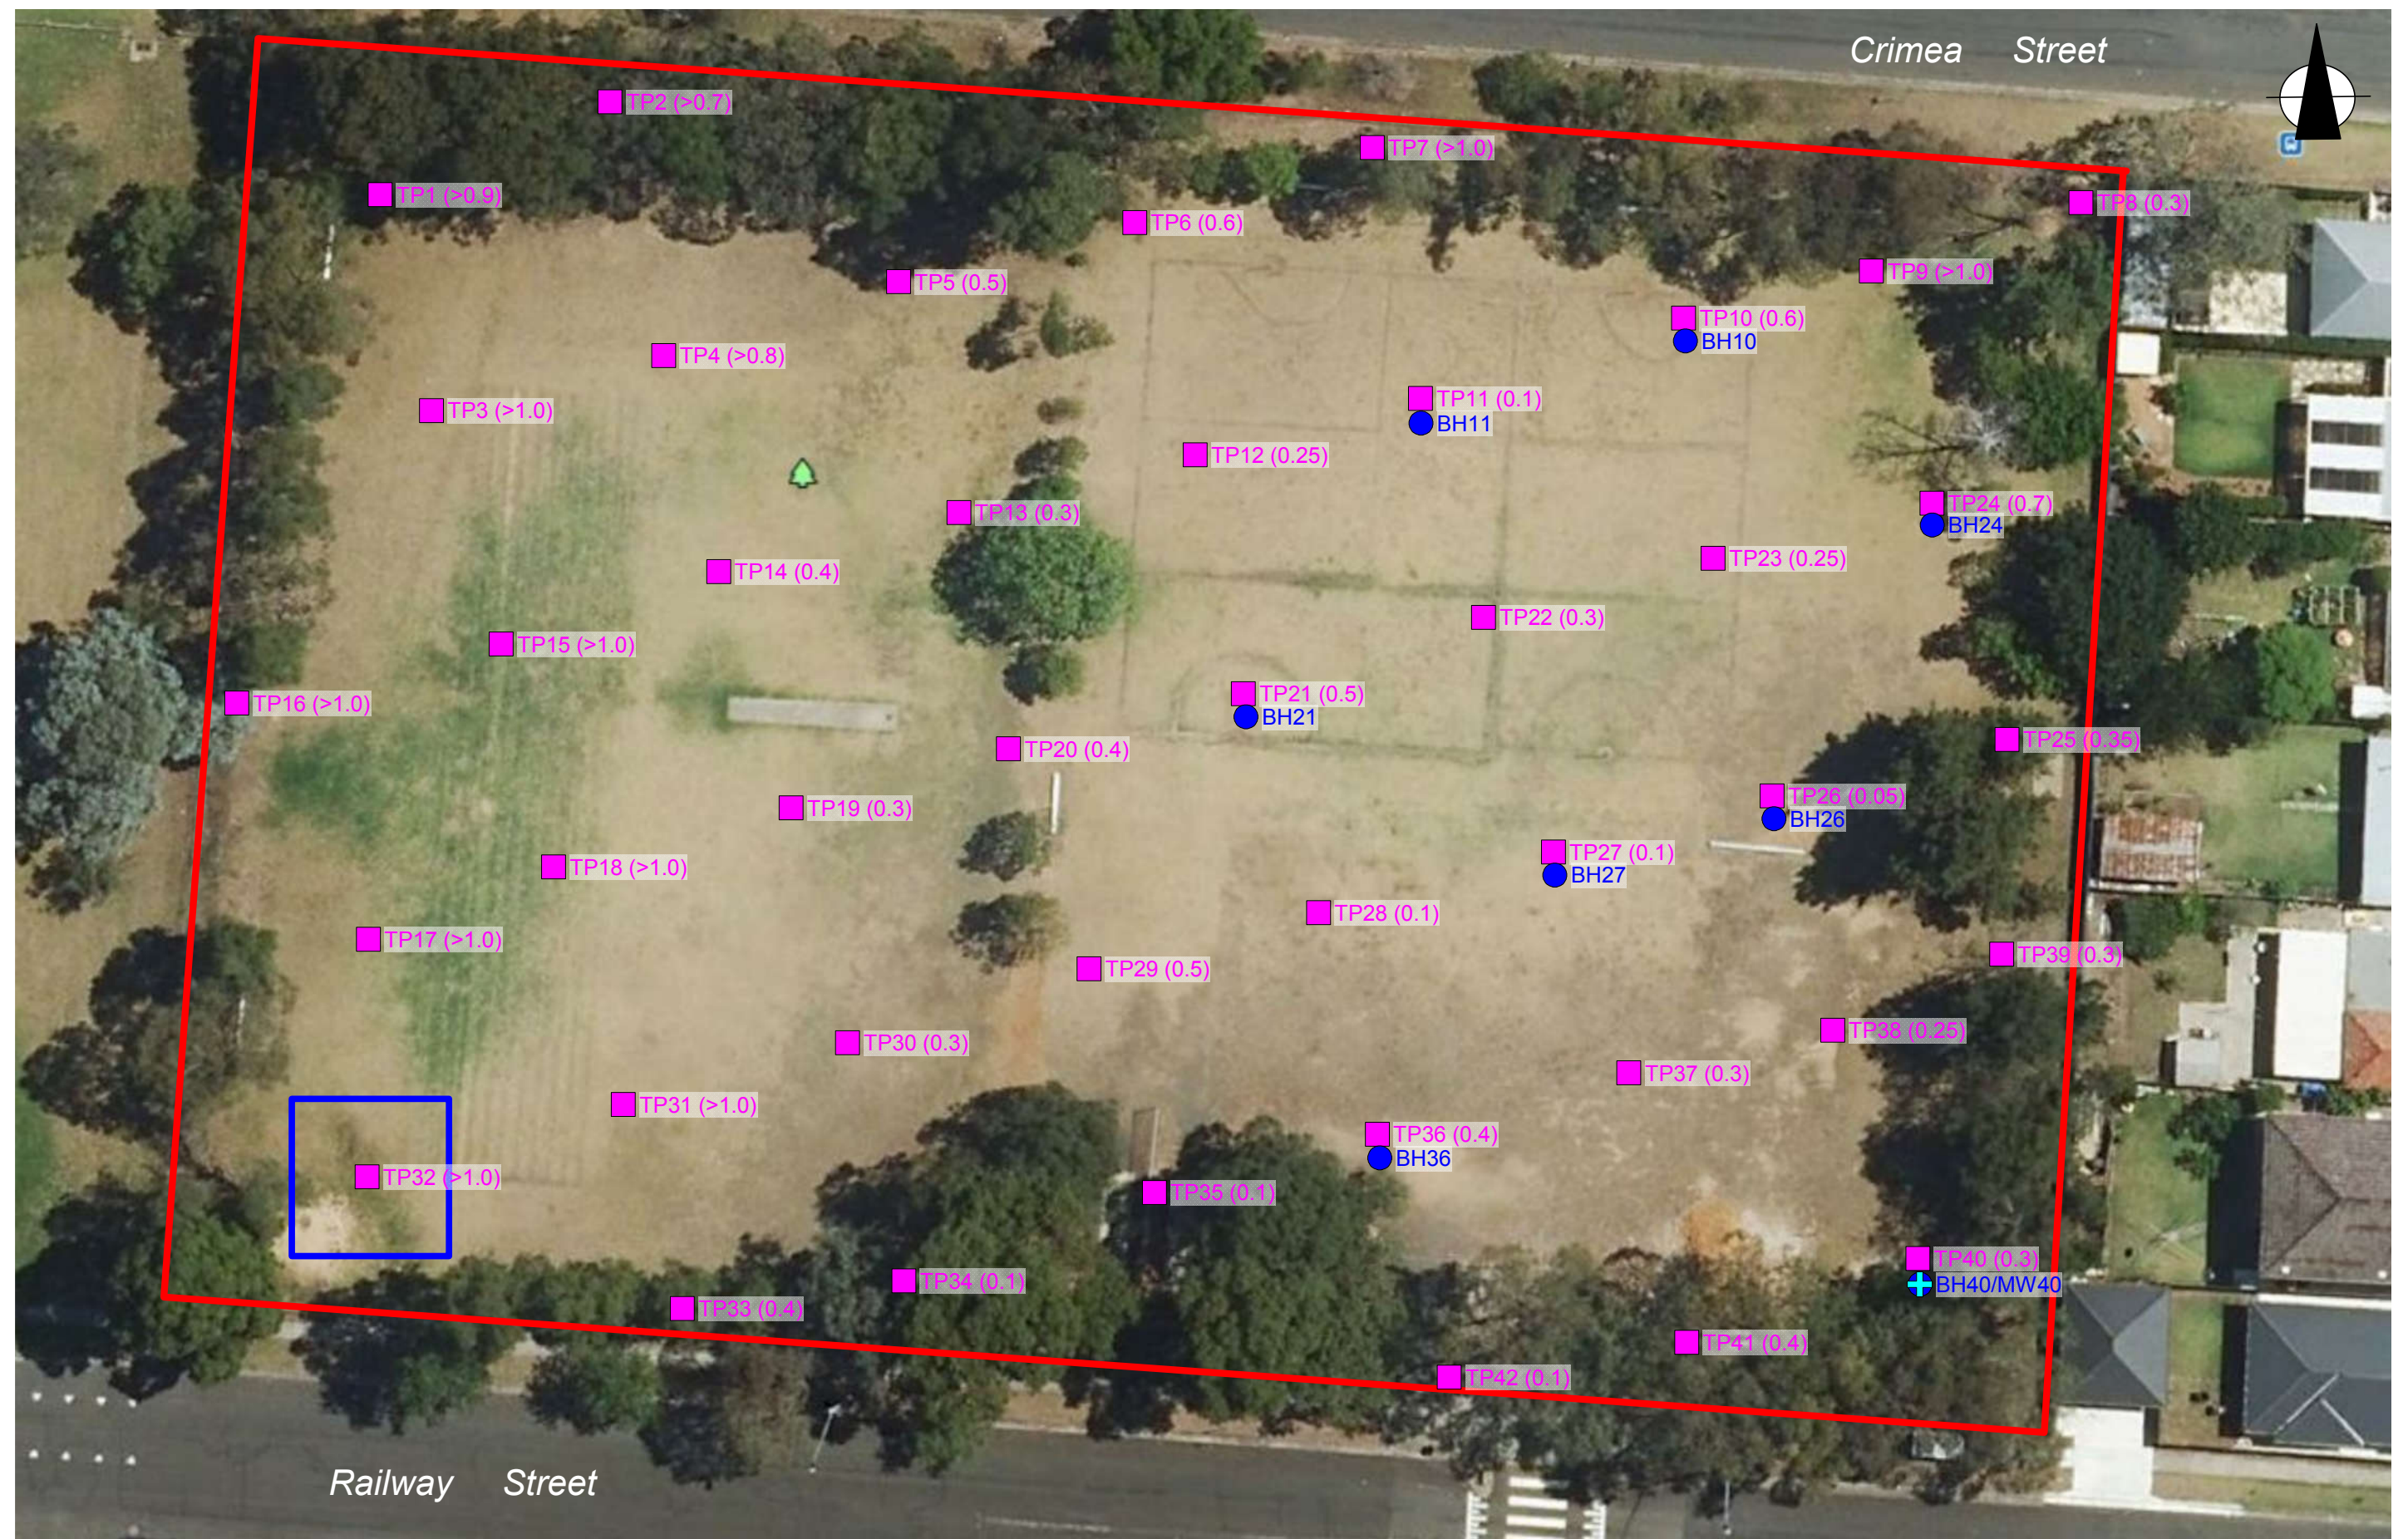
- TP40 (0.3) TEST PIT LOCATION, NUMBER AND DEPTH OF FILL (m)
- BH36 BOREHOLE LOCATION AND NUMBER
- MW40 MONITORING WELL LOCATION AND NUMBER
