Asbestos Management Plan

Proposed PLC Hotel Development
1 Eels Place, Parramatta, NSW

Project 94523.00
December 2018

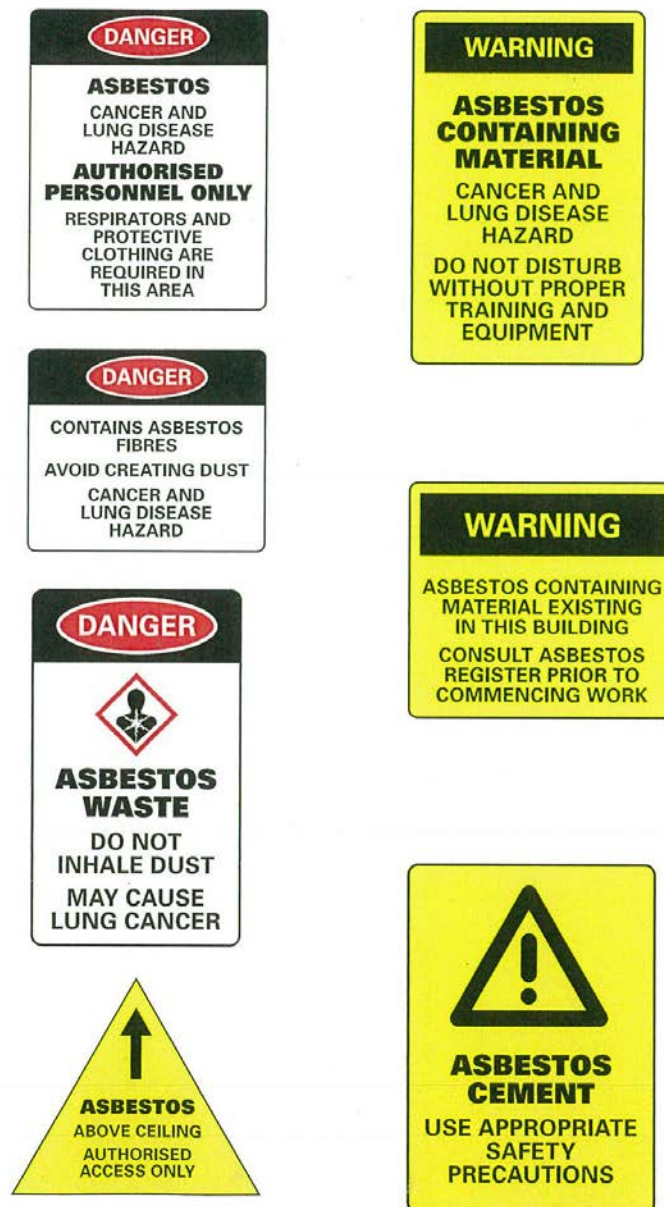
Figure 1: Examples of warning signs and labels contained in SafeWork (2016b)

The number, location and condition of signs should be reviewed by a competent person on a regular basis to ensure adequate warning is maintained in relevant locations. Warning signs should be consistent with the examples provided in SafeWork (2016b) (refer to Figure 1 below) and comply with AS 1319 *Safety Signs for the Occupational Environment*.

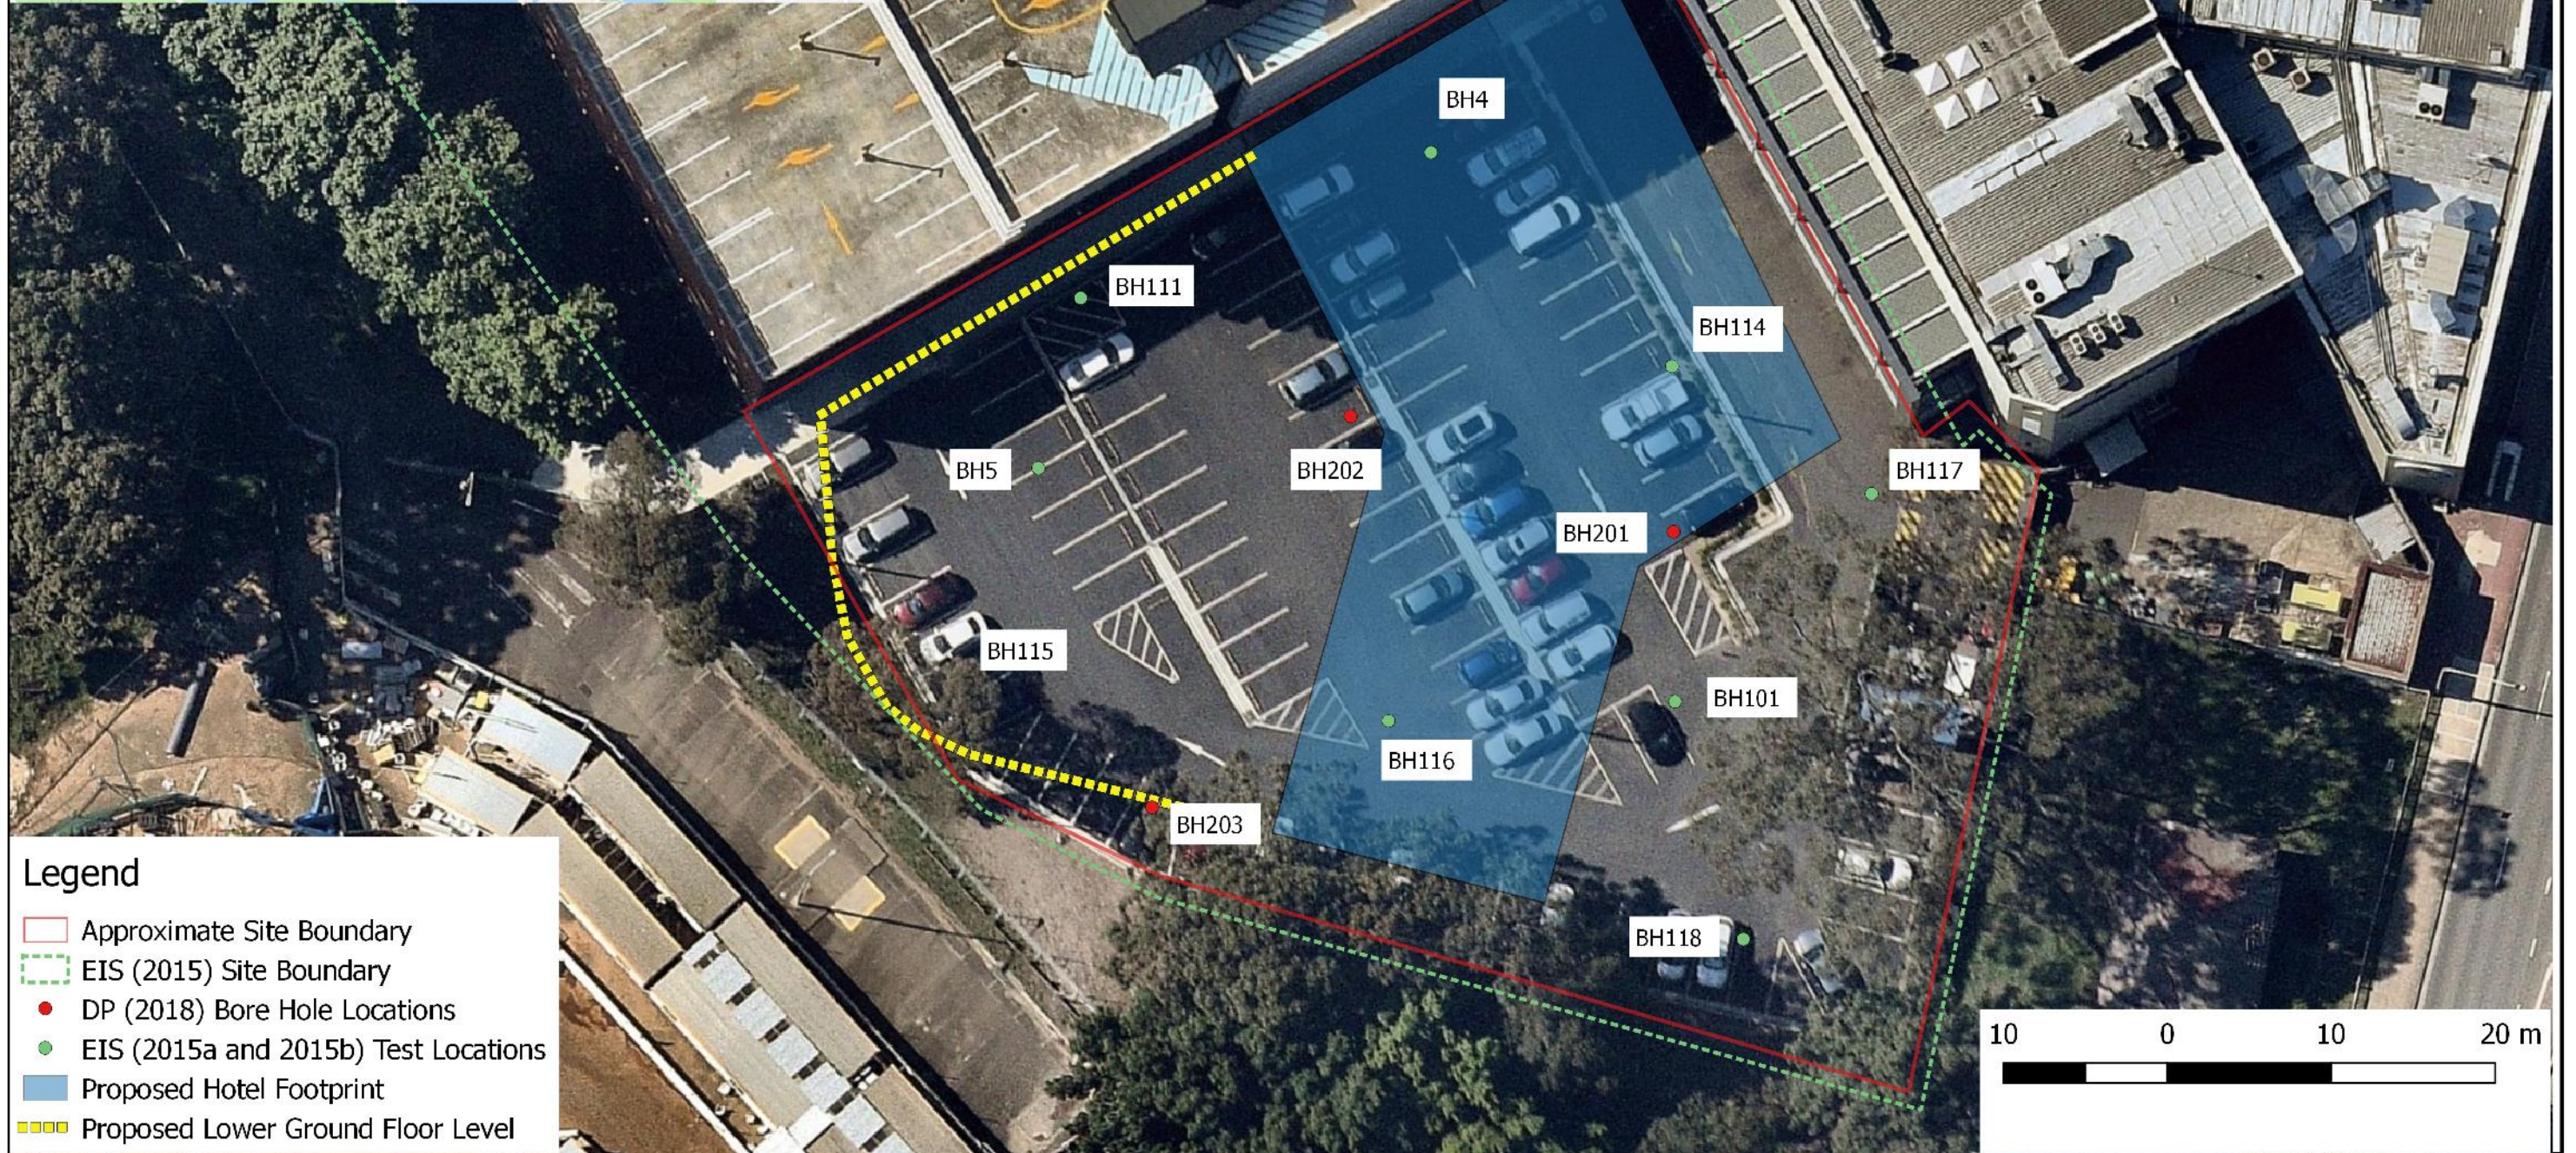
The site plan shown on Drawing 1 (Appendix B) is taken from DP (2018) and shows the approximate location and layout of the proposed hotel development as well as the approximate locations of former test pits and asbestos locations

The layout of the development including the proposed hotel footprint and lower floor footprint is shown on Drawing 1 (Appendix B).

The site is identified as part Land Crown Plan 80-3000. The street address is 1 Eels Place, Parramatta. The site is shown on Drawing 1, Appendix B.

This investigation included the drilling of 18 boreholes, seven of which (BH101, BH111 and BH114 to BH118) were located in the current site boundary (refer Drawing 1 – Appendix B).
