Part 10
Visual Impact
Statement

Howlong Sand and Gravel
Expansion Project

State Significant Development 17_8804

Prepared by
Advanced Environmental Systems Pty Ltd

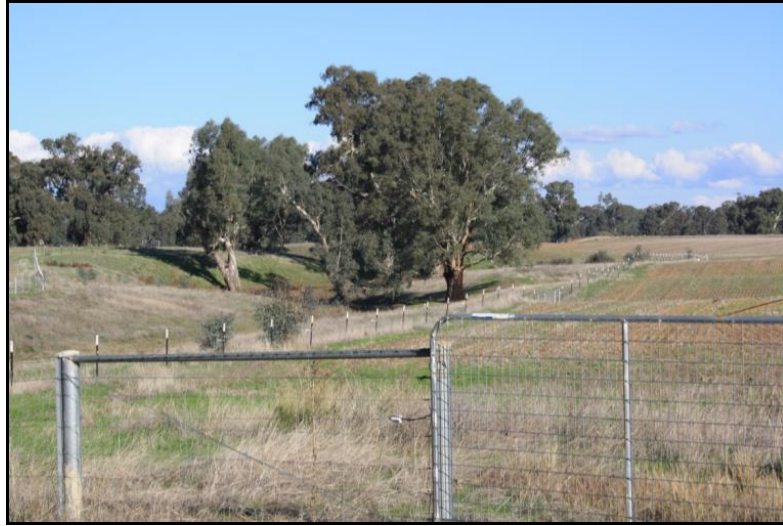
Plate 2 Major's Creek , view south east from Riverina Highway to the subject site

This profile commences at the Riverine Highway (**Figure 7**), at a point on the highway directly north of both the existing quarry, and the future extraction area. As is evident from the visual profile and **Plate 2**, the quarry footprint is not visible from this location on the highway. The subject site is not in the LoS, as it is behind the existing vegetation.
