**SPECIALIST ADVICE TO
ST LEONARDS PROPERTY UNIT TRUST**

**ON
GEOTECHNICAL INVESTIGATION**

**FOR
PROPOSED MIXED-USE DEVELOPMENT**

**AT
46-52 NICHOLSON STREET &
59-67 CHRISTIE STREET, ST LEONARDS, NSW**

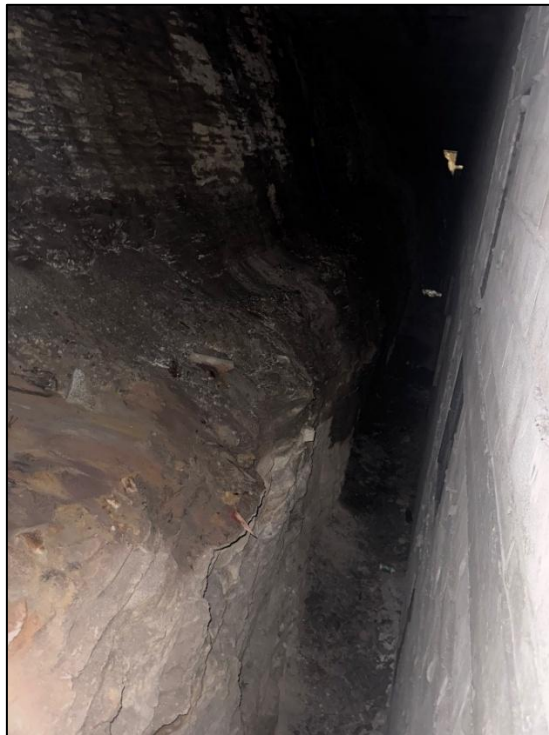
Plate 1: View looking north-west inside the air plenum of the neighbouring basement to the south-east

During our limited inspection of the neighbouring basement to the south-east, there was an opening in the one of the air vents in the concrete block wall along the south-western (Christie Street) side of the basement, about 3m above the lowest level. Inside the opening, we observed a narrow air plenum which exposed a sub-vertical sandstone cut face, as shown in Plate 1 below. No seepage was observed emanating from the rock face at this location, and the base of the plenum was ‘dry’. Based on these observations, it appears that the neighbouring basement is a ‘drained’ structure.

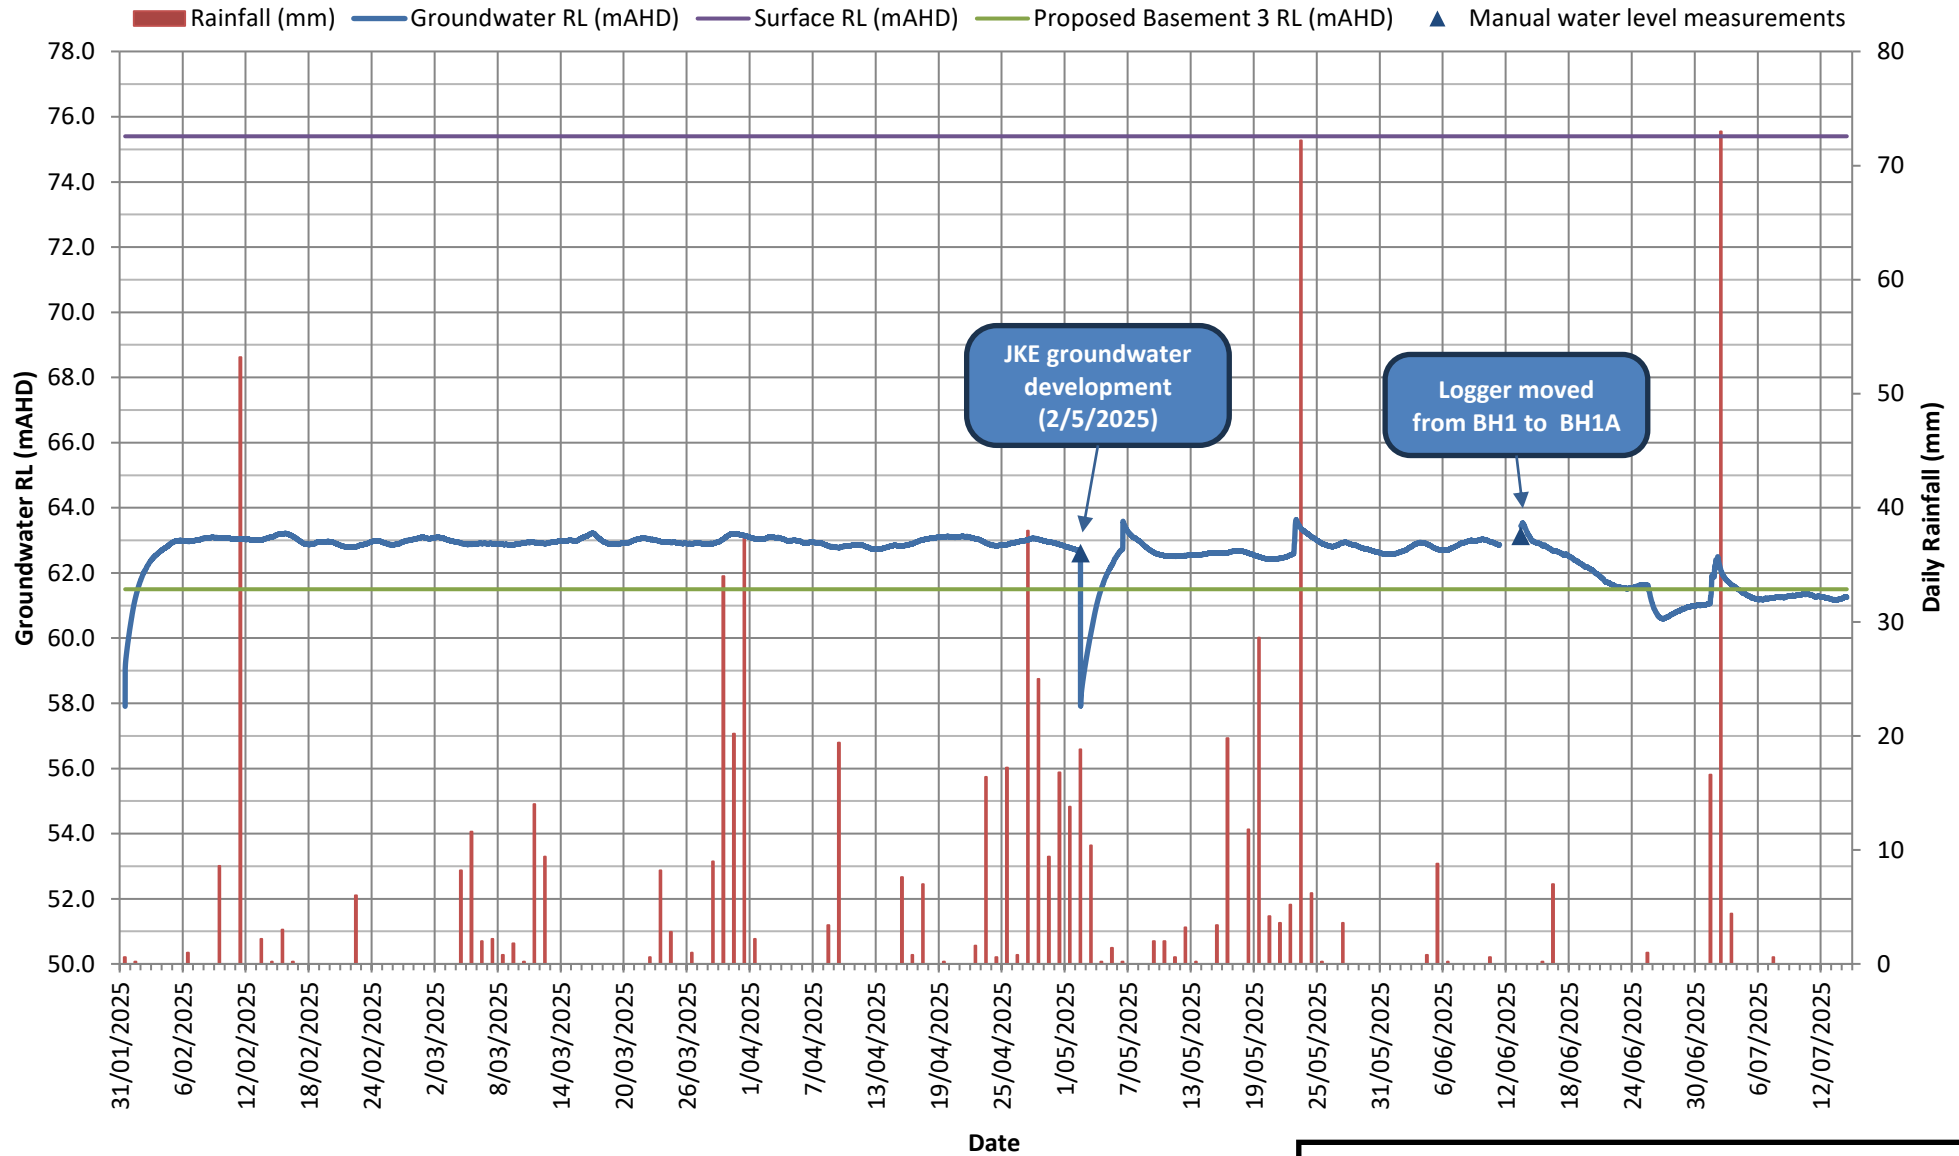
Groundwater Level and Daily Rainfall -v- Time Plot BH1/1A

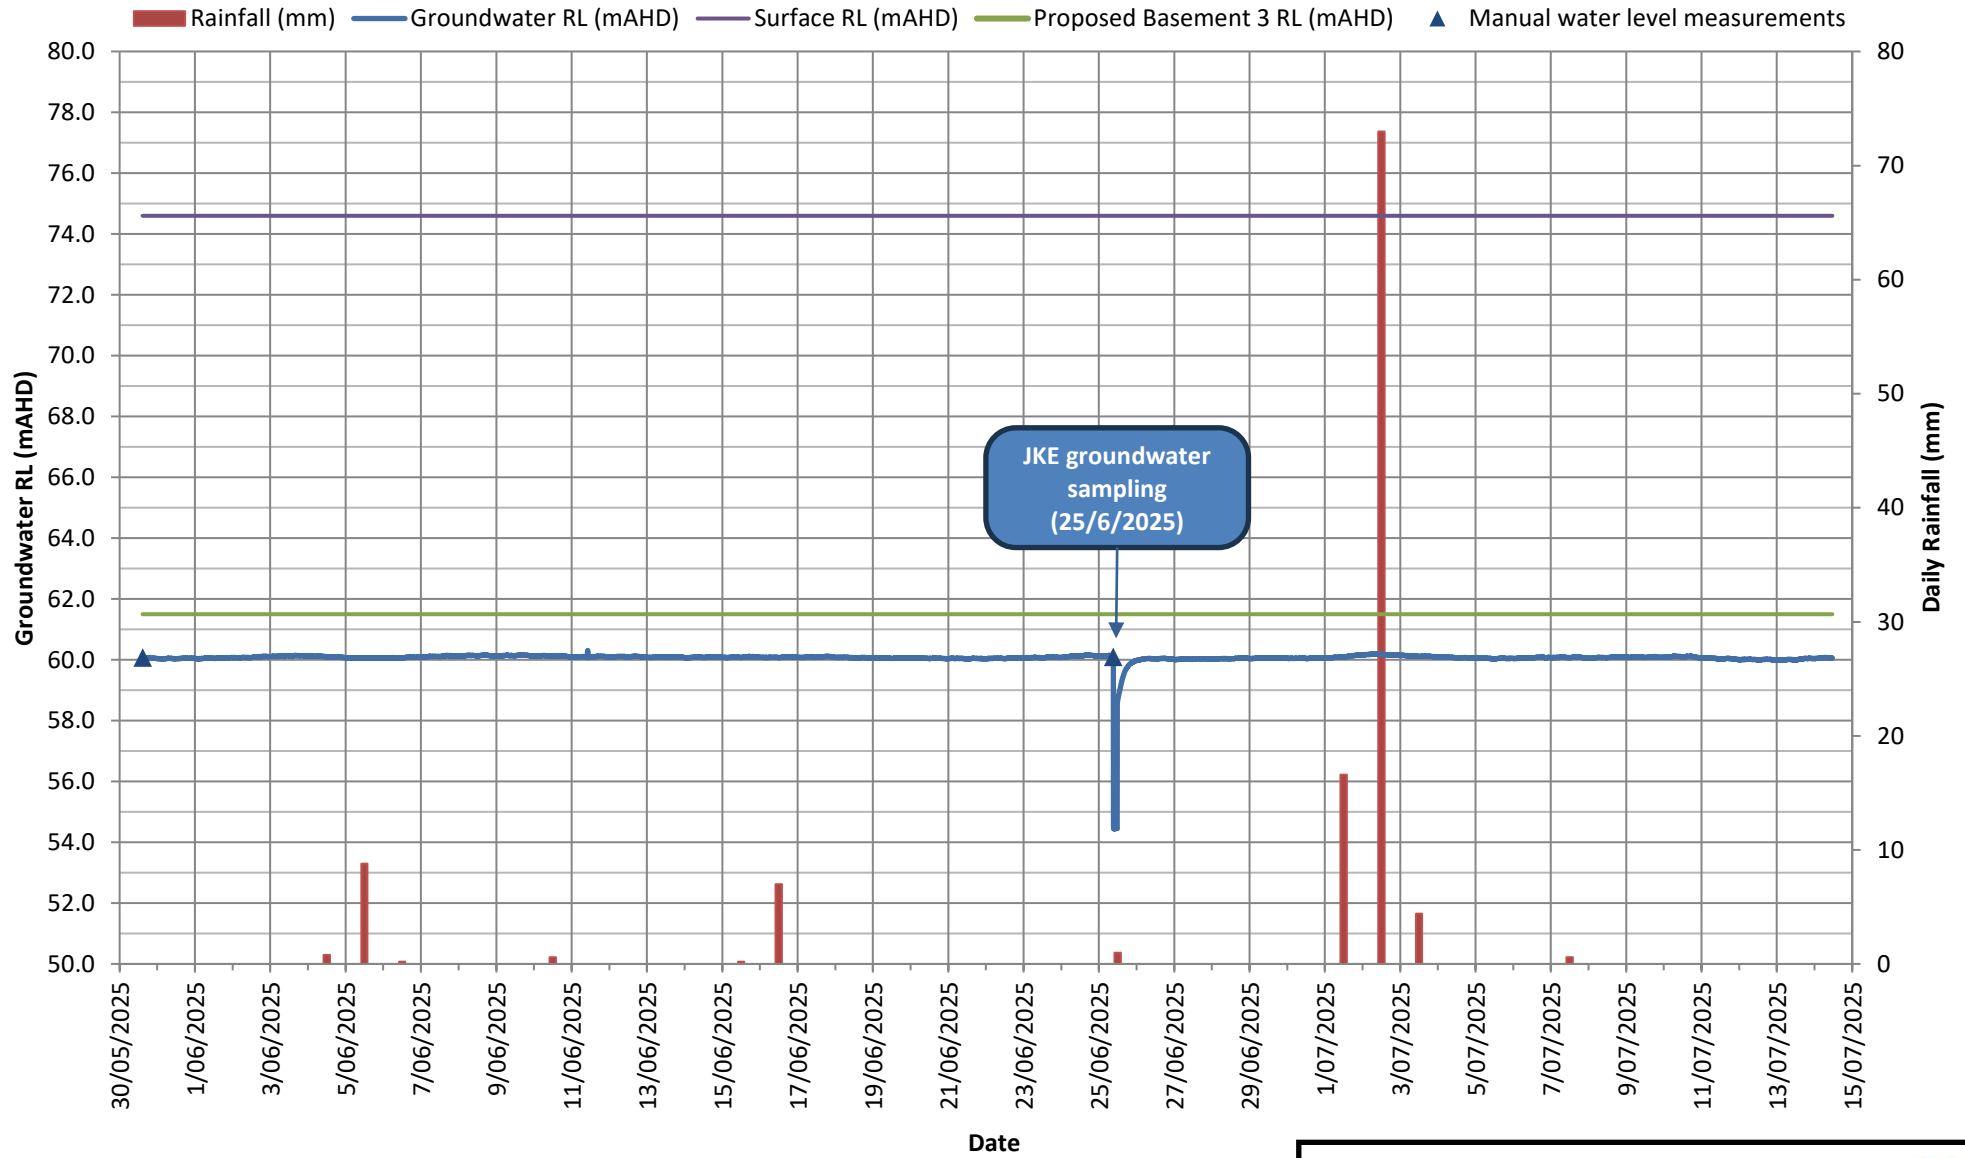
Groundwater Level and Daily Rainfall -v- Time Plot BH2

Rainfall data from: Sydney (Observatory Hill), Station No. 66214

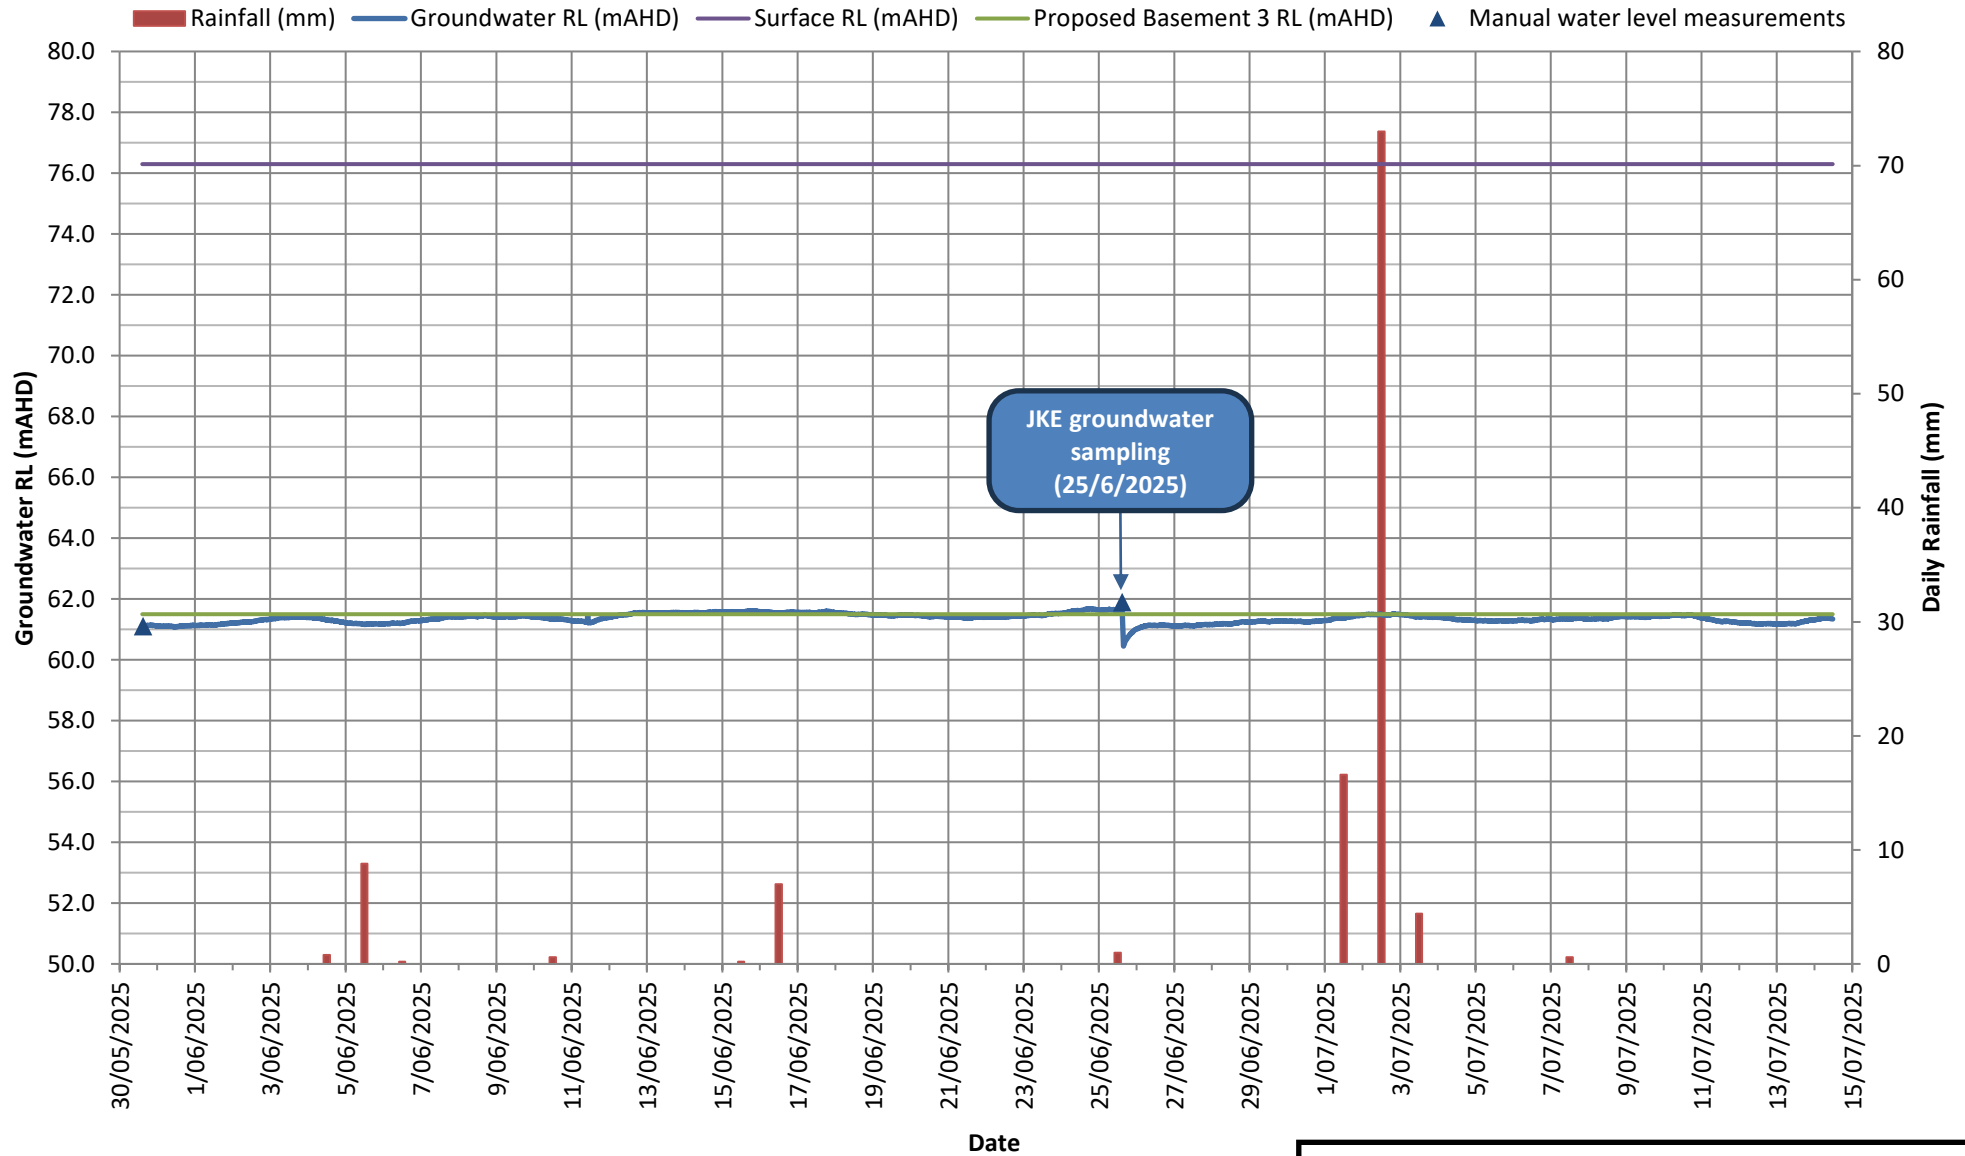
Groundwater Level and Daily Rainfall -v- Time Plot BH4

Rainfall data from: Sydney (Observatory Hill), Station No. 66214
