Cranbrook school development

Structural Scheme design report

0001 REPT

Rev A | 6 April 2018

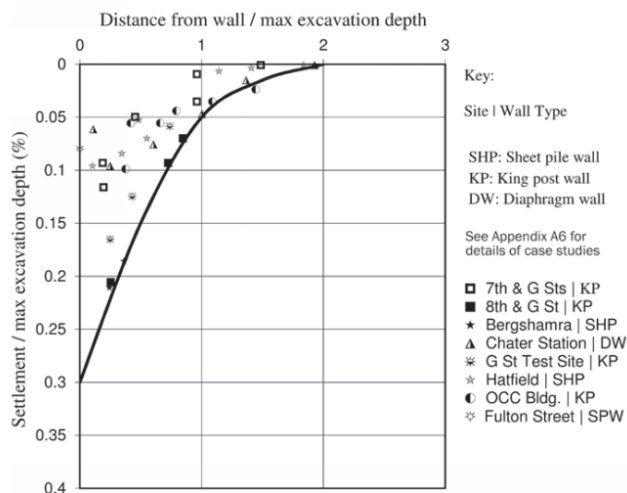
Figure below provides expected ground service settlement due to excavation – based on a 12m soil retention height could have up to 36mm vertical settlement behind the wall or 20mm vertical settlement at Perkins (3m behind the wall).

Figure 6.16 Ground surface settlement due to excavation in front of wall in sand

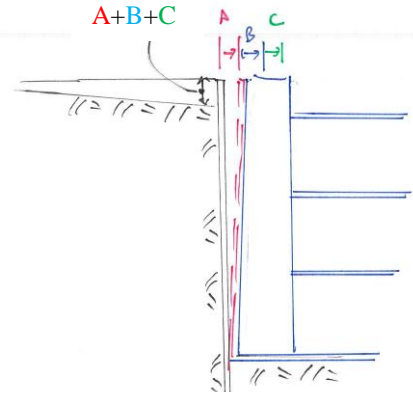
<p>Stiff buttress system to minimise lateral displacements</p> <p>Design retention and temporary anchors to limit defection during excavation (A)</p> <p>Then construct a shear wall as part of the permanent structure and with adequate stiffness so that (B) and (C) deflections are within acceptable limits.</p> <p>Note (B) and (C) deflections will be also influenced by building frame and foundation stiffness</p>

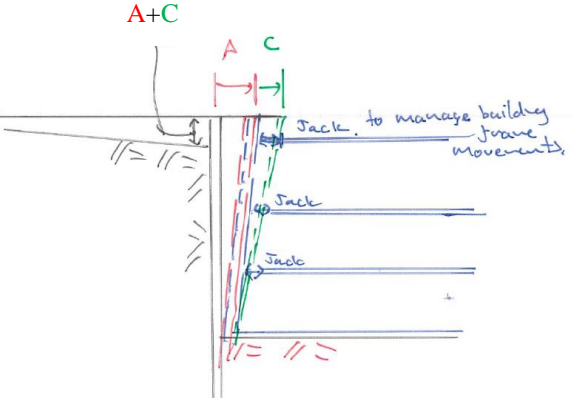
<p>Laterally jack the building with hydraulic bottle jacks, or similar, to preload the building frame before de-stressing anchors.</p> <p>This will mean retention system will not experience the (B) displacement.</p> <p>Surface settlement will only be a result of excavation displacement (A) and long term displacement (C)</p>

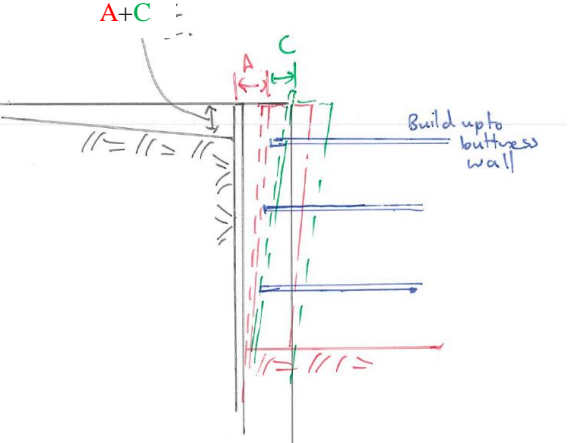
<p>Build permanent retention and buttress system during excavation.</p> <p>That is use a secant pile wall system to build the orthogonal buttress with the retention wall. Removes the needs for temporary anchors.</p> <p>Majority of the displacement will occur during excavation, ie (A)</p> <p>Surface settlement will only be a result of excavation displacement (A) and long term displacement (C).</p> <p><u>PLAN</u></p>

<p>Disadvantage – larger buttress system required. Interlocking piles is not as efficient as a monolithic wall. Significant movement required to “engage” the buttress.</p>

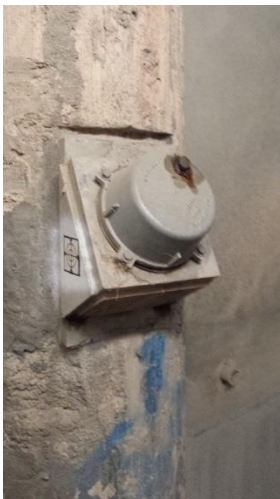
Example of access able anchor head

It is noted that reasonable access to the anchor heads will need to be provided thought the life of the building for maintenance and re-stressing of anchors should relaxation occur.

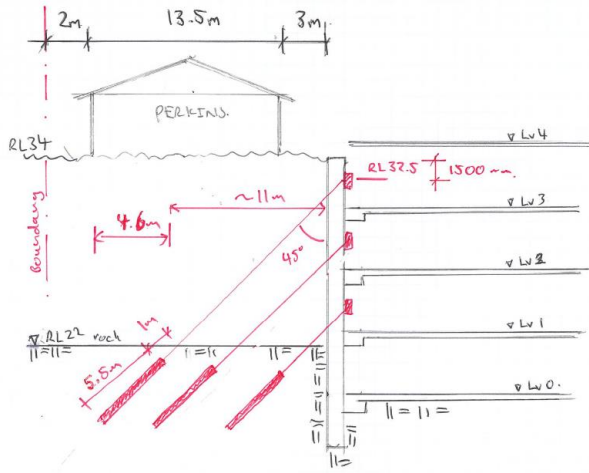
<p>Permanent anchor system</p> <p>Based on 900 dia pile wall with 3 rows of anchors over the height of the excavation. At 6m c/c, initial calculations indicate anchors need about 900kN (SLS) anchor</p> <p>This would result in 9x 15.2 strand anchors, 250dia with a bonded length of 5500mm (into class III rock) at 6m c/c.</p> <p>Hence anchors would extent about 16m from rear of wall. In this area boundary is 18.5m min so appears anchors could just fit within the boundary</p> <p>Expected lateral movement: 10mm (short term) + 10mm long term</p> <p>TOTAL = 20mm horizontally</p> <p><i>Potentially 20mm vertical surface settlement behind the wall</i></p>

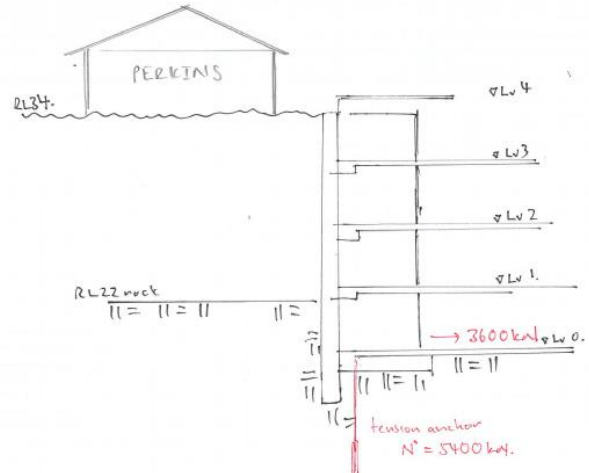
<p>Stiff buttress system.</p> <p>Temporary retention is formed with 900 dia pile with 3 rows of temporary anchors (at 2m c/c). Permanent lateral restraint is provided by 5000mm x 450mm blade wall at 6m c/c</p> <p>Such a system will result in tension loads on foundations and require tension anchors into the ground. On each 6m girder require 2x[10x15.2 strands] each with a 300mm dia socket 9000mm into class III rock. This would require a double corrosion protection system.</p> <ul style="list-style-type: none">A) Excavation displacement = 10mmB) Framing lateral displacement = 15mmC) Long term displacement = 15mm <p>TOTAL = 40mm horizontally</p> <p><i>Potentially 40mm vertical surface settlement behind the wall</i></p>

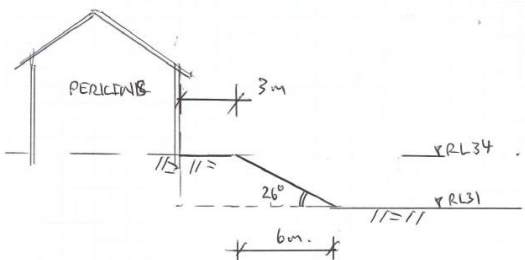
<p>Battering</p> <p>As in sands would require a 26deg batter or 2 (H):1(V) permanent batter ,</p> <p>Hence for a 3m height will need a 6m wide batter</p>

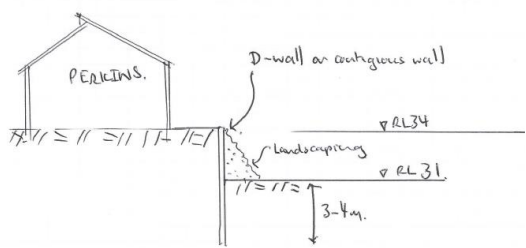
<p>Retention wall</p> <p>D-wall or contiguous wall, embedded H into the ground</p>
