## HERITAGE AND HISTORICAL ARCHAEOLOGICAL REPORT

**Budawang SSP, 17 Croobyar Road,  
Milton, NSW**

<b>Company</b>	Schools Infrastructure NSW
<b>Contact</b>	Michael Stern
<b>Date</b>	February 2021

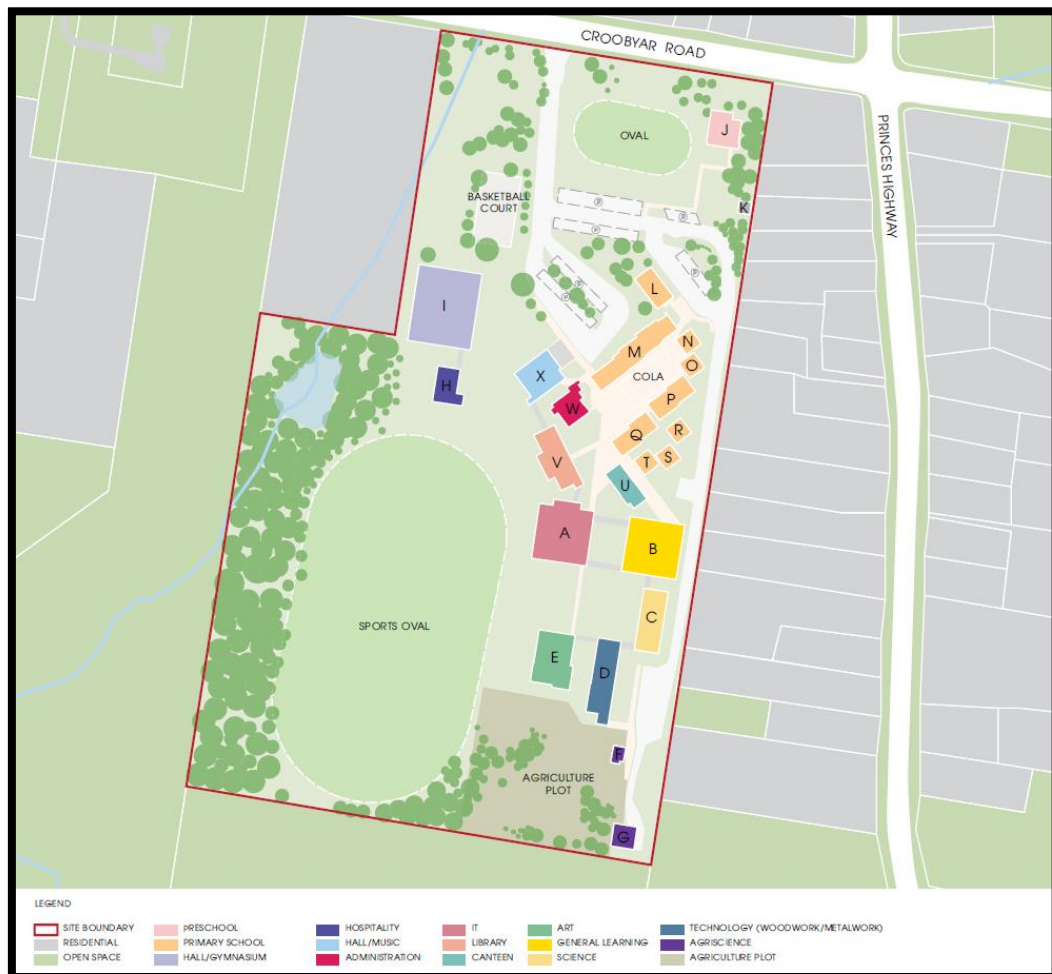
**Figure 1: Layout of existing buildings within the study area (Group GSA 2020).**

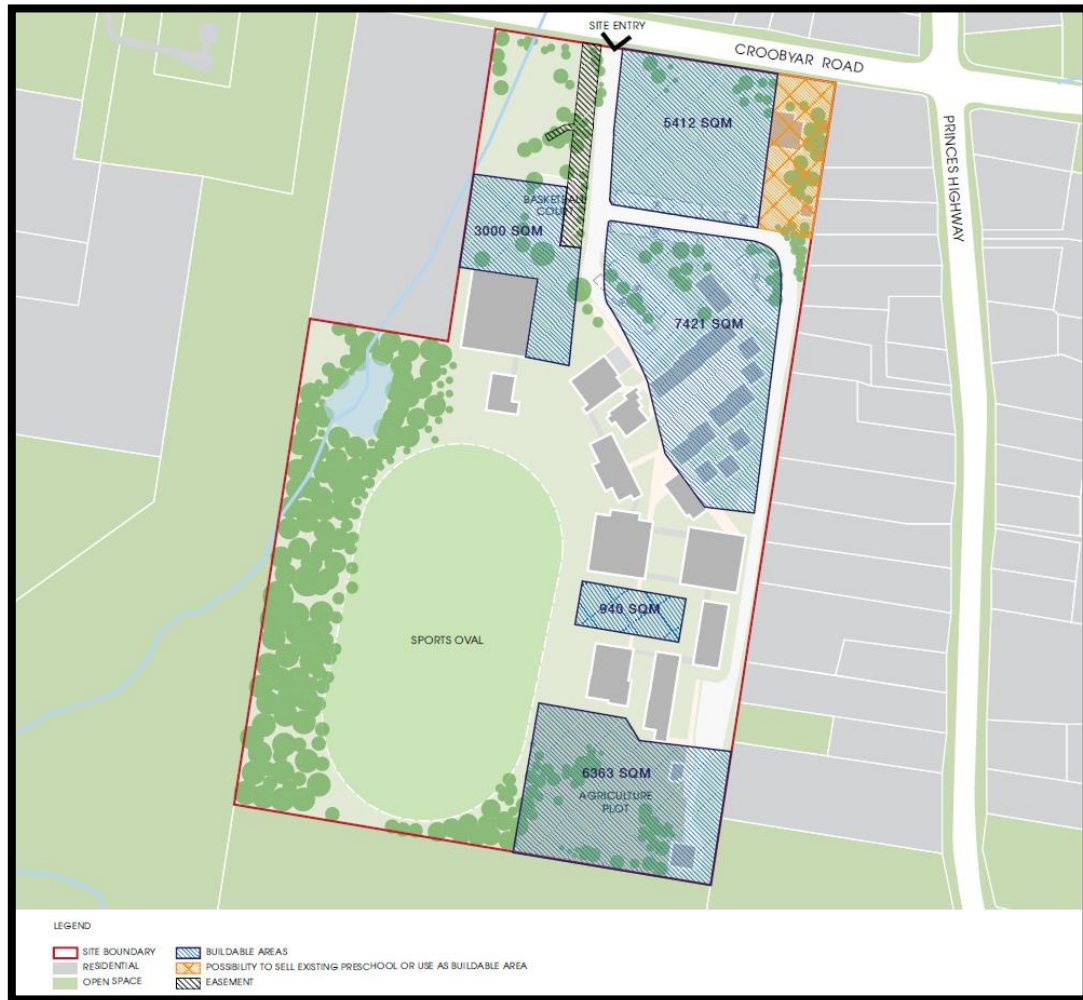
Figure 2: Locations considered as buildable areas within the study area (Group GSA 2020).

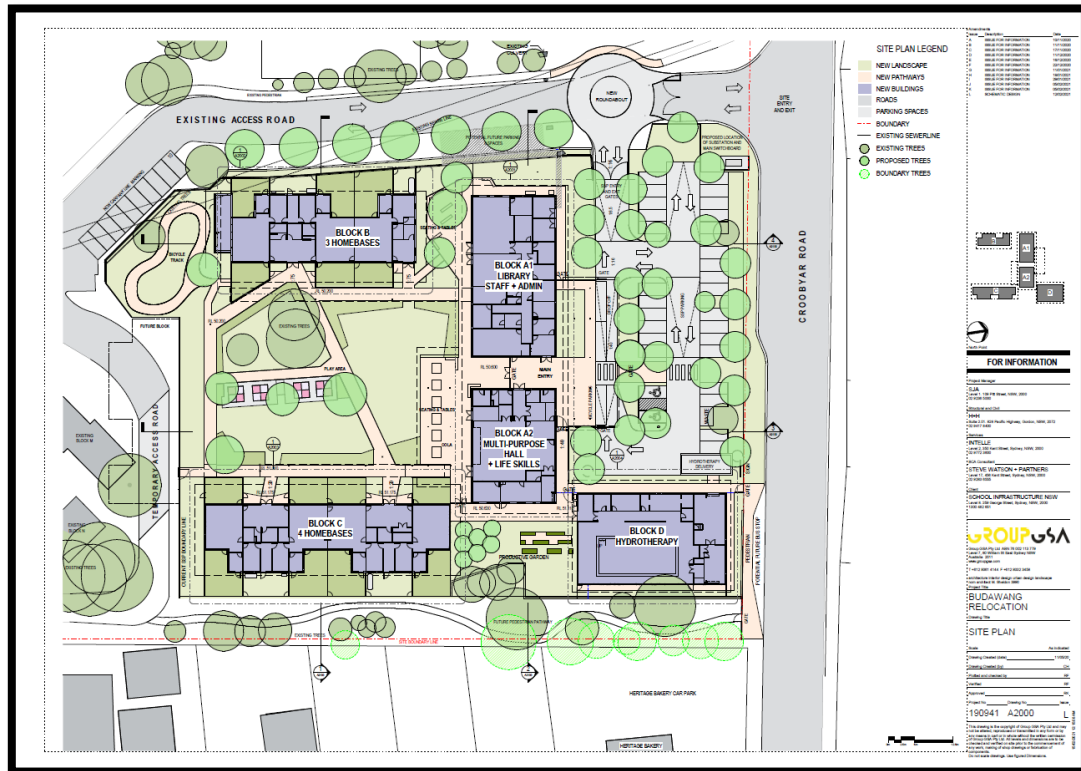
Figure 4: Masterplan option showing the locations of new buildings (Group GSA 2020).

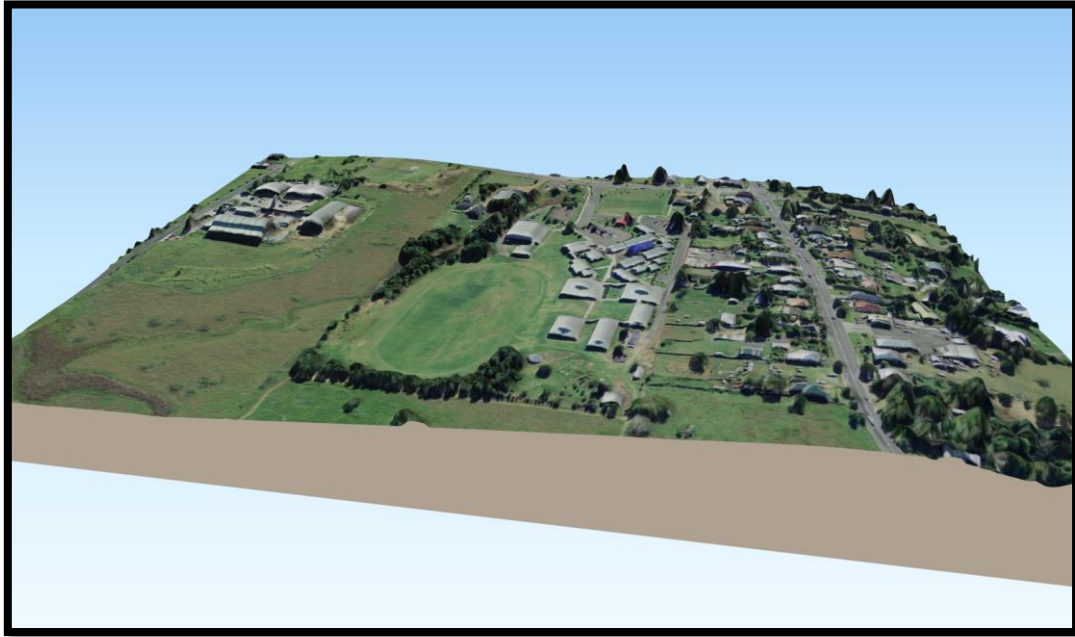
**Figure 5: A 3D image looking north over the study area. LiDAR and basemap image © Department Finance, Services and Innovation.**

The study area is located on the side of a low ridge, gently sloping to the west towards a small first order stream that drains into Pettys Creek. The ridgeline runs east to the coast at Mollymook/Ulladulla, and west to the ranges between Croobyar Creek to the north, and Stoney Creek to the south. Lot 200 fronts onto Croobyar Road, and is located behind a cluster of residential lots, and a commercial lot that are east of Lot 200. Figure 5 and Figure 6 show two perspectives using a 3D model derived from LiDAR to illustrate the terrain conditions across the study area.

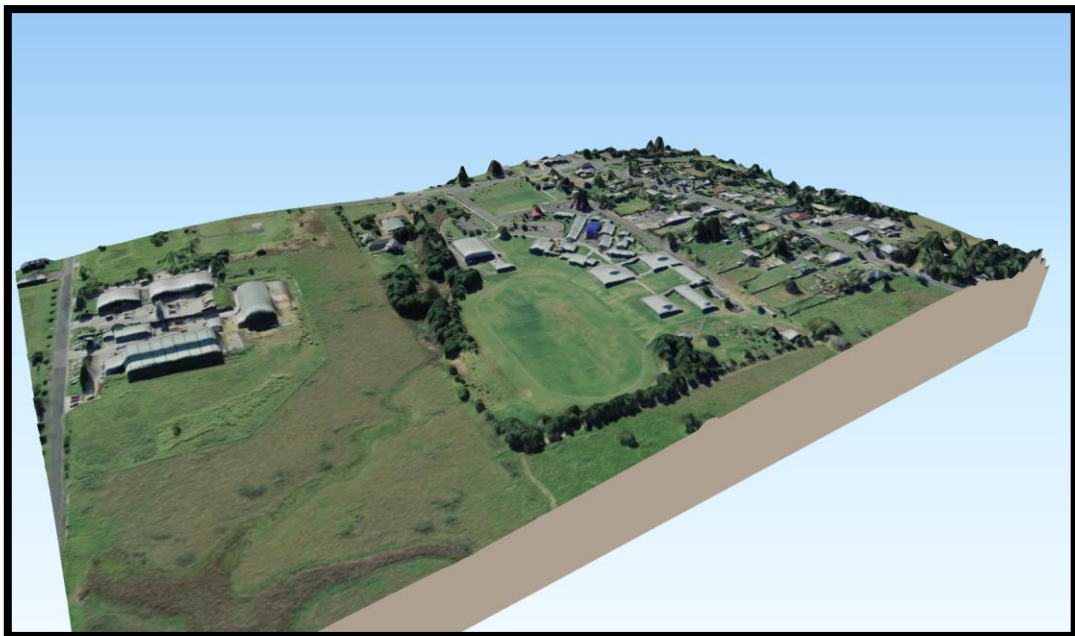
**Figure 6: 3D model looking northeast over the study area 3D model of the study area derived from an aerial image overlaying a LiDAR derived DEM showing the terrain of the study area. LiDAR and basemap image © Department Finance, Services and Innovation.**

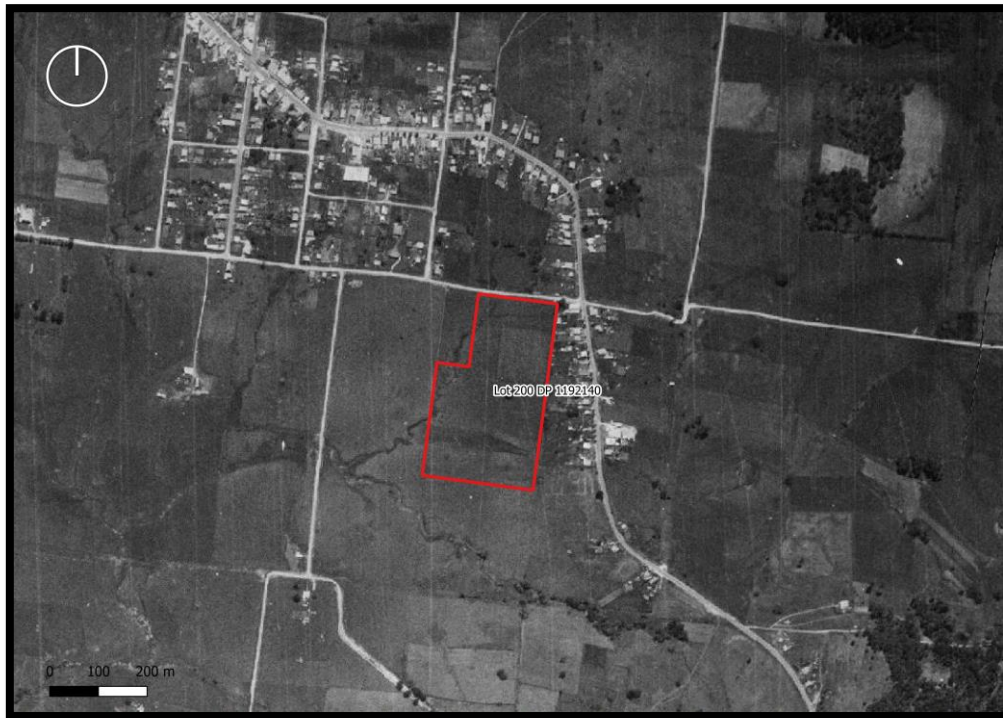
**Figure 10: Aerial image from 1959. Source © Spatial Services NSW Government.**

Aerial imagery of the study area from 1959 shows that the land was clear of vegetation and there are no buildings or other structures (refer to Figure 10). A 1991 aerial image (refer Figure 11) of the study area shows the first building on the site at the location of the present pre-school building. The most likely use for the study area was for grazing and growing pasture. As part of this assessment, no historical records were identified that indicate any historical structures or buildings had been built on Lot 200 DP1192140 (Portion 121).

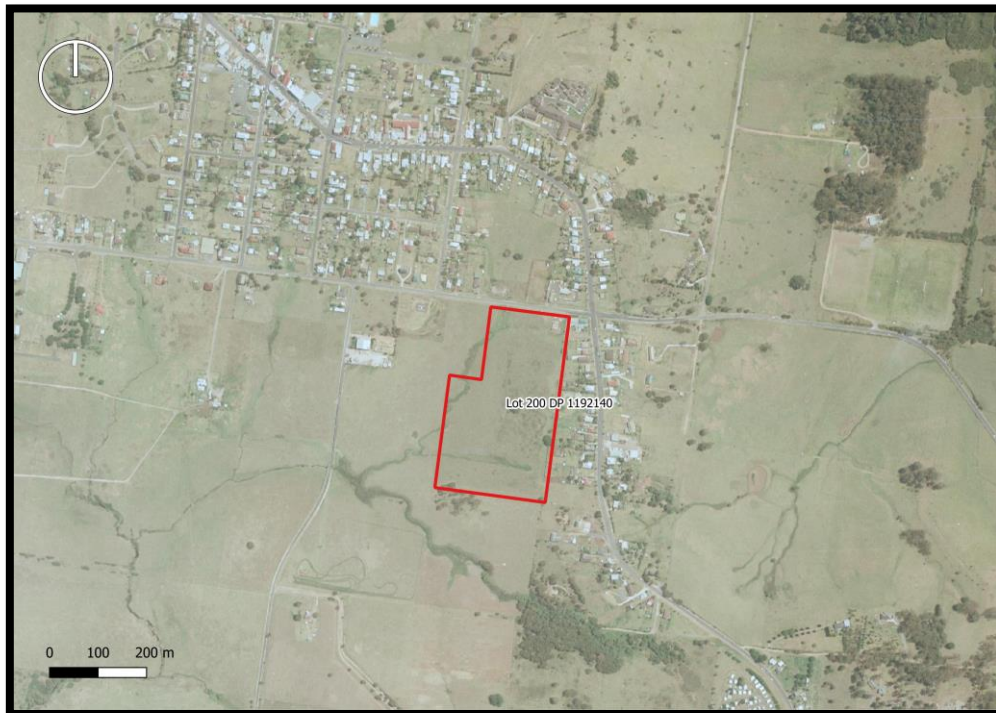
**Figure 11: Aerial image of the study area from 1991. Source © Spatial Services NSW Government.**

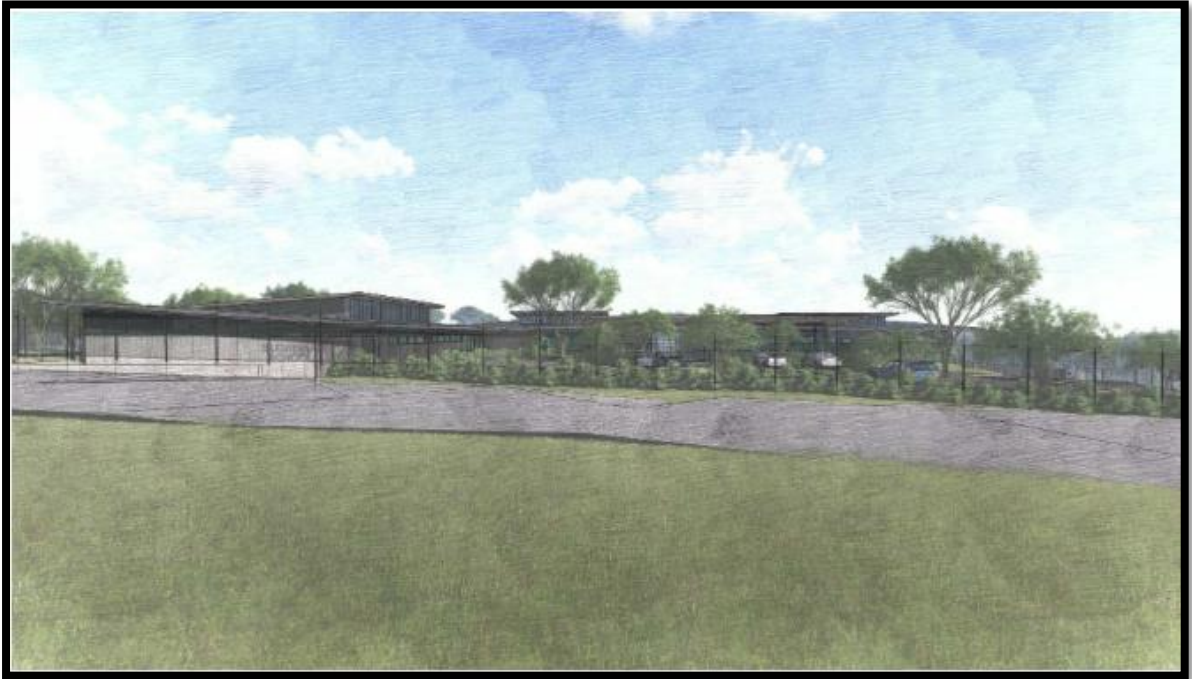
**Figure 14: Model showing the perspective of the Budawang SSP as viewed from the graveyard (Source GroupGSA).**

The view south from behind the memorial will be over the new buildings associated with the proposed development. The present view (refer Figure 19) is across the sports field to the existing school buildings. The view does not form a visual link to a significant topographic feature or feature associated with the history of the site. Whilst the Budawang SSP buildings and landscaping will be visible from the site, the design has been developed to be sympathetic to the surrounding context (Group GSA 2020:27). Refer to Figure 14. The significance of the heritage site is mostly intangible, there are no remaining grave sites or heritage objects visible on the site. The remaining tangible heritage item is the memorial which was erected after the destruction of heritage objects on the site. The proposed development is not expected to impact upon the intangible values and the memorial. Views from the site have already been impacted by the residential and commercial development around the site (refer to Figure 12). A model of the view from the graveyard has been produced to demonstrate the view from the graveyard into the school in Figure 14.

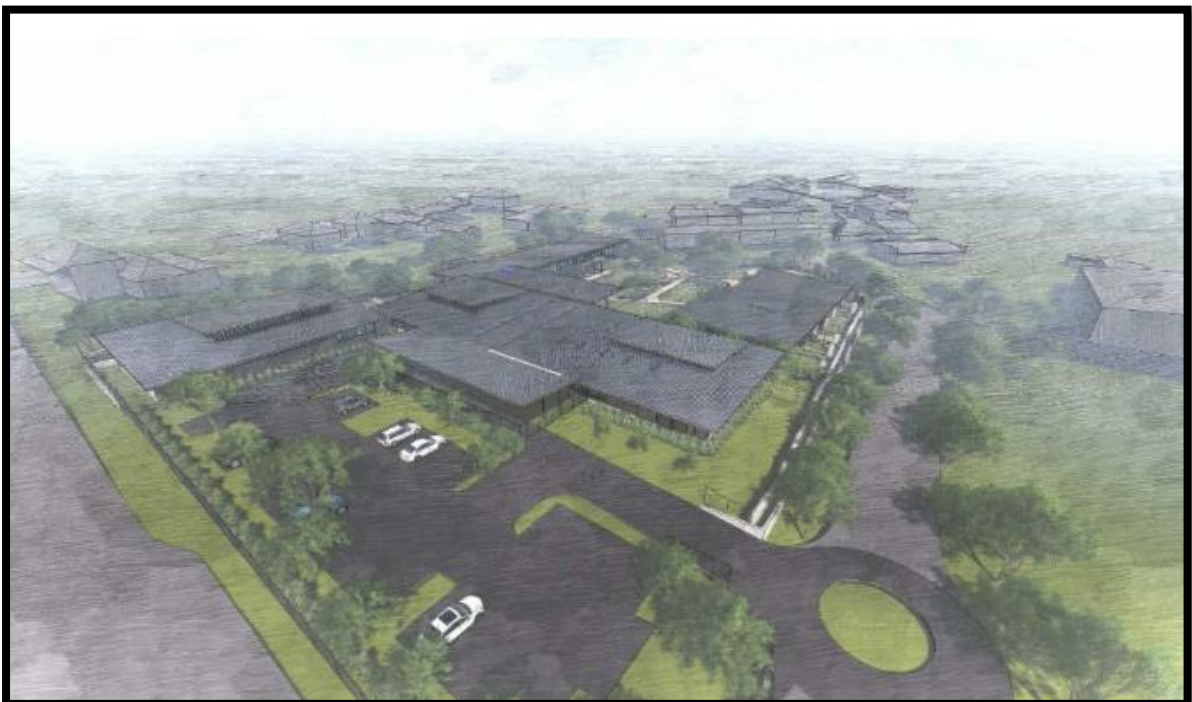
**Figure 15: Model aerial perspective of the Budawang SSP sitting within the surrounding local context (Source GroupGSA).**

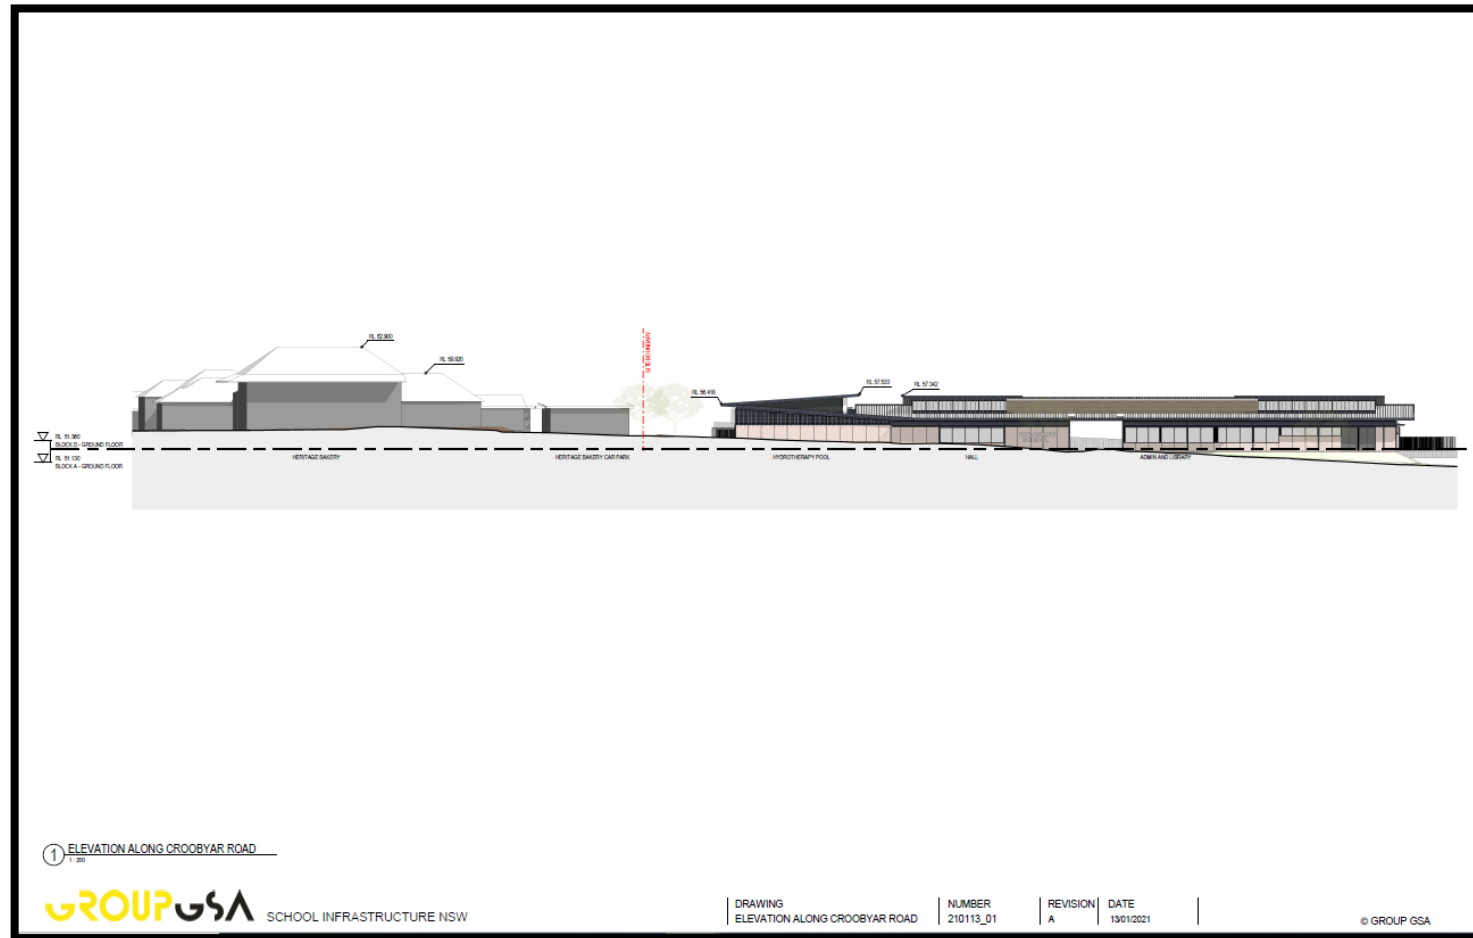
Figure 24: Drawing of the Budawang SSP design relative to the Heritage building 296.

The roof height for the buildings that form the proposed Budawang SSP are at a level of a maximum of 5.753 metres maximum height (refer to Figure 24). This height is approximately the same height as the existing pre-school building situated immediately to the west of the heritage site. A line of trees along the western boundary of Lots 1 and 2 DP37905 obscures the view from the heritage site into the school site (refer to Figure 20 to Figure 23). Figure 20 to Figure 23 below show that the existing pre-school is not visible from the heritage store when standing on the footpath to the north and south. The veranda on the heritage store does not face the school grounds so there is no impact to the views from the store veranda. The proposed development will not impact upon any views to the heritage store.
