Report on
Salinity Investigation and Management Plan

Proposed Budawang School Relocation
17 Croobyar Road, Milton

Prepared for
School Infrastructure New South Wales (SINSW)

Project 89390.03
Revision 2
April 2021

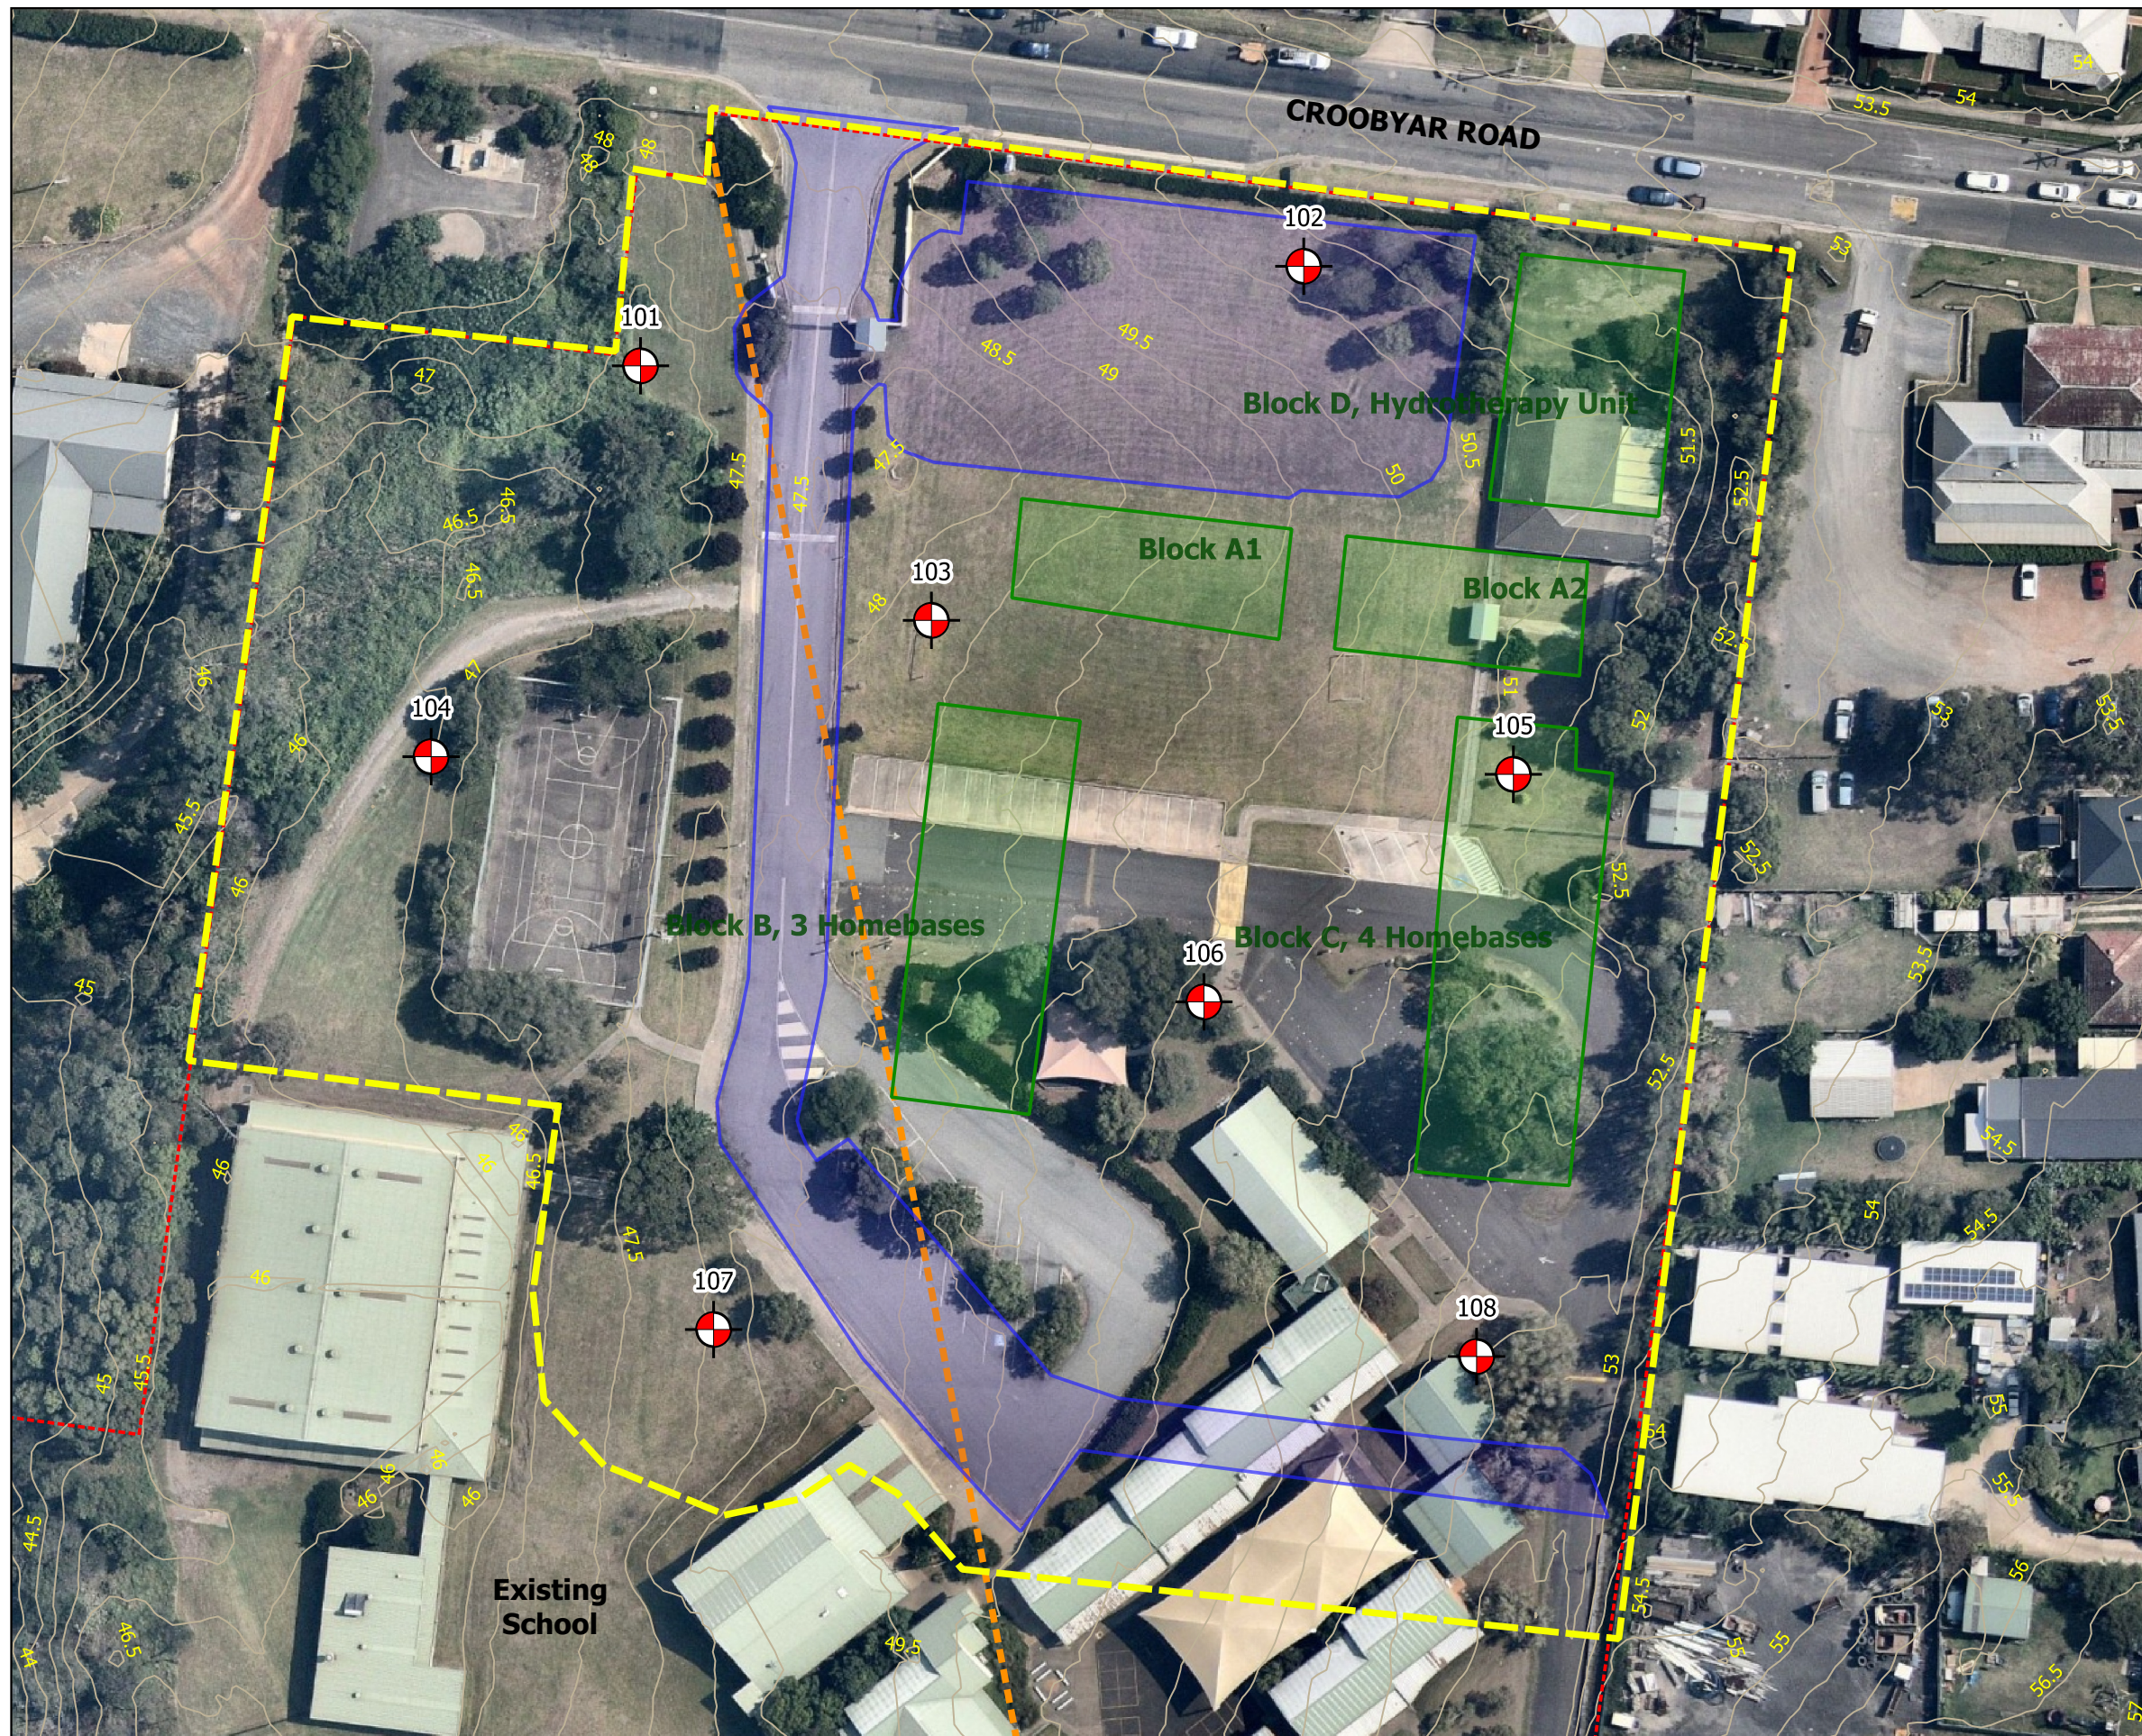
About This Report
Drawing 1

Borehole Location
-

Lot Boundary (Approx.)
-

Proposed Pavement Area (T.B.C)
-

Proposed Building (T.B.C)
-

Approximate Proposed Development Boundary (T.B.C)
-

Approximate Location of Existing Sewer Main

The approximate borehole locations are shown on Drawing 1 in Appendix B. The surface levels to Australian Height Datum (AHD) and coordinates to Map Grid of Australia (MGA) were determined using a digital GPS receiver for which a typical accuracy of ± 20 mm is expected.
