November
2018

Soil Report: 'Dunedoo Solar Farm' Site

Prepared for: ib vogt GmbH

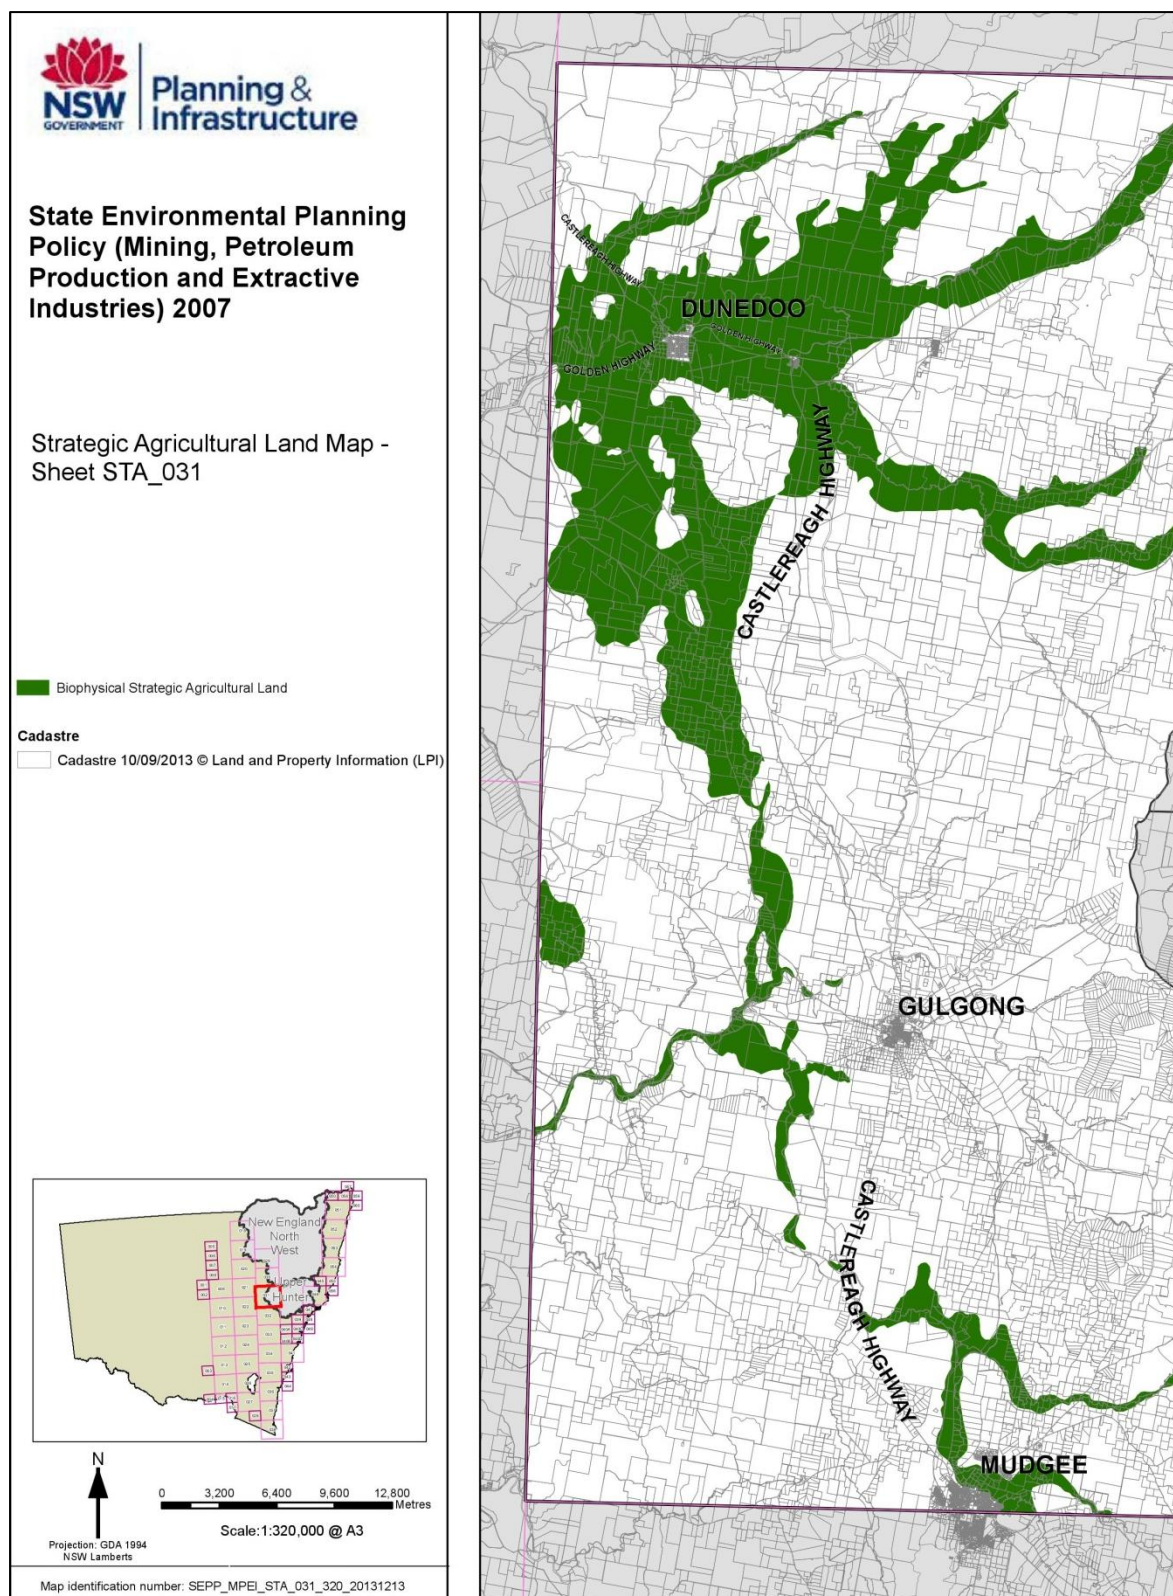
Figure 2. Map of government-estimated BSAL in the Dunedoo district (NSW Planning & Infrastructure 2013).

The *State Environmental Planning Policy (Mining, Petroleum Production and Extractive Industries) 2007* (Mining SEPP) includes mapping of lands identified as BSAL. NSW Government BSAL mapping estimates that about 80% of the area (all of the site except for the sloping northwest corner) is BSAL (NSW Planning & Infrastructure, 2013) (Figure 2).

A thorough BSAL assessment would require a total of about 9 soil pits. However, the current 'first approximation' based on a 4-pit assessment indicates that only the Black Vertosol zone (~30% of the area) is BSAL. This contrasts with the NSW Government BSAL mapping which estimates that about 80% of the area of interest (all of the site except for the sloping northwest corner) is BSAL.

However, the current 'first approximation' based on a 4-pit assessment indicates that only the Black Vertosol zone (~30% of the area) is BSAL. This contrasts with the NSW Government BSAL mapping which estimates that about 90% of the area – all of the site except for the sloping northwest corner – is BSAL.

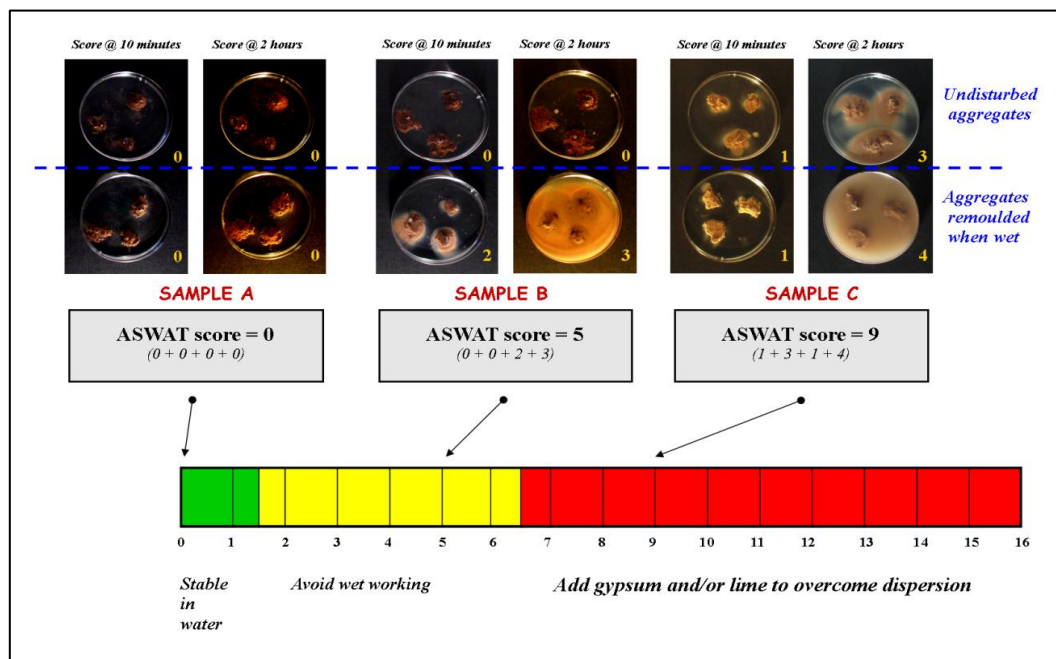
Figure 3. The link between ASWAT results and soil management options.

Soil dispersibility, as measured by the Aggregate Stability in Water (ASWAT) test (Field *et al.*, 1997), was assessed by Soil Management Designs in Orange, NSW. The results are presented in Attachment D. The ASWAT test has been related to the well-known Emerson aggregate stability test by Hazelton and Murphy (2007) – see Table 1. An advantage of the ASWAT test is that the results can be linked with management issues such as the need for gypsum application and avoidance of wet working (McKenzie, 2013) (Figure 3). The conversion factors of Slavich and Petterson (1993) allowed the ECE to be calculated from the EC of 1:5 soil:water suspensions ($EC_{1:5}$) and texture.

Table 1. The relationship between the Emerson Aggregate Stability Test and the ASWAT test.

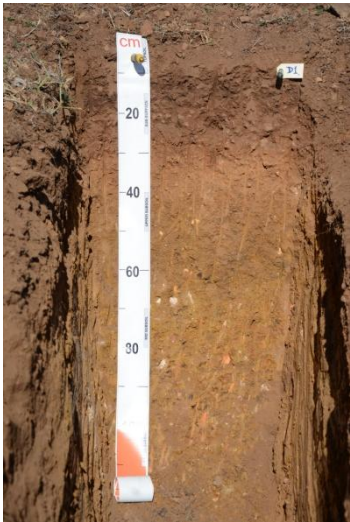
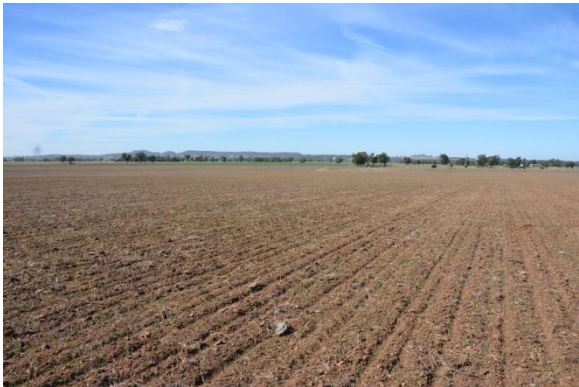
Site	Soil profile and ASC description	Landscape View
Pit 1	<p>Brown Chromosol</p>

The Australian Soil Classification (ASC) (Isbell, 2002) has been used to determine soil types at each of the 4 sampling sites. Photographs of the soil profiles (and associated landscapes) at each site are presented in Figure 4.

Water erosion is unlikely to be a serious issue, except in the north-western corner (3% slope) where a protective organic groundcover needs to be maintained where possible (preferably perennial pasture). However, the absence of extreme subsoil sodicity in the sloping area represented by Pit 1 means that tunnel erosion is very unlikely.

- Pit 1; distinct mottling (an indicator of waterlogging in the subsoil when moist) within 75 cm of the soil surface.
- Pit 3; prominent mottling in the topsoil and a sodic/dispersive subsoil below 30 cm.
- Pit 4; prominent mottling within 75 cm of the soil surface.

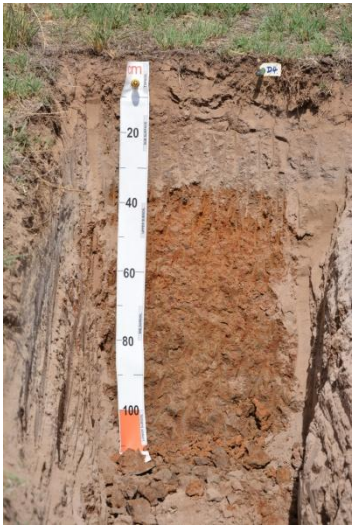
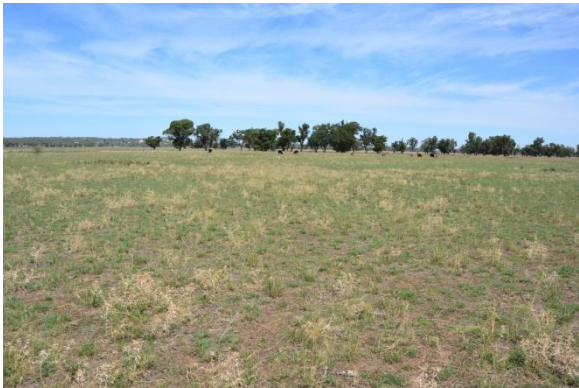
Site	Soil profile and ASC description	Landscape View
Pit 4	<p>Brown Chromosol</p>

Figure 4. Photographs of soil profiles and landscapes at each of the four sampling sites.

Wind erosion is a potential problem on Brown Chromosols in the vicinity of Pit 4. The sandy topsoil will be prone to loss by wind erosion if left bare. Protection by perennial pasture is recommended.

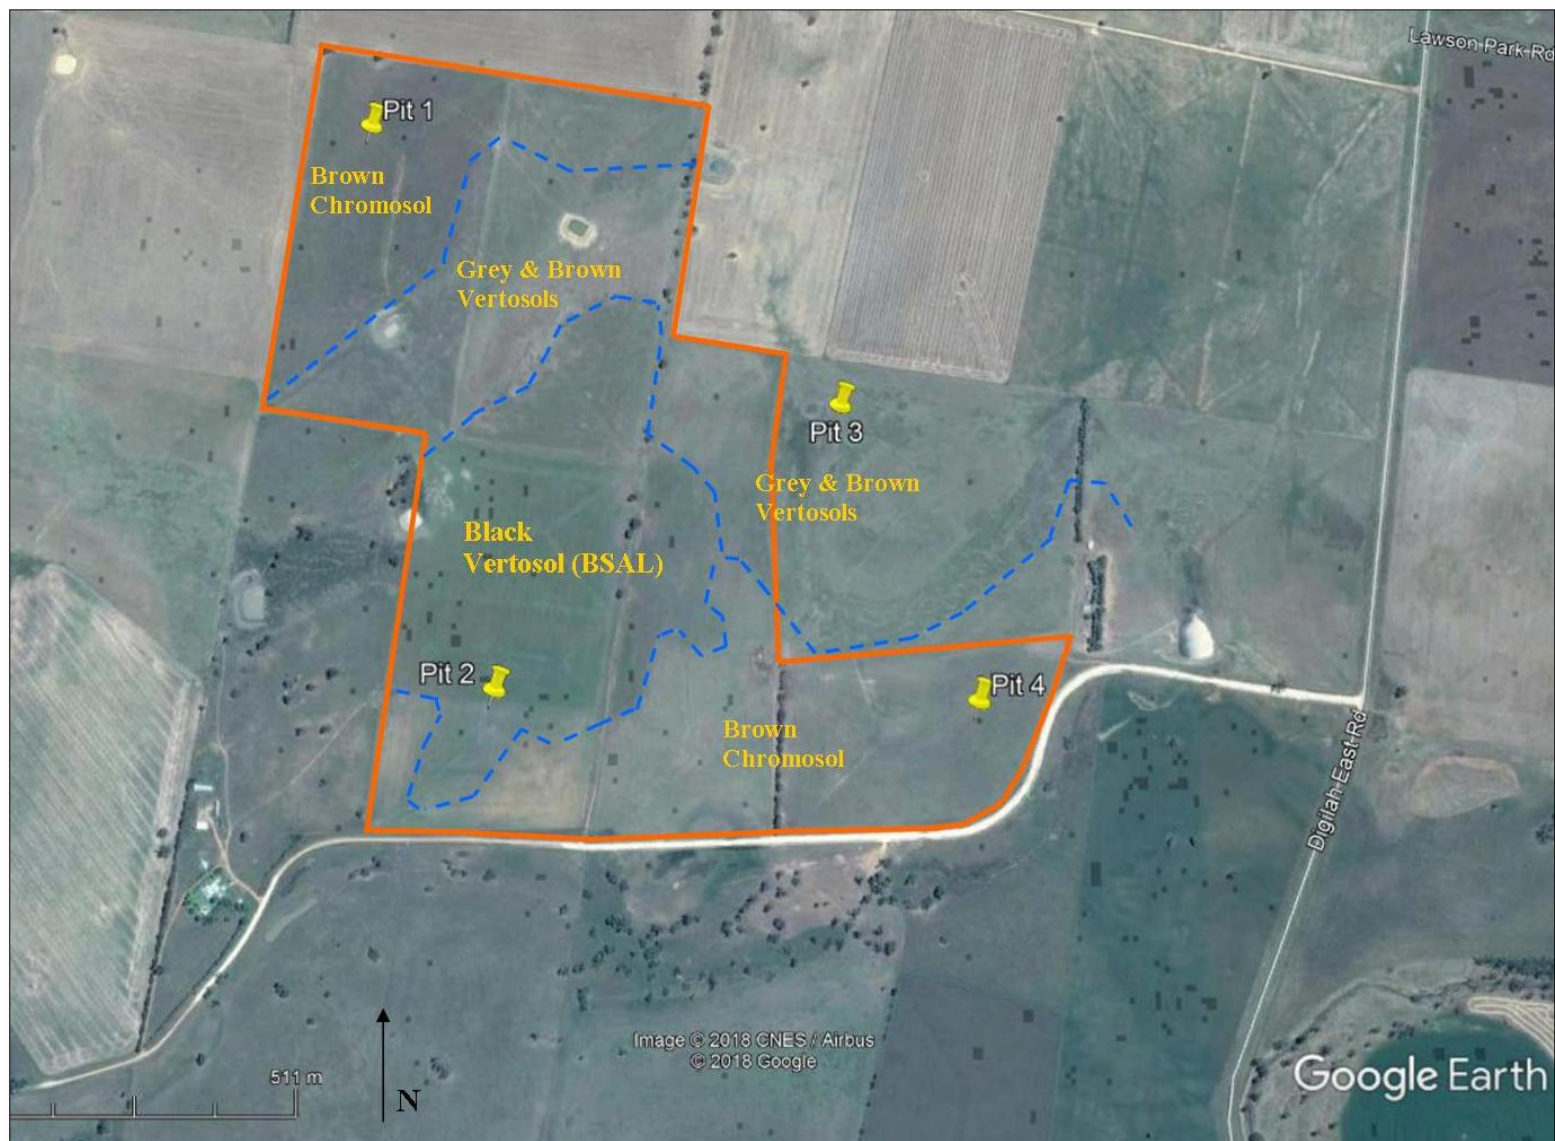
Figure 5. Soil type map.

A soil map for the area of interest is shown in Figure 5. Soil boundaries in-between the pits were estimated from the patterns on 'Google Earth' image, and impressions of soil and landscape conditions when driving around the study area.

The soil types on the soil map have the following characteristics (Isbell, 2002):

- Vertosols are clay-rich soils with shrink-swell properties in both topsoil and subsoil that exhibit strong cracking when dry.
- Chromosols have strong texture contrast between the A and B horizons, and the B horizon is non-sodic with a neutral to alkaline pH.

A soil type map based on 4 soil pit descriptions has been prepared. Approximately 30% of the study area (25 ha) was found to have high quality Black Vertosol soil with 'biophysical strategic agricultural land' (BSAL) qualities. Poorly drained Grey and Brown Vertosols cover approximately 17 ha. Brown Chromosols (light textured topsoil overlying poorly drained clay-rich subsoil) cover approximately 23 ha along the flat southern edge of the study area.

- Gypsum (calcium sulphate; CaSO_4) application (6 t/ha) is recommended for the 'Grey and Brown Vertosol' zone (Figure 5). This is because the subsoil is strongly dispersive and therefore poorly drained. The gypsum will improve subsoil drainage via its electrolyte effect and through replacement of exchangeable sodium and magnesium by calcium. A coarse-grade gypsum product is recommended that maintains the beneficial electrolyte for as long as possible. For the remainder of the study area, gypsum application at a rate of 3 t/ha is recommended to improve both subsoil drainage and sulphur nutrition.
