## **Report on Geotechnical and Hydrogeological Investigation**

### **Proposed Mixed Use Development**

**33 - 37 Herbert Street, St Leonards NSW**

**Project 237003.00**

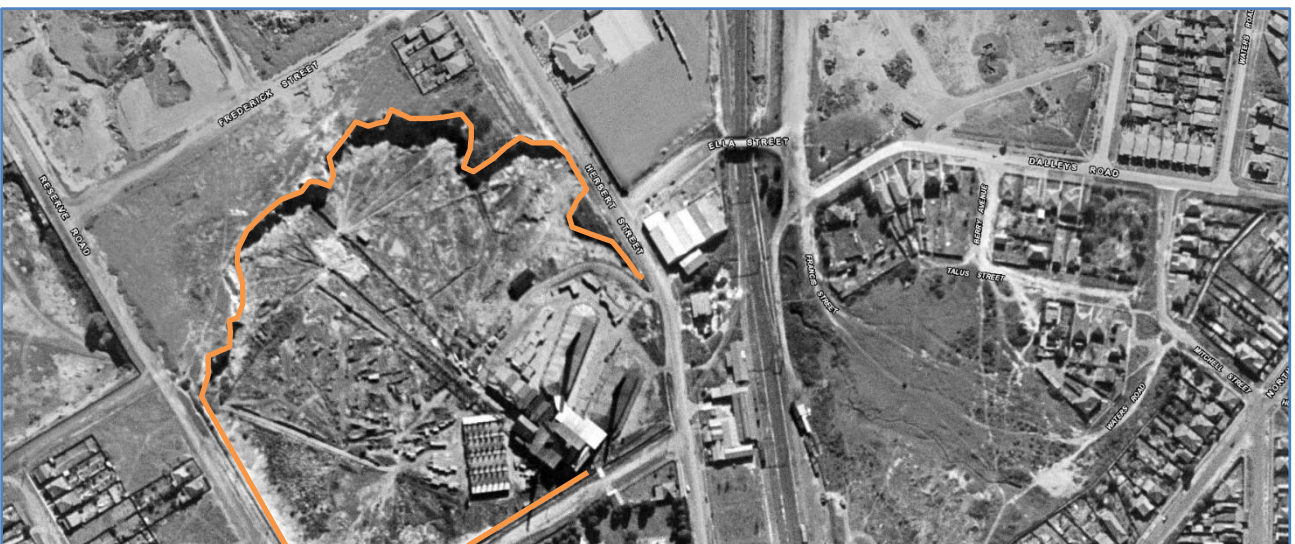
**Figure 2. Aerial Photograph (1943) showing location of site with respect to the quarry; approximate areas of cut face marked in orange.**

Historical aerial photography from 1943 (see Figure 2) shows the site is located directly to the east of an old brick quarry (also reflected in the soil landscape section below as disturbed terrain) with Herbert Street forming the eastern boundary of the quarry.

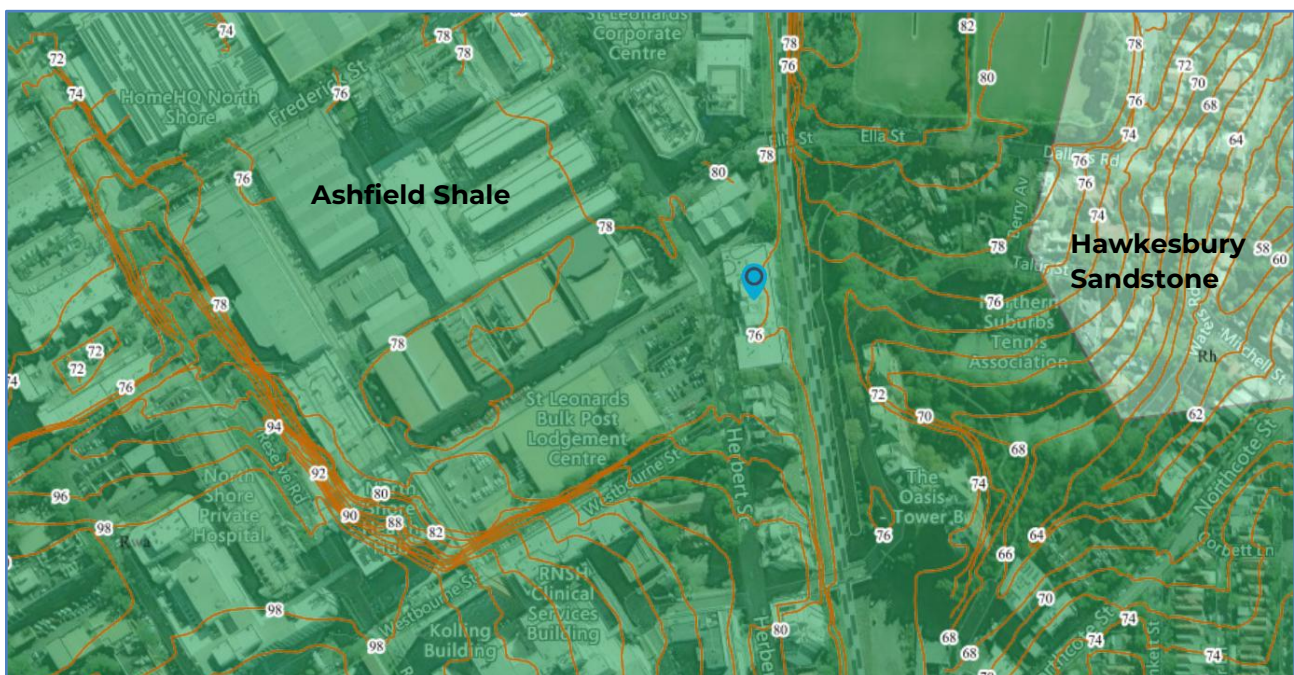
**Figure 3. Extract from Sydney 1:100,000 Geological Series Sheet 9130 With 2 m Contour Lines (Blue Pin marks the site location)**

It is noted that the site is orientated sub-parallel to north and therefore the eastern and western site boundaries are orientated sub-parallel to Joint Set 1. Based on the investigation results, however, competent rock is not expected to form part of the retained material, apart from the northern portion of the site where some medium strength sandstone is expected.

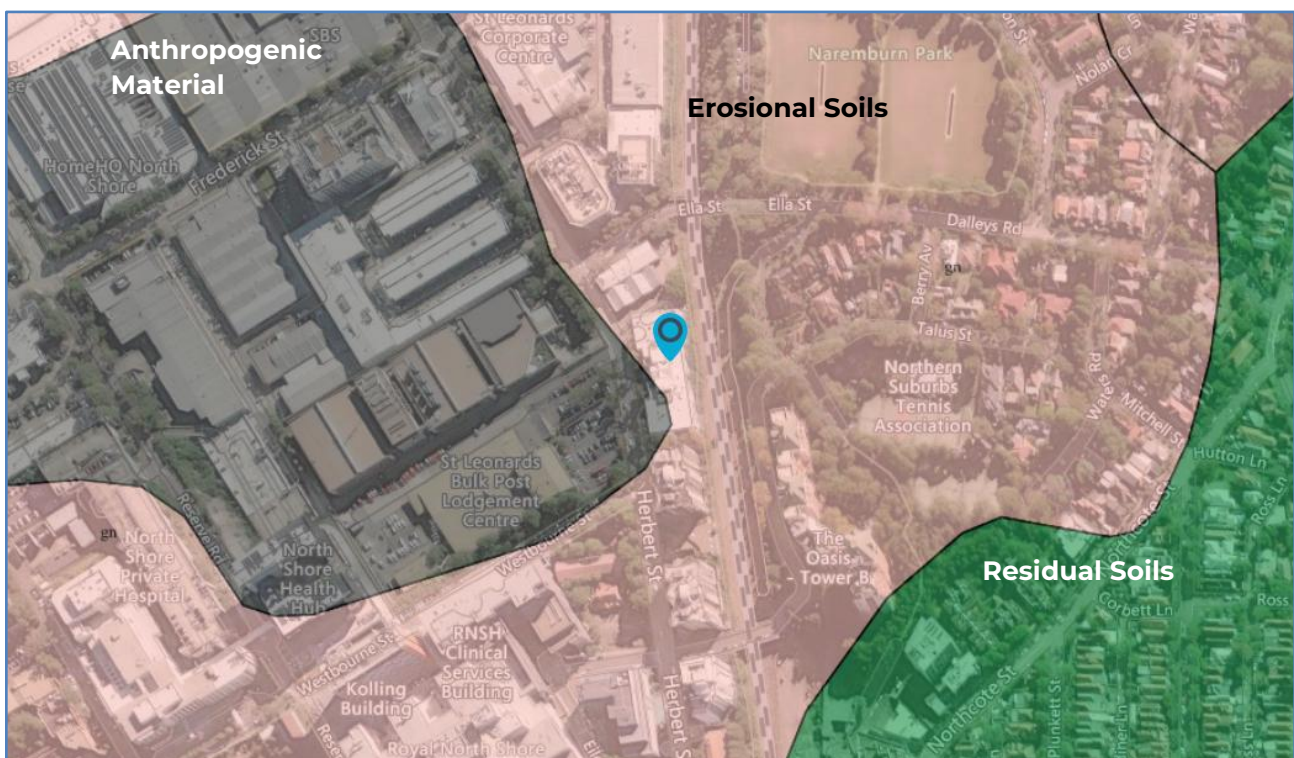
**Figure 4. Extract from Sydney 1:100,000 Soils Landscape Sheet (Blue Pin marks the site location)**

Reference to the Sydney 1:100 000 Soil Landscape Sheet indicates that the site is underlain by shallow to moderately deep and deep erosional soils over bedrock (see Figure 4 below). The sheet also show that disturbed terrain (anthropogenic material) is present along the southwestern boundary of the site.

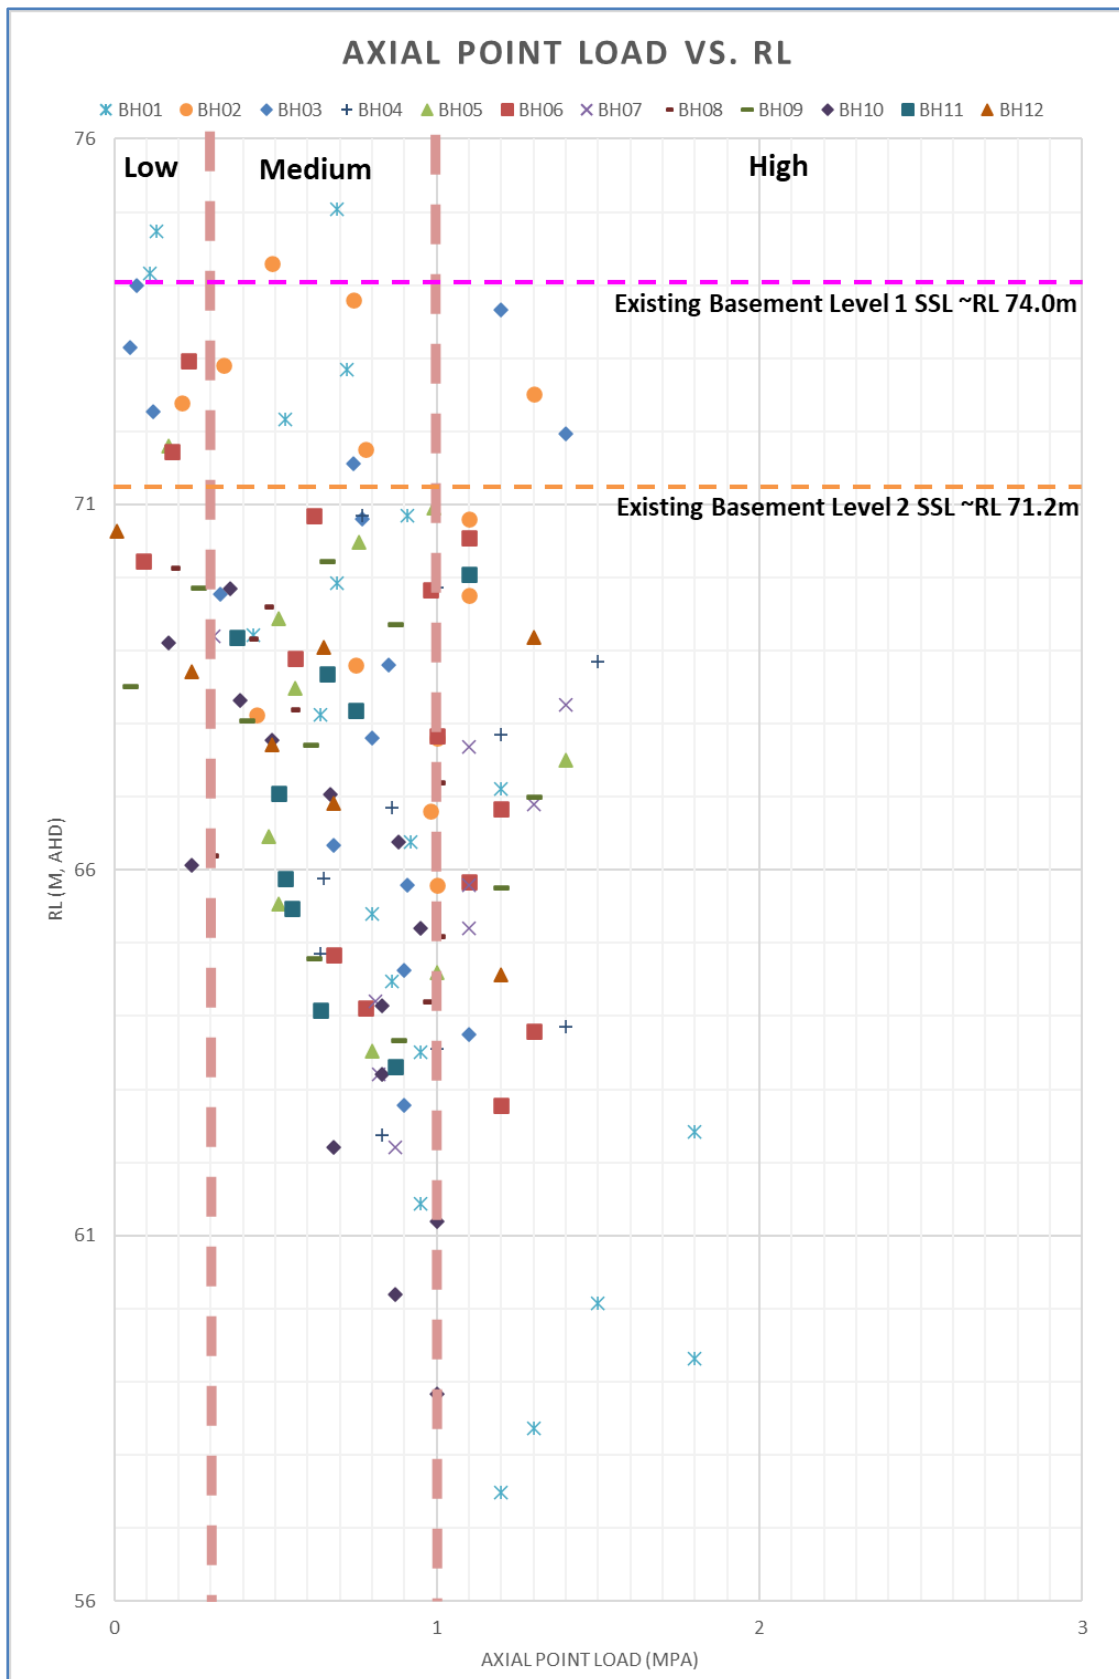
**Figure 5. Axial Point Load (MPa) vs RL (m, AHD) Graph**

The results of point load strength index testing ( $Is_{(50)}$ ) carried out at regular intervals on rock cores are shown on the respective borehole logs (see Appendix E). The results show  $Is_{(50)}$  values in the range of 0.05 to 1.8 MPa, indicating that the rock tested ranged from very low through to high strength. The test results were plotted against depth, as shown in Figure 5. It is noted that point load strength testing can be inaccurate in weathered (leached and ferruginous / iron cemented) rock and very low strength materials (i.e. below  $Is_{(50)}$  values of 0.1 MPa).

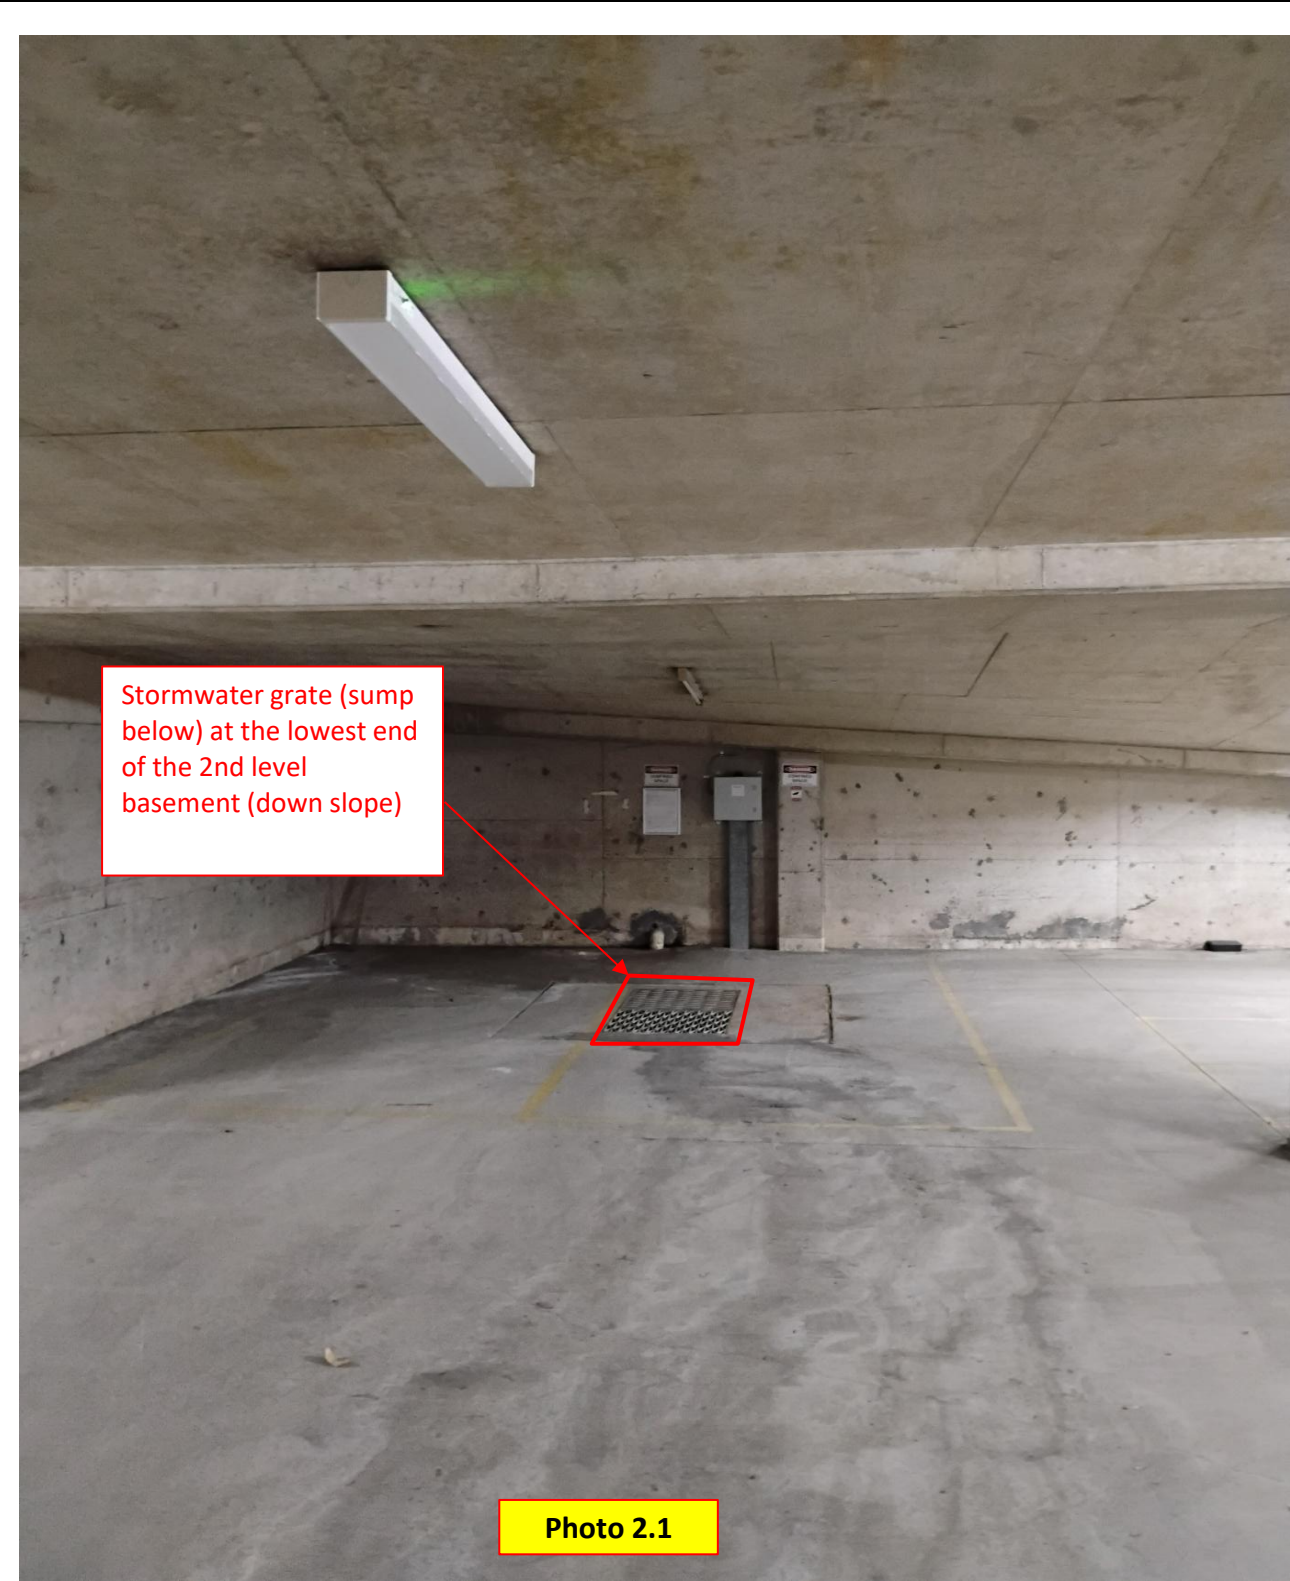
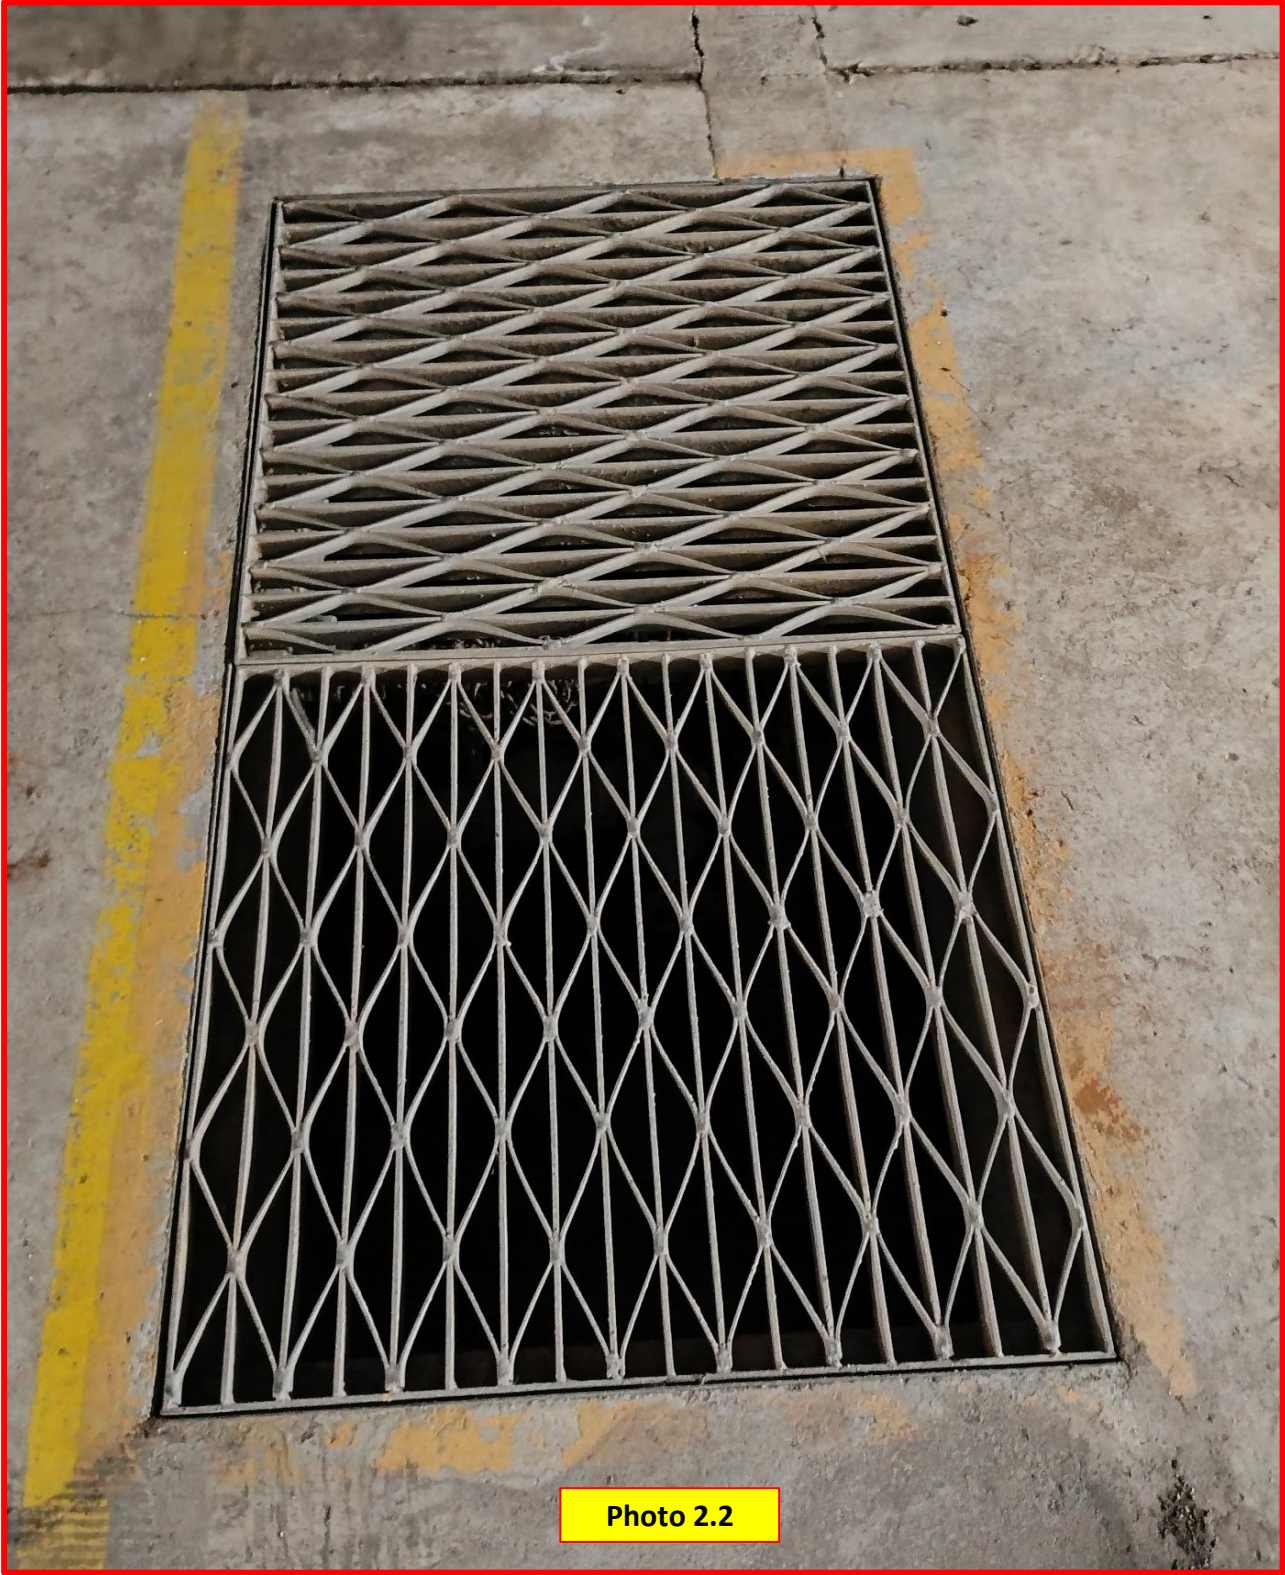
Photo 2.1

Stormwater grate (sump below) at the lowest end of the 2nd level basement (down slope)

The basement level also has a stormwater sump with a steel grate at RL 70.36 m (lowest floor level) with the sump invert level at RL 67.5 m (refer Appendix B and Plate 2, Appendix F). The stormwater sump appeared to have continuous water inflow, possibly associated with the leaking stormwater tunnel.

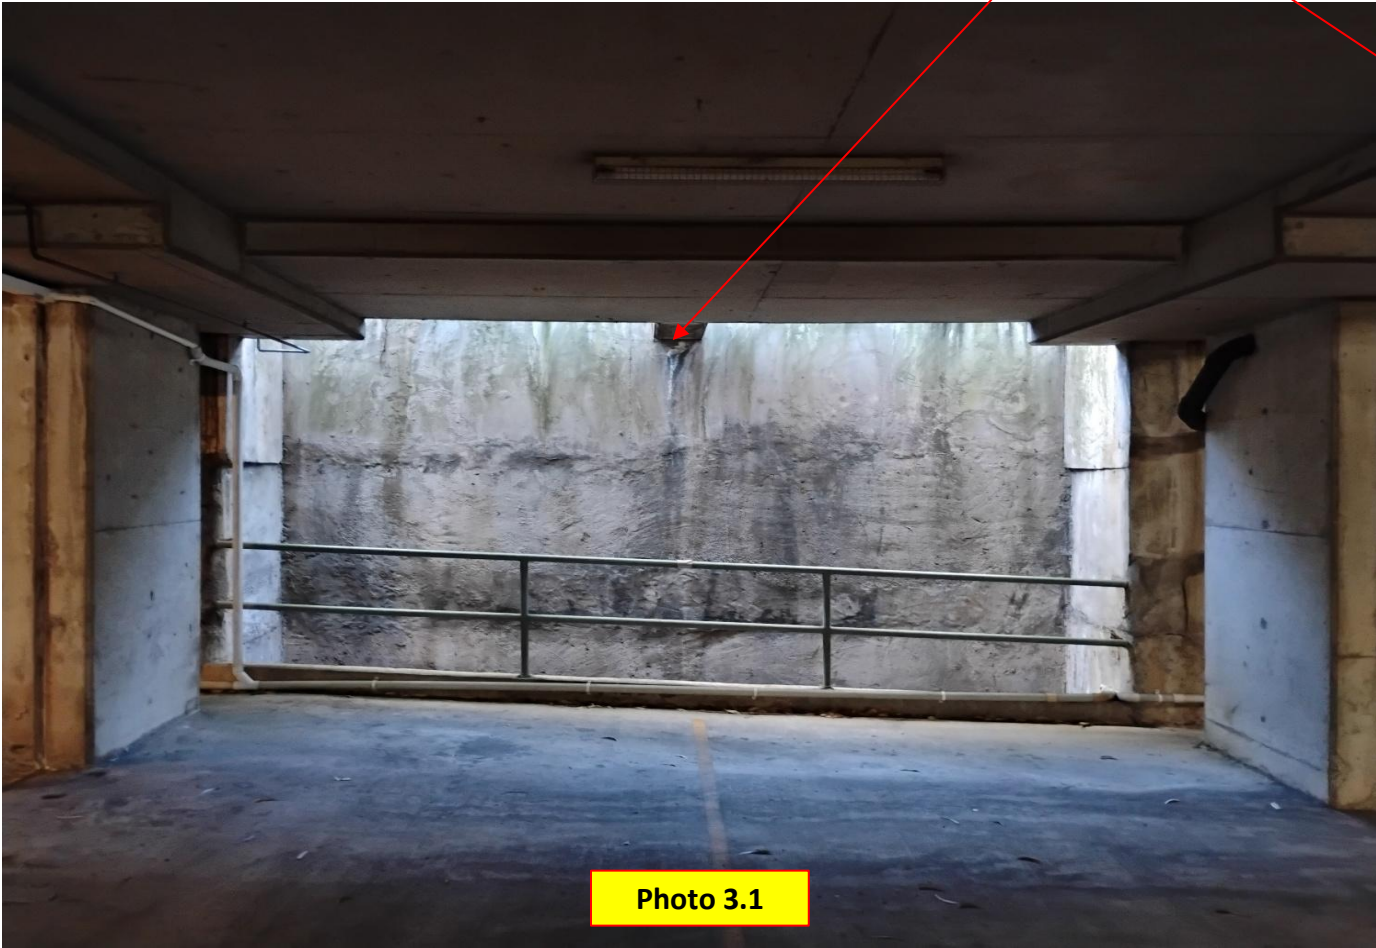
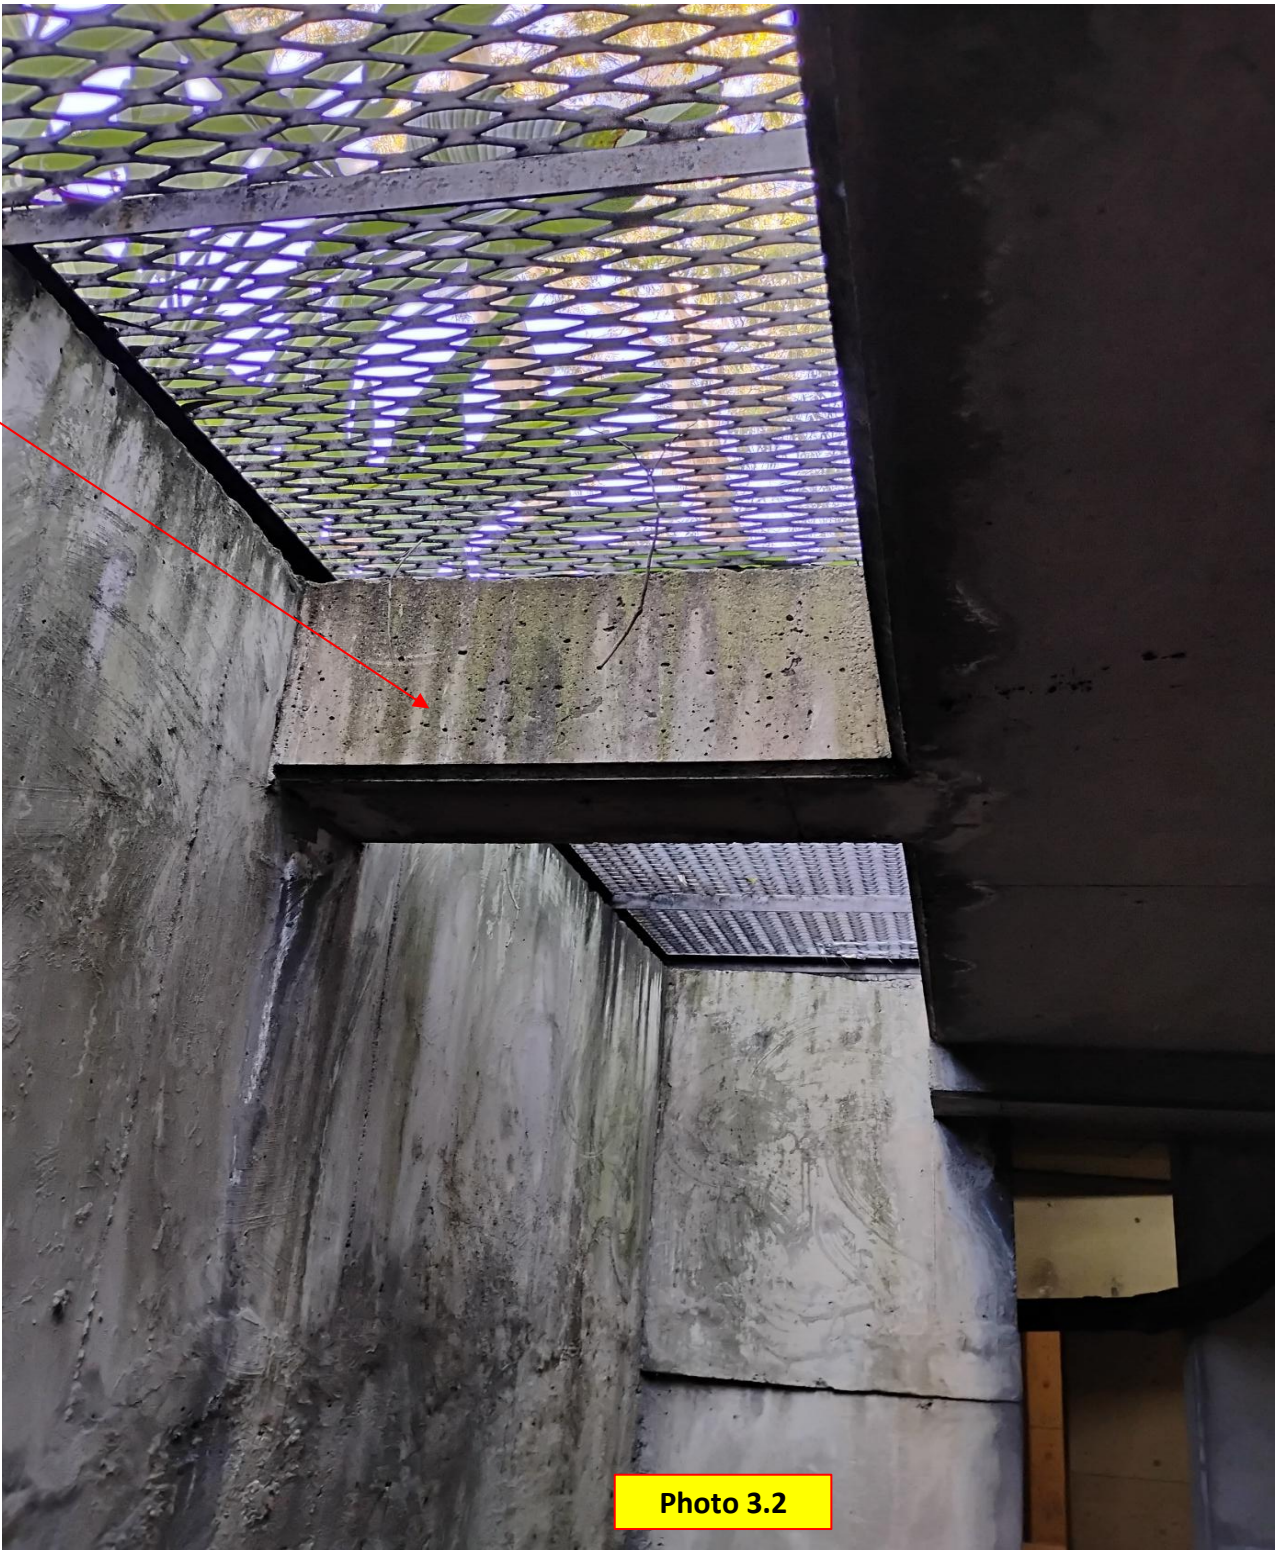
Photo 3.1

Floor slabs do not have full contact with the

The western basement wall of 33 Herbert Street includes a local extension which is not in full contact with the basement floor slabs (refer Plate 3, Appendix F). Instead, the basement wall appears to be locally propped by a buttress beam.

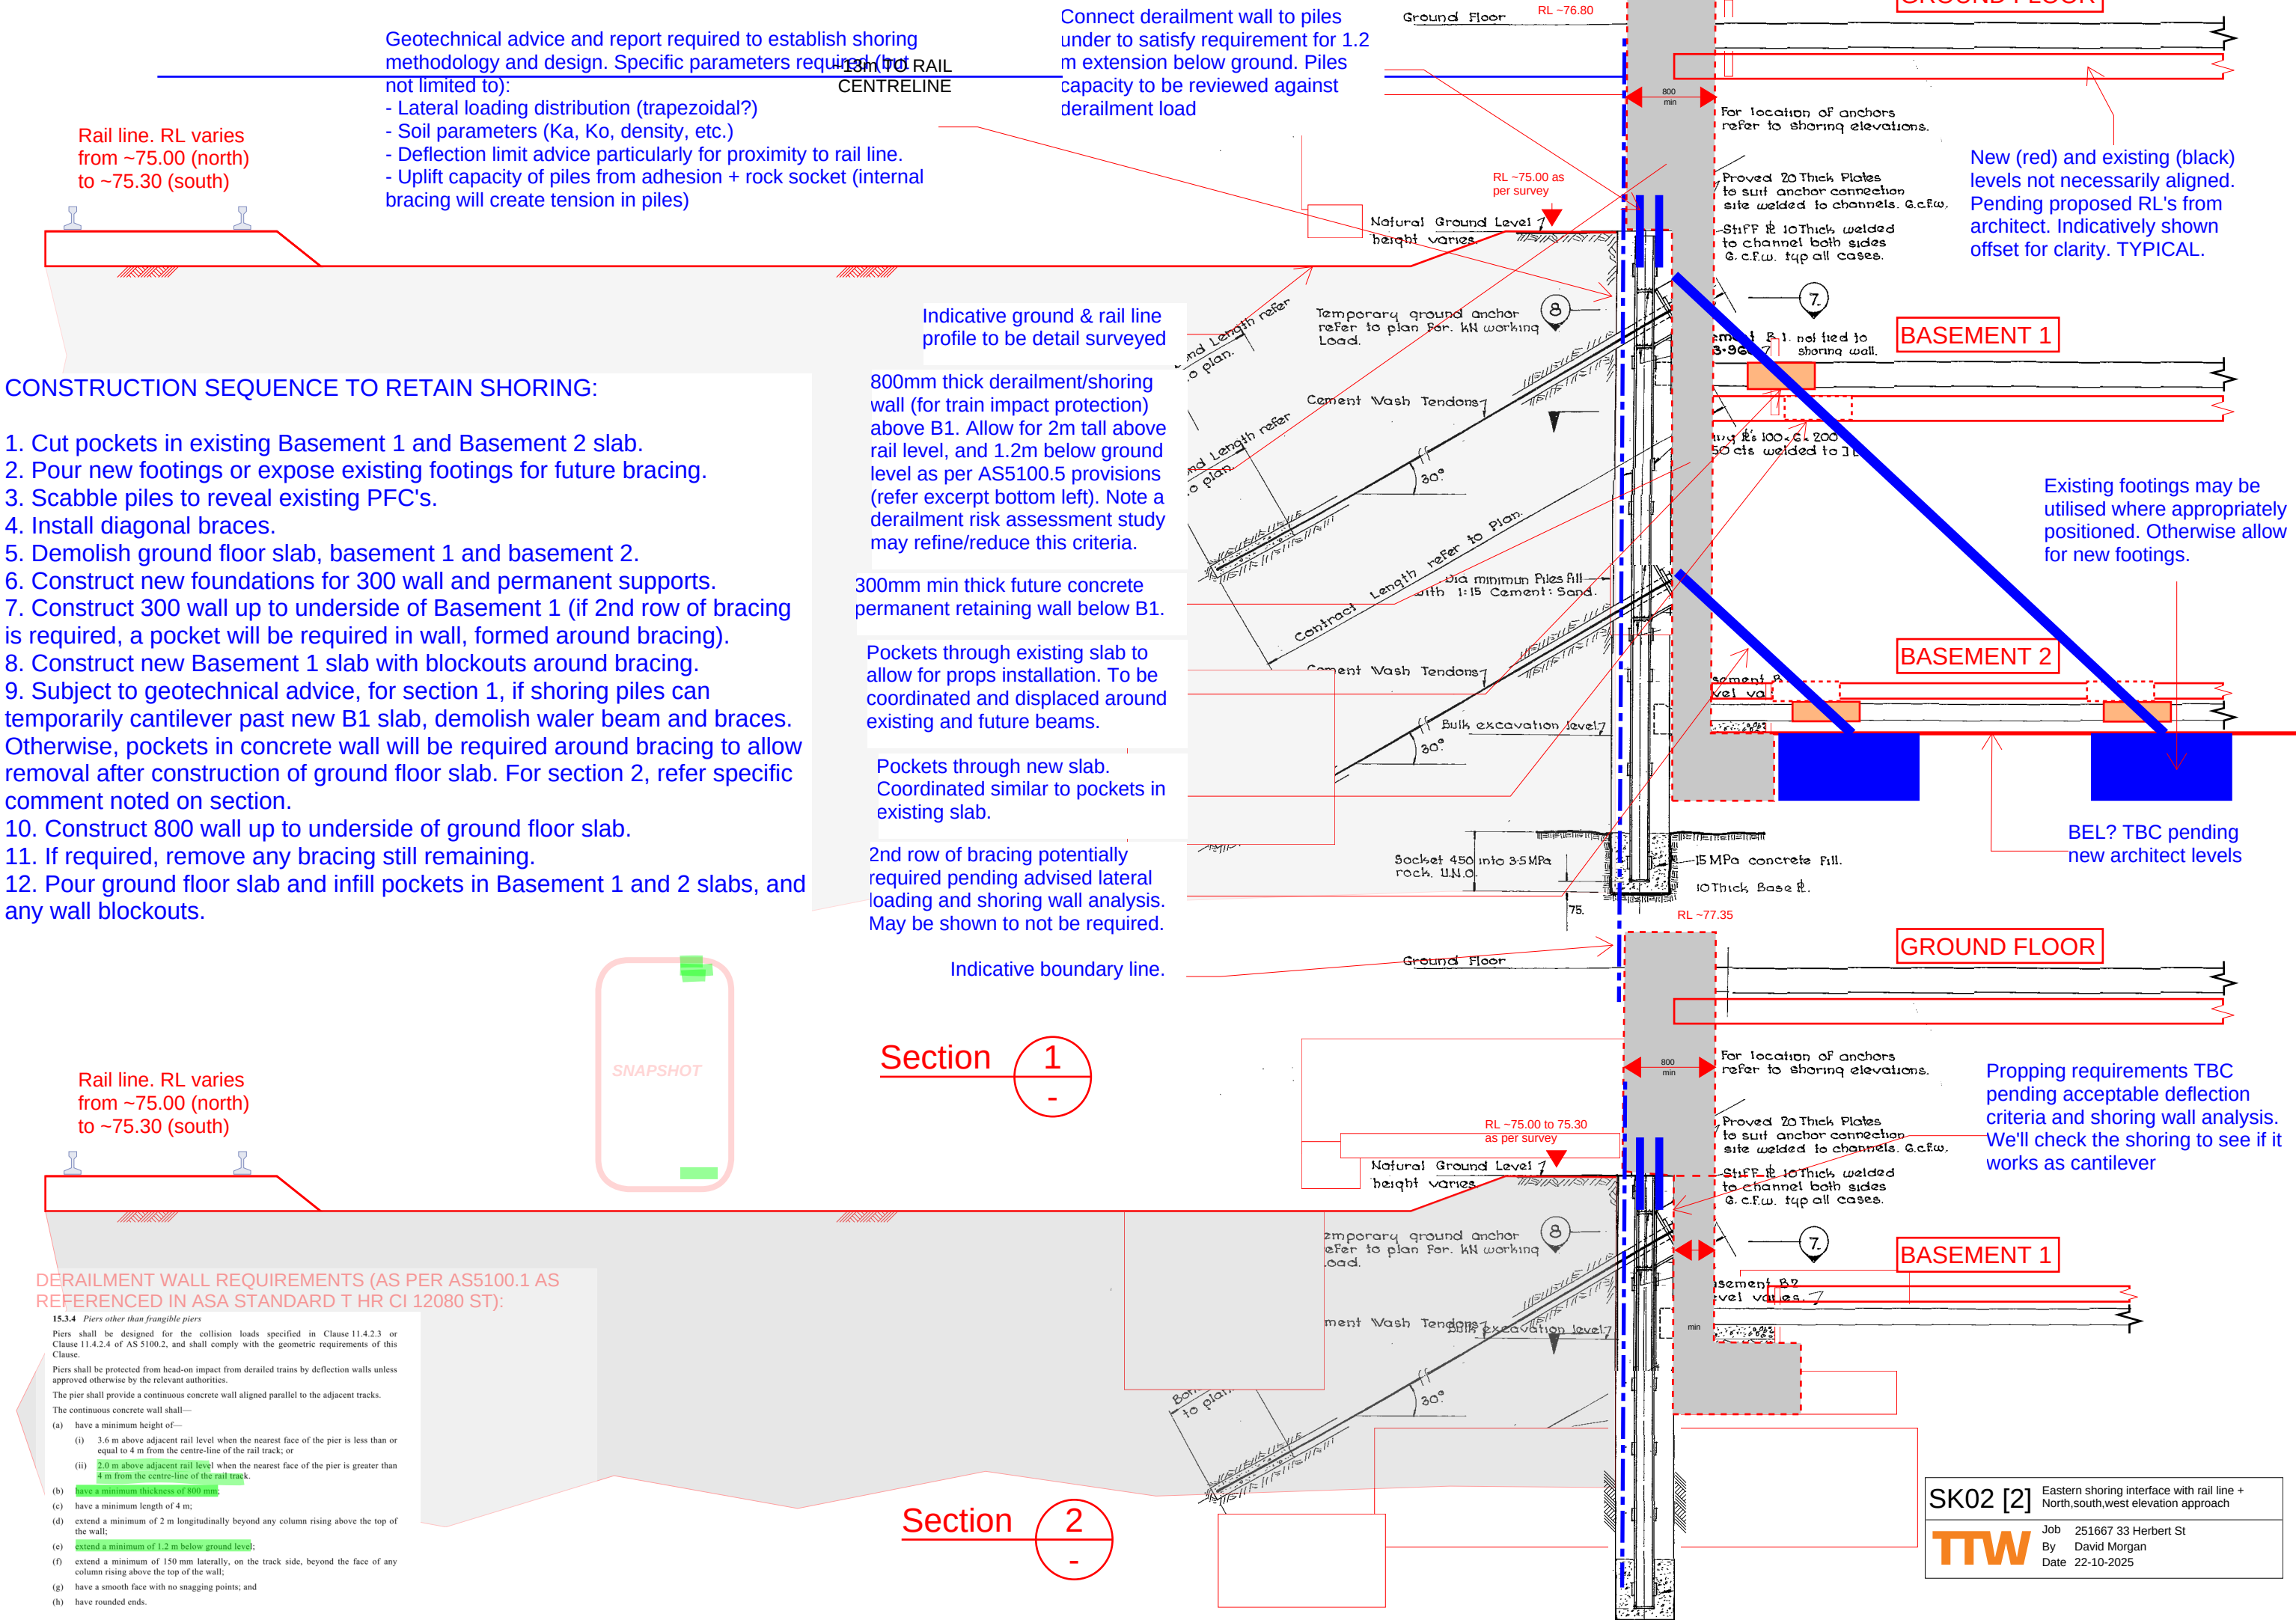
Option 1 (red) - install new temp anchors above the existing ones, on same pile.  
Option 2 : install new temp anchors on a different pile

existing anchors (likely de-stressed but not removed)

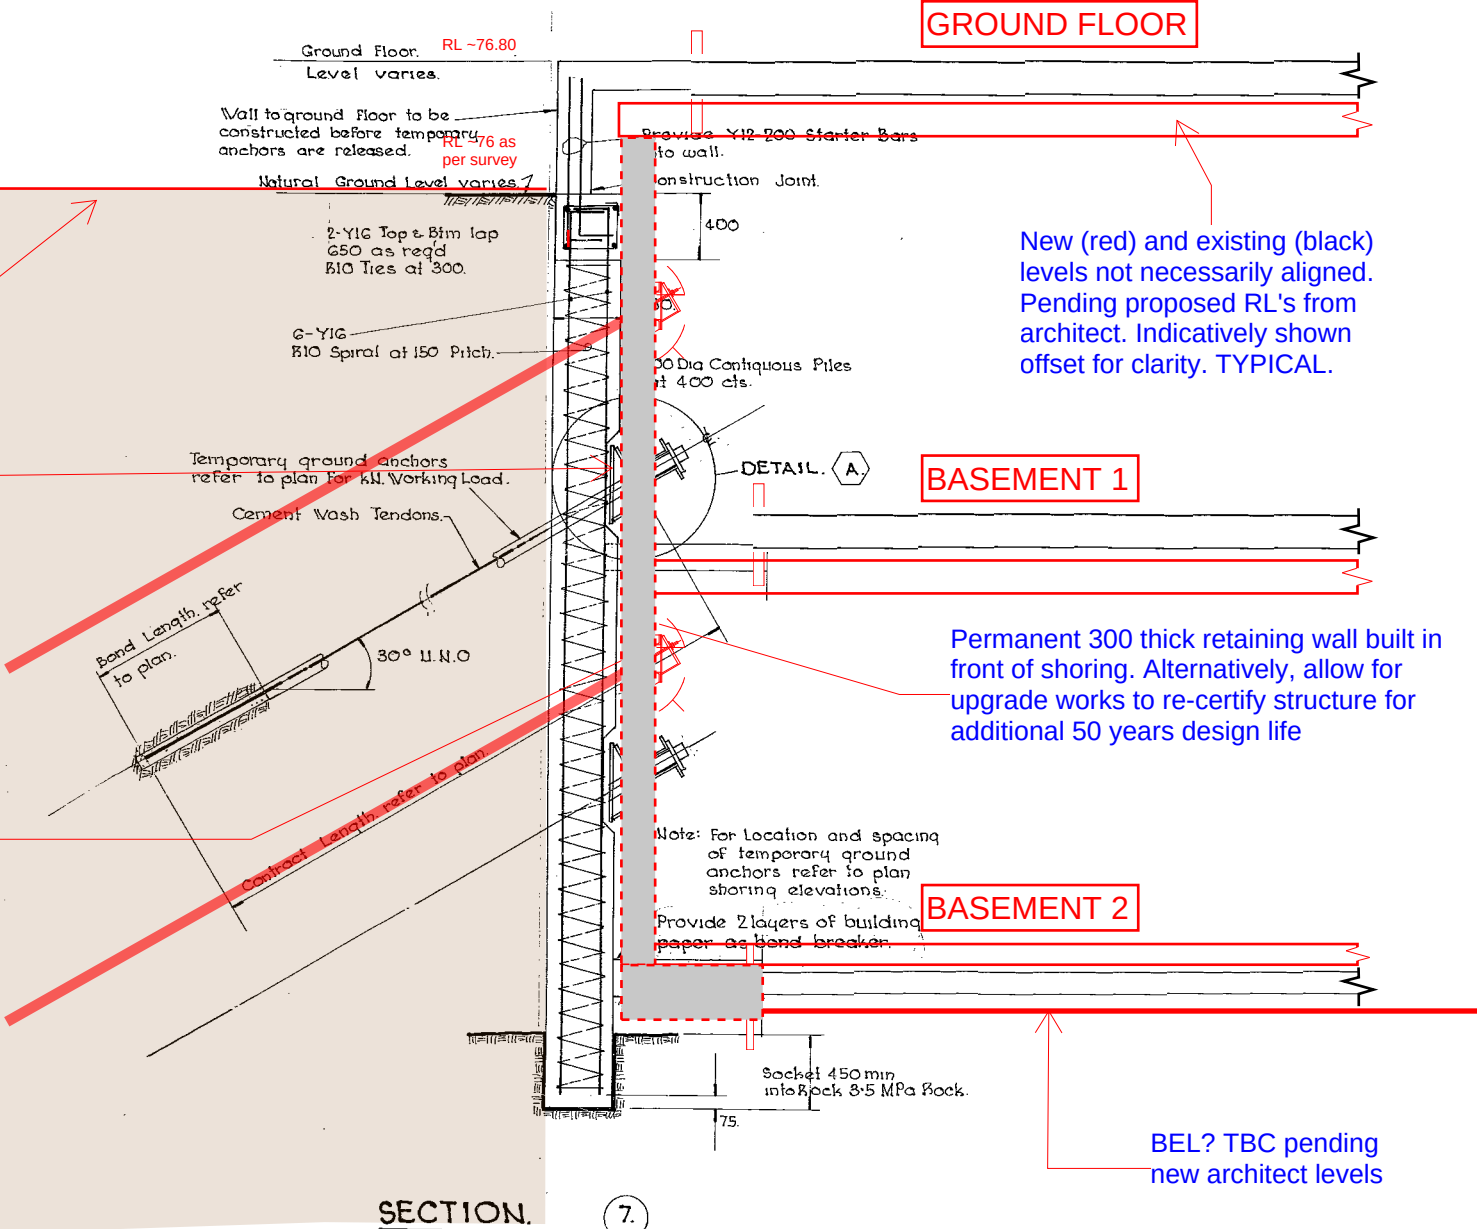
Section 3

Present of existing basement behind our shoring TBC
