Preliminary Site Investigation:
Lot 2 Sec 4 DP2954,
1111-1141 Elizabeth Drive, Cecil Park, NSW

P1706121JR01V01
September 2018

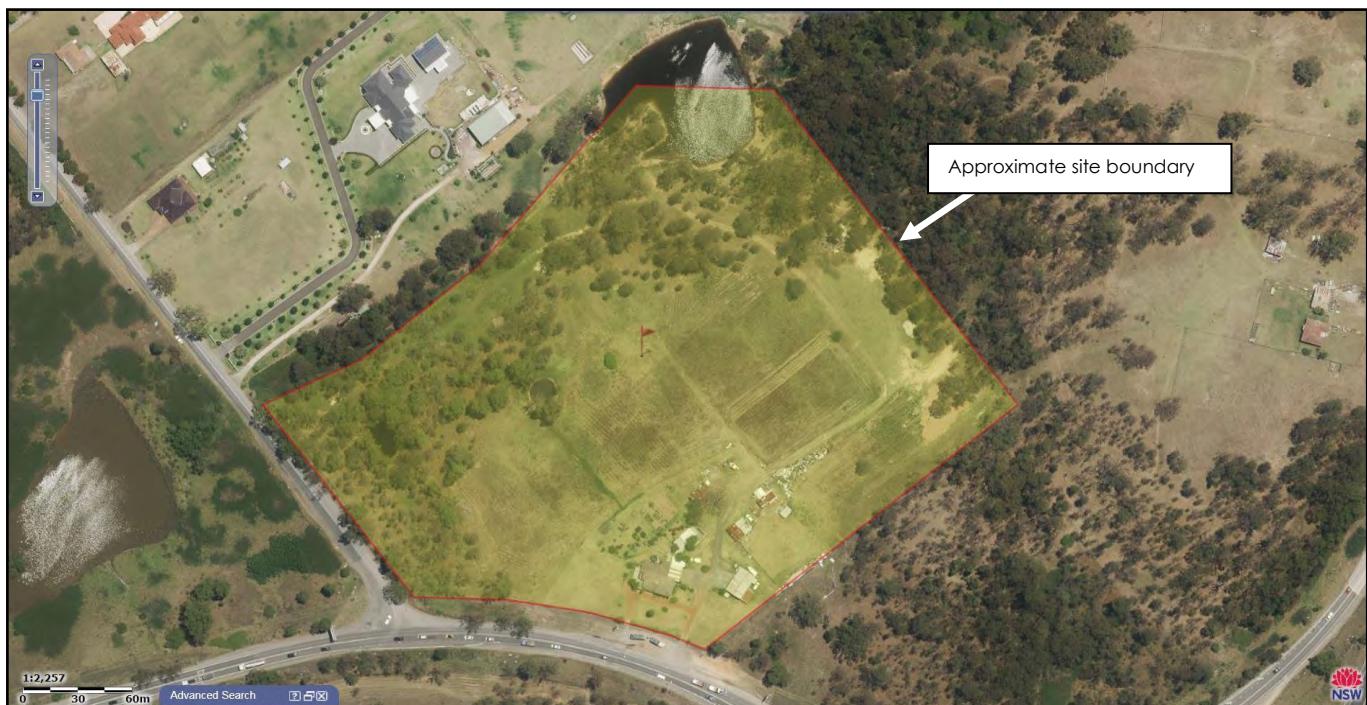
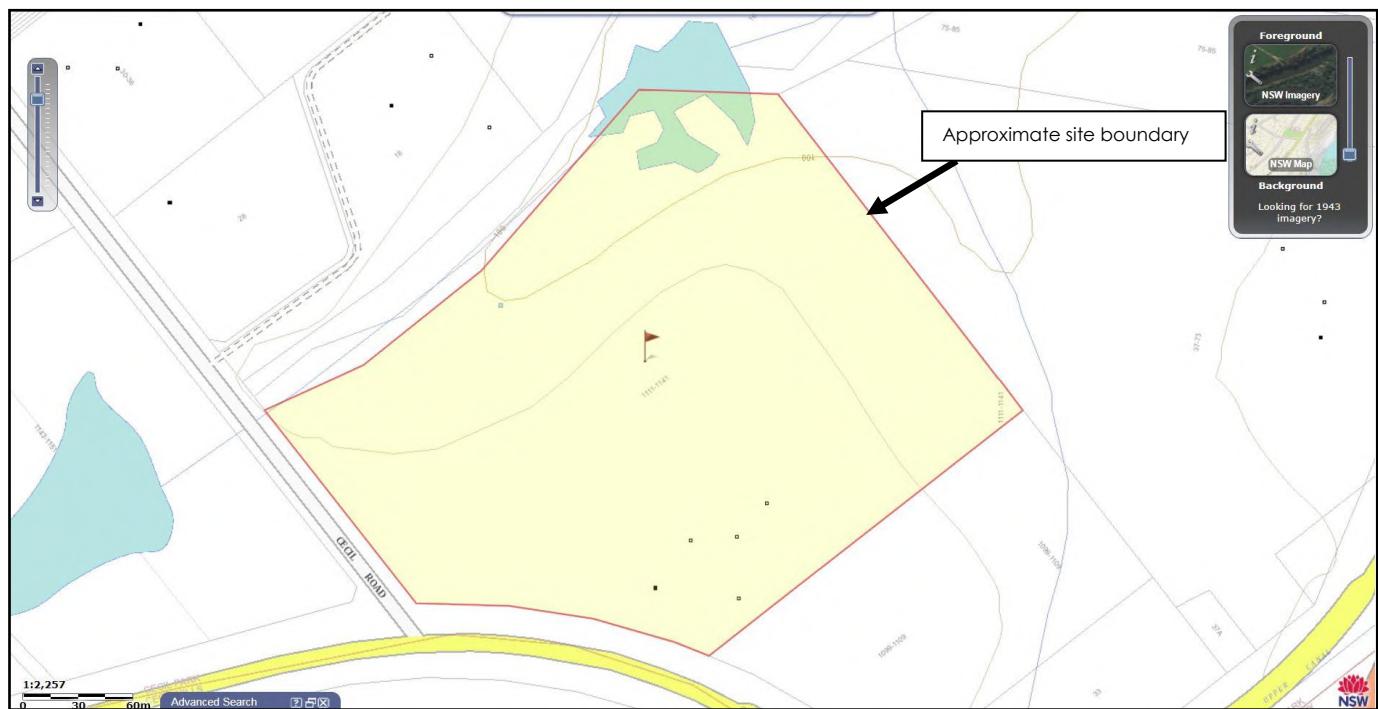
Approximate site boundary

Martens & Associates Pty Ltd		ABN 85 070 240 890	Environment Water Wastewater Geotechnical Civil Management	
Drawn:	MV	Site Location 1111-1141 Elizabeth Drive, Cecil Park, NSW (Lot 2 Sec 4 DP 2954) Source: NSW SIX Viewer, 2017	Drawing No:	
Approved:	GT		FIGURE 1	
Date:	11.01.2018			
Scale:	Not to Scale			Job No: P1706121

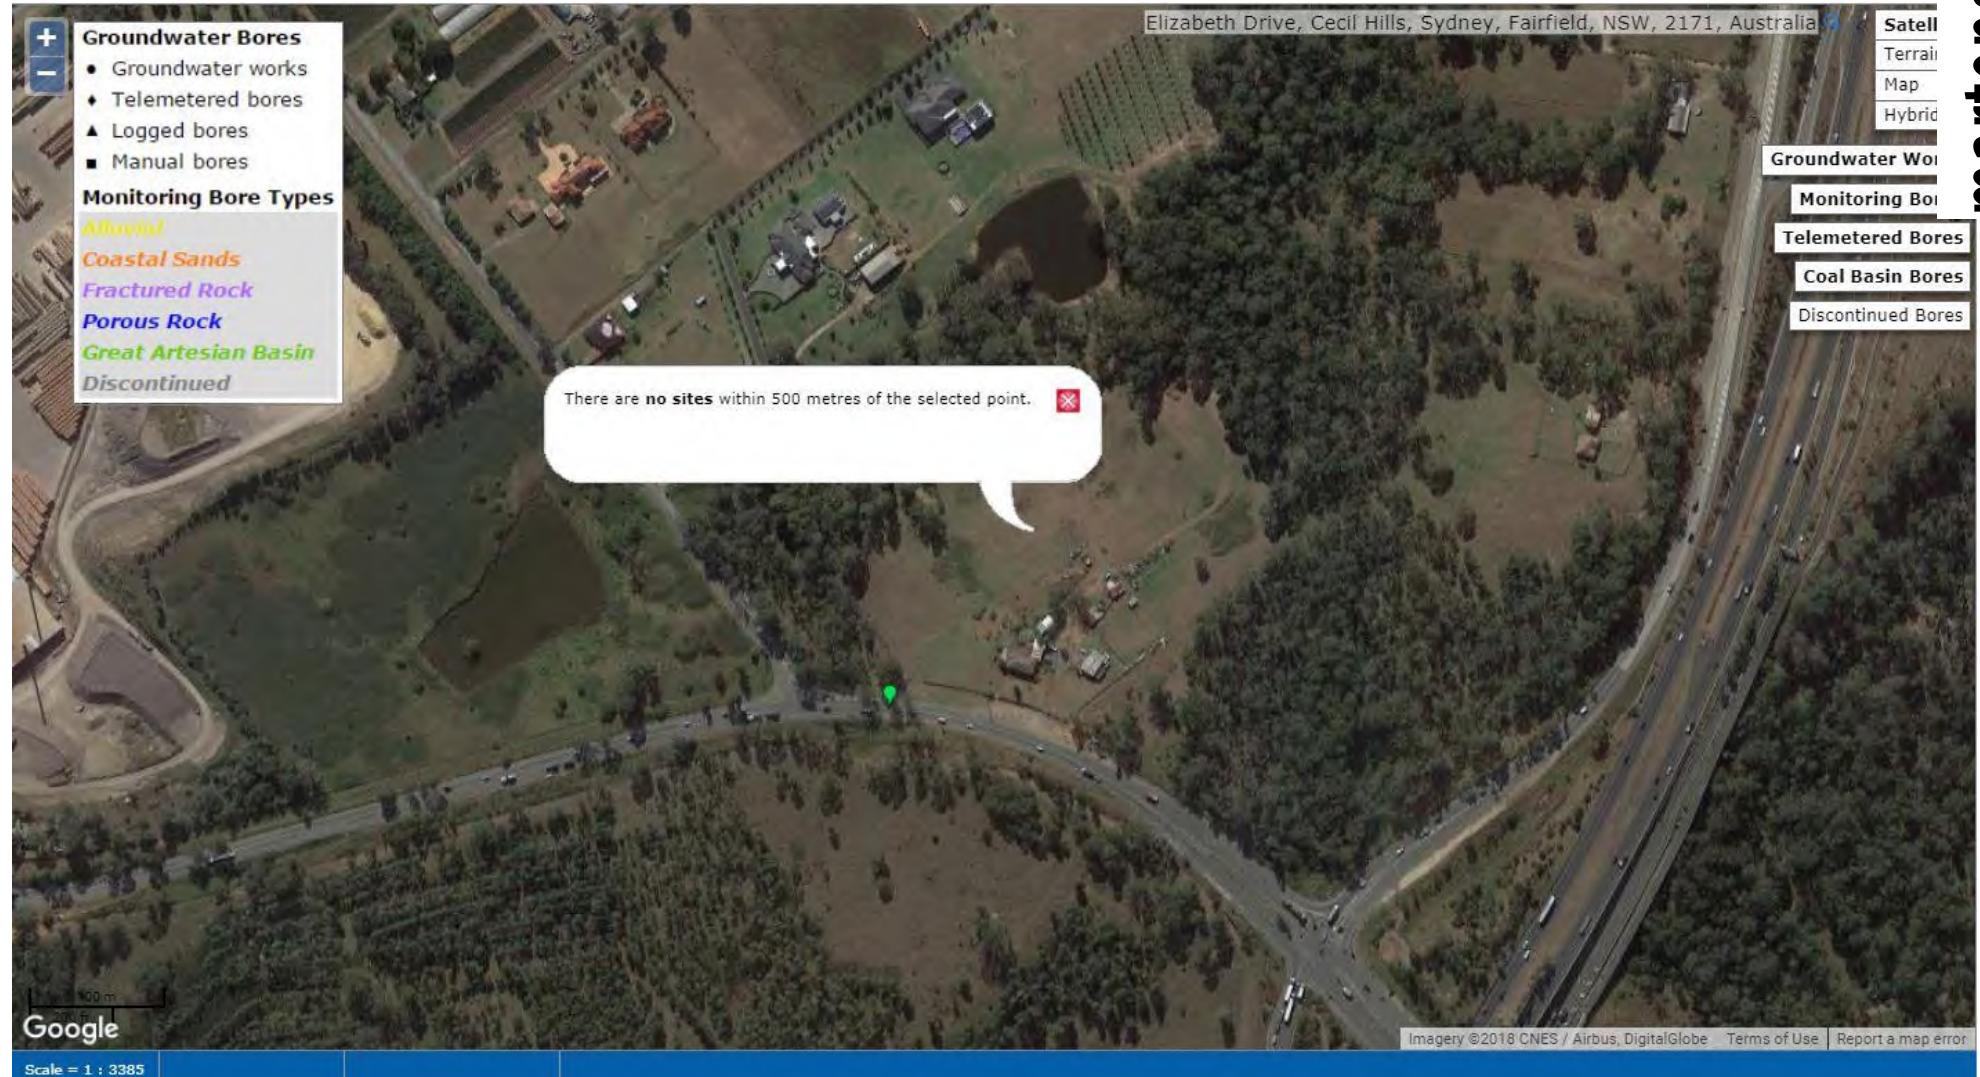
Environment Water Wastewater Geotechnical Civil Management	
Groundwater Bore Locations 1111-1141 Elizabeth Drive, Cecil Park, NSW (Lot 2 Sec 4 DP 2954) Source: NSW DPI Water Groundwater Database, 2018	Drawing No: Figure 2 Job No: P1706121

Review of NSW Department of Primary Industries - Water's database indicated no groundwater bores with available information (refer to Attachment A) within 500 m of the site.

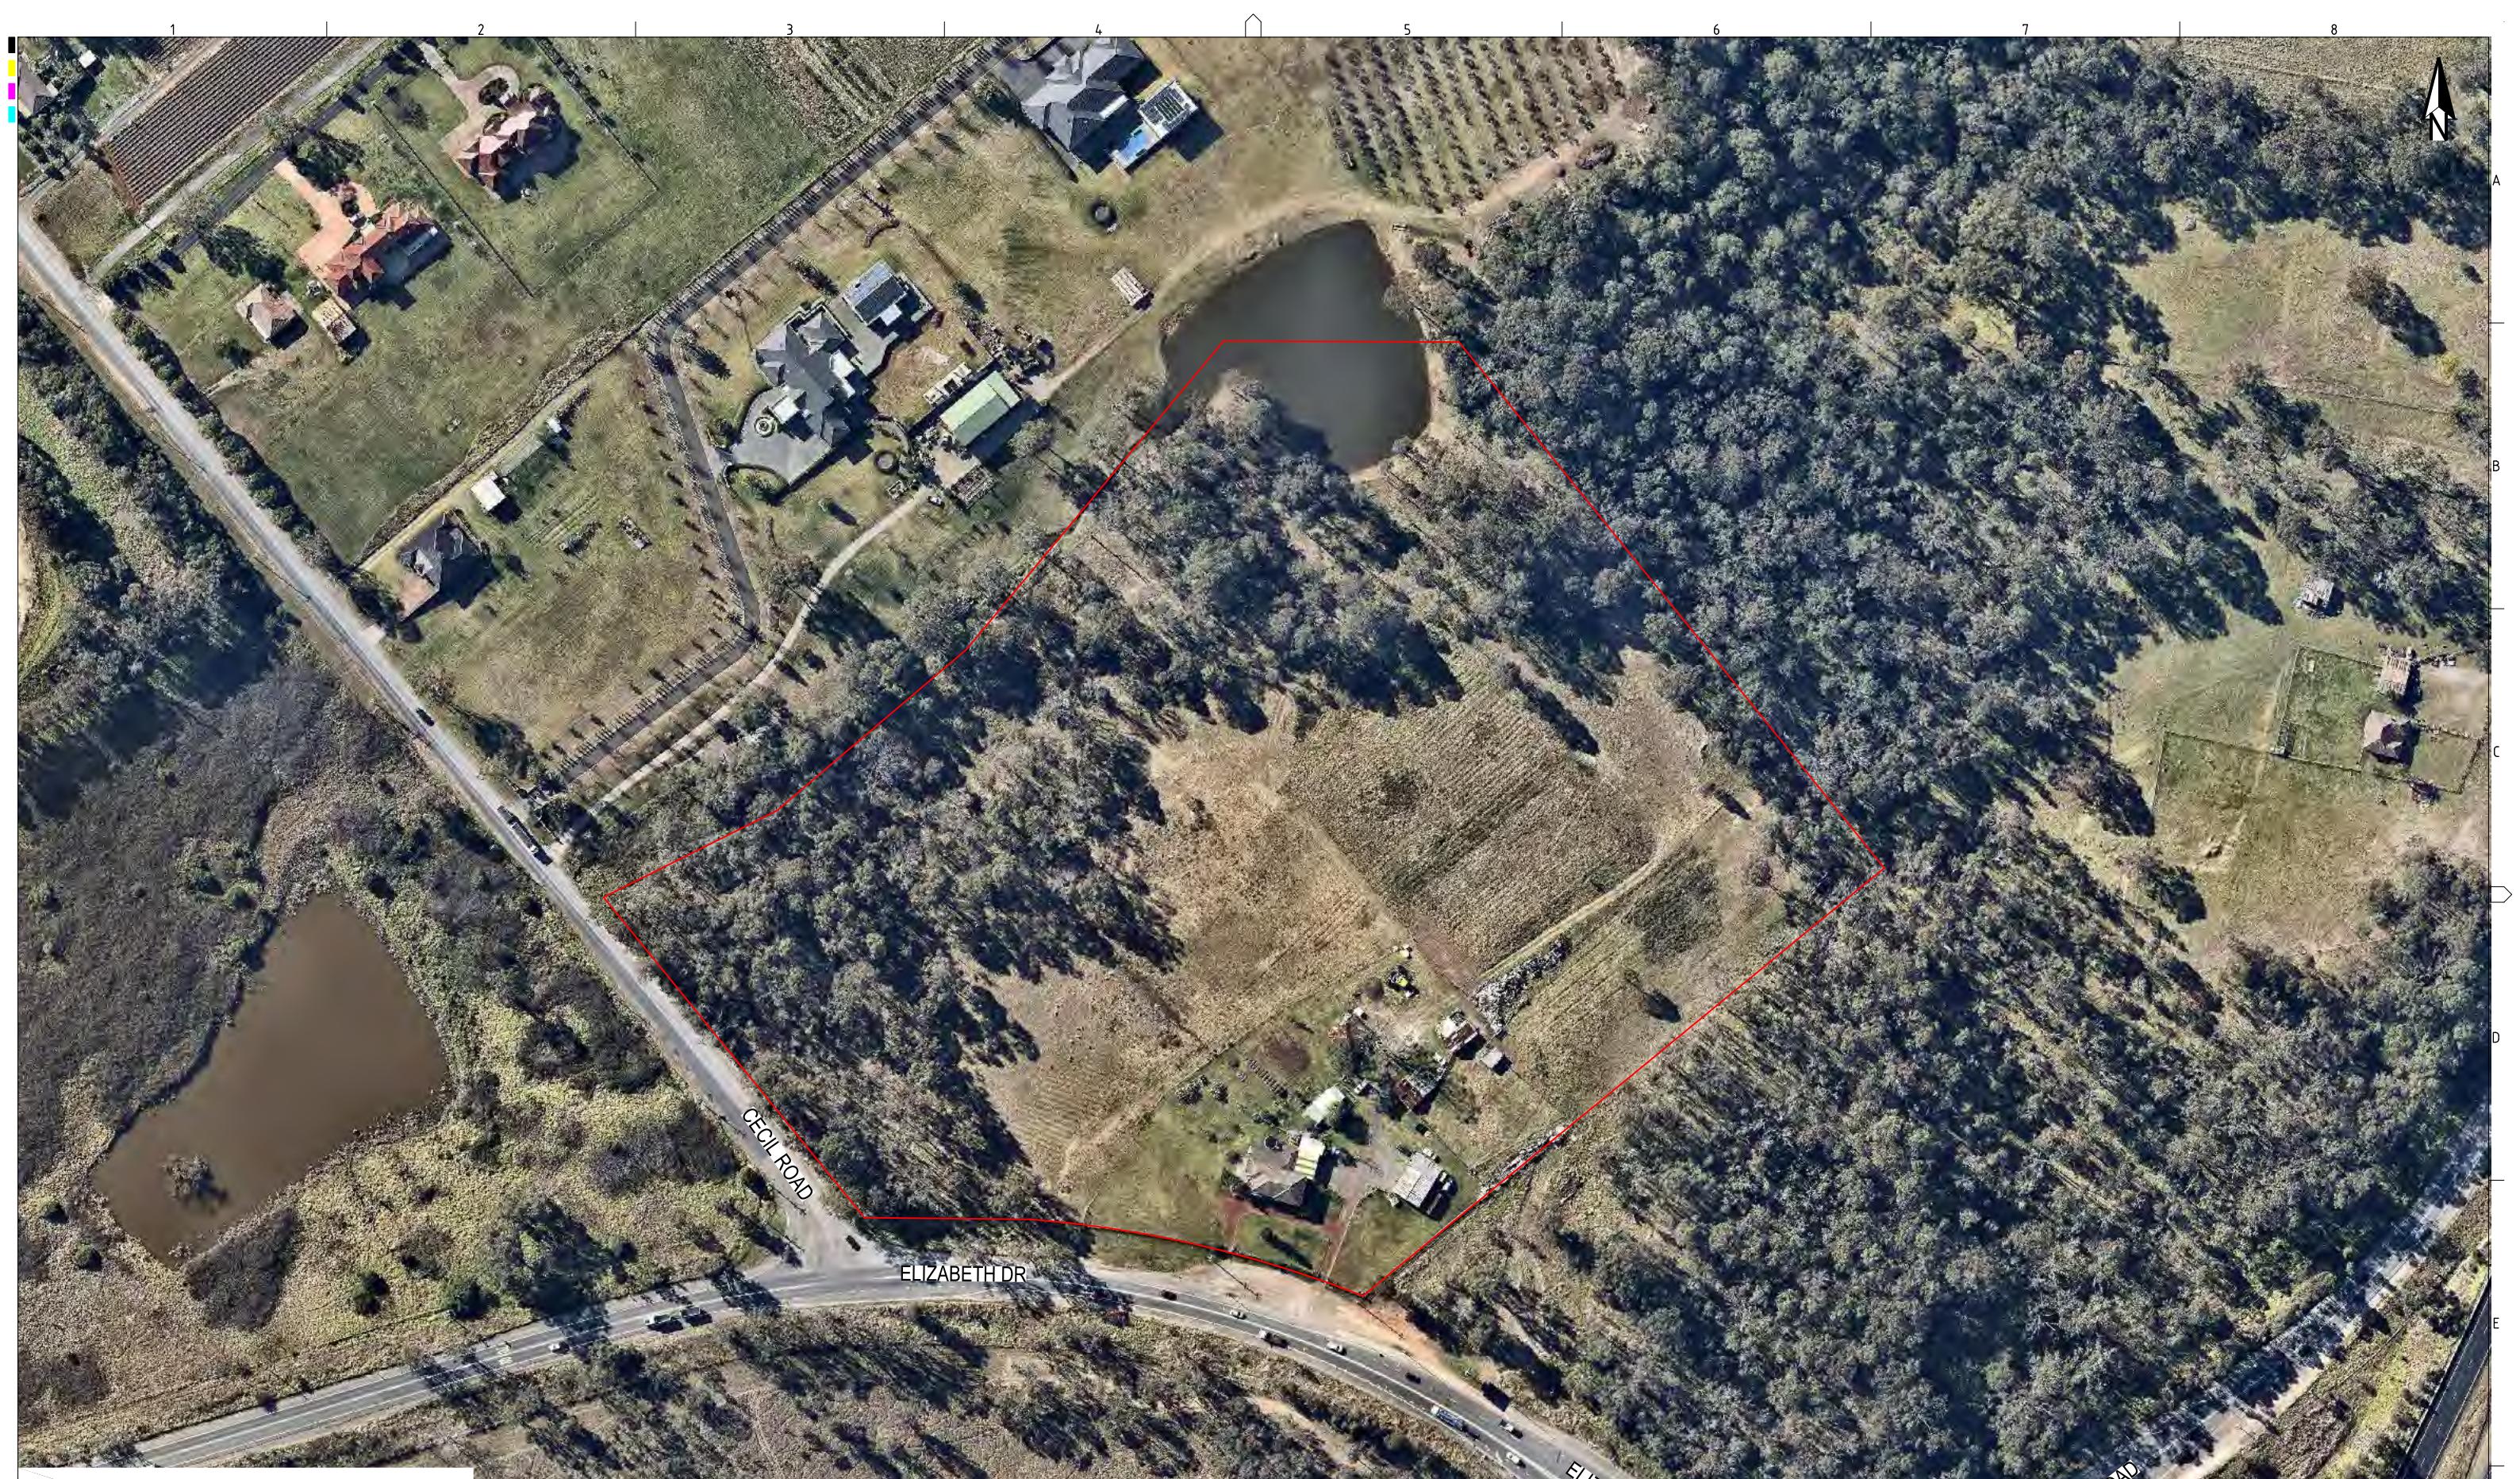
S	DRAWING TITLE				
	<p style="text-align: center;">AERIAL PHOTOGRAPH SOURCE: NEARMAP 2017</p>				
PROJECT NO.	PLANSET NO.	RELEASE NO.	DRAWING NO.	REVISION	
9476 8767 P1706121	PS01	R01	PS01-A706	A

2004 (Google Earth Maps)	Additional stockpiles in the south and north east. Market gardens mostly removed and land appears for grazing use. Dam in centre of the site appears to be filled.	New road (M7) being constructed to the east of Wallgrove Road. Market gardens to the north. New rural residential dwellings to the north.
2017 (Nearmap)	Multiple new stockpiles in the north and east of buildings. Increase in tree cover in the north and west.	Several new dwellings and orchard to the north of the site, M7 motorway completed to the east. Otherwise little change from previous photo.
