Remedial Action Plan:  
Proposed Commercial Subdivision,  
1111 – 1141 Elizabeth Drive, Cecil Park  
NSW

P1706121JR07V02  
June 2021

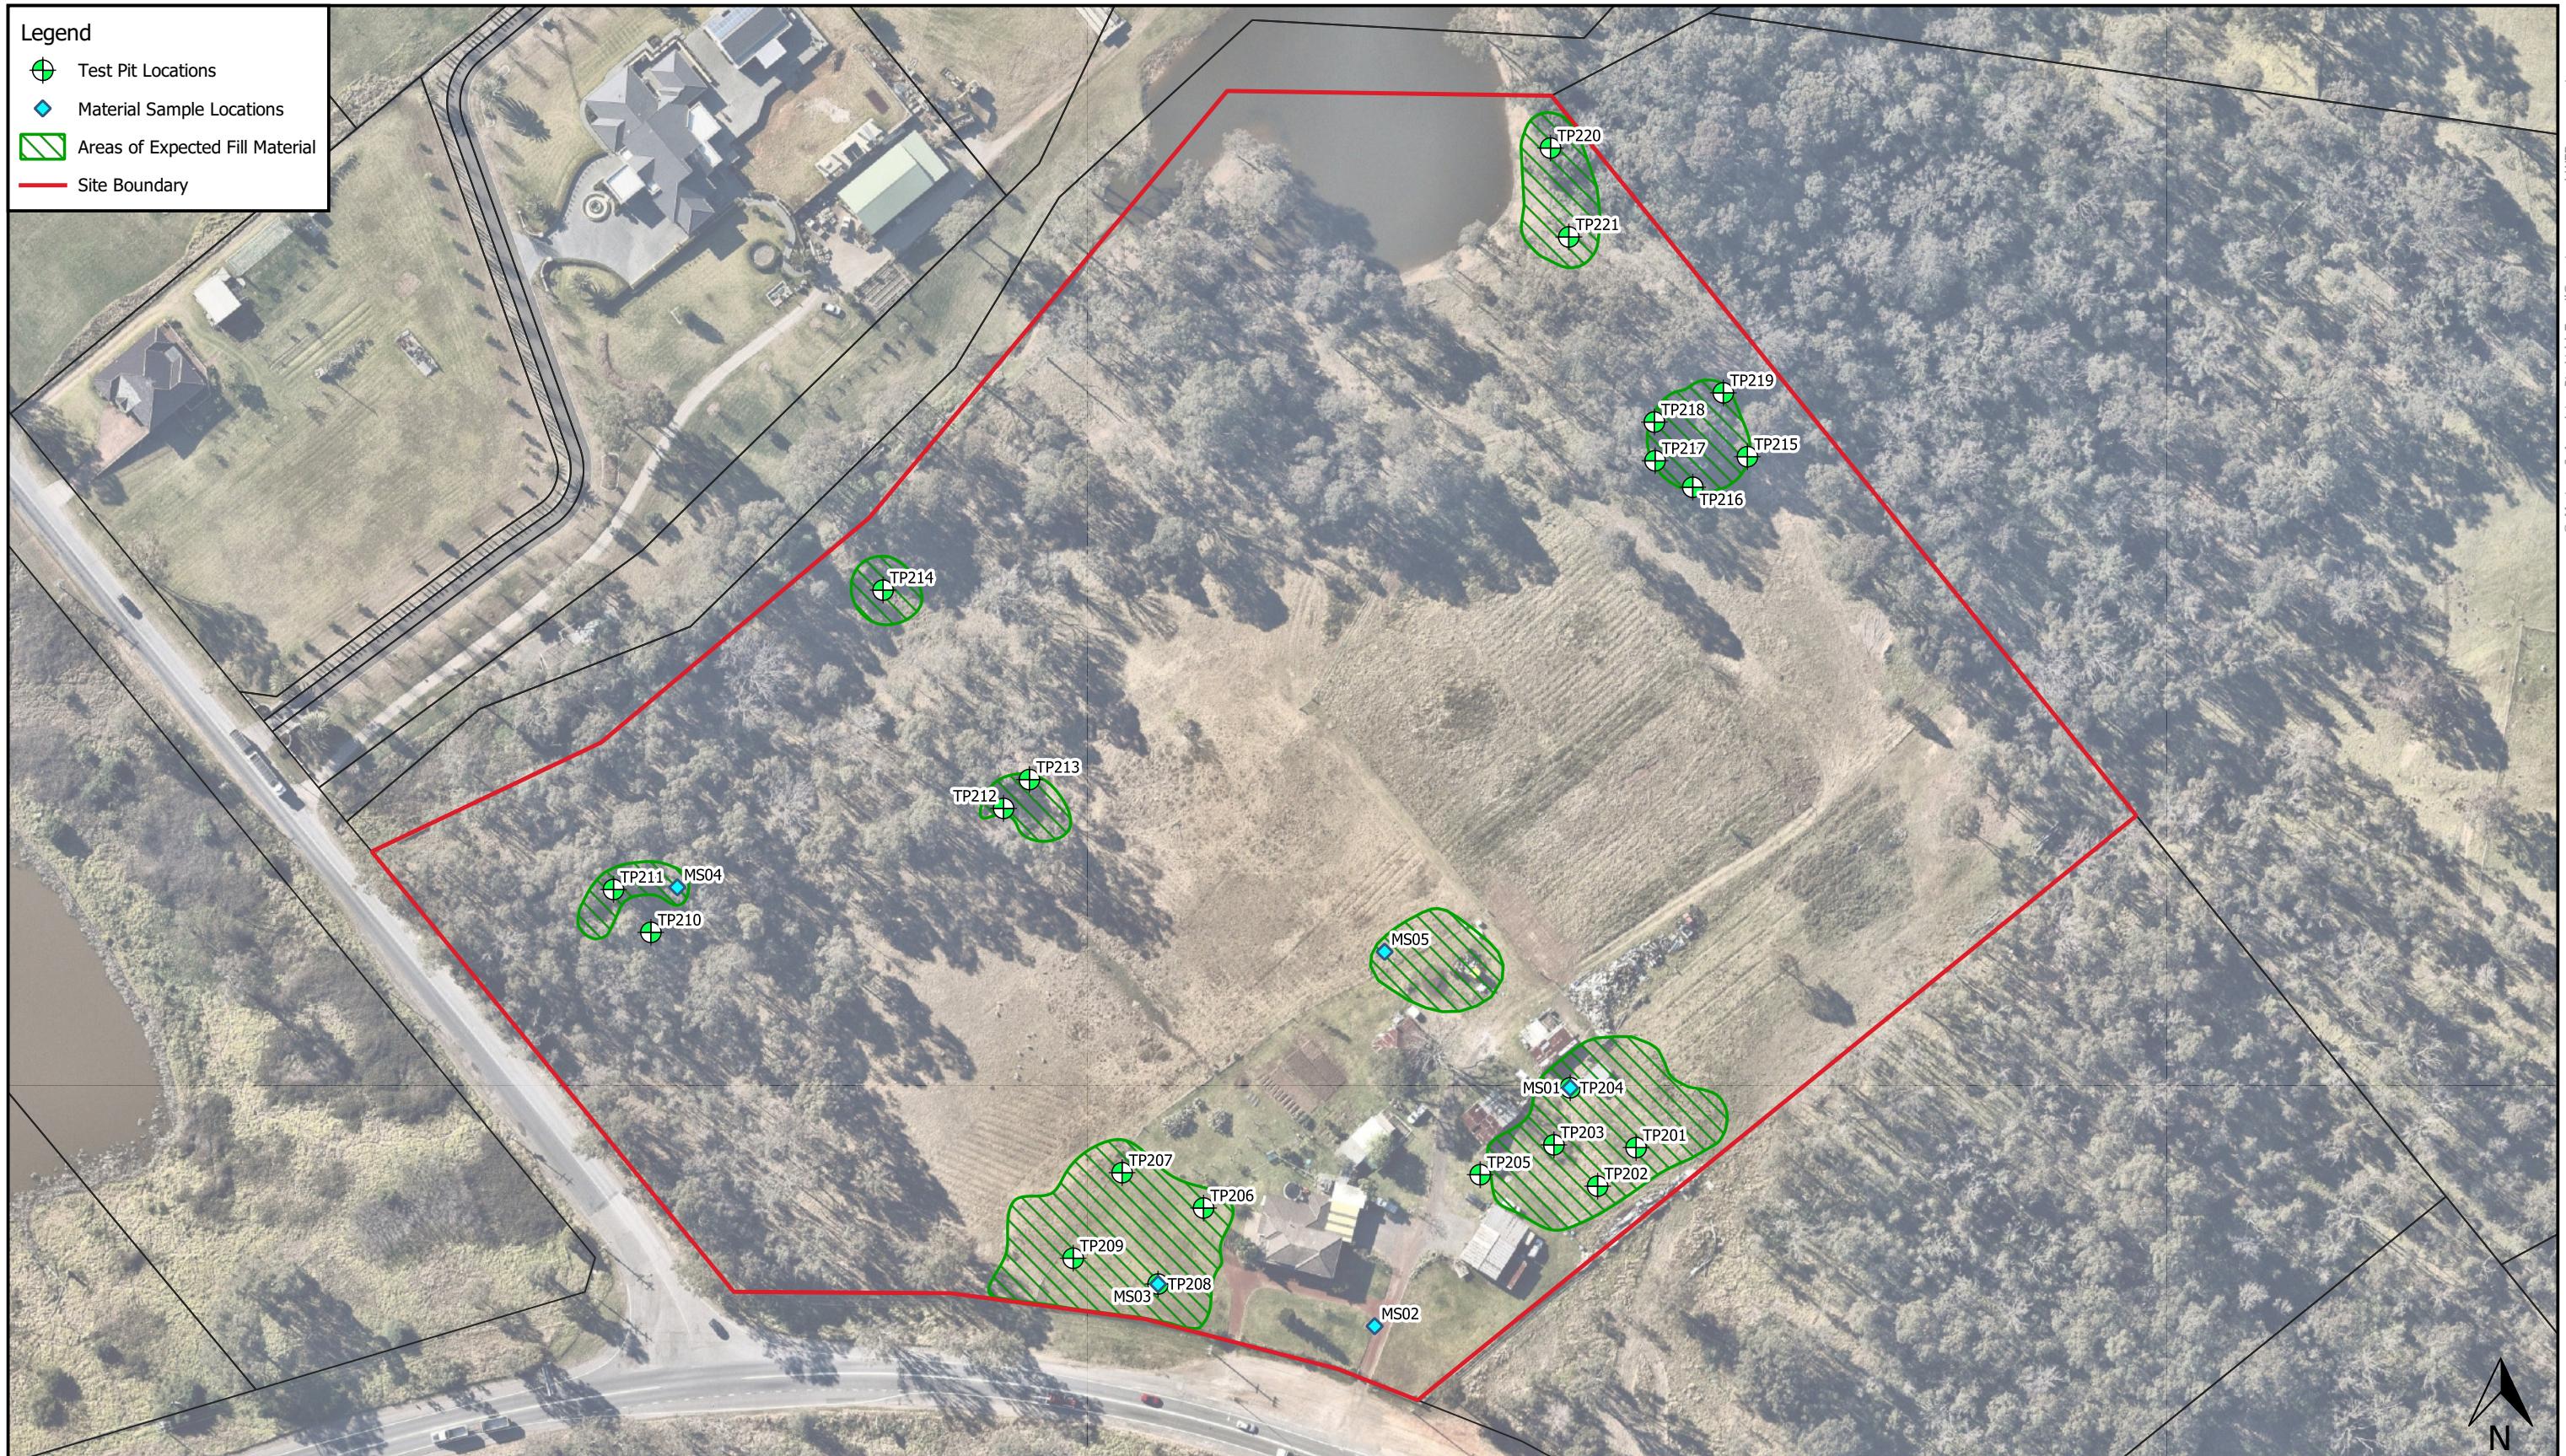
Sampling locations and identified ACM are shown on the DSI sampling plan in Attachment A.

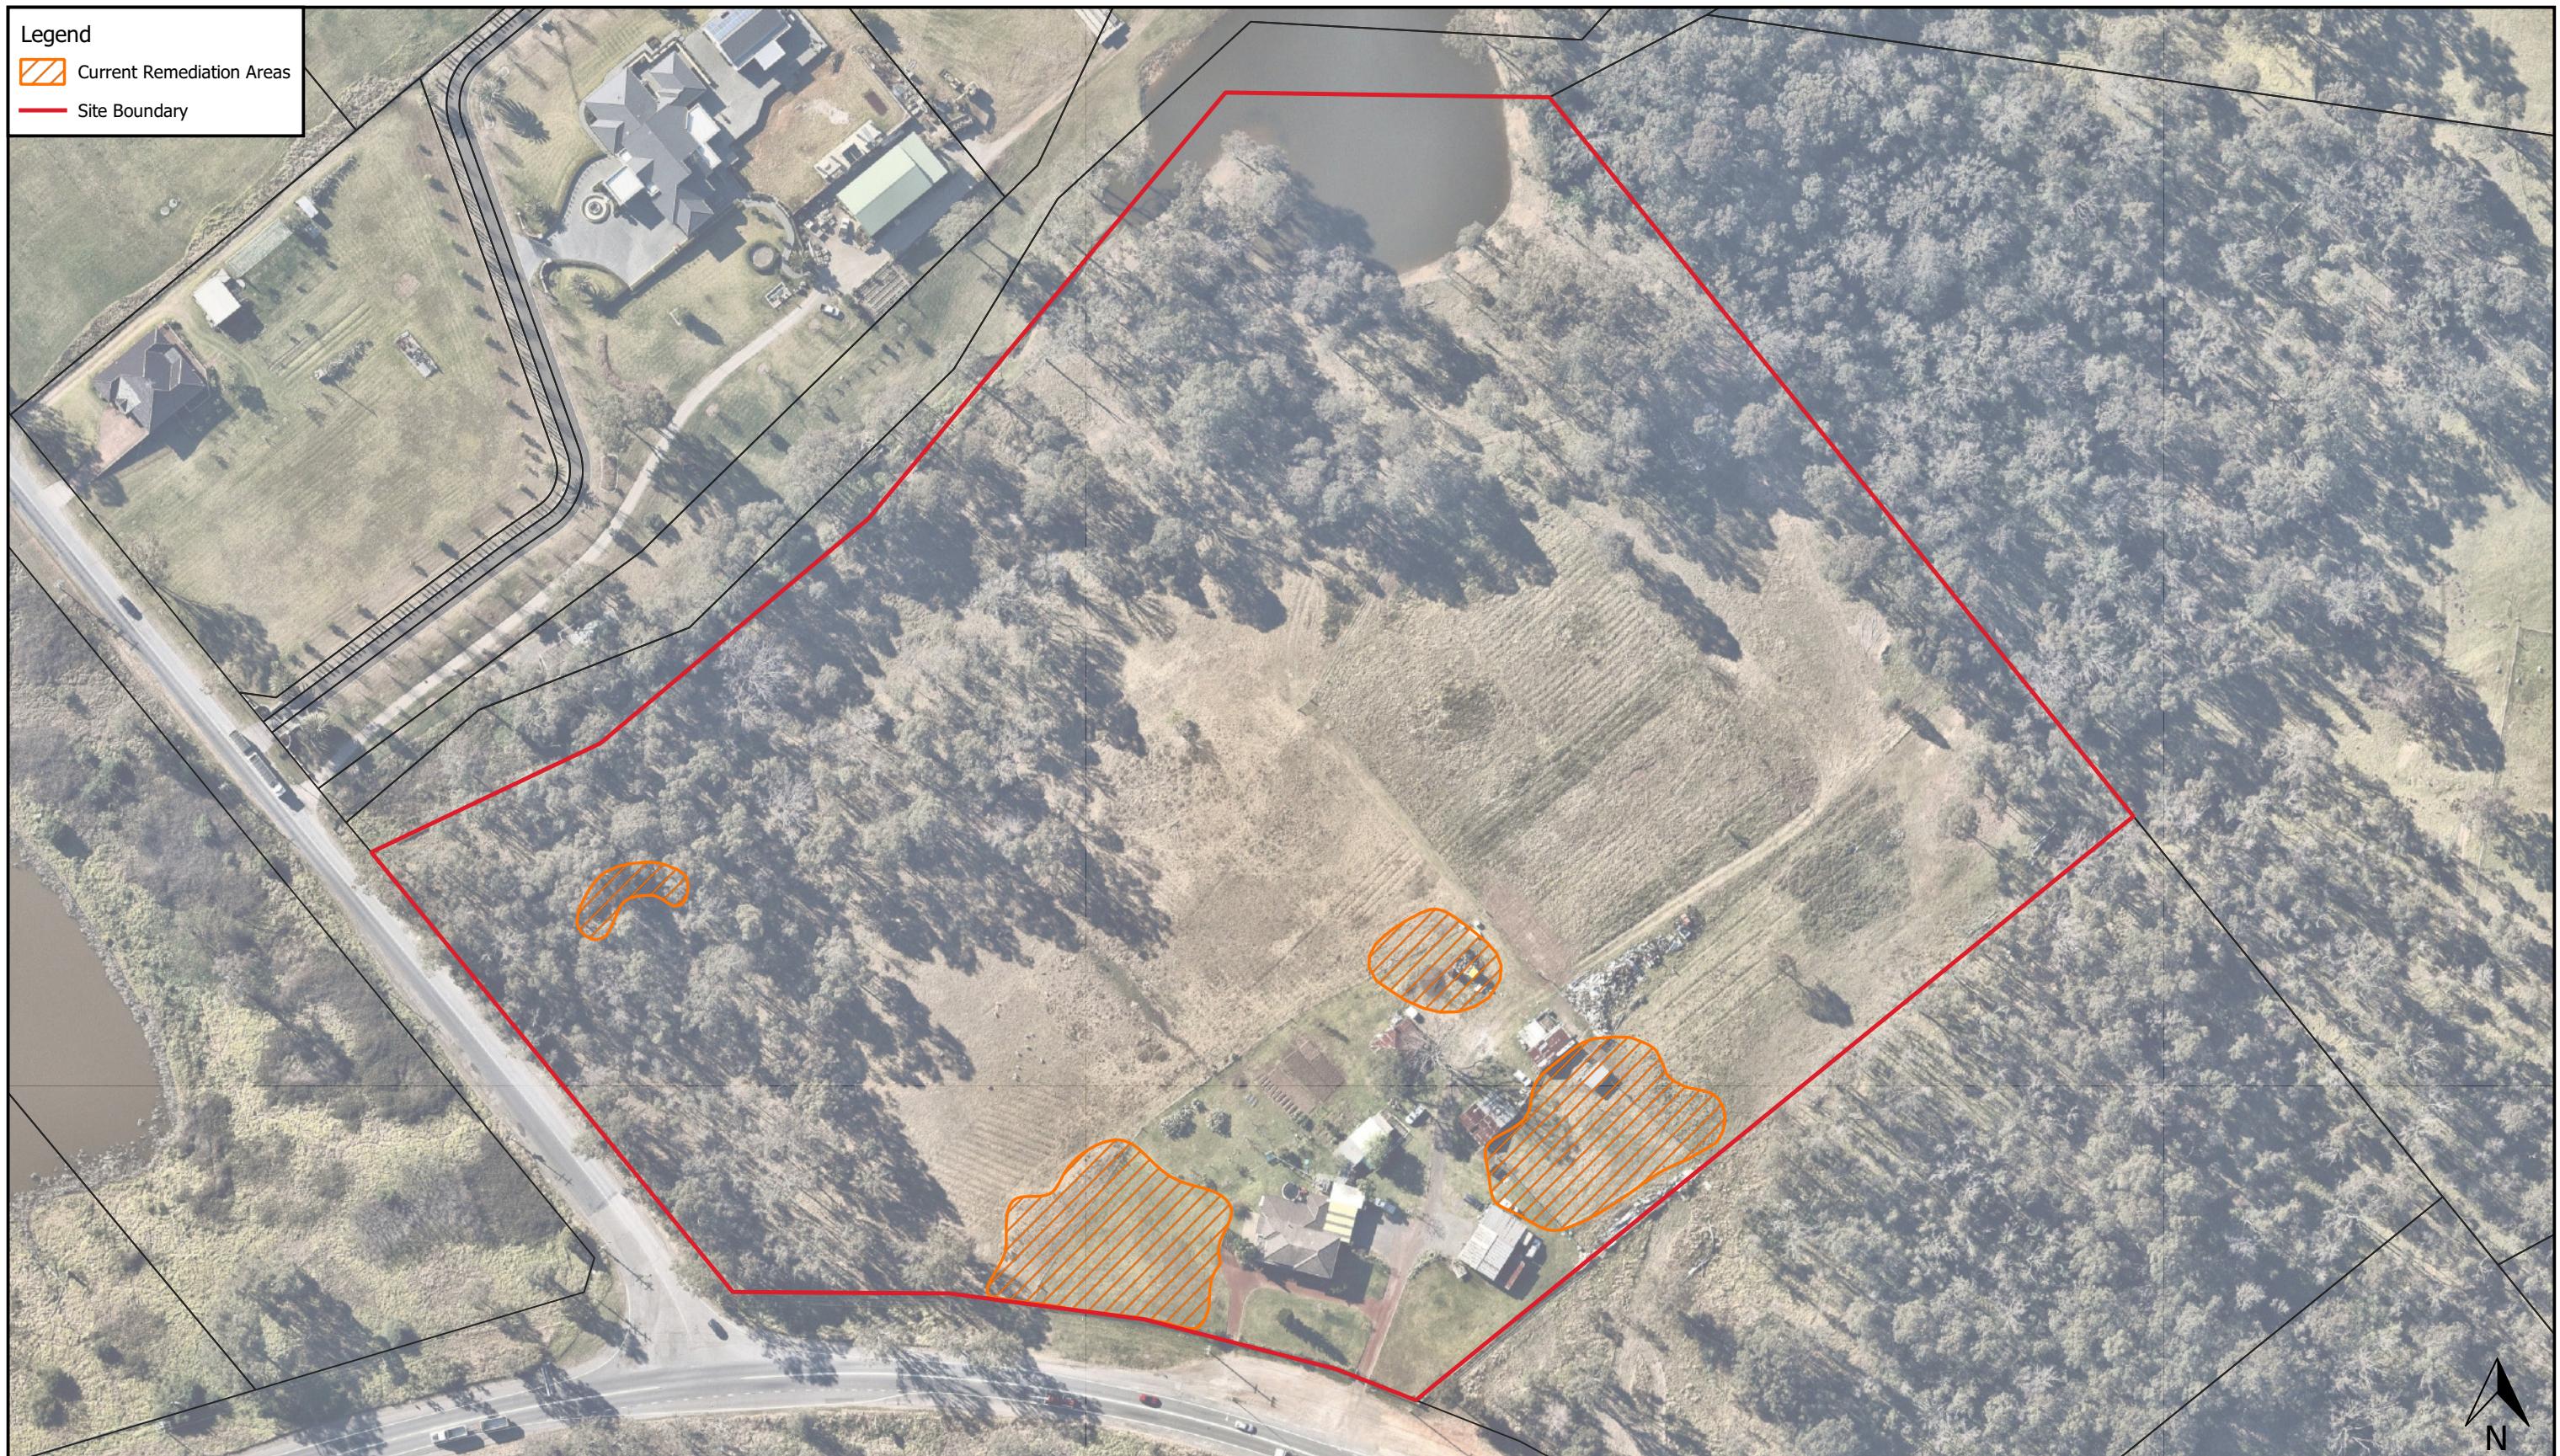
For the purposes of this RAP, the extent of remediation is currently defined as site fill areas where asbestos has been identified. Current remediation areas include the fill pads adjacent to the existing dwelling, stockpiles to the north of the existing dwelling and the former dam in the north western corner of the site. Remediation areas are shown in Attachment A. Following the recommended data gap closure investigation (data gap B), the extent of asbestos impacted fill material can be better defined. This may see a reduction in the volume of asbestos impacted fill requiring remediation. The results of the data gap closure investigations are not, however expected to change the overall remediation approach outlined in the following Sections of the RAP.

Note: Subject to data gap closure findings.

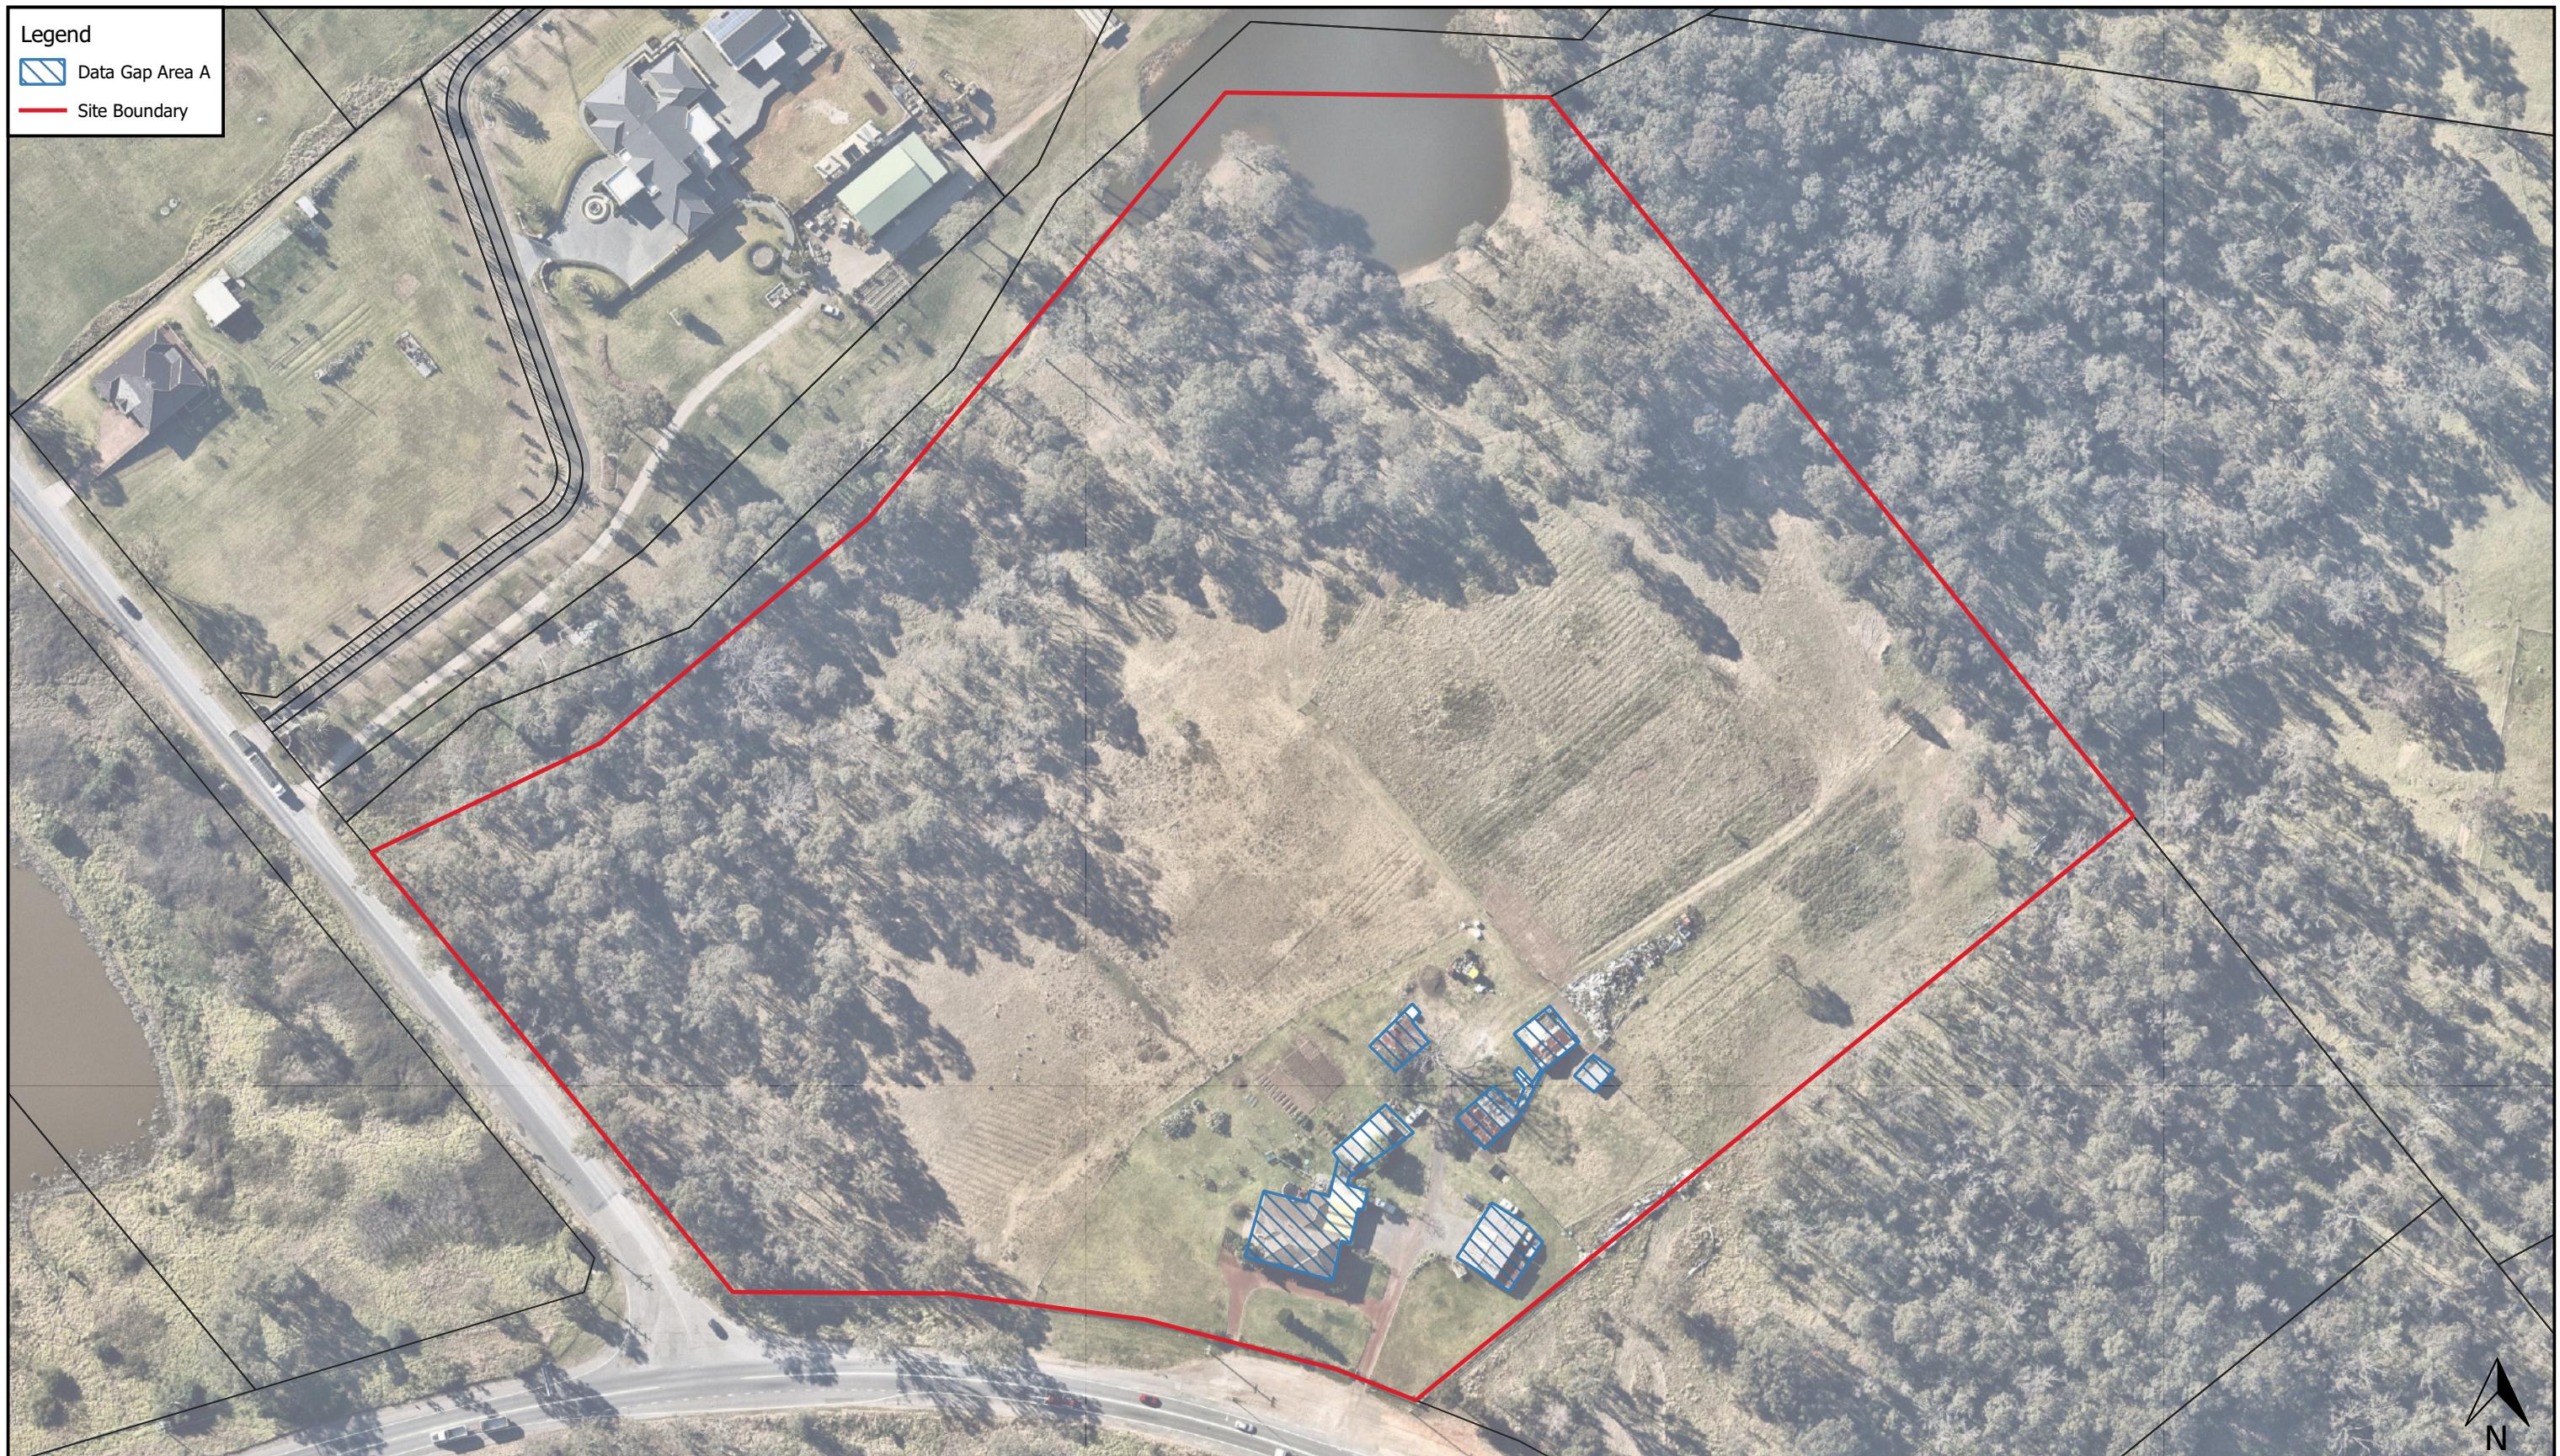
EN04  
1111 - 1141 Elizabeth Drive, Cecil Park, NSW  
Proposed Commercial Subdivision  
Remedial Action Plan  
AE Design Partnership  
11/08/2020

Viewport A
