Preliminary Onsite Wastewater Assessment:

Lot 2 Sec 4 DP2954

1111-1141 Elizabeth Drive, Cecil Park, NSW

P1706121JR03V06

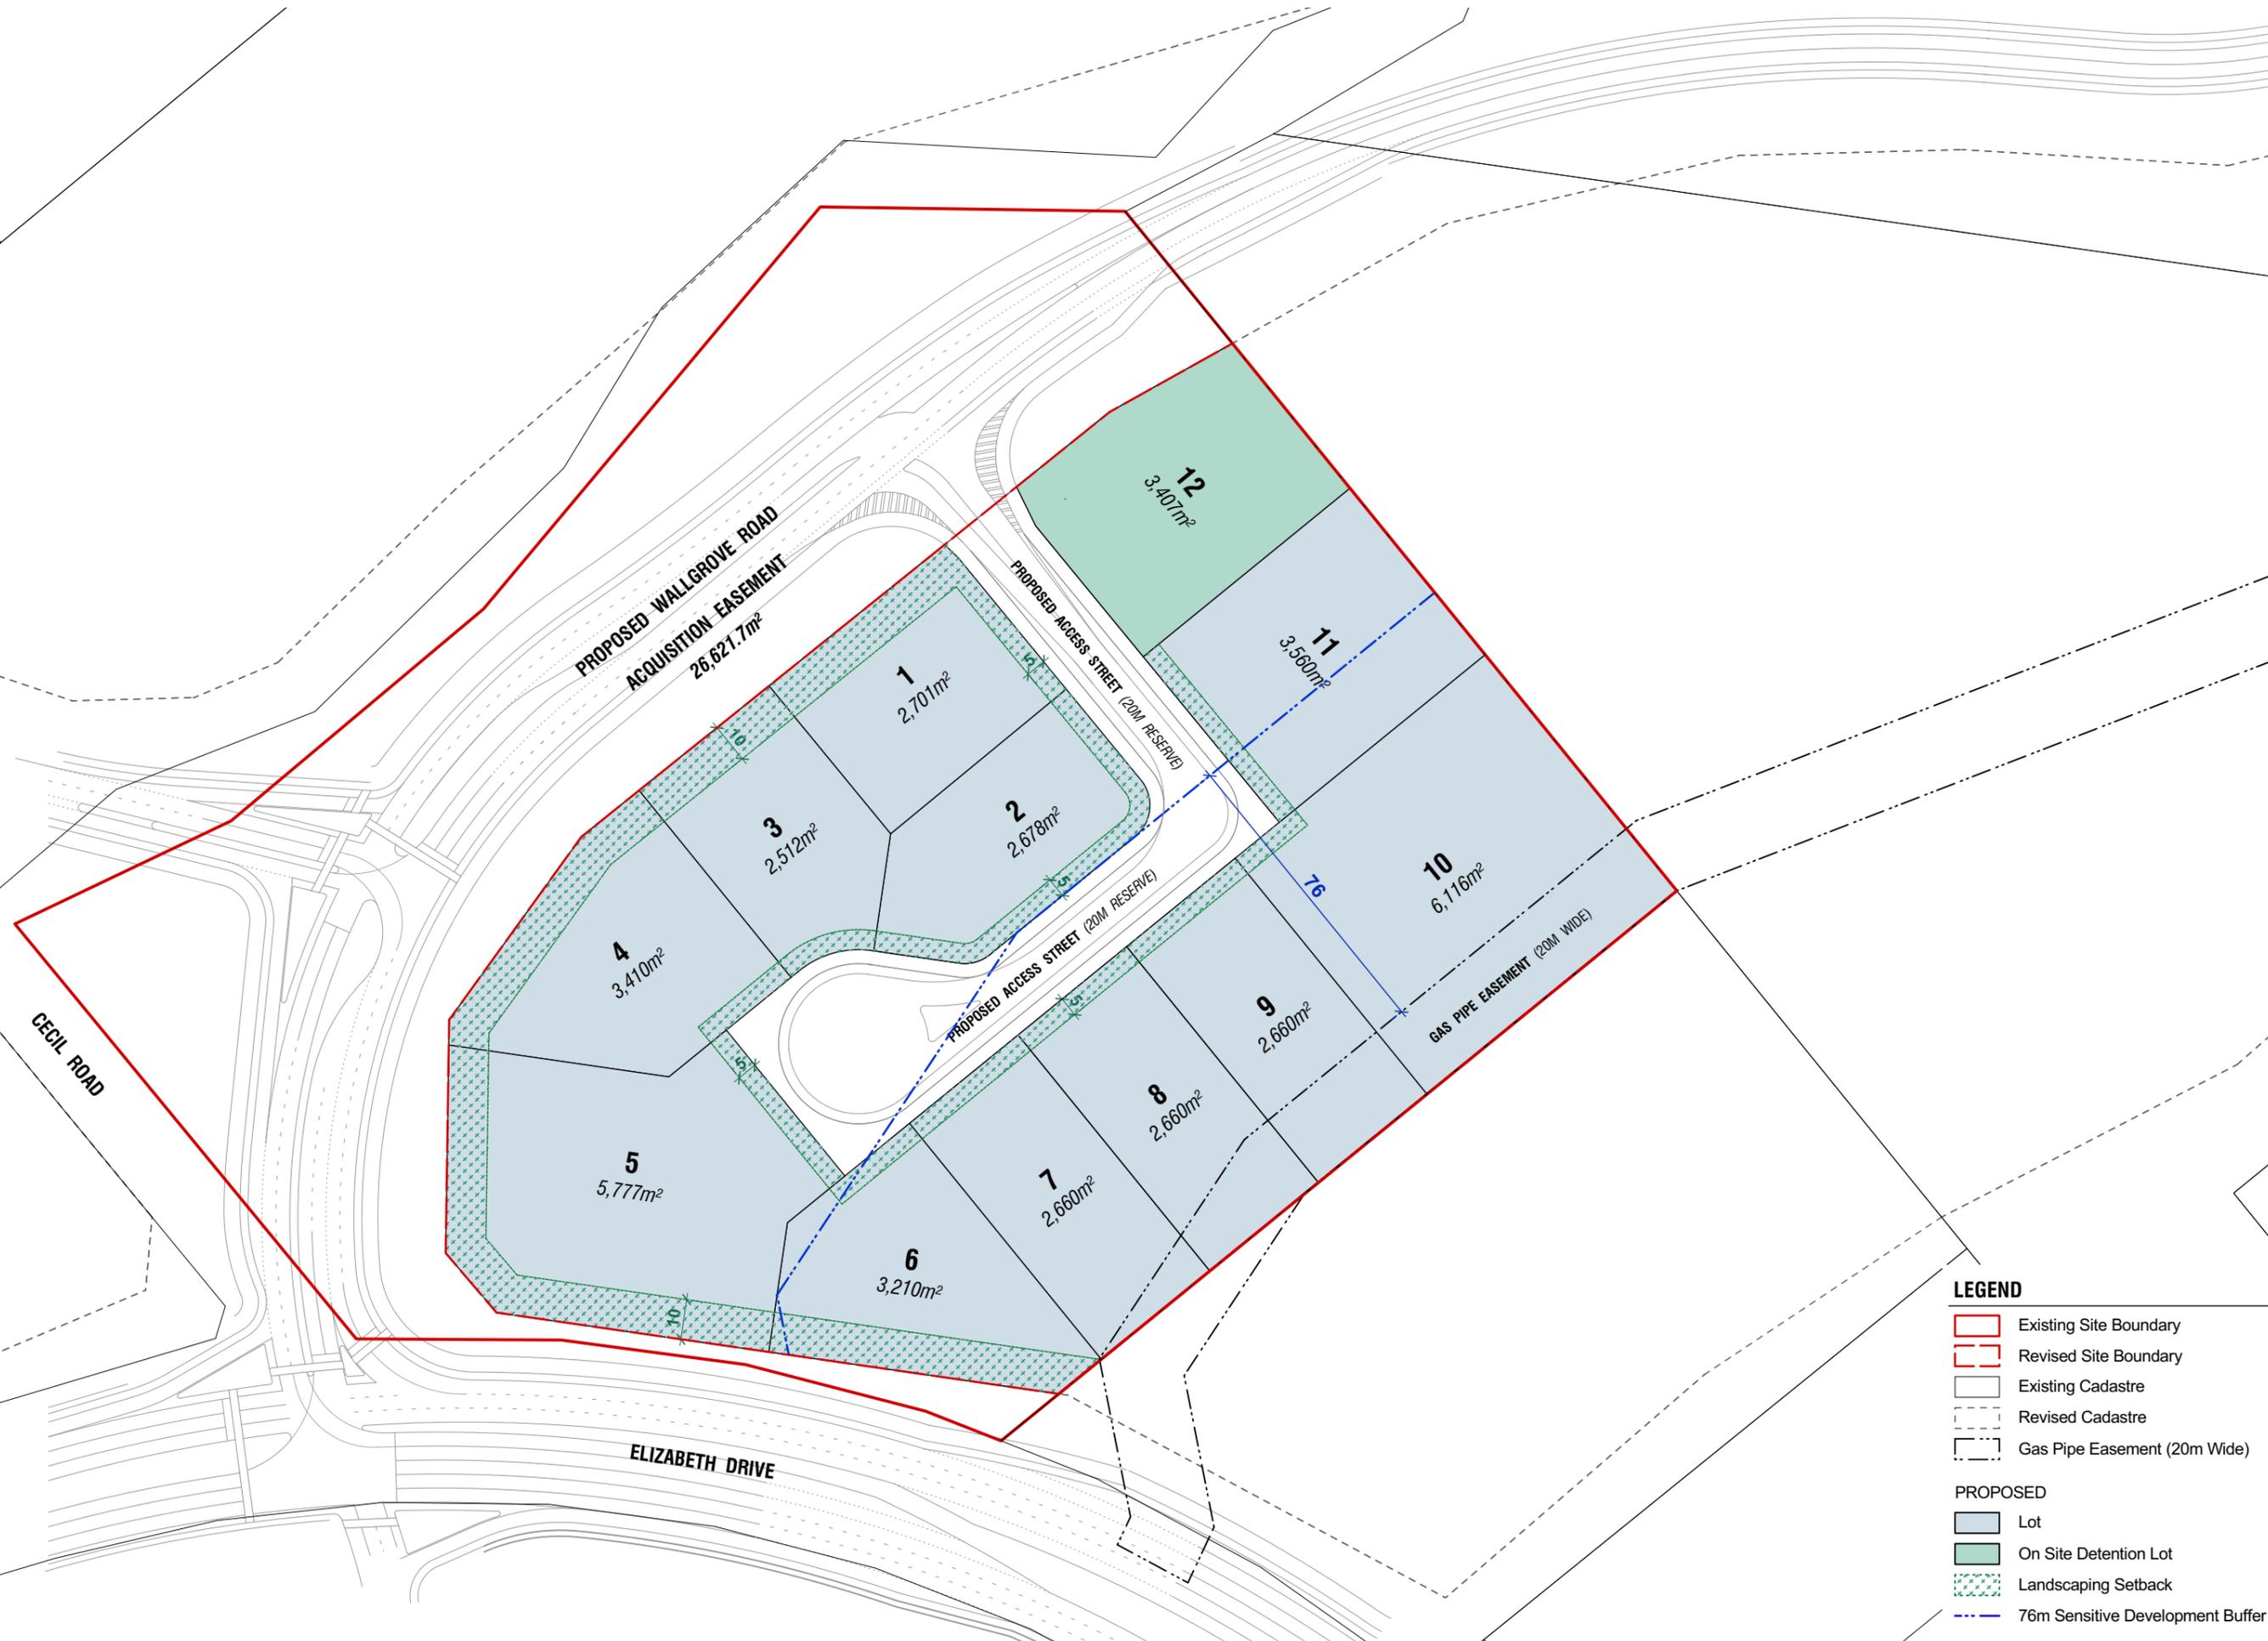
TITLE			
CONCEPT PLAN			
DRAWN SB	CHECKED	DATE 26/04/2021	ISSUE

With reference to the development plans prepared by AE Design Partnership Pty Ltd (26 May, 2020), the proposed subdivision will include 11 commercial lots and associated internal access roads. Proposed scheme plan is provided in Attachment A.

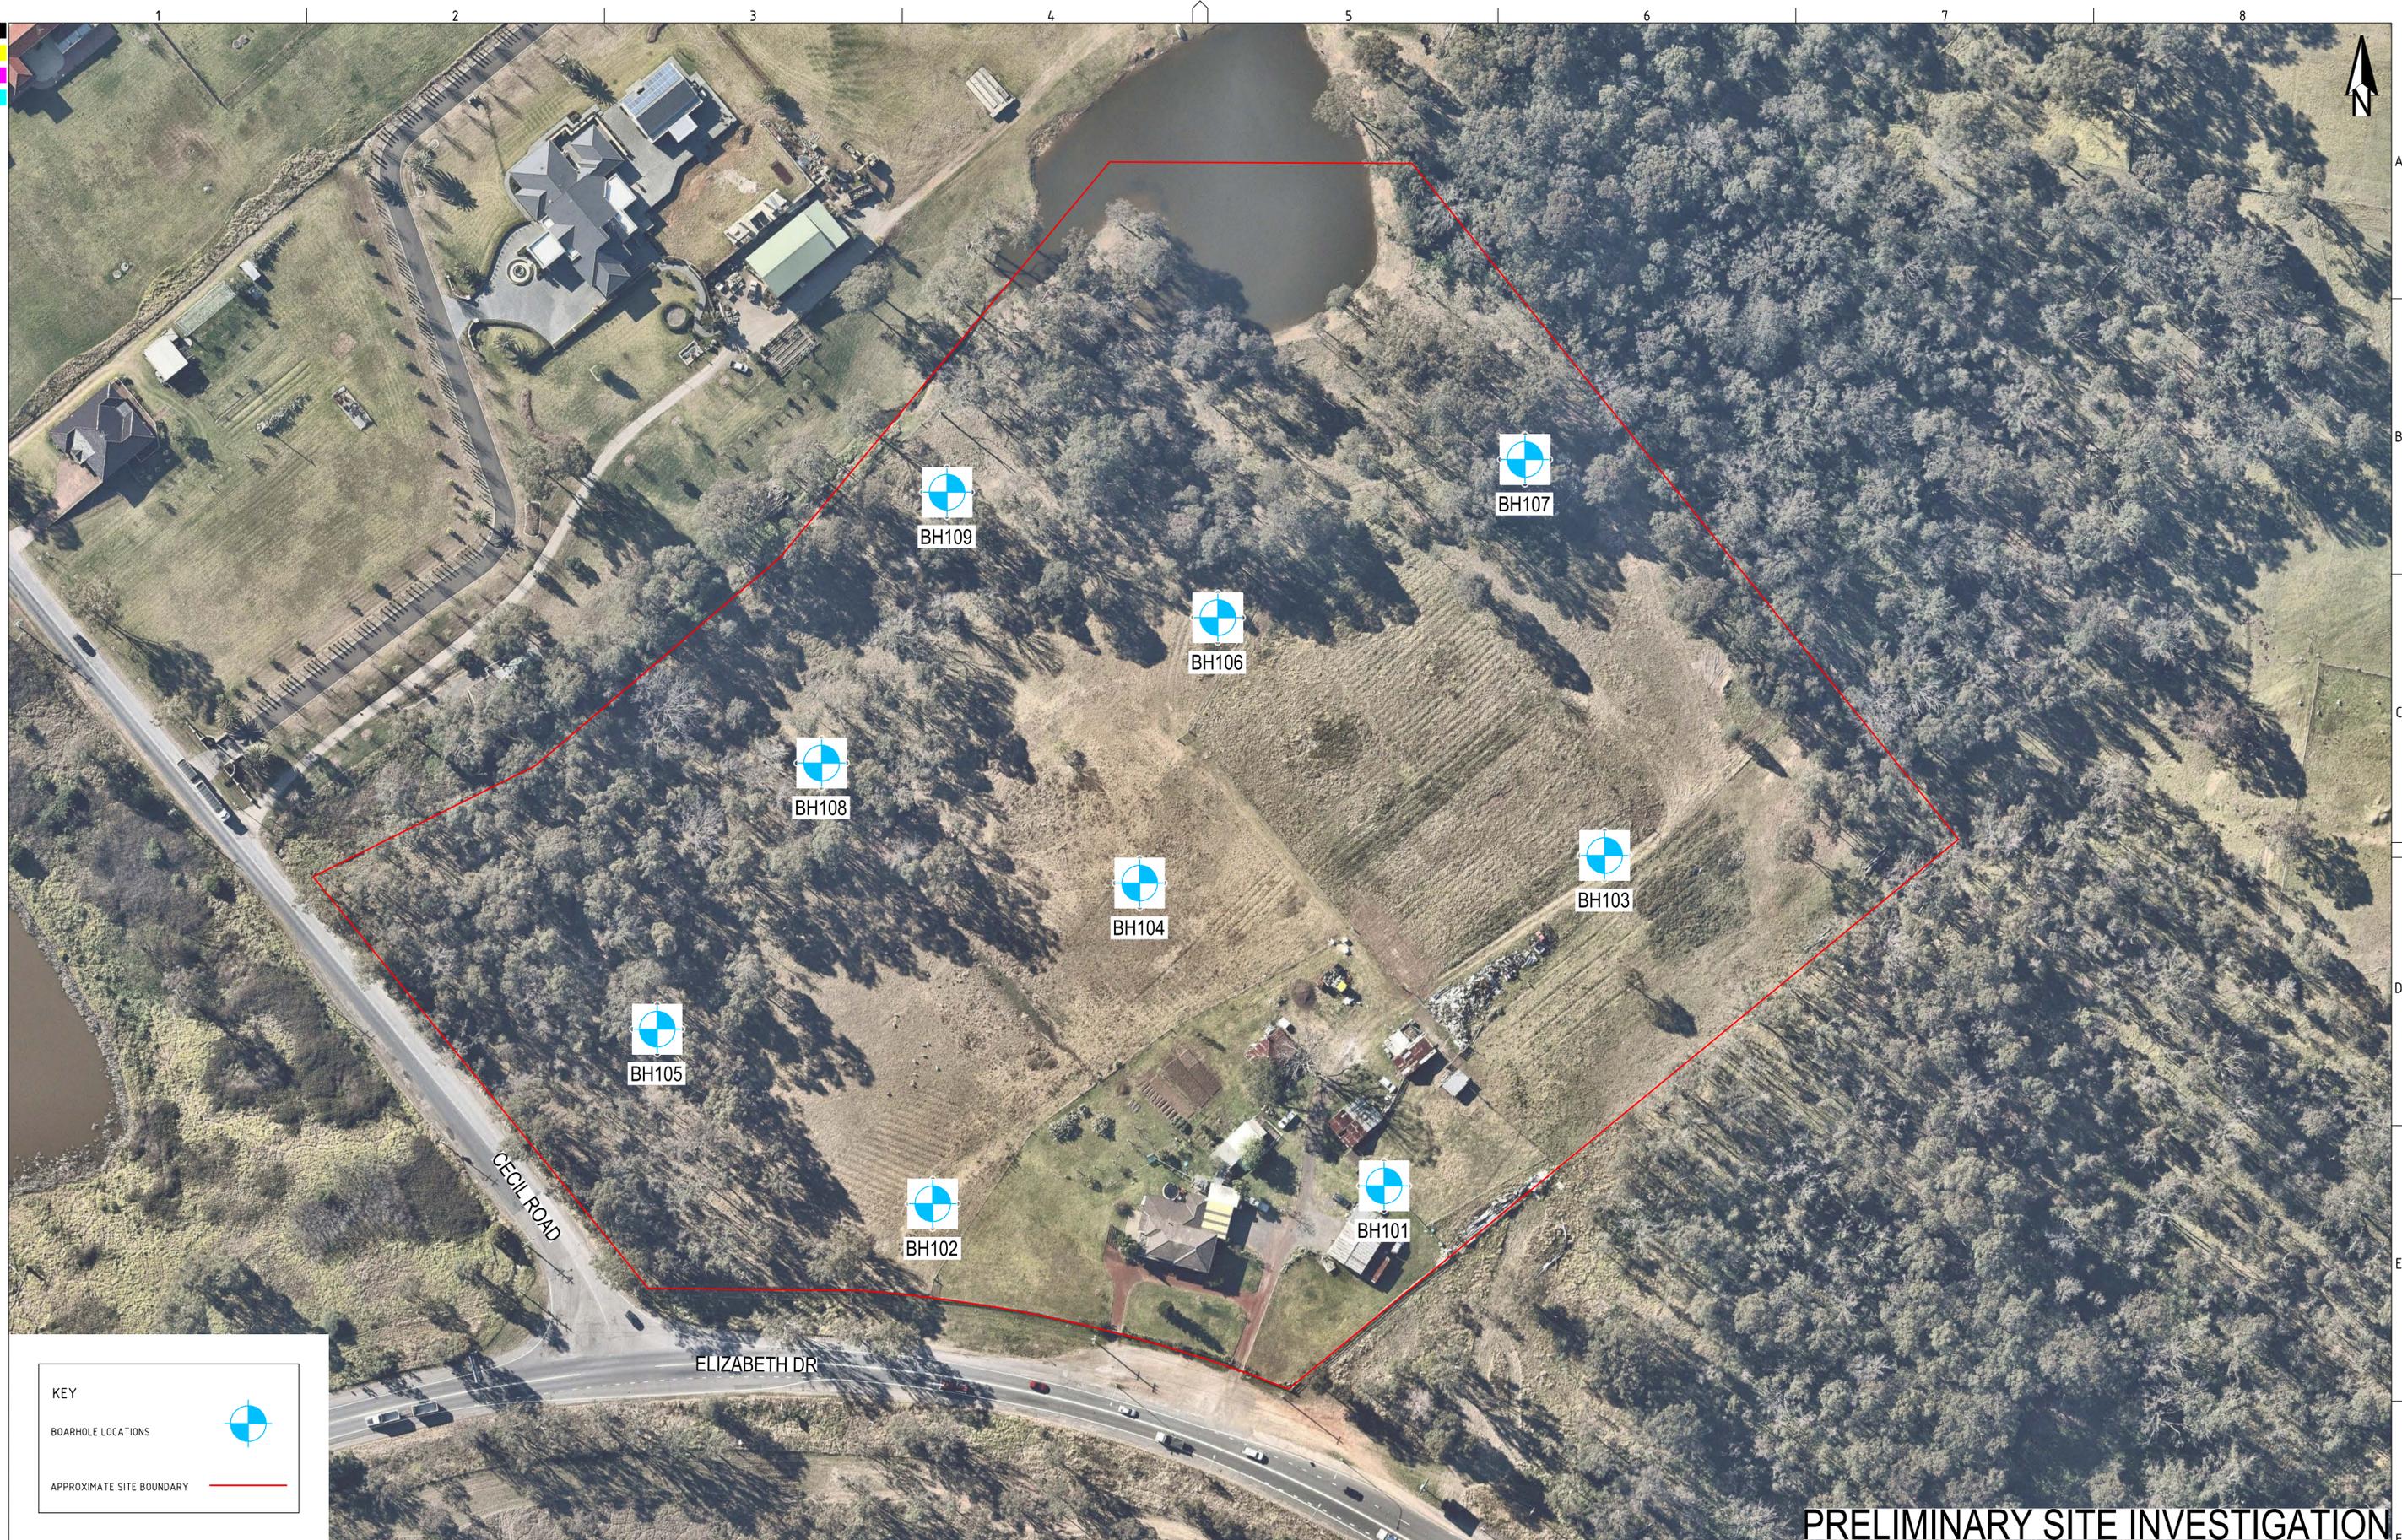
BOARHOLE LOCATIONS

A geotechnical investigation was completed by Martens and Associates on 12 January, 2018 which involved the excavation of nine boreholes (BH101 – BH109) using a hydraulic auger to a maximum depth of 4.3 m below ground level (mbgl). Borehole testing locations are shown on the

site testing plan in Attachment A and detailed borehole logs are provided in Attachment B.

Nine (9) boreholes were excavated on the site. The boreholes were located to characterise site soil characteristics. Attachment B provides full borehole log sheets. These showed a generally consistent soil profile across the site. All boreholes undertaken have also been logged in accordance with soil agricultural classification scheme for wastewater purposes.
