Geotechnical Investigation Report

St Anthony of Padua Catholic School Austral

**135-165 Tenth Avenue and 140 - 170 Eleventh Avenue,
Austral, NSW 2179**

Report Number: 6930-GR-1-1

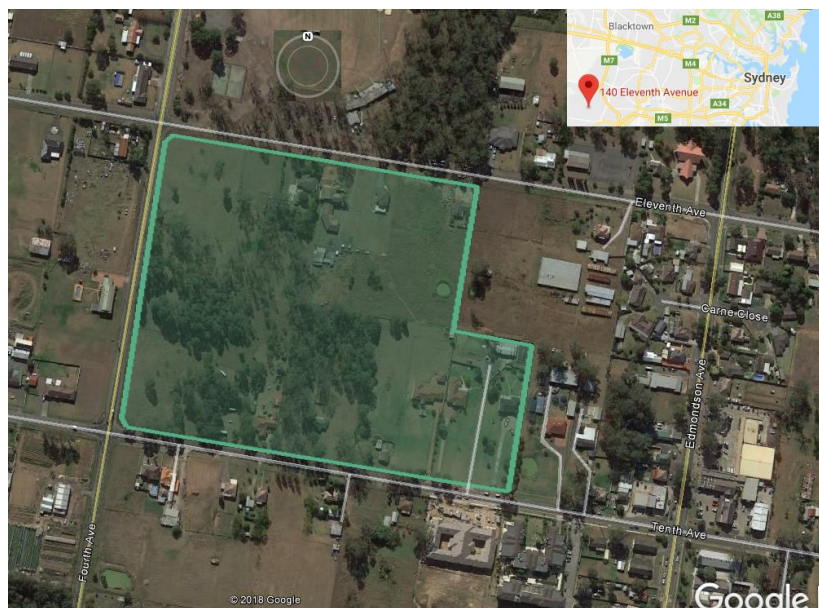
Figure 1- General Site Location Map

The site is located on Lots 809, 812, 841-843 DP 2475, known as 135-165 Tenth Avenue and 140 - 170 Eleventh Avenue, within the semi-rural area of Austral. The general site location is shown in Figure 1.

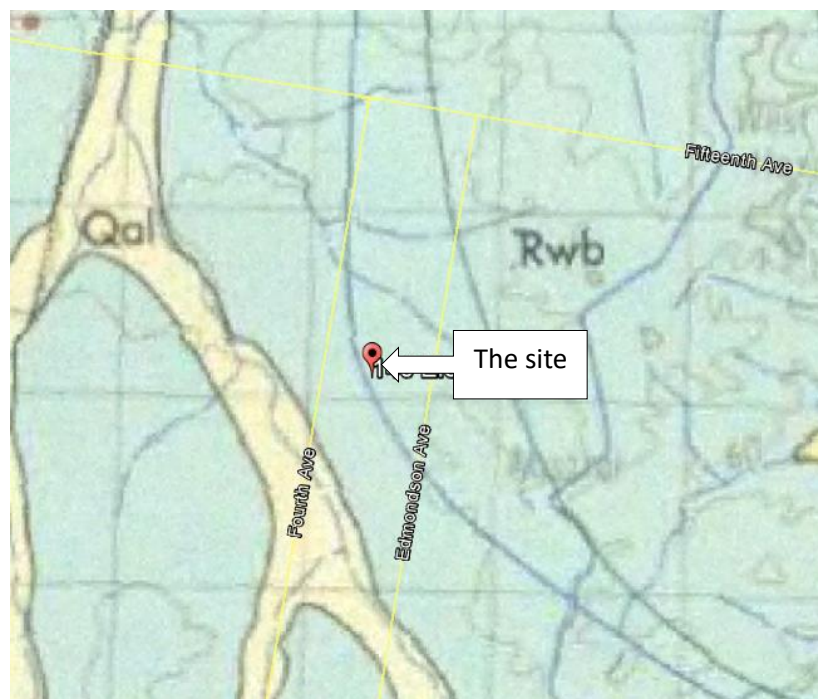
Figure 2- Extract from the Geological Map of Penrith

Bringelly Shale is a component of the Wianamatta group of sedimentary rocks in the Sydney basin. Residual soils derived from Bringelly Shale typically comprise high plasticity clays with low bearing strength.

The investigation confirmed that the site is underlain by residual soils overlaying the shale bedrock. Figure 2 shows the site location on the geological map.
