**STAGE 1 ENVIRONMENTAL SITE ASSESSMENT**

**PROPOSED SHOOOL – DUE DILIGENCE**

**135,135A,145, 155, 165 TENTH AND 140,160,170  
ELEVENTH AVENUE,  
AUSTRAL, NSW**

**REF: E27556KrptRev3**

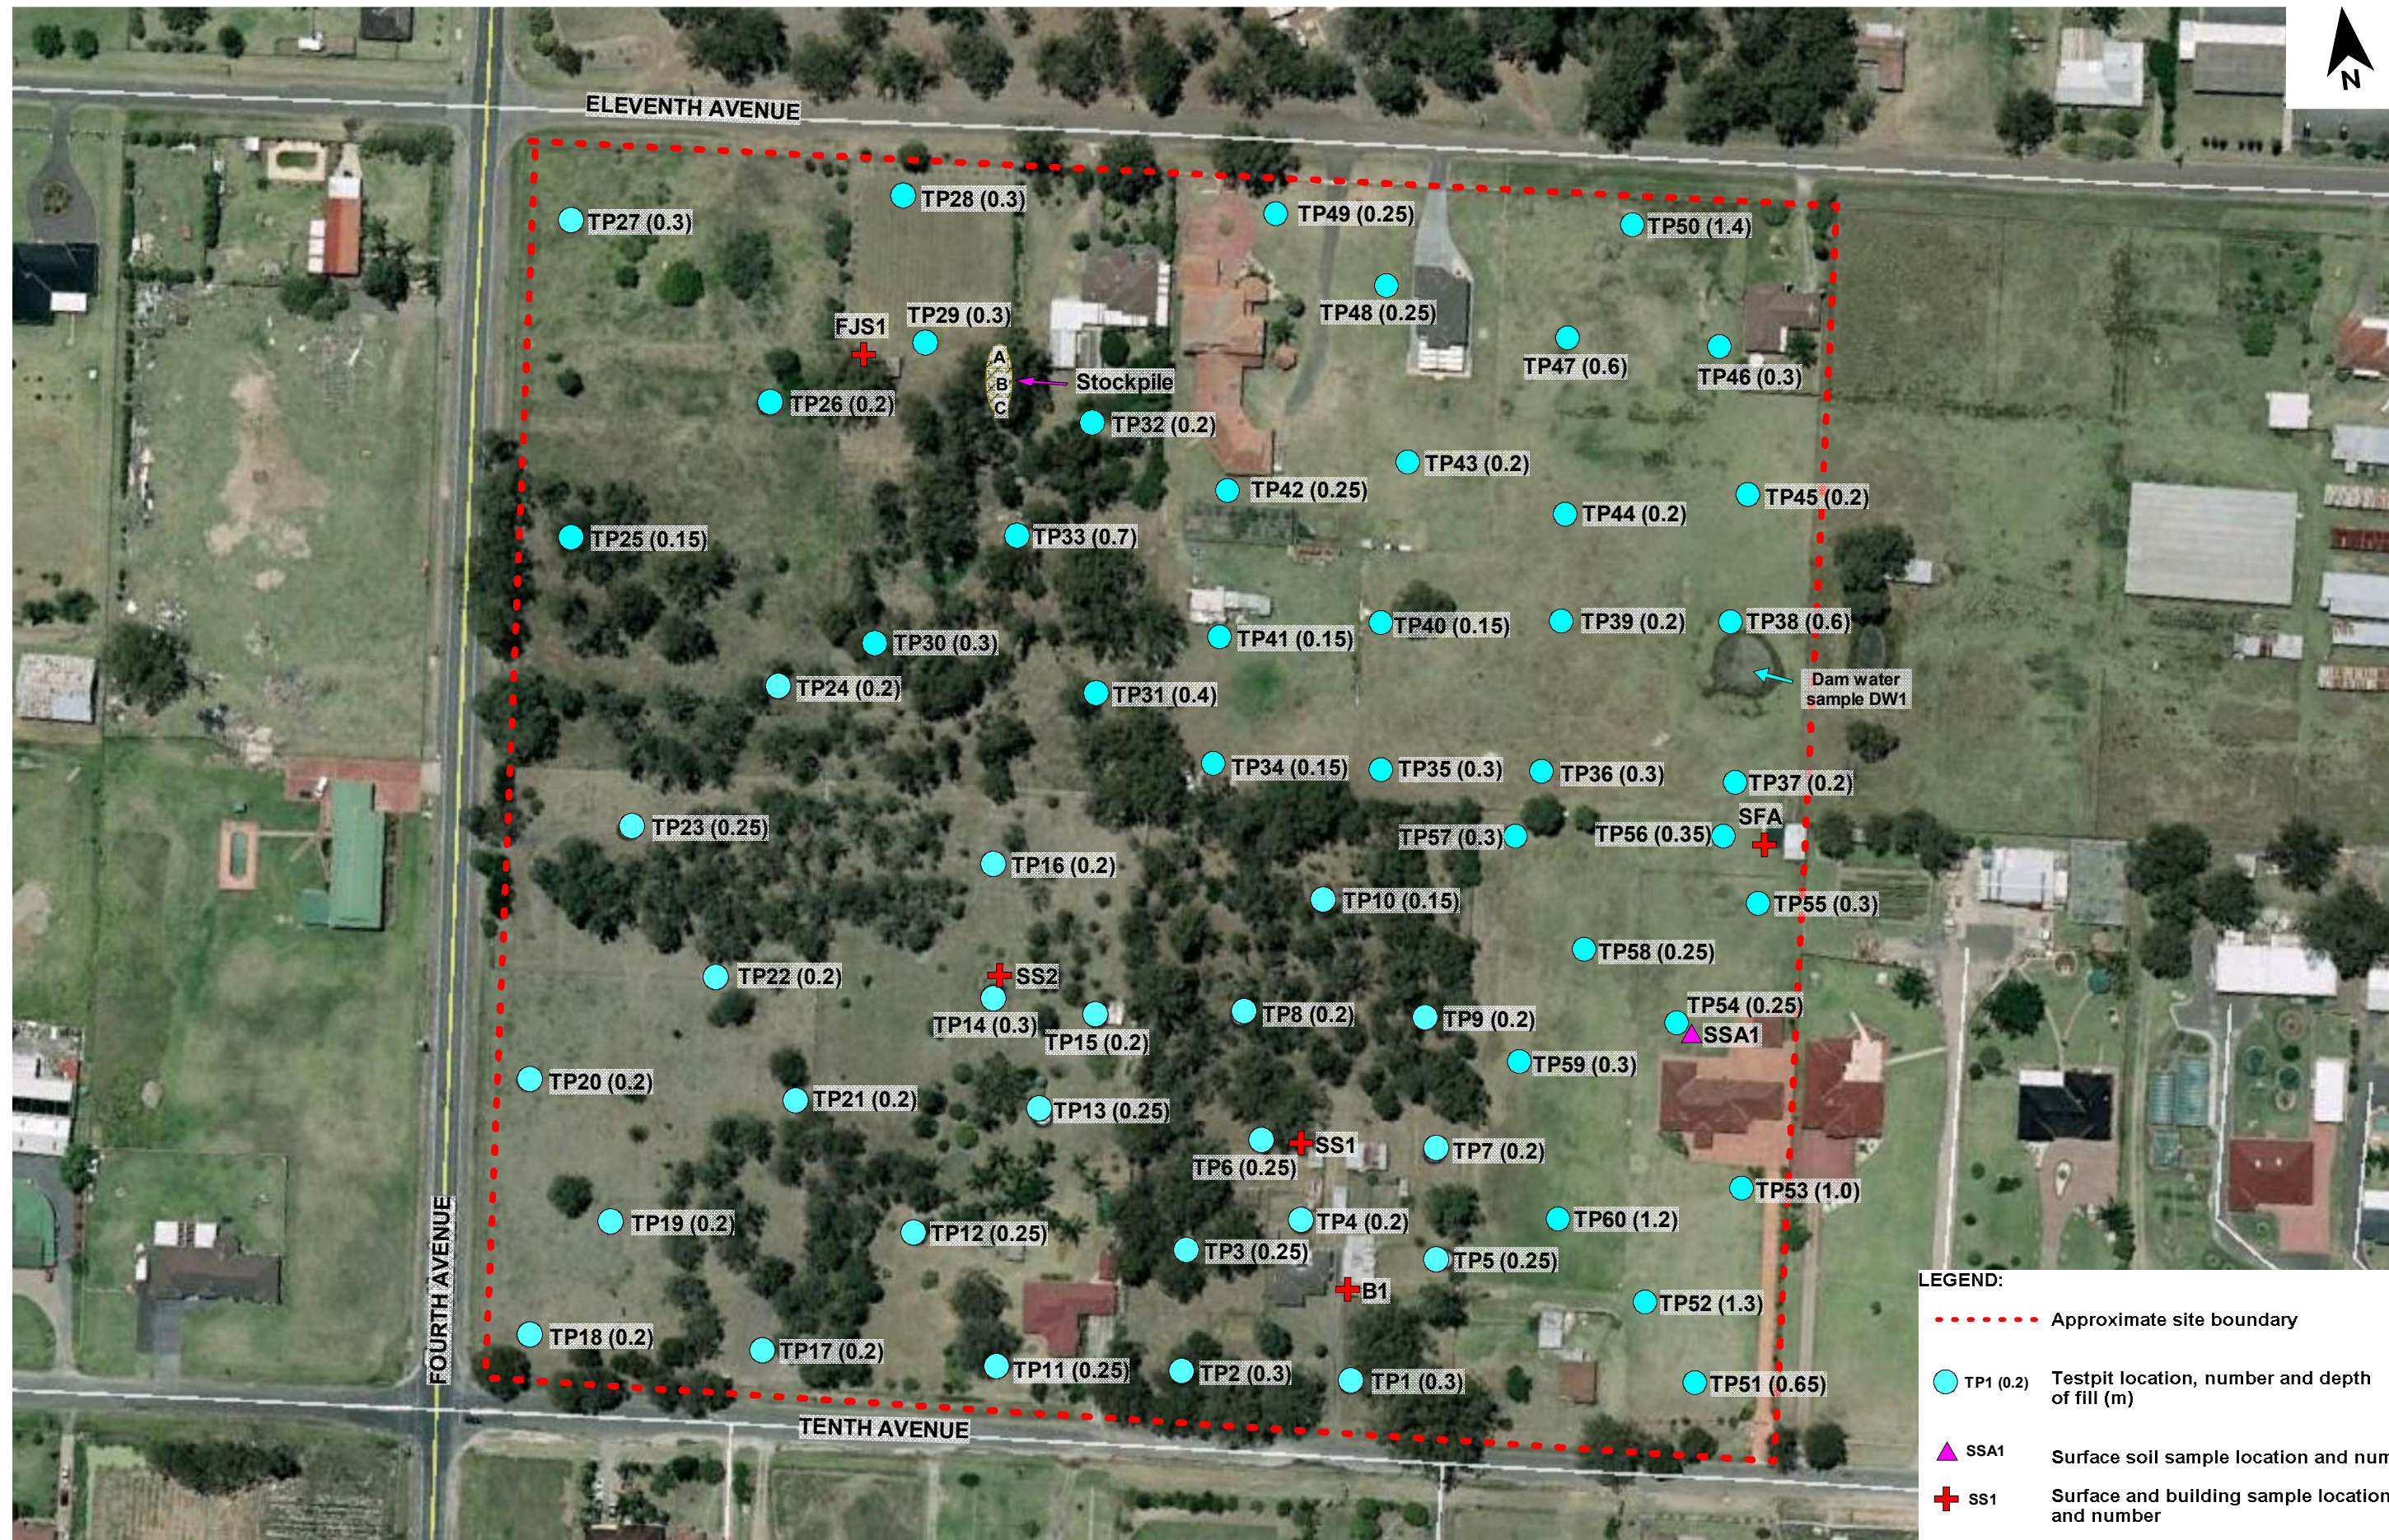
Title:  
**SAMPLE LOCATION PLAN**

Samples for this investigation were obtained from sixty (60) evenly spaced sampling points (testpits) as shown on the attached Figure 2. This density is approximately 55% of the minimum sampling density recommended for a Stage 2 ESA.

Samples for this investigation were obtained from sixty (60) evenly spaced sampling points as shown on the attached Figure 2. This density is approximately 55% of the minimum sampling density recommended for a Stage 2 ESA.

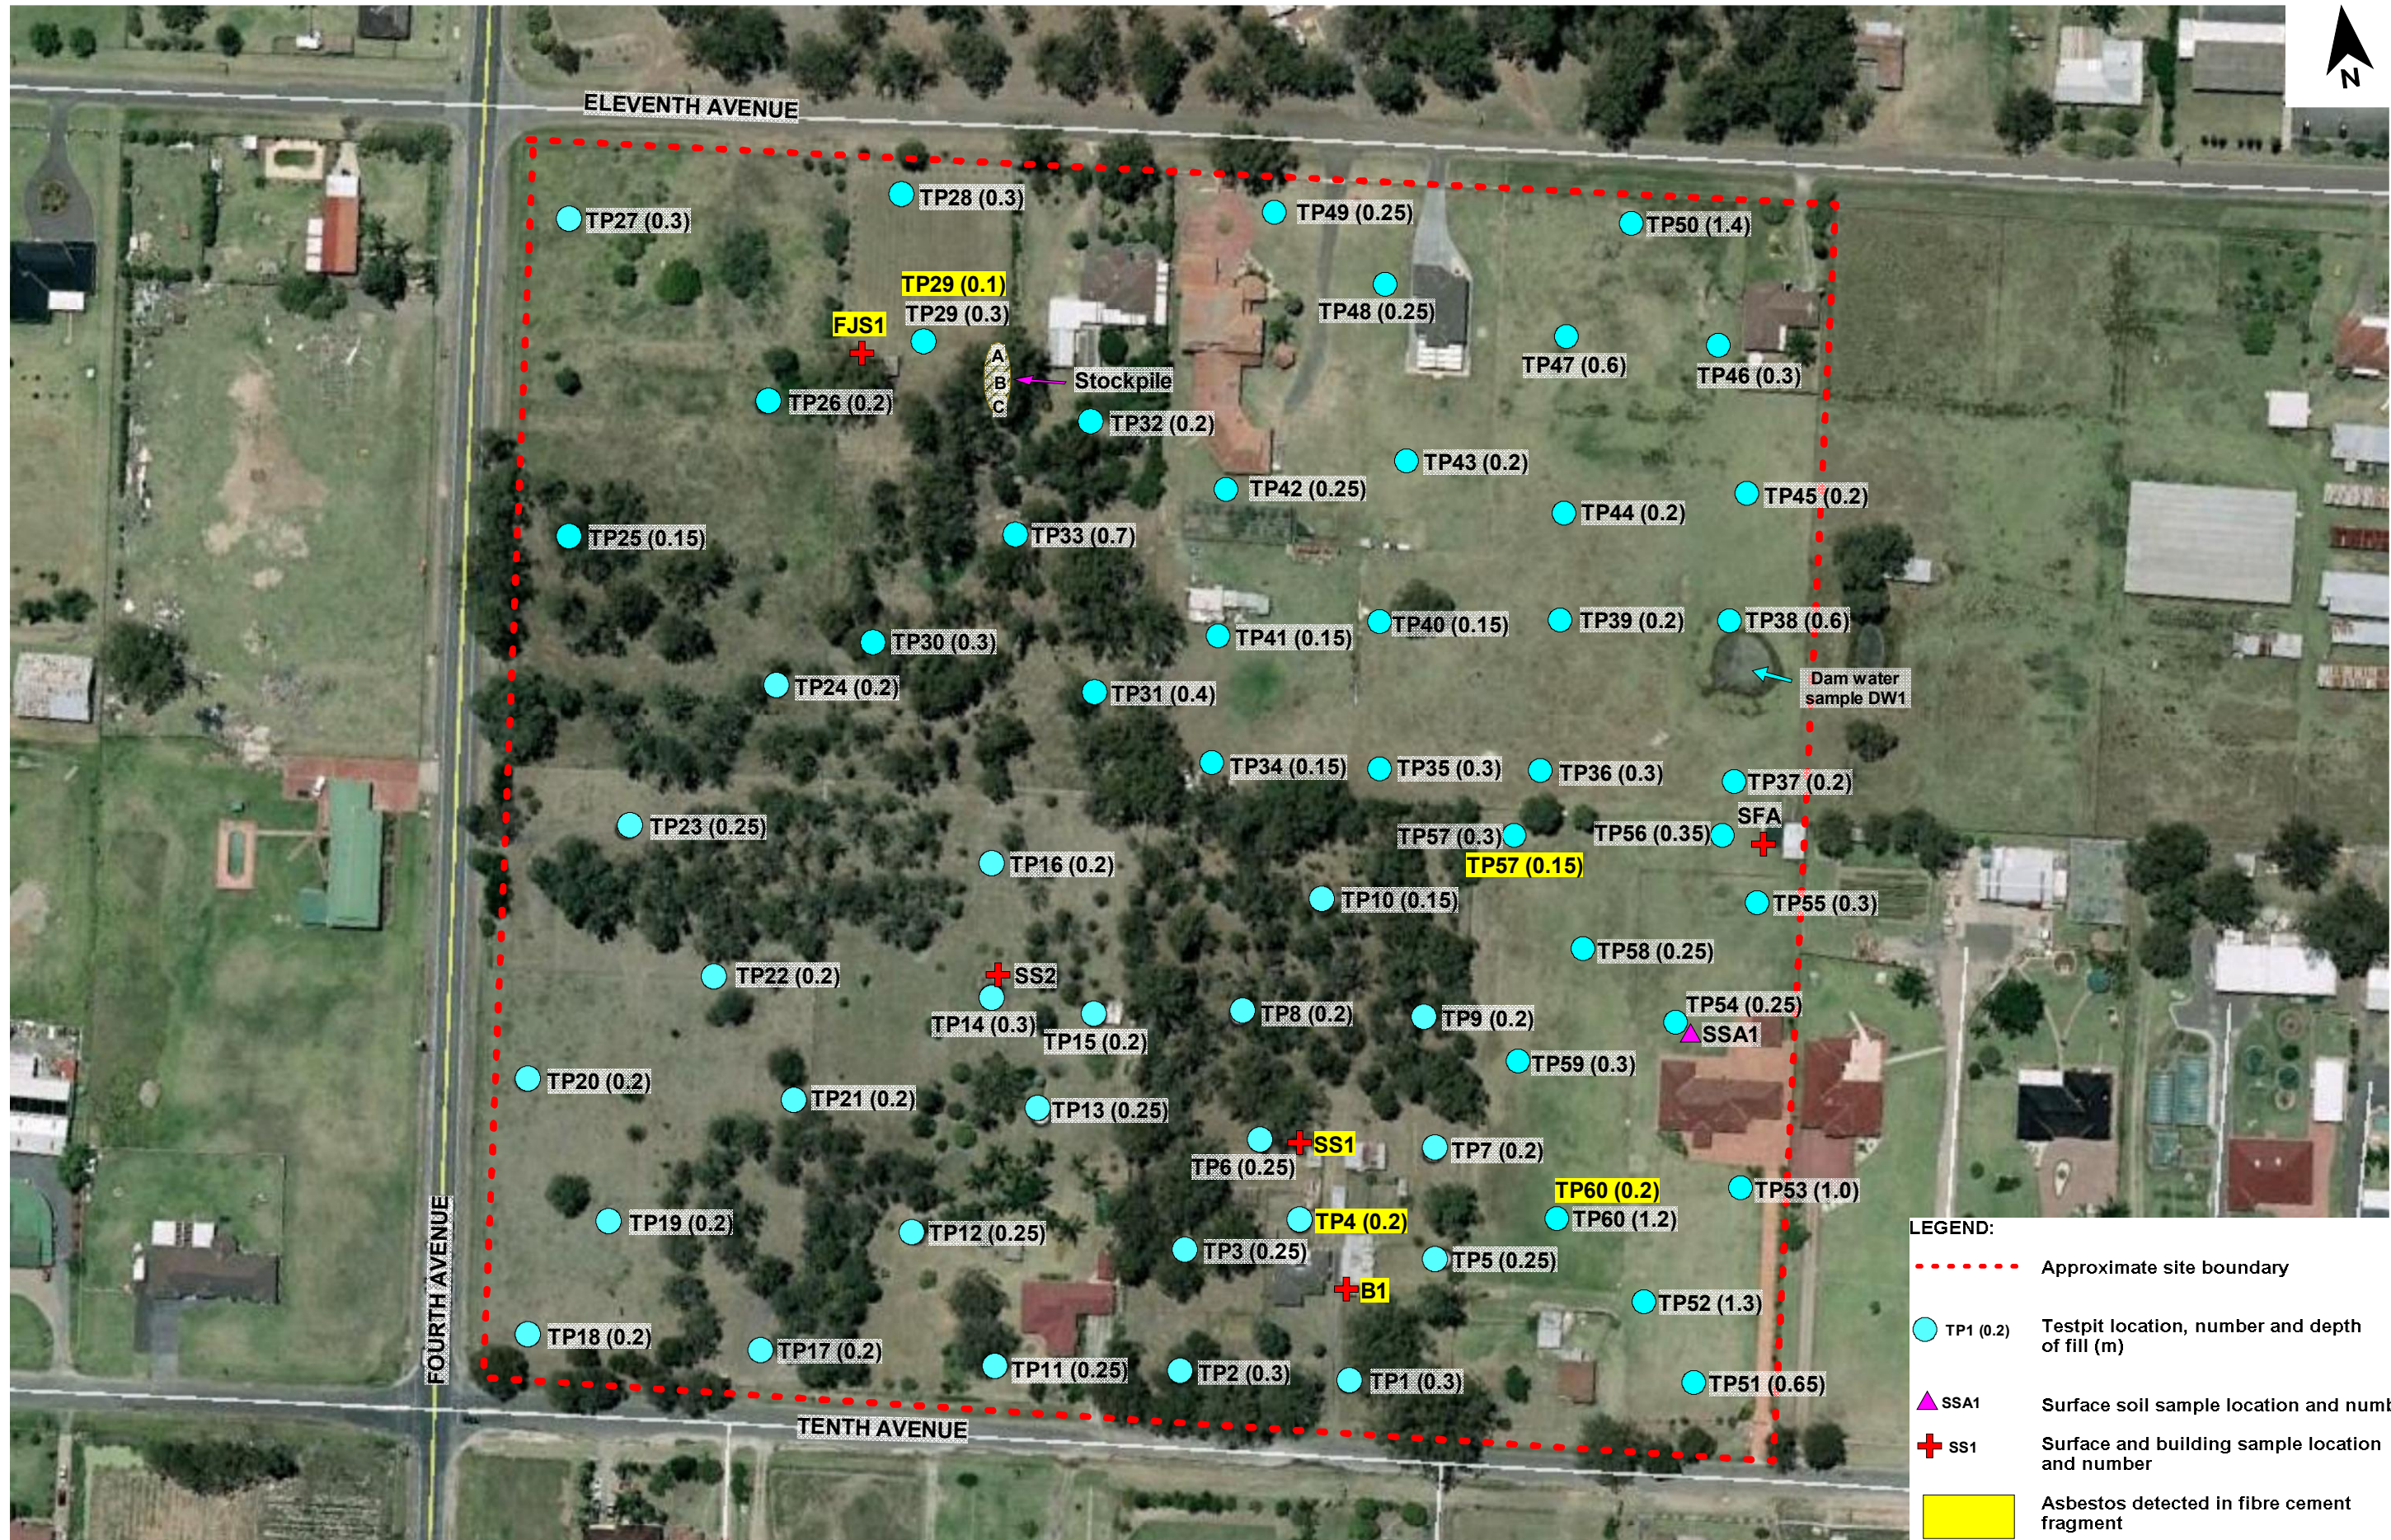
All remaining results were below the SAC adopted for this investigation. However, fibre cement fragments containing asbestos were encountered in the following samples:

- Fill soil sample TP4 (0-0.2m) located in the south-east section of the site adjacent and immediately to the north of the residential building at 145 Tenth Avenue;
- Fill soil sample TP29 (0.1m) located in the north-east section of the site immediately adjacent and to the north-east of the site shed at 160 Eleventh Avenue;
- Surface sample SS1 located adjacent to a small shed at 145 Tenth Avenue;
- Building sample B1, obtained from a building to the east of the residential building at 145 Tenth Avenue;
- Surface sample SS2 located within the northern garden bed at 155 Tenth Avenue;
- Surface sample FJS1 located in the north-east section of the site immediately adjacent and to the north of the site shed at 160 Eleventh Avenue;
- Fill soil sample TP57 (0.15m) located in the north-west section of the site identified as 135 Tenth Avenue; and

- Fill soil sample TP30 (0.2m) located in the south-west section of the site identified as 135 Tenth Avenue.

The site asbestos contamination data is shown in the Tables and on Figure 3 attached.

1. Excavation and off-site disposal of all of the topsoil/fill material from across the site (refer to Section 11 and Section 12); or
2. Undertake a detailed soil investigation (DSI) for asbestos in accordance with the Western Australian Asbestos Guidelines 2009 (endorsed in NEPM 2013) to assess if asbestos hot spot areas can be estimated for remediation purposes.
