# Construction Environmental Management Plan

St Anthony's of Padua – Stage 4

This Construction Environmental Management Plan describes how Lipman proposes to manage the demolition and construction activities at St Anthony's of Padua – Stage 4. These works relate to Development Consent Number SSD-8865-Mod-1.

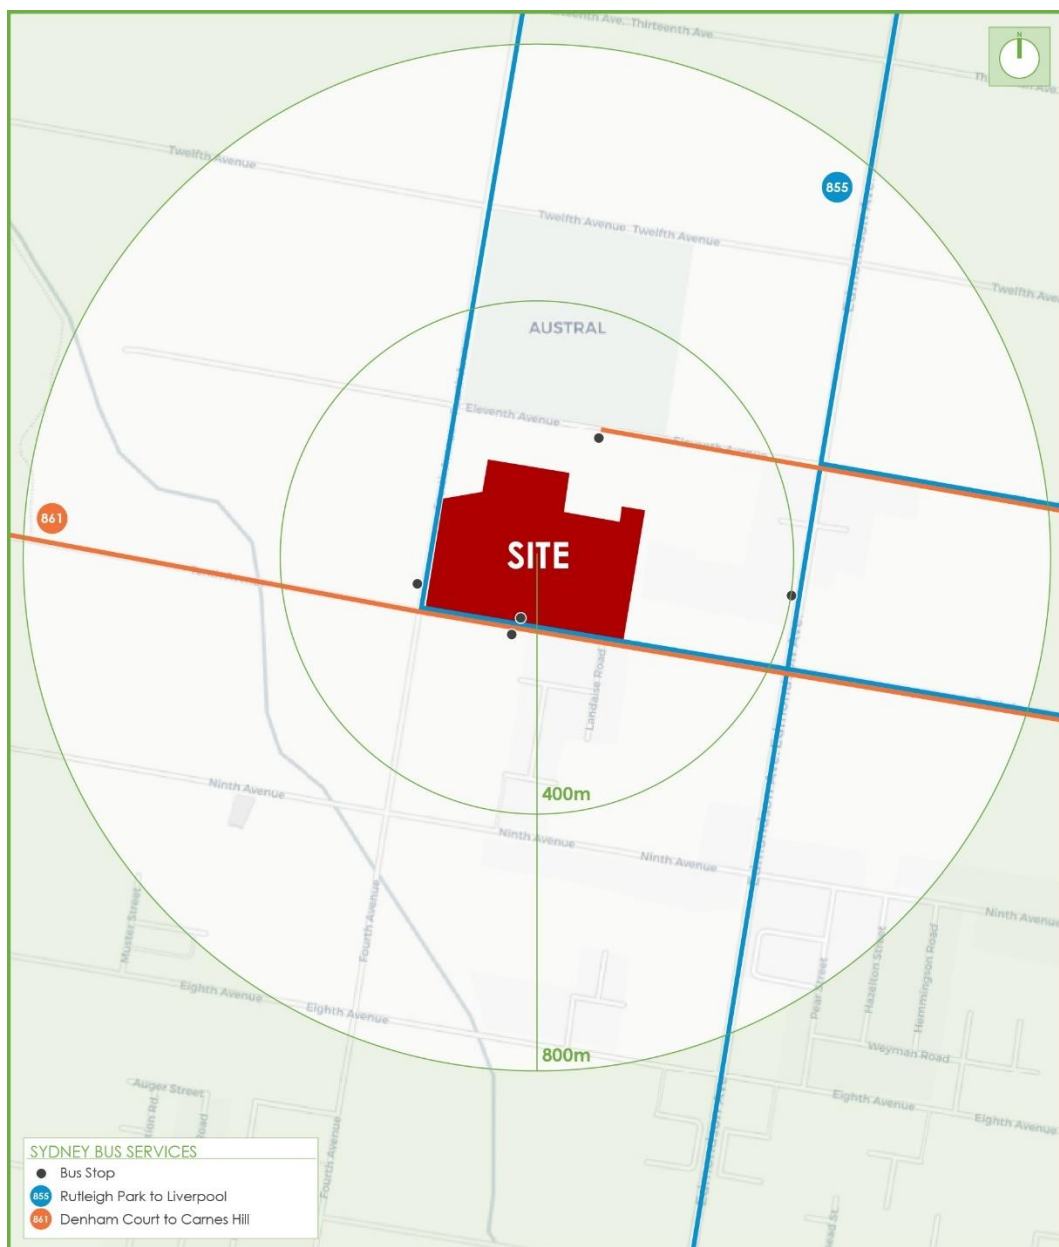
**Figure 4: Public Transport**

- 855 – Rutleigh Park to Liverpool via Austral and Leppington Station
- 861 – Denham Court to Carnes Hill via Austral

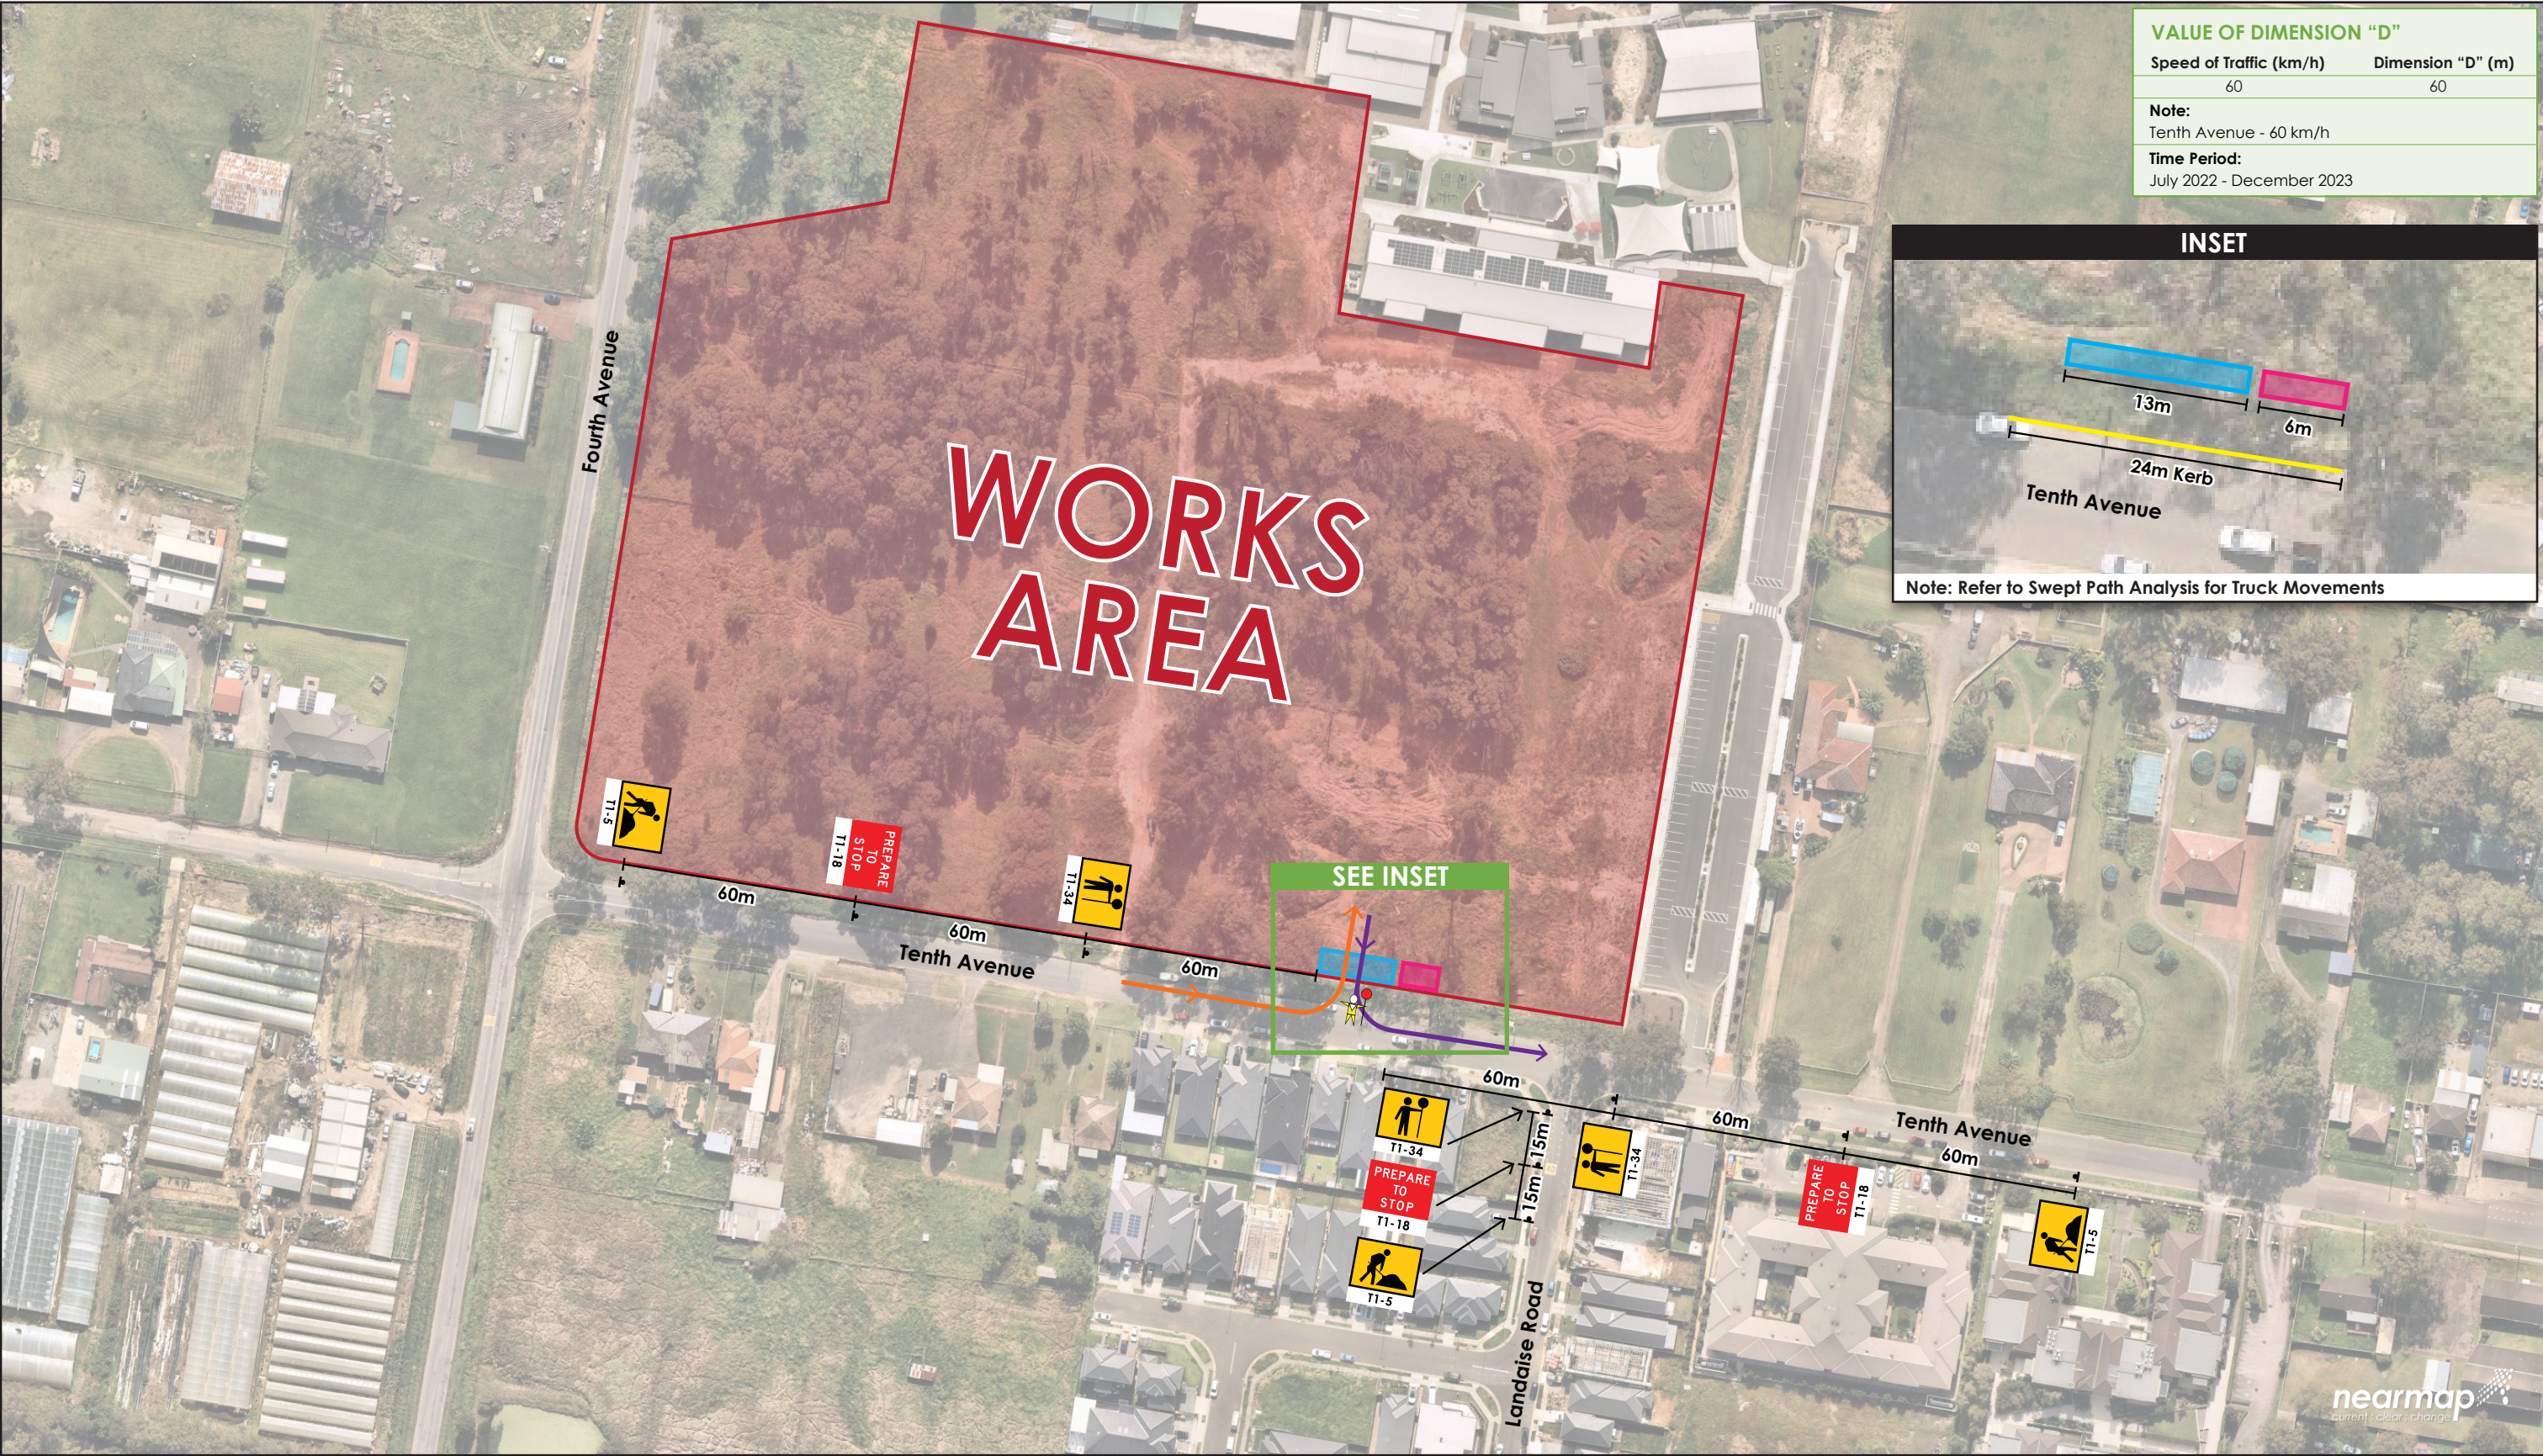
### Traffic Guidance Scheme

VALUE OF DIMENSION "D"

Speed of Traffic (km/h)	Dimension "D" (m)
60	60

The Traffic Guidance Scheme (TGS) that is included in this report, should be implemented taking due account of on-site conditions as will occur over the construction period. Accordingly, construction crew are expected to respond in a pro-active manner to ensure that this plan is implemented to maximum effect and with no obvious safety issues being overlooked. In particular, the following matters are considered noteworthy:

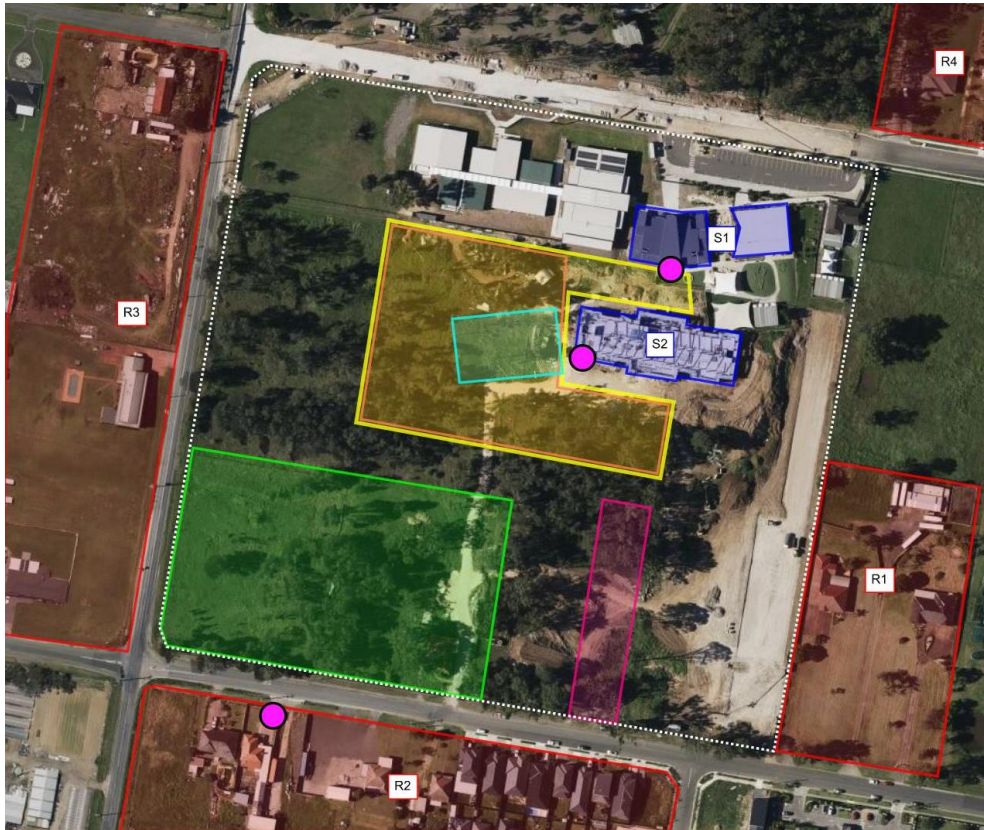
**Figure 2 – Indicative Unattended Noise Monitoring Locations**

The location of the unattended noise monitors will depend on the location of affected receivers. Pending complaint responses, unattended noise monitoring may require up to three noise monitors. An example of noise monitoring locations has been presented in Figure 2.
