Sampling and Analysis Quality Plan

New Public School in Epping  
86 Chelmsford Avenue, Epping

Prepared for  
School Infrastructure New South Wales (SINSW)

Project 99671.03  
April 2021

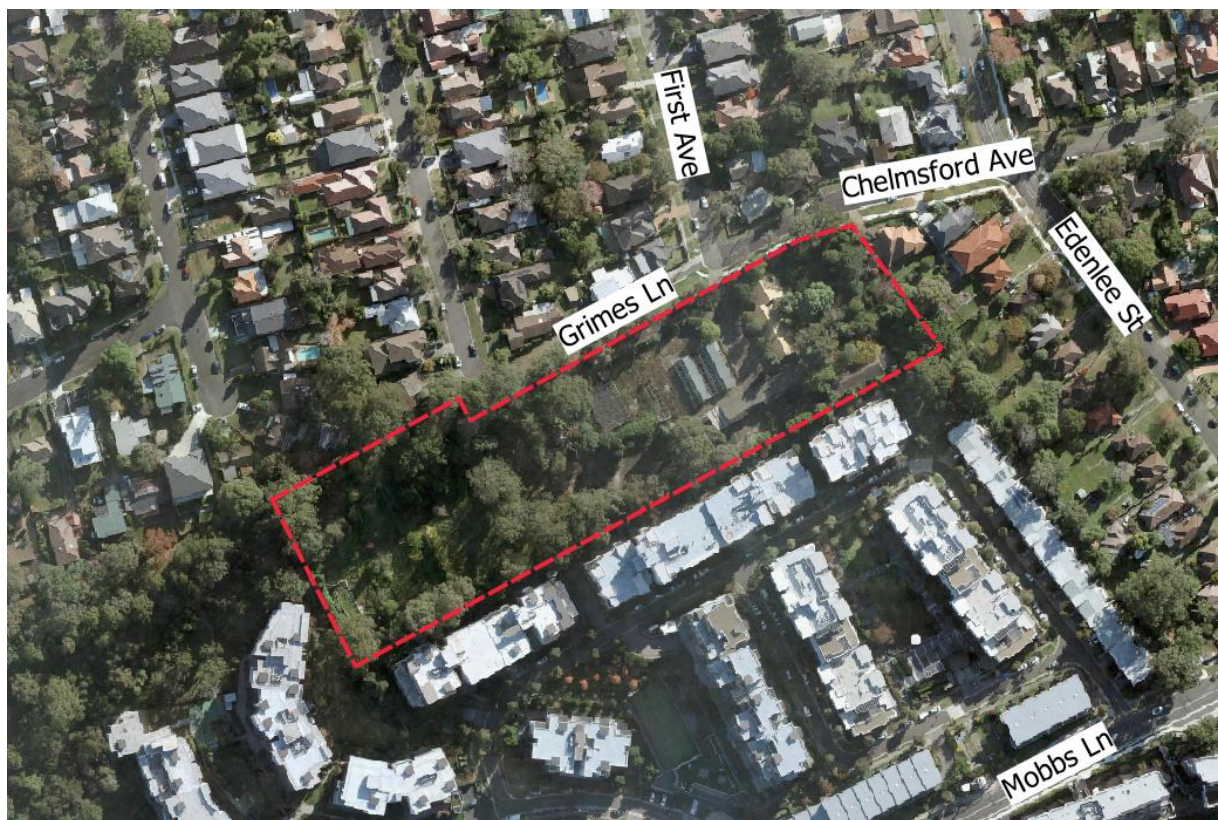
**Figure 1: Site Location and Approximate Boundary (in red)**

The site is currently unoccupied, with infrastructure from the previous TAFE use remaining. Site details are shown in Table 1. The site location and boundary is shown in Figure 1 and Drawing R.001.D01, Appendix A.

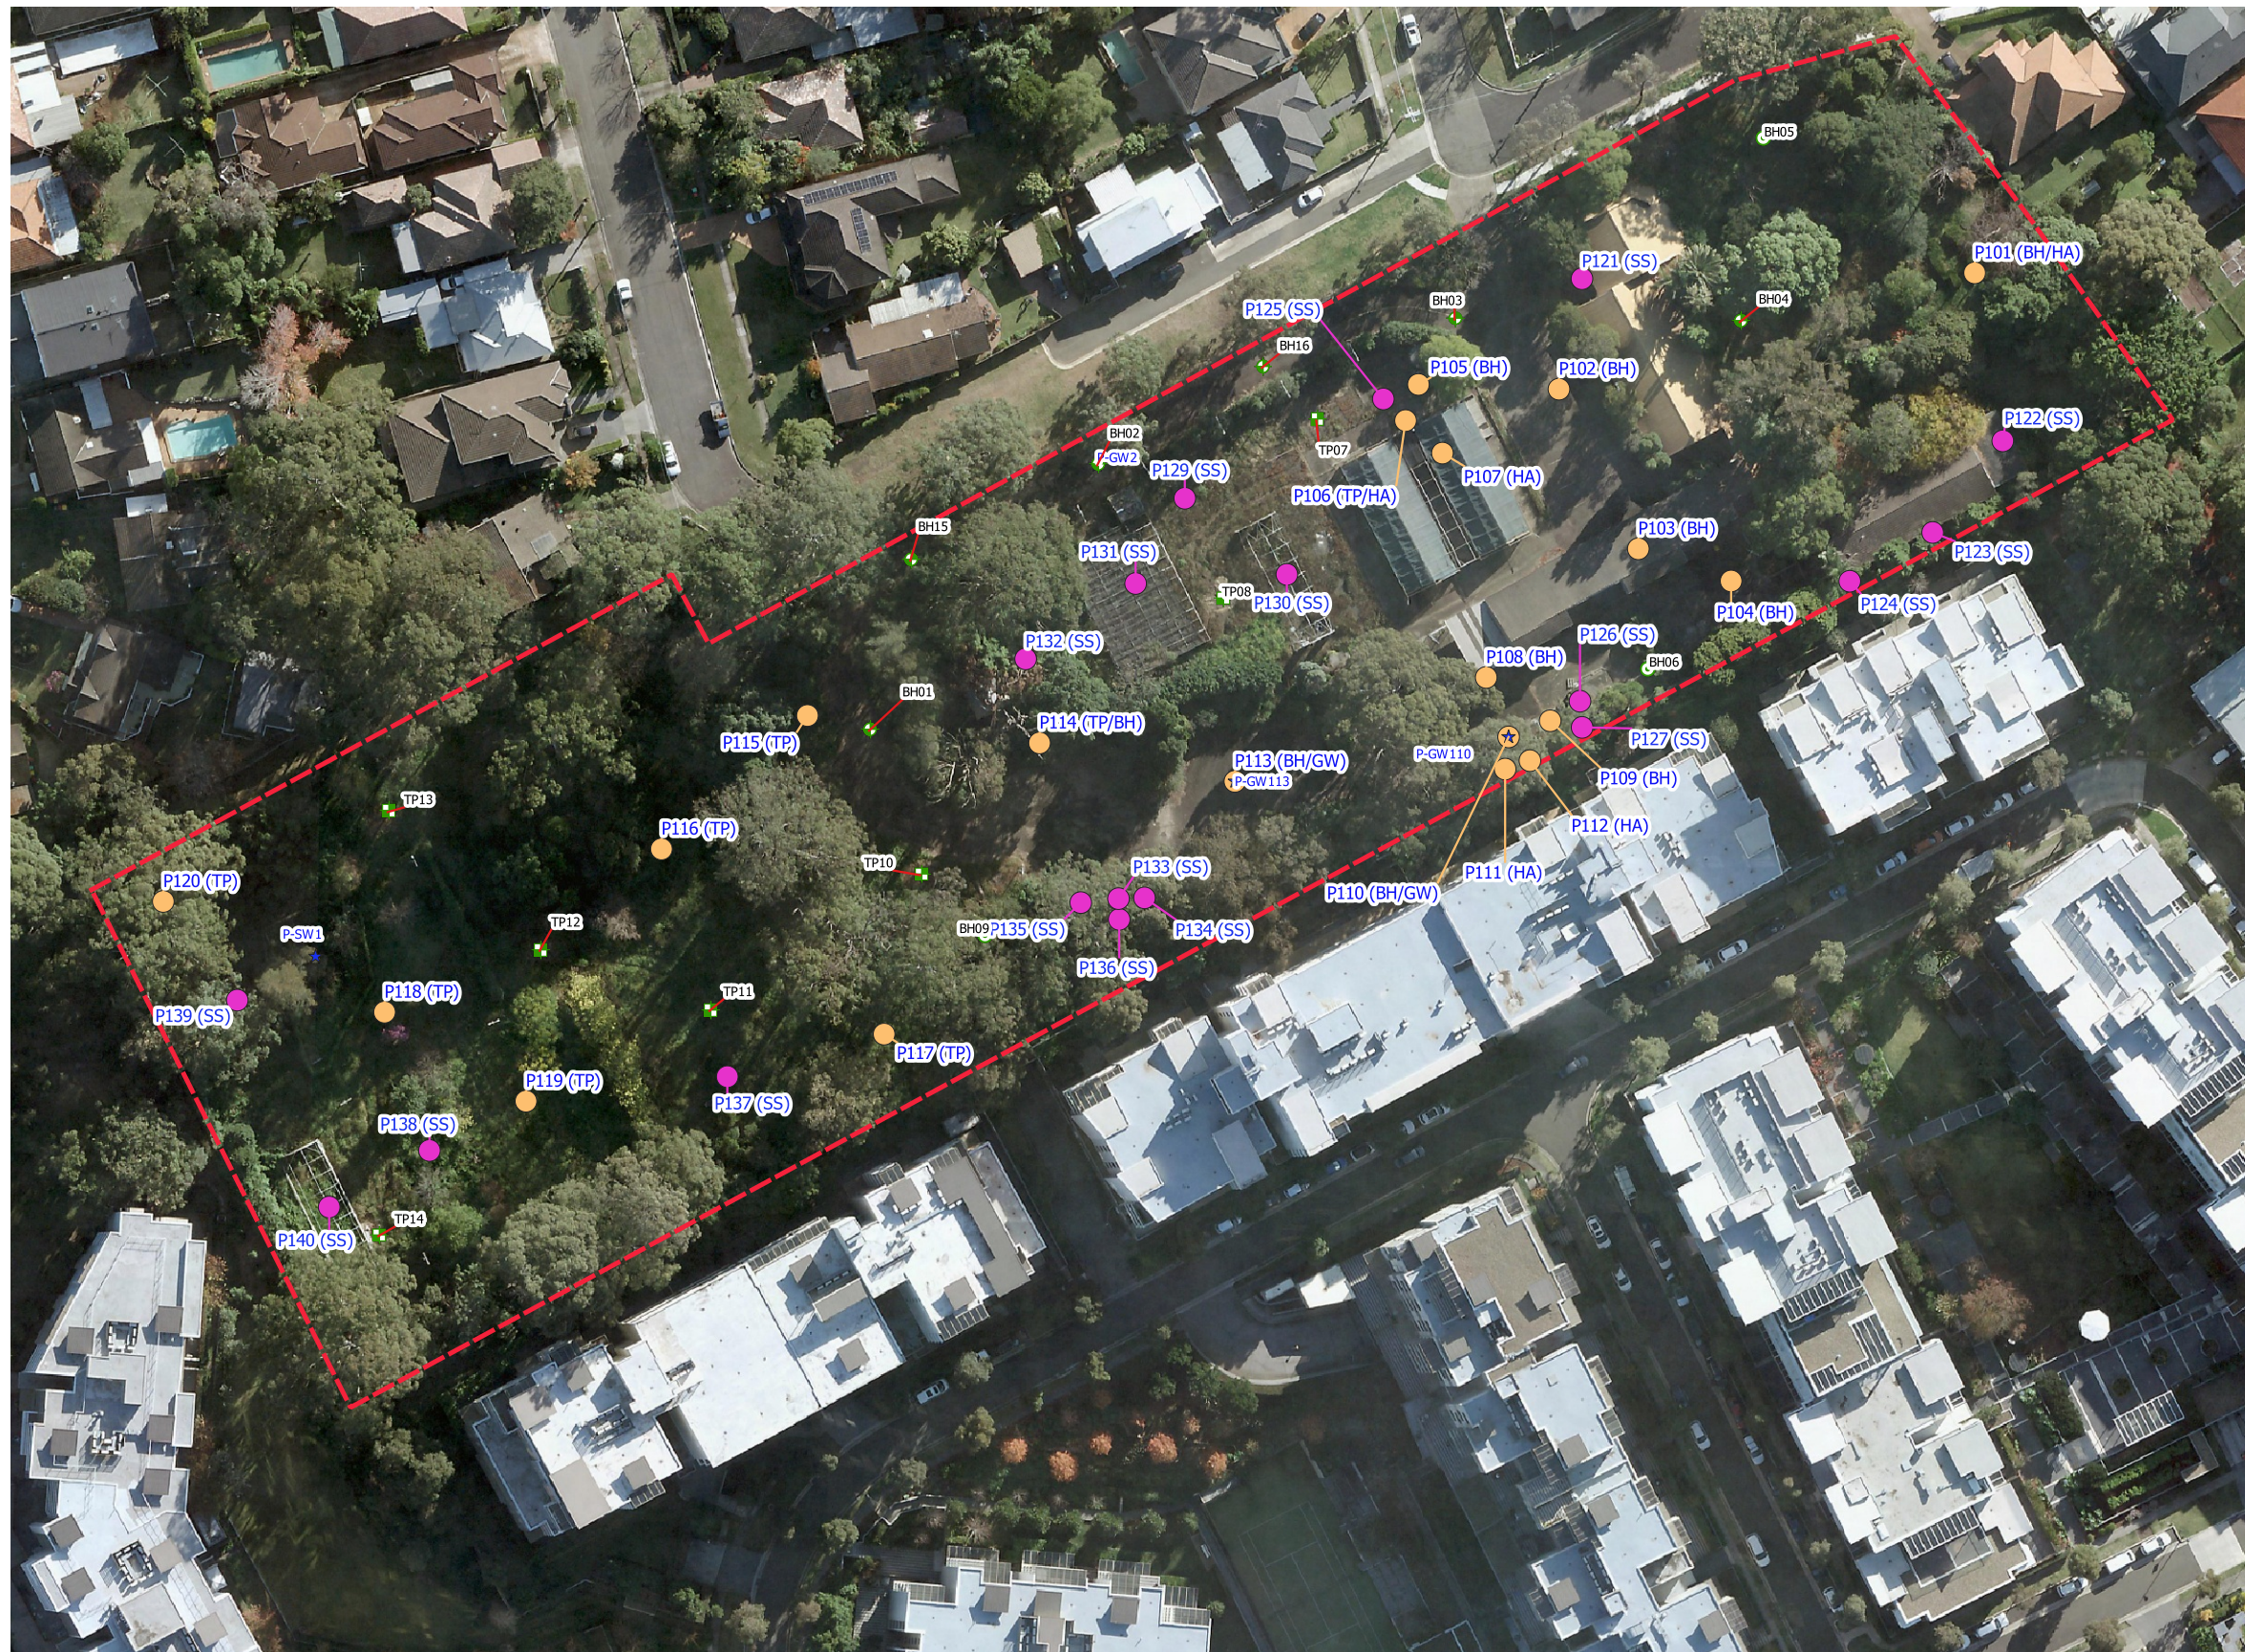
- Legend**
- Site Boundary
  - Proposed test pit (TP), borehole (BH) or hand auger (HA)
  - Proposed surface sample location
  - Previous borehole (DP, 2021b)
  - Previous hand auger location (DP, 2021c)
  - Previous test pit location (DP, 2021c)

The borehole or test pit locations referenced in this section are shown on Drawing R.001.D03, Appendix A.
