RE: INTERIM AUDIT ADVICE LETTER NO. 1 - REVIEW OF RAP, NEW PUBLIC SCHOOL IN EPPING, 86 CHELMSFORD AVENUE, EPPING

Ref 318001042

Attachment 4: Proposed Data Gap Groundwater Well Location Plan

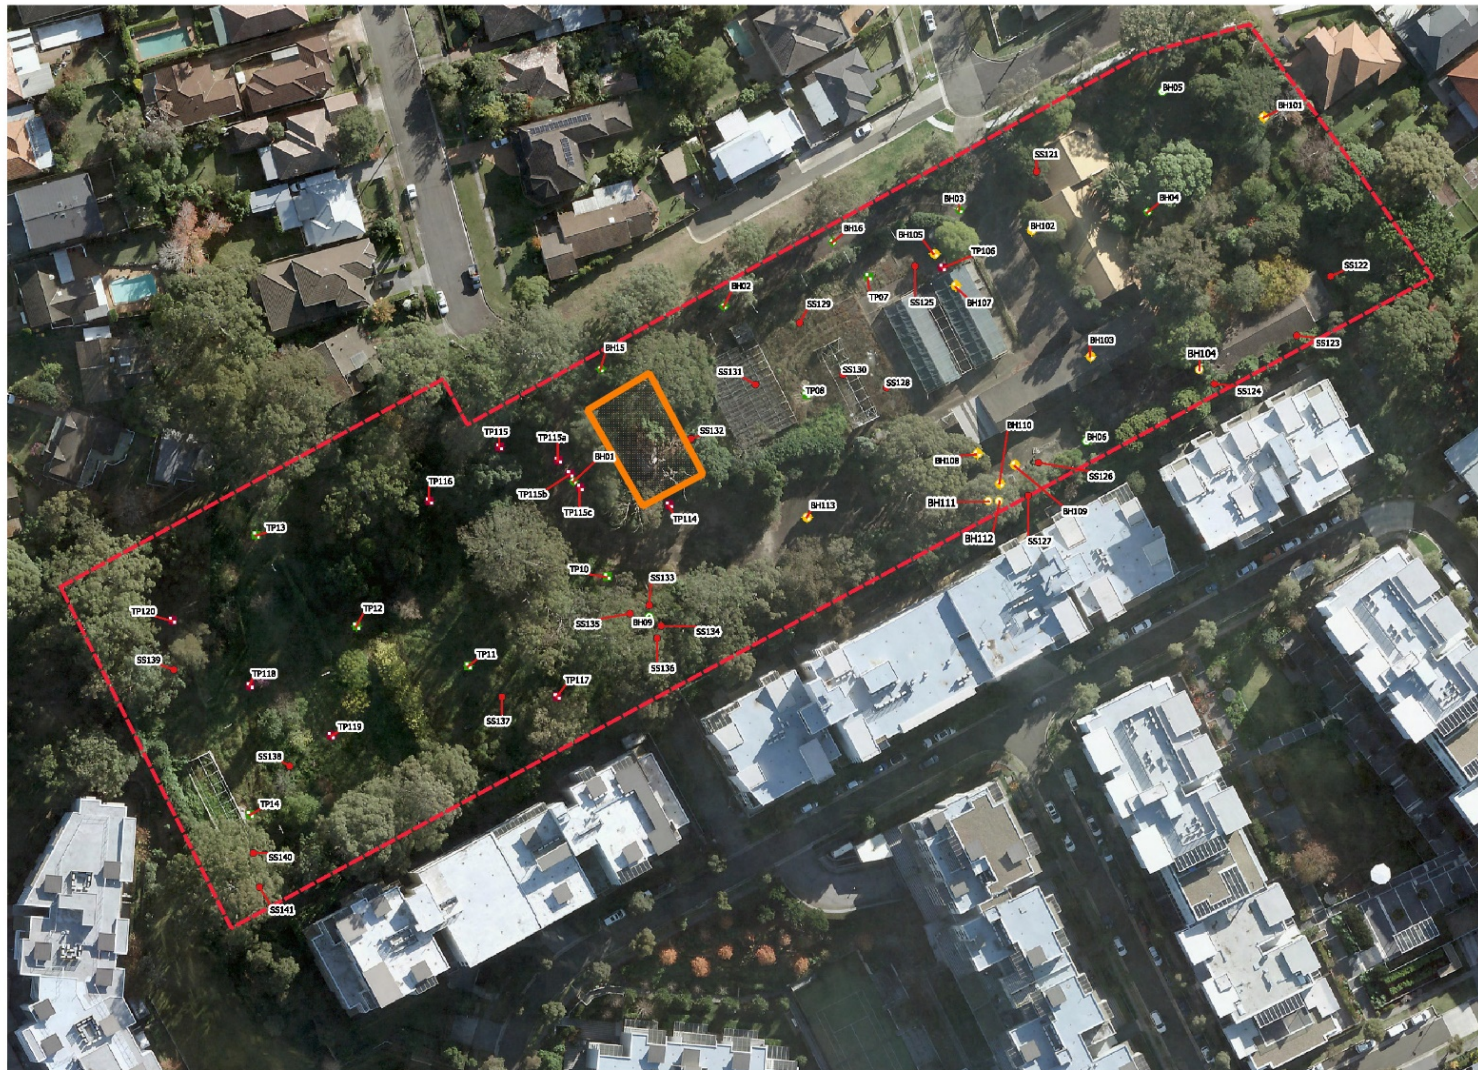
Soil, groundwater and surface water investigations at the site are shown on Attachment 3 and identified the following:

- Fill was identified in all sample locations to depths of between 0.25 m and 1.65 m below ground level (mbgl). Anthropogenic inclusions including ash, burnt wood, brick, terracotta, fabric, plastic, metal, glass, ceramics and concrete were observed in approximately 30% of test locations. Residual clay, sandstone and/or siltstone bedrock was identified beneath the fill in the majority of the sample locations at depths of between 0.8 and 1.7 mbgl. A slight hydrocarbon odour was recorded in fill in TP8 (PSI test location) between 0.2 and 0.8 mbgl.

- No groundwater was observed during drilling of boreholes or excavation of test pits with the exception of one location BH113 where groundwater was encountered at 5.0 mbgl. Groundwater has been recorded in three wells at the site at depths of between 3.6 and 6 mbgl and RL of between 110.6 m and 112.4 mAHD.

- Generally, concentrations of contaminants in the soil samples analysed were below the laboratory detection limits and the adopted assessment criteria. Elevated concentrations of total recoverable hydrocarbons (TRH) C₁₆ to C₃₄ (TRH F3) were identified above the adopted ecological criteria at two surface fill locations (SS126 and SS127).

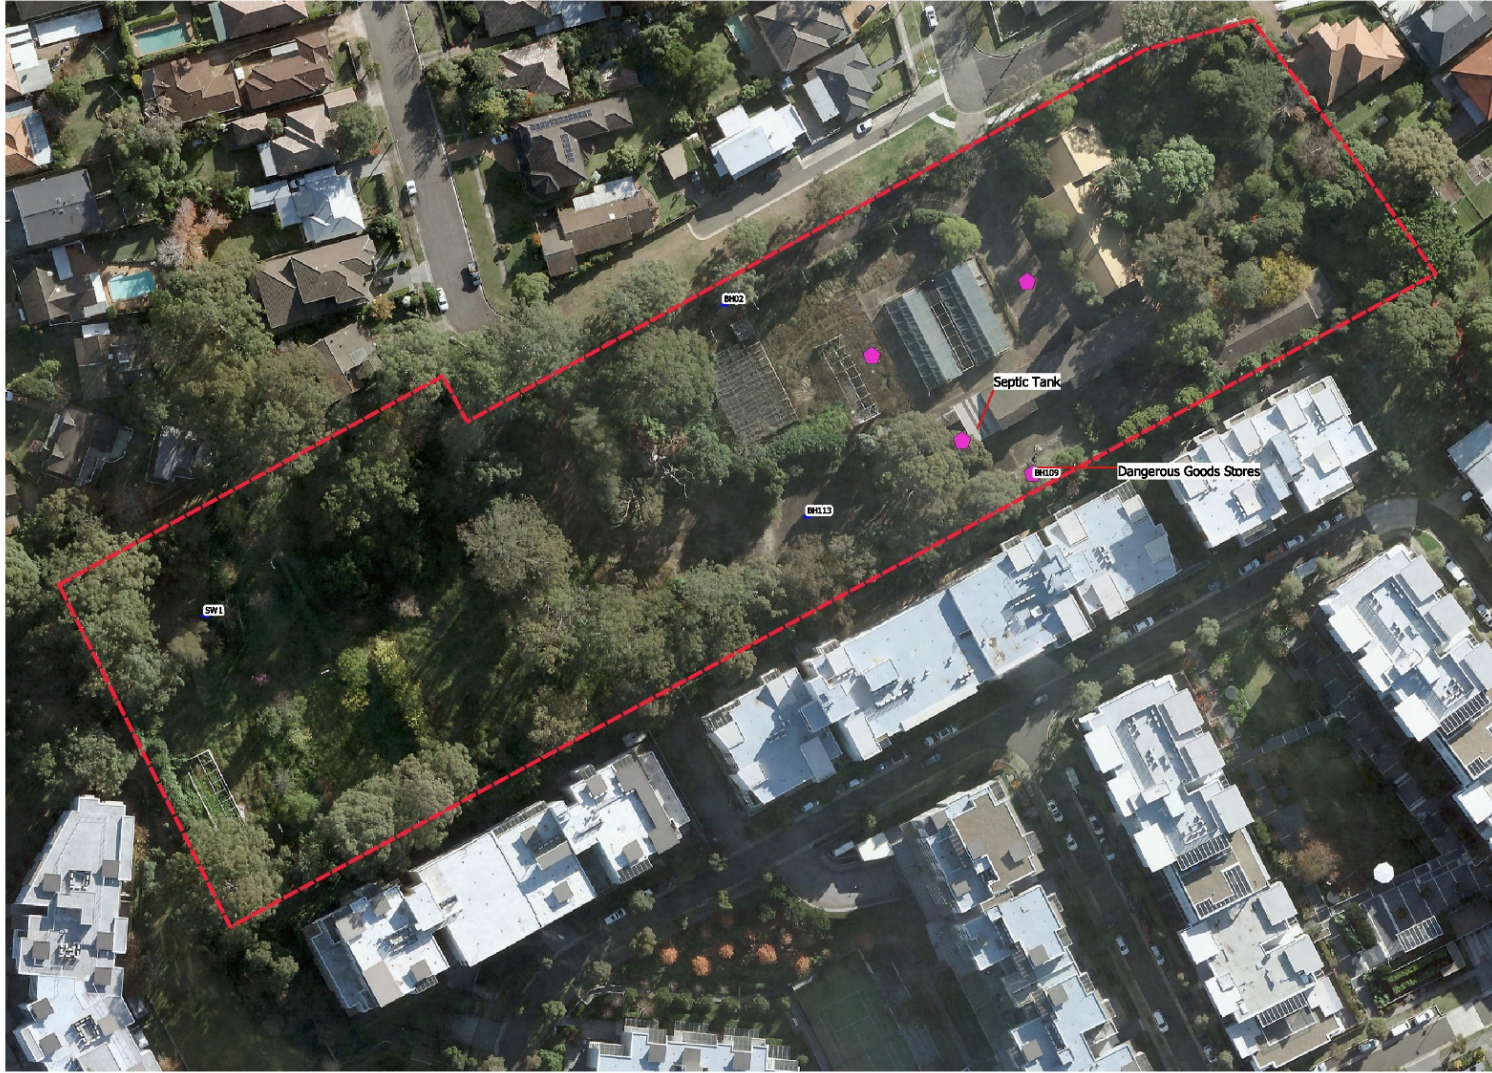
TITLE: **Proposed Groundwater Well Location**
Epping South Public School
 86 Chelmsford Ave, Epping

Description	Extent of Investigation/Remediation Required	Preferred Options
Additional groundwater and surface water investigations to assess the data obtained to determine if TPH and/or BTEX in groundwater and surface water potentially pose a risk to future site users	<p>Construction of four additional groundwater monitoring wells in central portions of the site to assess groundwater impacts in new wells and the existing well BH113.</p> <p>Additional surface water sampling of the onsite detention basin.</p> <p>The RAP recommends these investigations be conducted as early as practical (potentially prior to demolition).</p>	<p>Installation of an additional four wells in locations shown on Attachment 4, Appendix A. Contingency remediation options for groundwater contamination are provided in the RAP comprising:</p> <ul style="list-style-type: none"> • Source removal (if identified). • Further investigation/ assessment to determine the actual risk to future site users. <p>Preparation of a Groundwater RAP for Auditor approval if required.</p>

Item	Aspect	Sampling Frequency	Analytes
Data gap assessment	Groundwater and surface water	4 new wells to 15 m, sampling of new wells and BH113, sampling of onsite detention basin	TRH, TPH (with silica gel clean up) and BTEX
Data gap assessment	Previously inaccessible area	2 test pits 0.2 m into natural	Metals, PAH, TPH, BTEX, OCP/OPP, PCB and asbestos
Validation of decommissioning	Flammable Store, Shed 1 and Shed 2	<p>At least 1 sample targeting the former waste pit (west of Shed 2)</p> <p>At least 1 sample targeting the former bunded area (east of Shed 1)</p> <p>1 per 5 m length from any former below ground pipework, including the floor waste (minimum of one sample per pipe)</p> <p>Targeted sampling of any other potentially contaminated soils as identified by the inspection</p> <p>A minimum of 1 sample within the former building footprint per former building (including any targeted contamination samples collected from the building)</p> <p>Minimum of 2 samples per former building perimeter (including any targeted contamination samples collected from the building).</p>	<p>TRH, BTEXN, phenols, OCP, OPP, VOC.</p> <p>Additional analysis of at least 2 samples from the building perimeter of the Flammable Goods Store for asbestos and PCB</p>
