## **5-9 Cowan Road St Ives**

### **Desktop Aboriginal Due Diligence Assessment**

Prosper 5-9 Cowan Road Pty Ltd

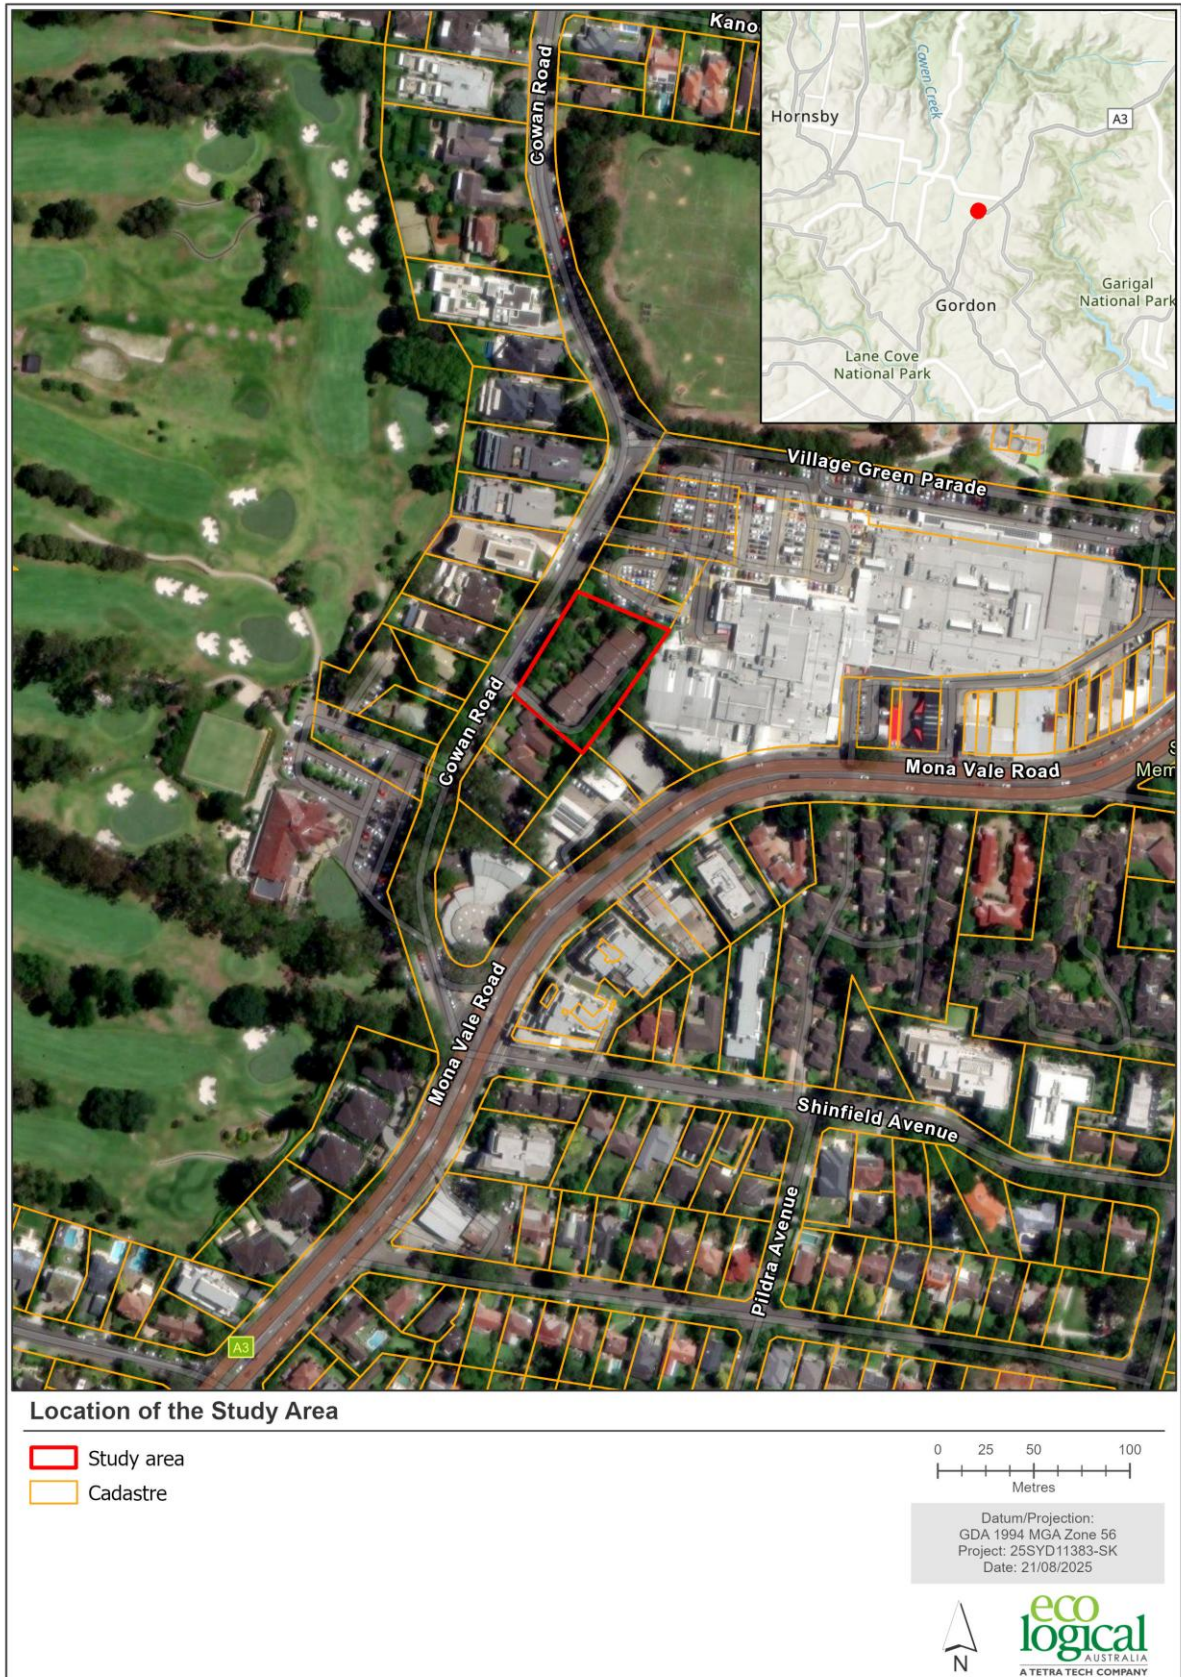
Figure 1: The study area

The study area is located at 5-9 Cowan Road, St Ives, within the Ku-ring-gai Local Government Area, and is legally described as SP30097 (Figure 1). The study area has an area of approximately 3,467.7sqm and is rectangular in shape.

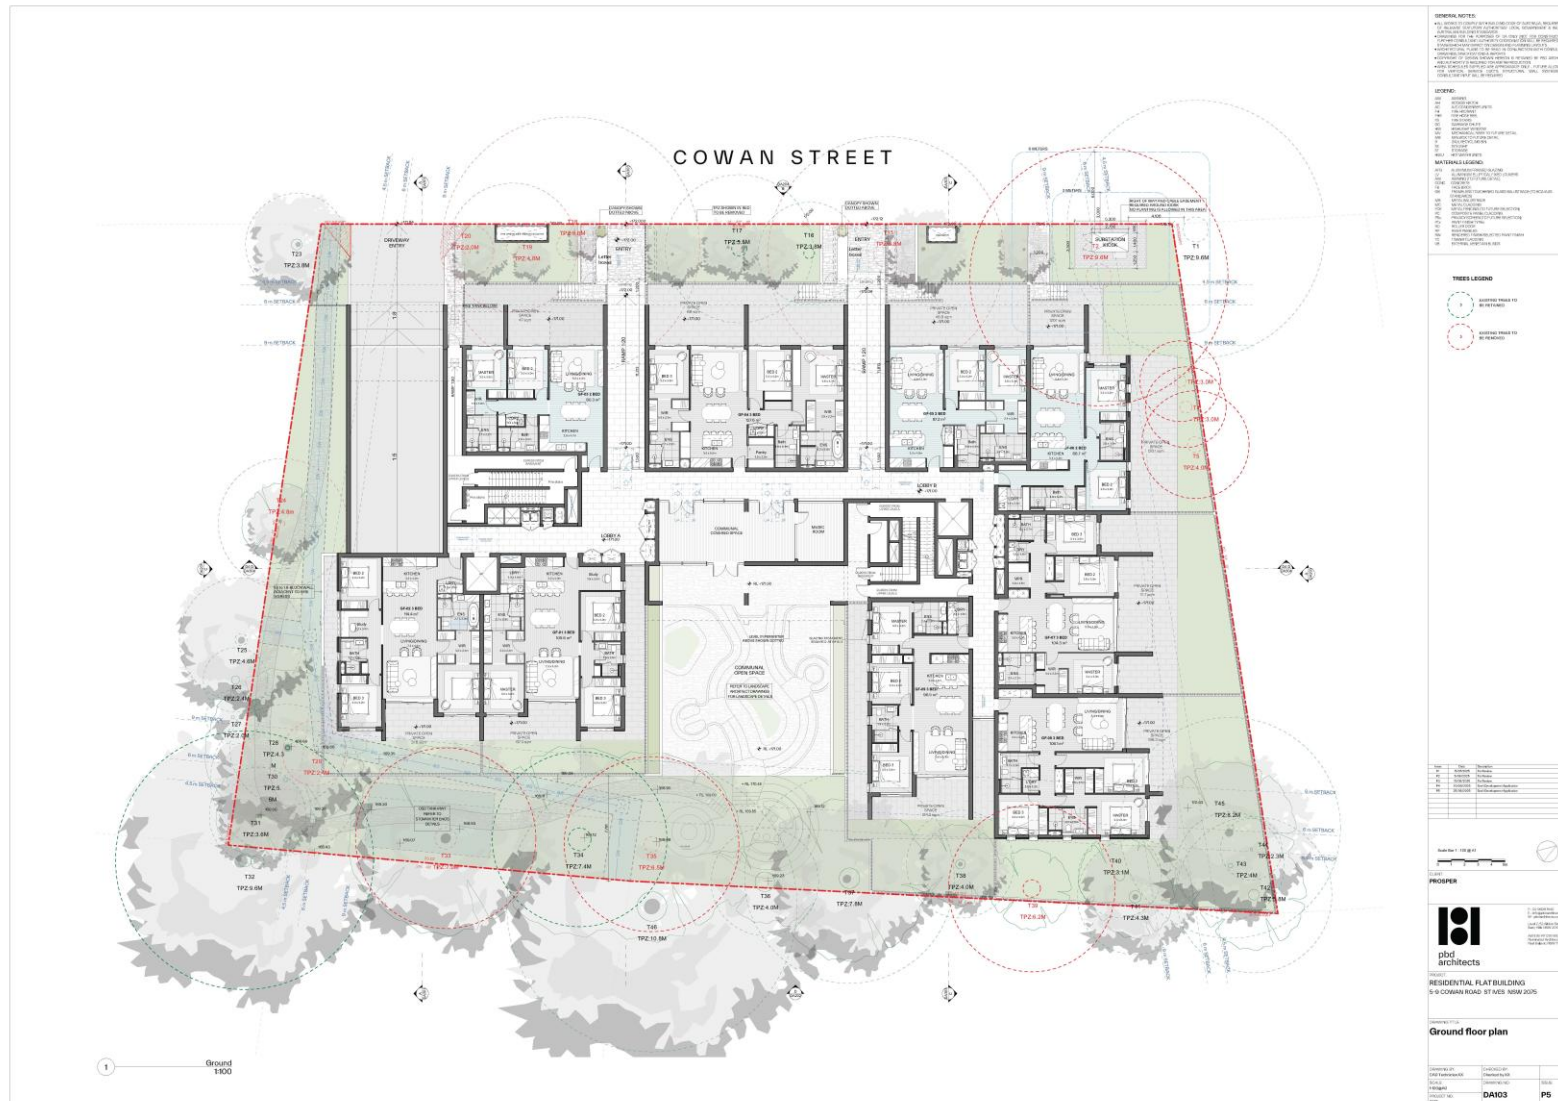
Figure 2: Ground floor plan (PBD Architects, 2025)

These works will disturb the ground surface. A plan of the proposed works has been provided by Prosper 5-9 Cowan Road Pty Ltd (Figure 2).

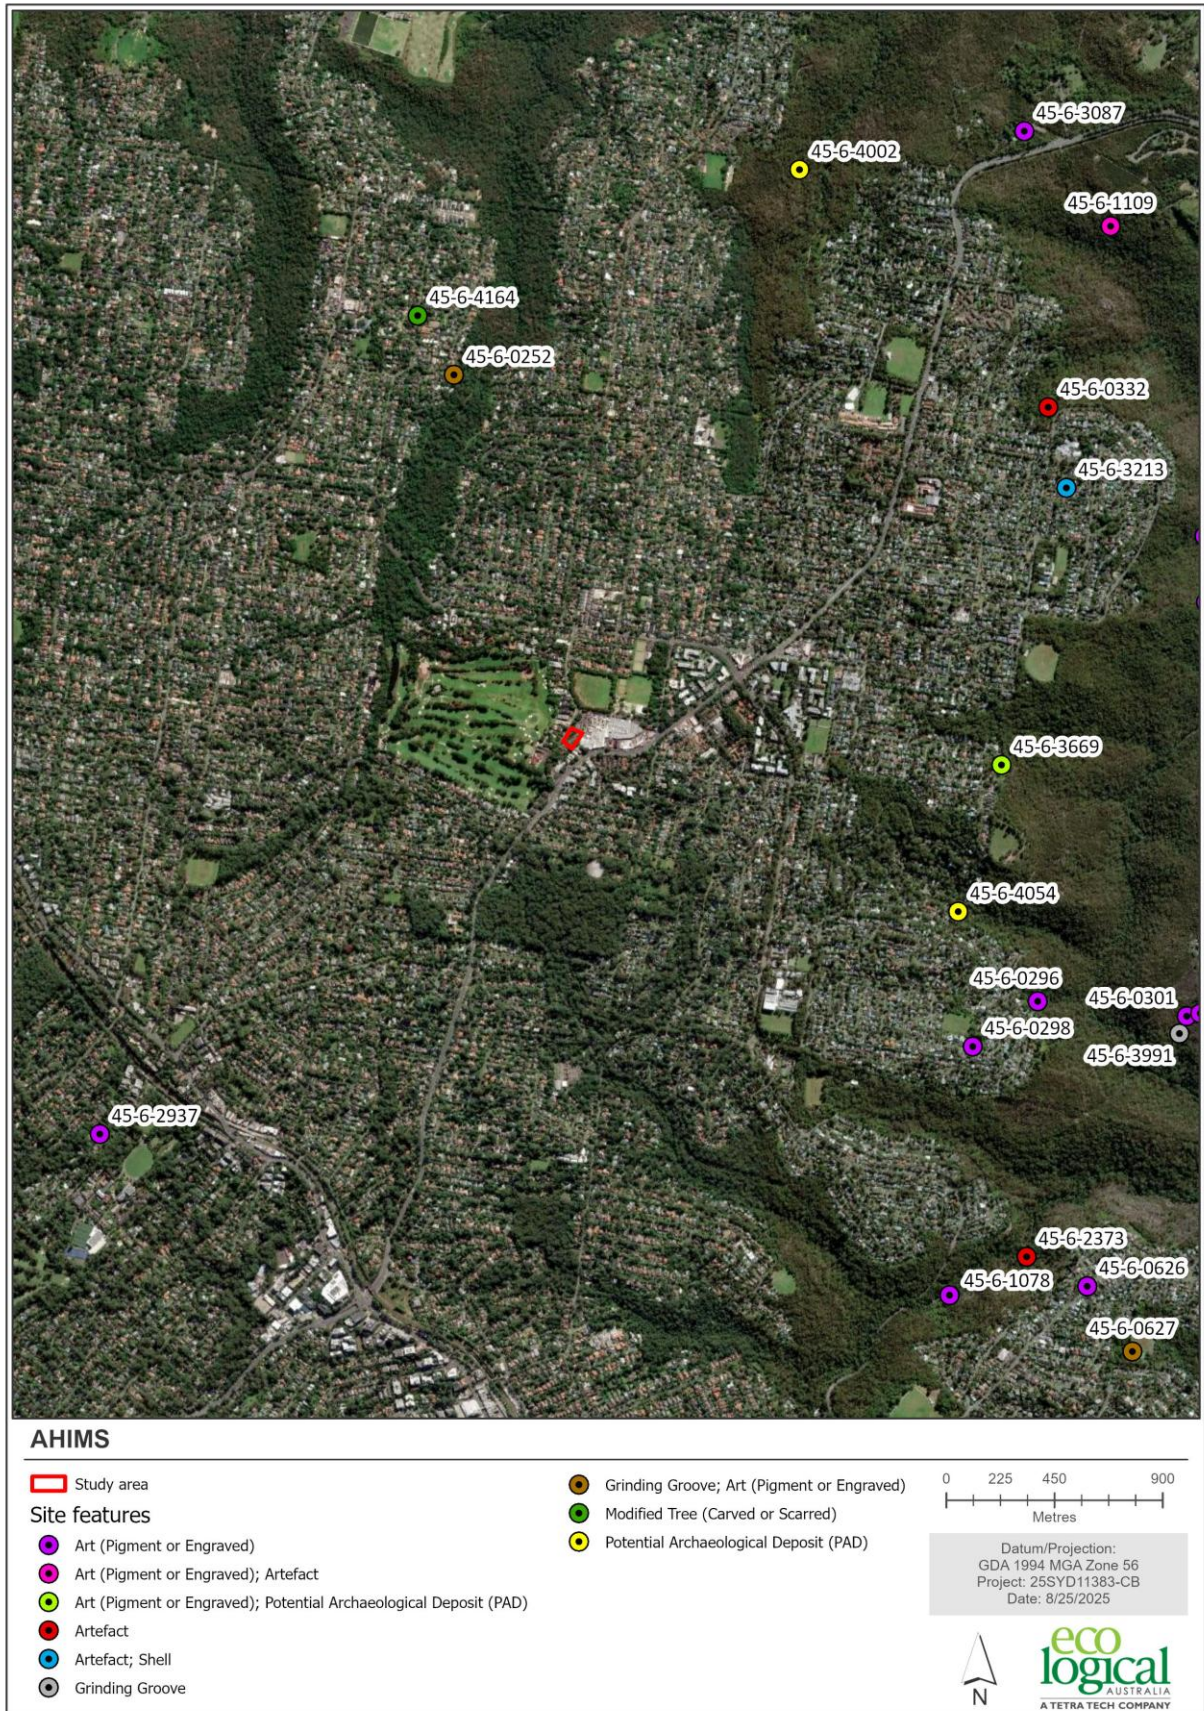
Figure 3: AHIMS sites within the search parameters

The distribution of recorded Aboriginal sites adjacent to the study area is shown in Figure 3. The frequencies of site types and contexts recorded within the AHIMS database search area are listed below.

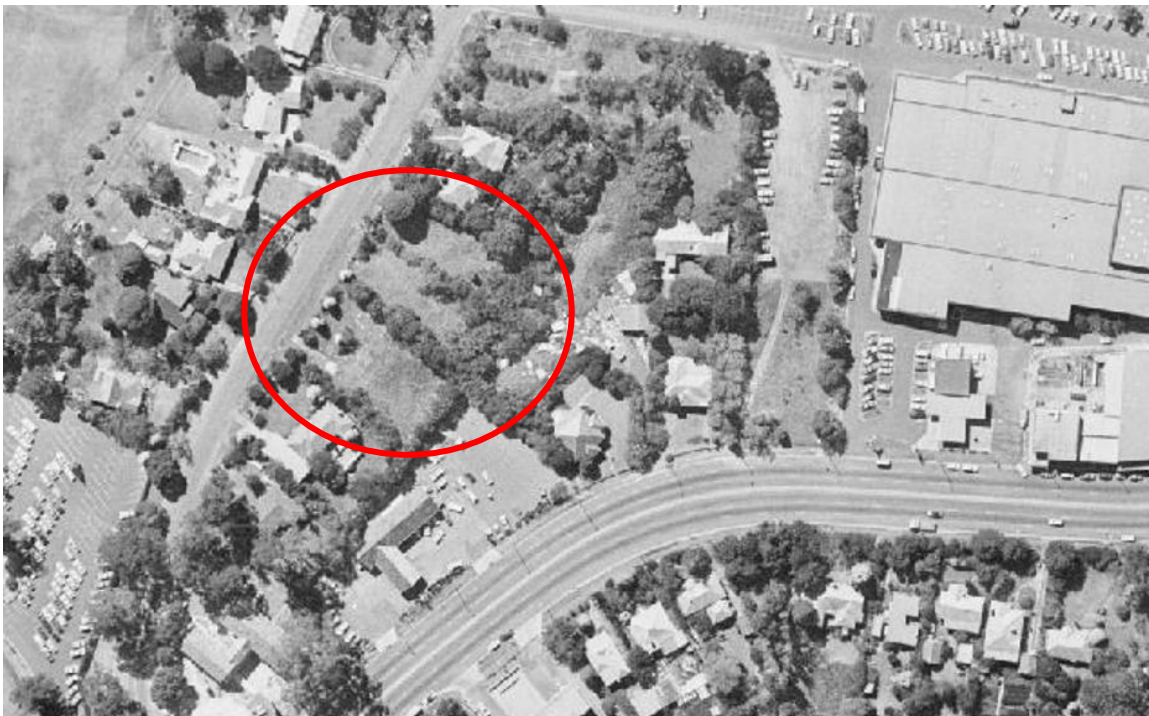
Figure 5: Aerial imagery of study area (red circle) 1978 (Historical imagery viewer)

A review of historical aerals from 1978 indicates that the dwellings now present at 5-9 Cowan Road had yet to be developed, however, clearing and urban development had occurred within the bounds of and surroundings of the study area, with established infrastructure present, reduced presence of farming activity and indication of suburban development occurring.

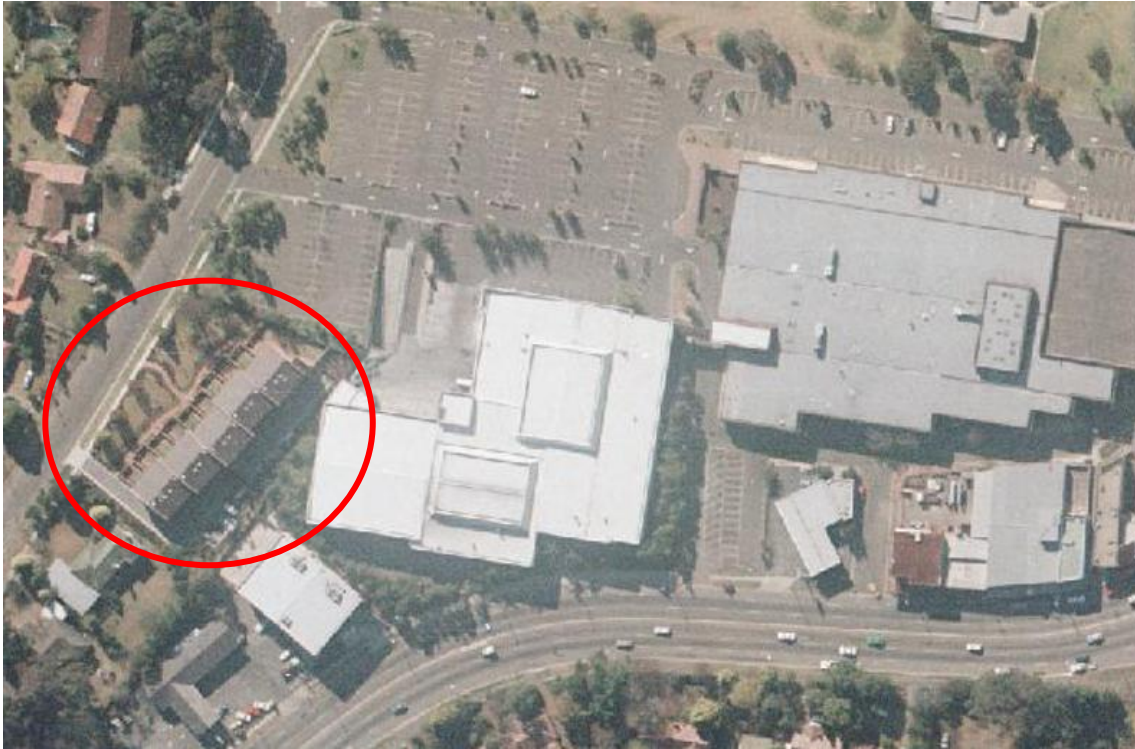
Figure 6: Aerial imagery of study area (red circle) 1986 (Historical imagery viewer)

By 1986, development had increased, with the establishment of several homes within the extent of the study area, accompanied by landscaping and the removal of vegetation. The surrounding area had additionally become more developed, with past green spaces being replaced by parking lots, as well as the establishment of the shopping centre directly adjacent to the study area. As such, it can be visualised that extensive disturbances relating to development of residential and commercial buildings as part of the wider St Ives and Ku-ring-gai municipality suburban growth strategy have impacted on the study area and its adjacent surroundings.

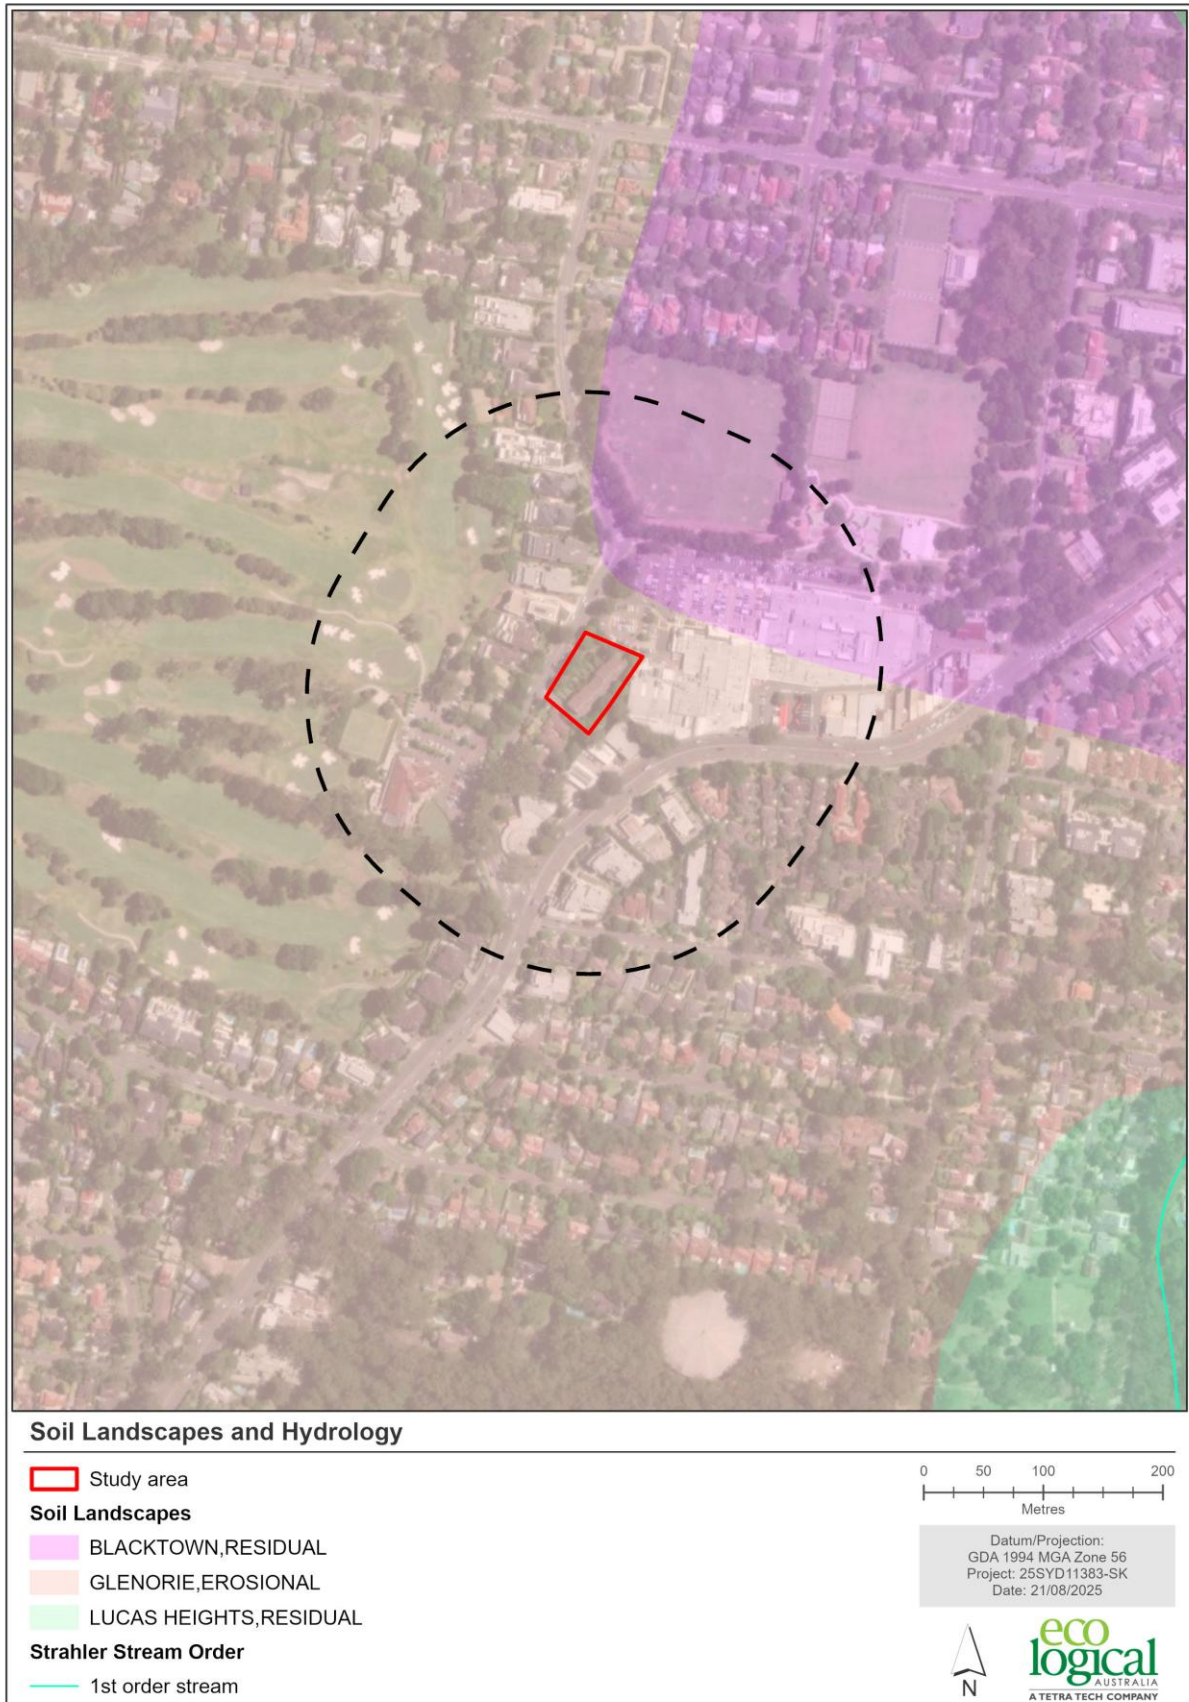
Figure 7: Soil Landscapes and hydrology (including 100 m buffer)

The study area is situated in the Cumberland subregion of the NSW Sydney Basin bioregion of NSW and is located within the Glenorie soil landscape (see Figure 5). A summary of the geology, landforms, soils, and vegetation that is typical within the subregion is provided below:

The study area is located within the Glenorie Erosional soil landscape, which is dominated by the undulating to rolling hills of the Wianamatta Group shales. Soils are typically shallow to moderately deep (<100cm) and are generally podzolic. Soils are typically impermeable and plastic, with high soil erosion hazards, and transition from friable loams (A1 horizon; topsoil), to pedal or plastic clays (B horizon), varying in colour from reddish brown to brownish grey.
