Geotechnical Investigation

Lot 4-5, 6-7 and 8, Buchan Avenue, Edmondson Park, NSW

Report No: E26949.G03_Rev2

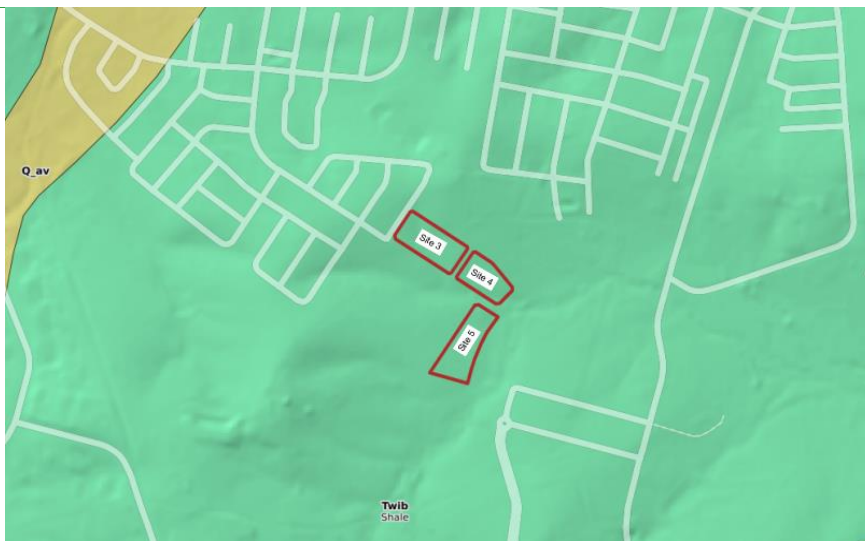
Plate 2 Excerpt of NSW Seamless Geology with site indicated (Source: MinView)

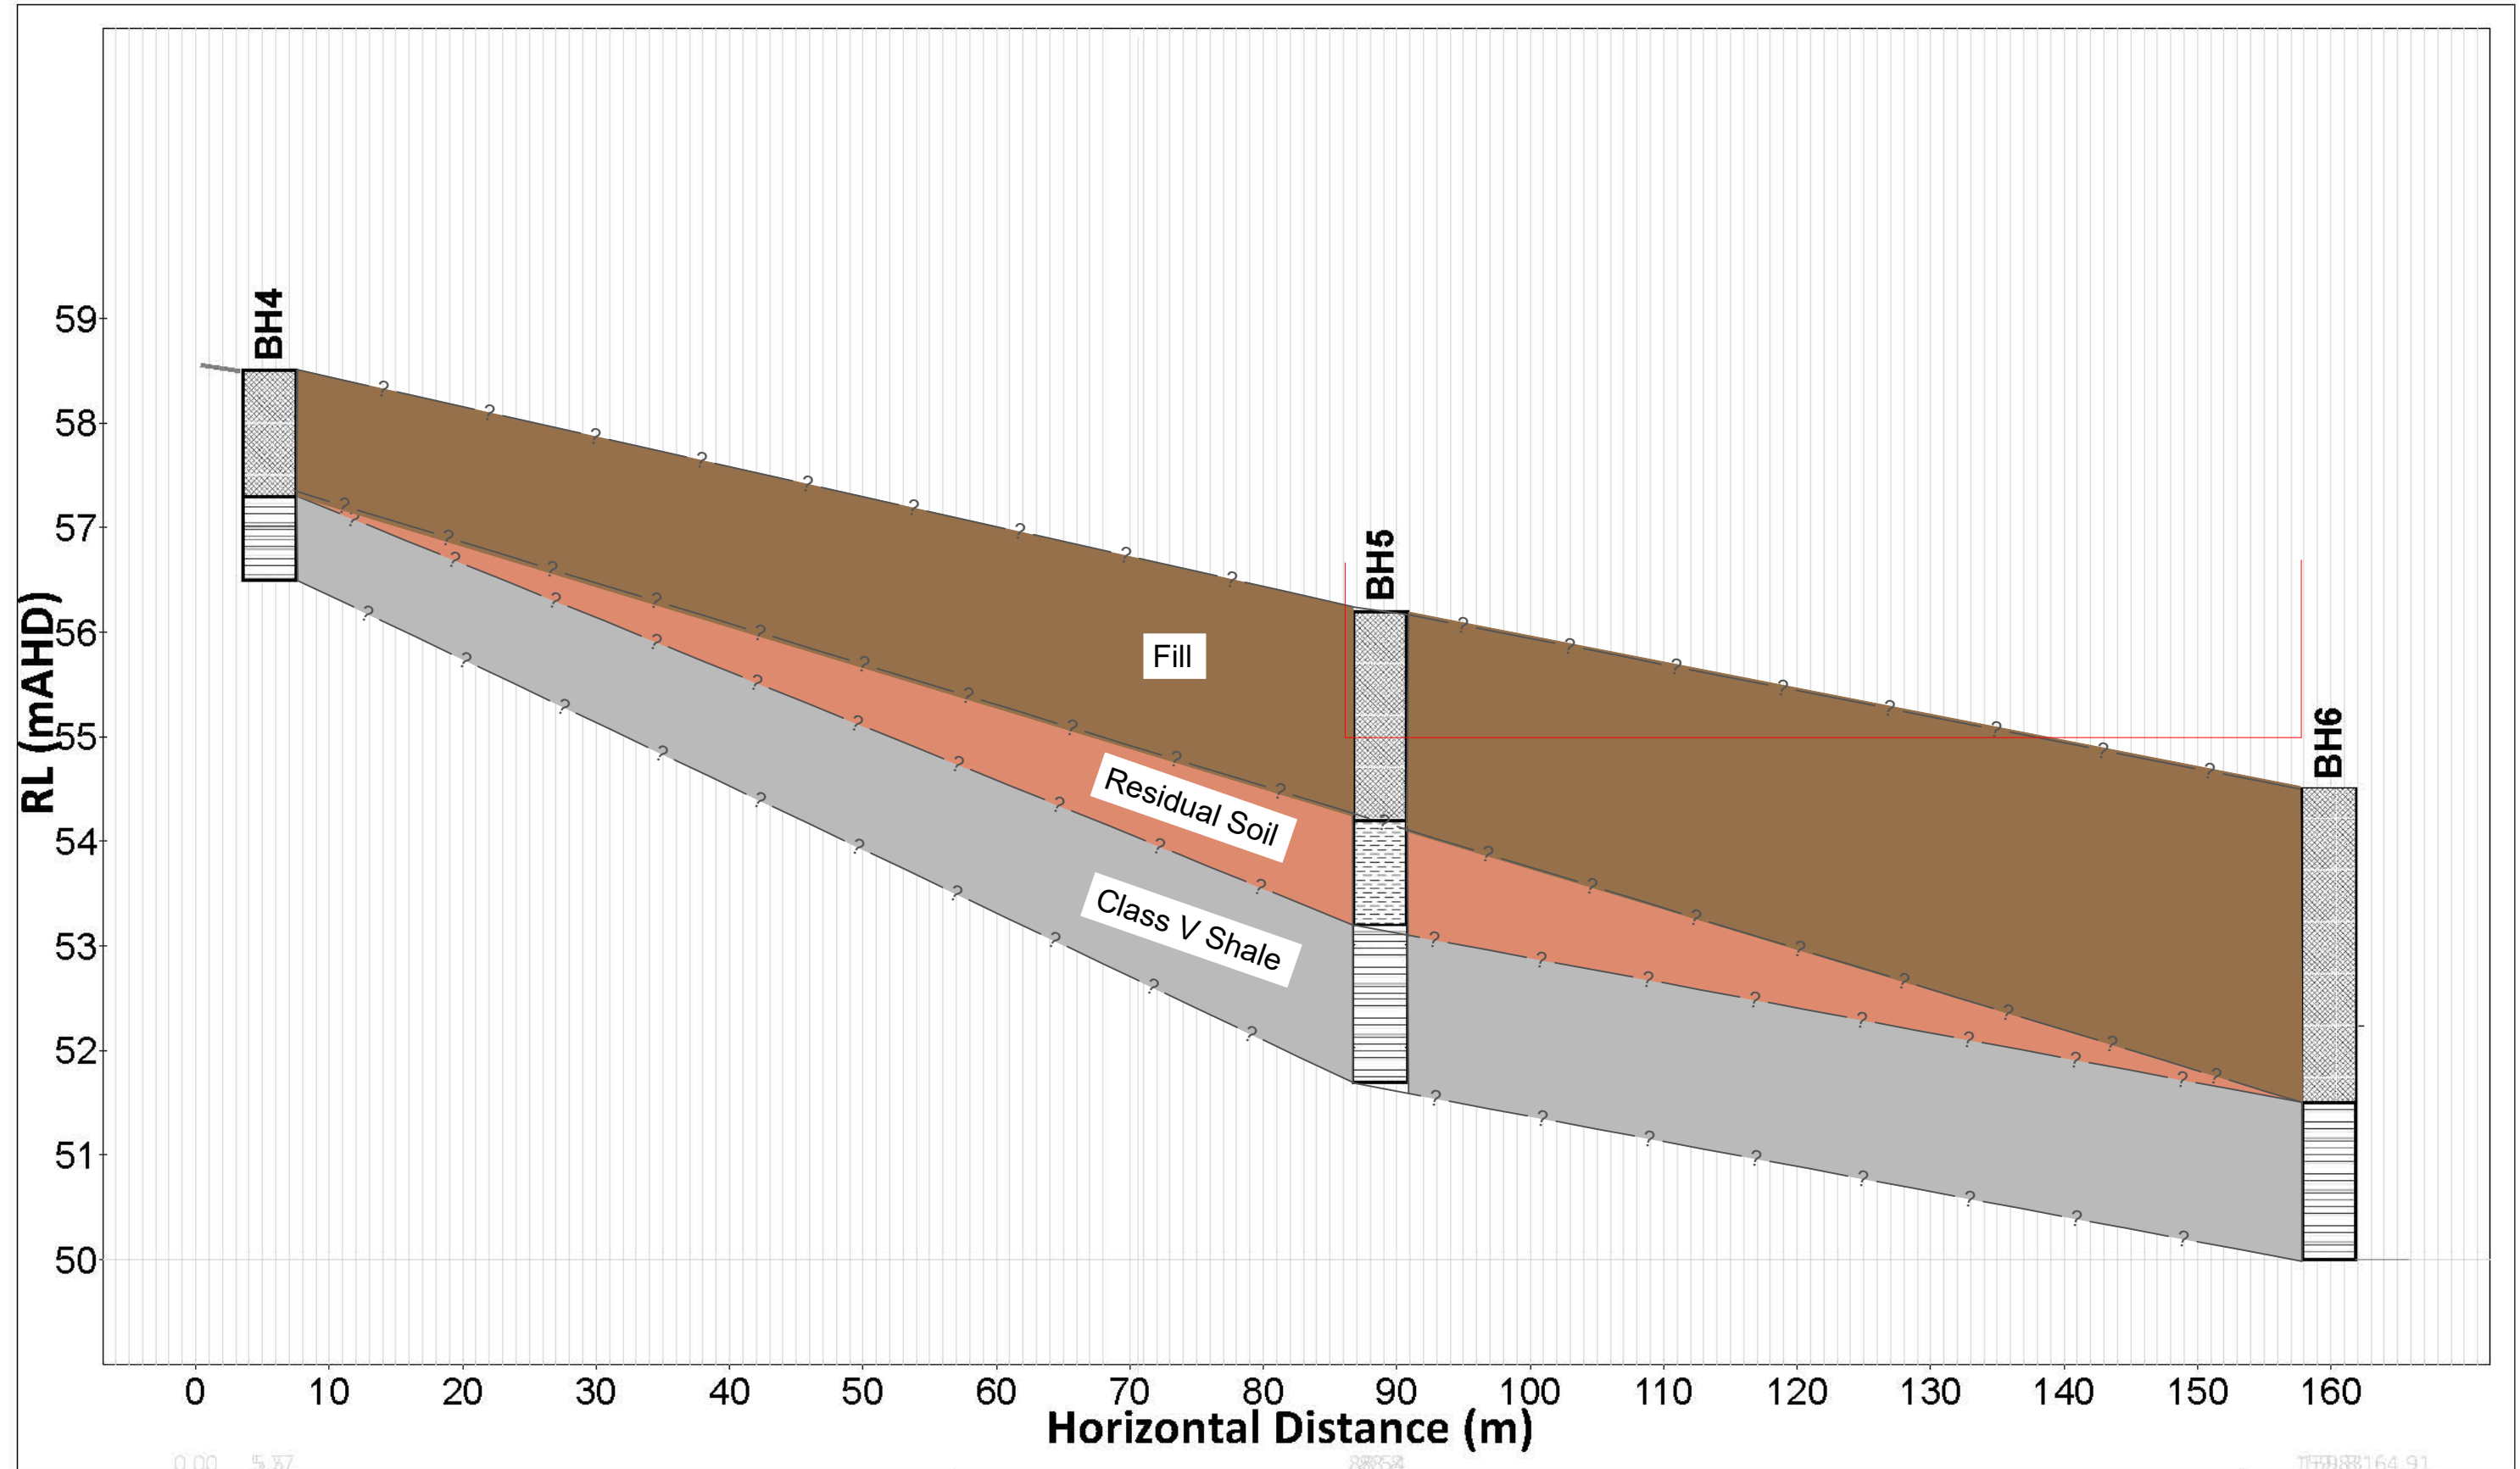
- - - Approximate Excavation Boundary
- Fill
- Residual Soil
- Class V / IV Shale
- Class III Shale

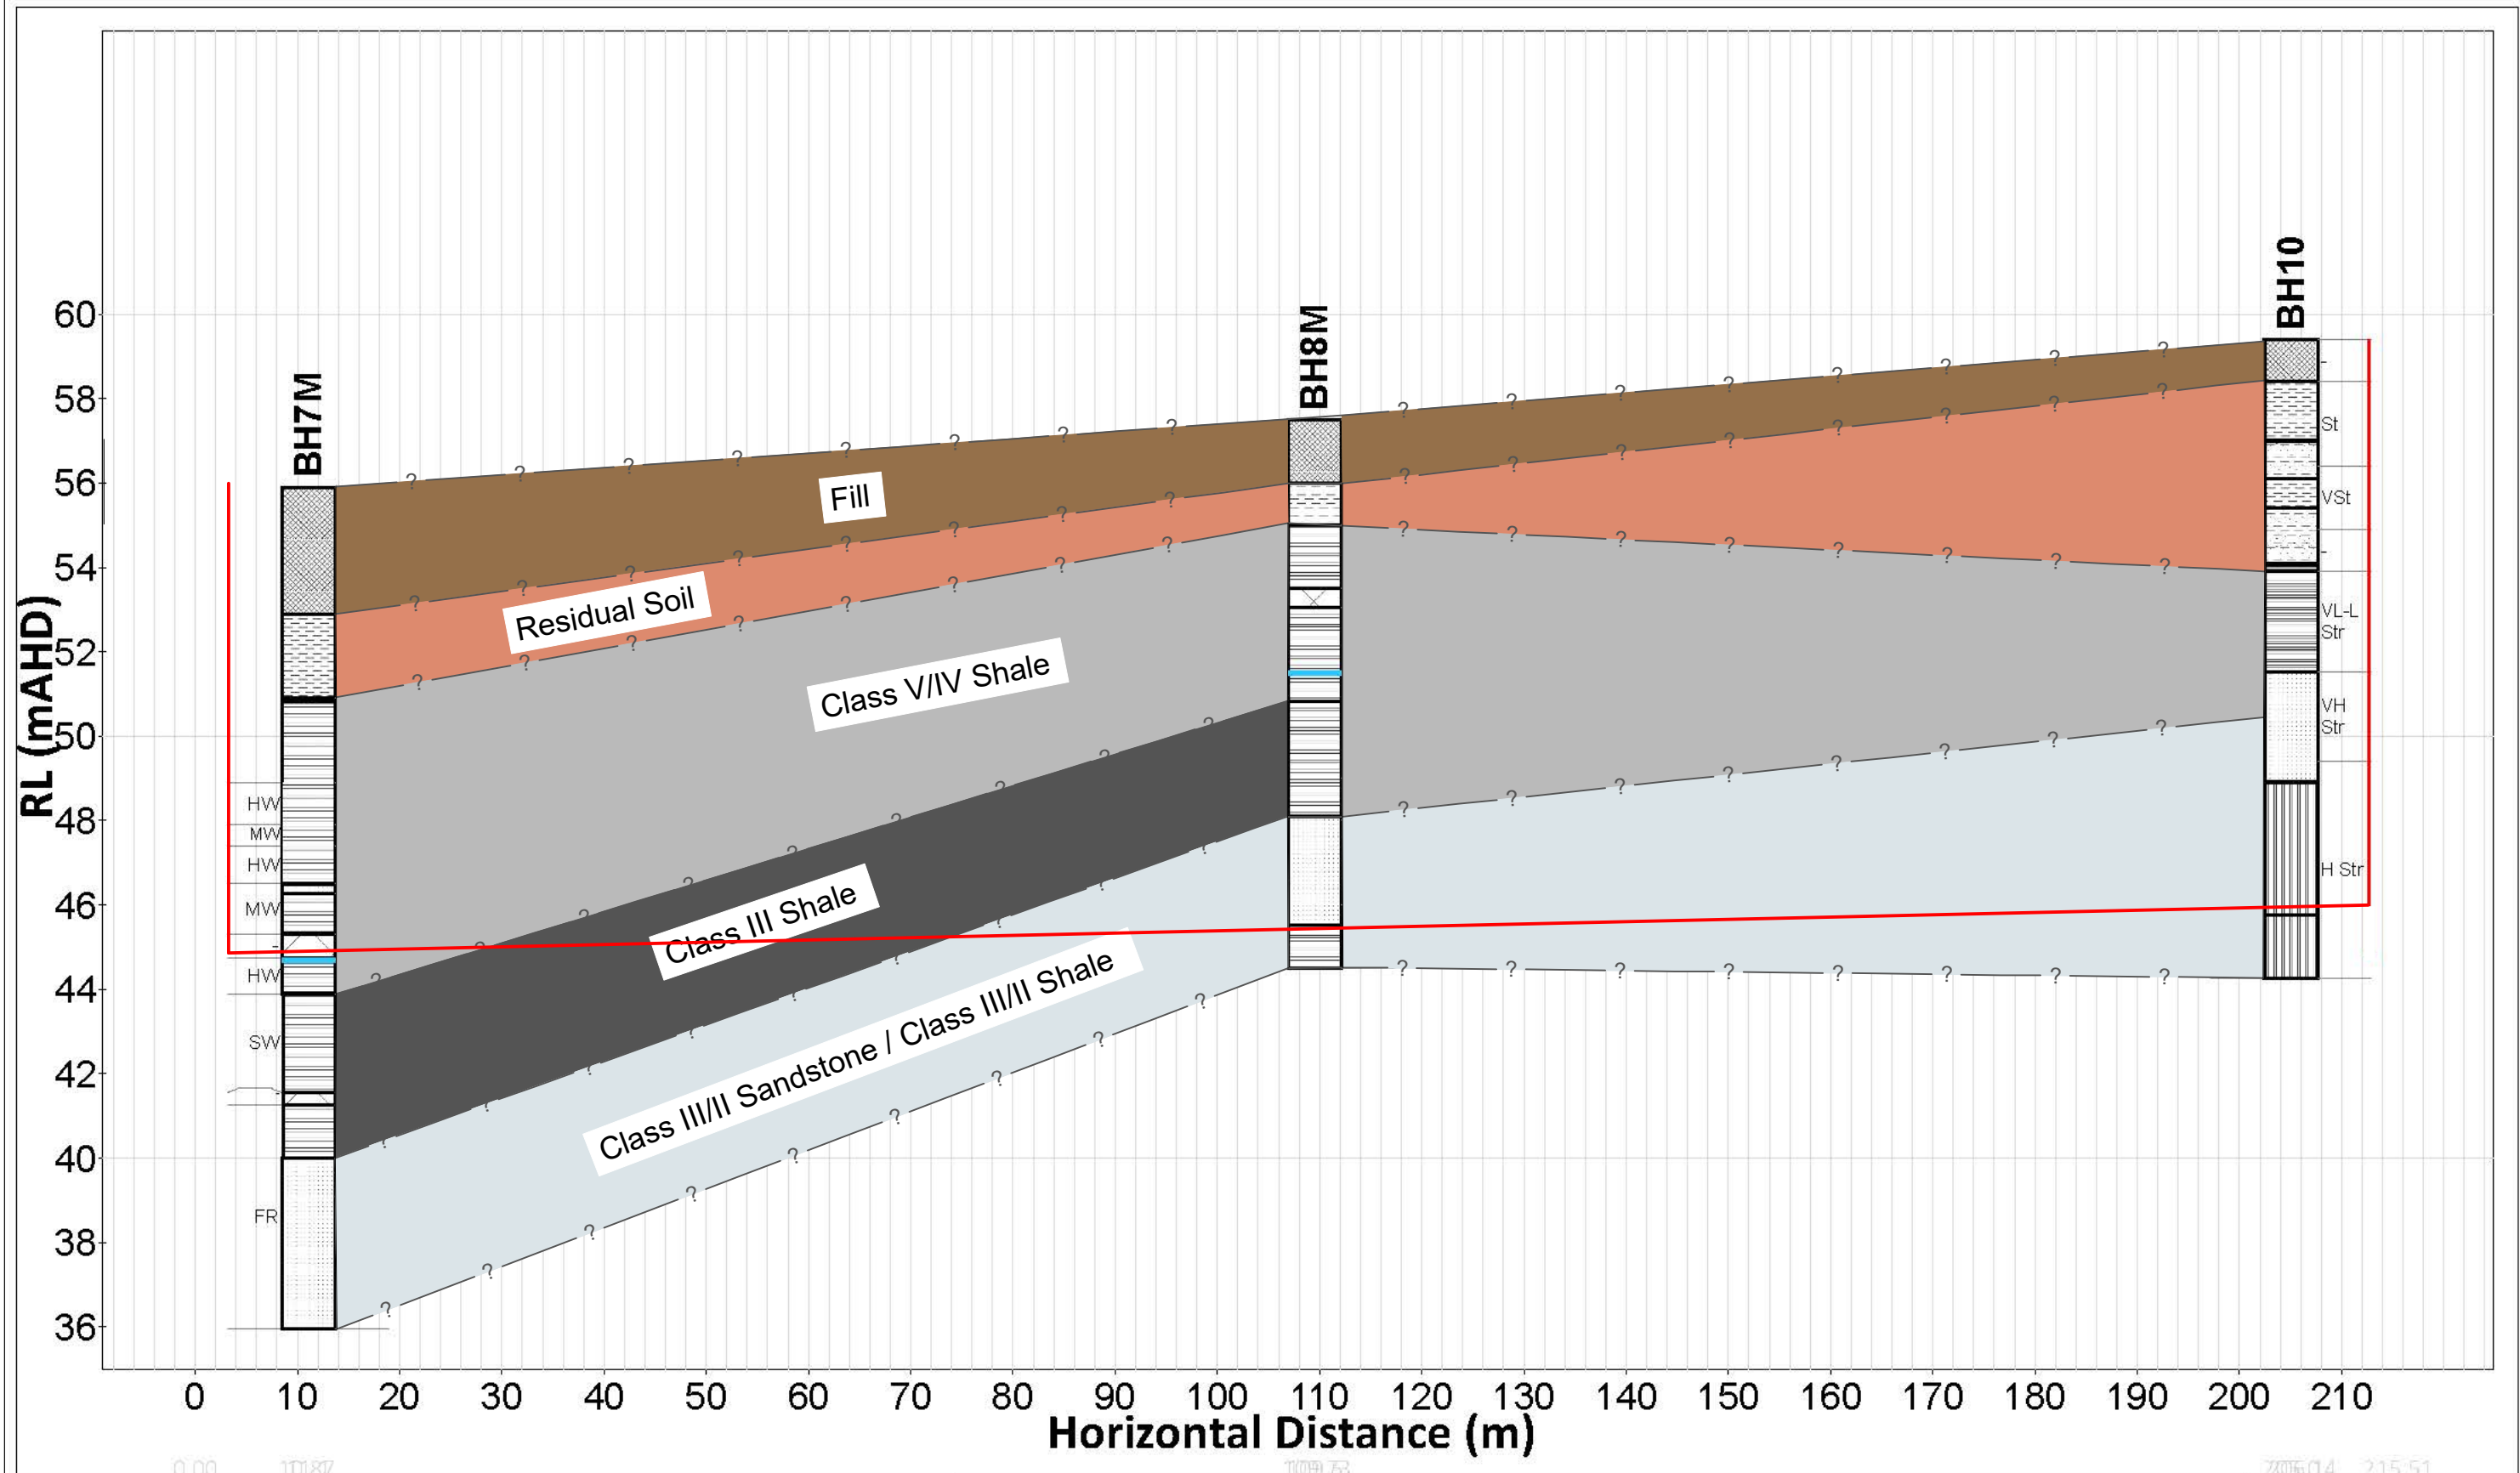
- Approximate Excavation Boundary
- Fill
- Residual Soil
- Class V / IV Shale
- Class III Shale
- Class III/II Sandstone / Class III/II Shale

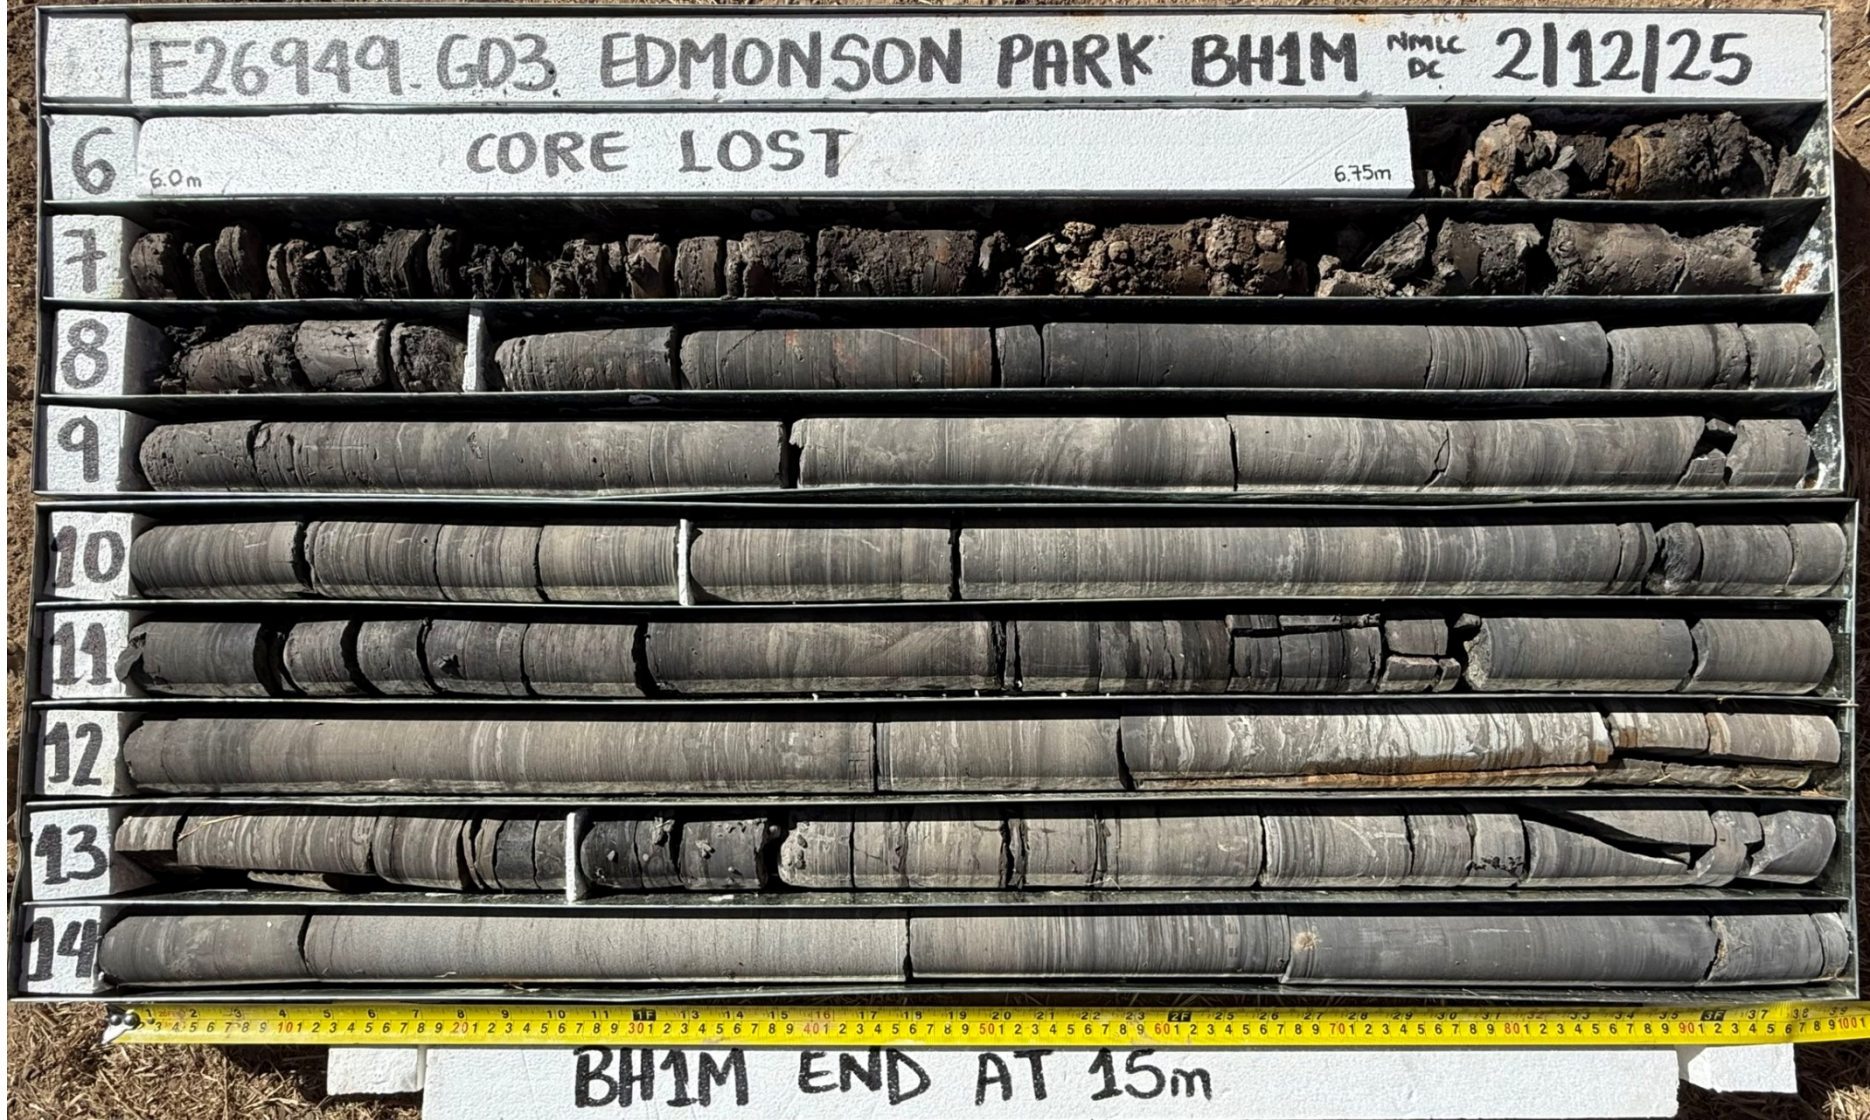
CORE PHOTOGRAPH OF BOREHOLE: BH1M

Project	Proposed Development	East	301685.081	Depth Range	6.0m to 15.0m	
Location	Lot 4 to 8 Buchan Avenue, Edmondson Park, NSW	North	6239623.591	Contractor	Geosense Drilling Engineers	
Position	See Figure 2	Surface RL	63.7 mAHD	Drill Rig	Comacchio Geo 205	
Job No.	E26949.G03	Inclination	90°	Logged	DC	Date 04 / 12 / 2025
Client	UPG Edmondson Parkland Pty Ltd	Box	1-2 of 2	Checked	SK	Date 29 / 01 / 2026

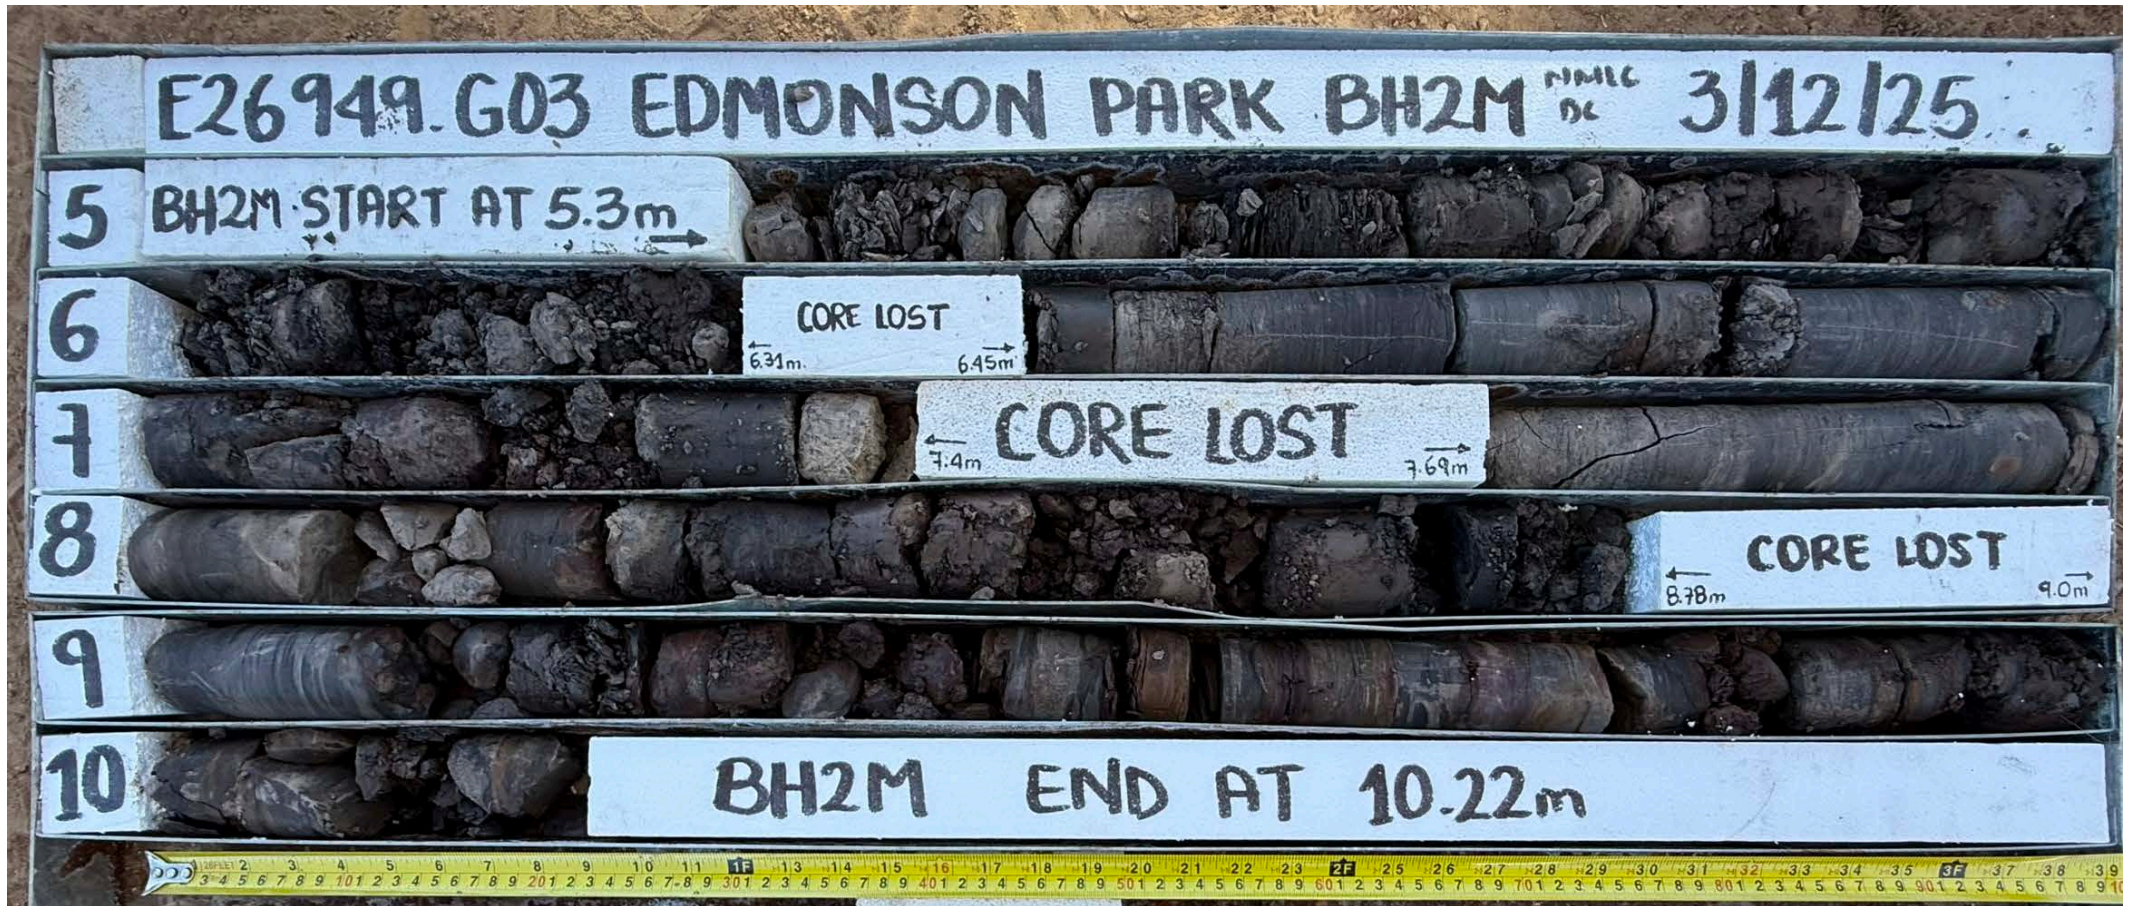
CORE PHOTOGRAPH OF BOREHOLE: BH2M

Project	Proposed Development	East	301778.143	Depth Range	5.3m to 10.22m	
Location	Lot 4 to 8 Buchan Avenue, Edmondson Park, NSW	North	6239631.956	Contractor	Geosense Drilling Engineers	
Position	See Figure 2	Surface RL	62.7 mAHD	Drill Rig	Comacchio Geo 205	
Job No.	E26949.G03	Inclination	90°	Logged	DC	Date 03/ 10 / 2025
Client	UPG Edmondson Parkland Pty Ltd	Box	1-2 of 2	Checked	SK	Date 29 / 01 / 2026

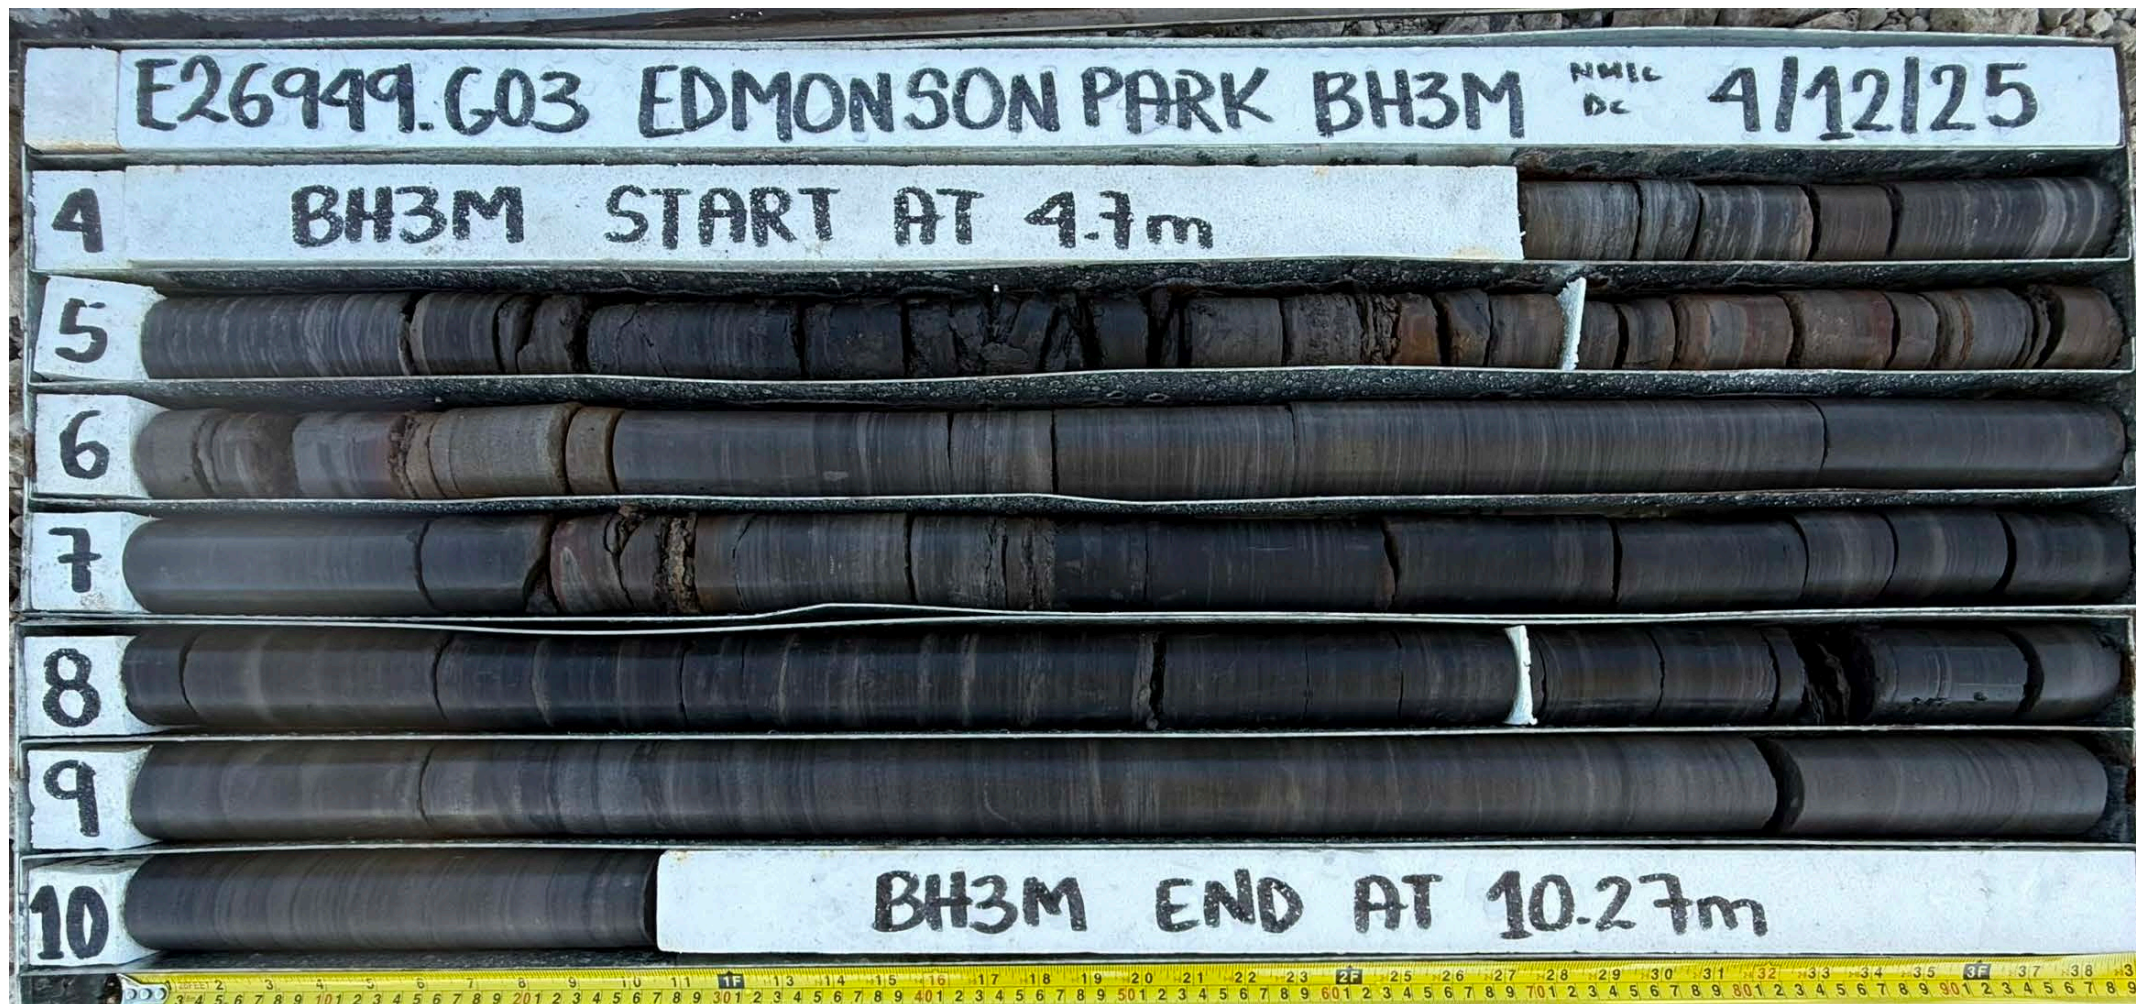
CORE PHOTOGRAPH OF BOREHOLE: BH3M

Project	Proposed Development	East	301802.598	Depth Range	4.7m to 10.27m	
Location	Lot 4 to 8 Buchan Avenue, Edmondson Park, NSW	North	6239553.484	Contractor	Geosense Drilling Engineers	
Position	See Figure 2	Surface RL	57.5 mAHD	Drill Rig	Comacchio Geo 205	
Job No.	E26949.G03	Inclination	90°	Logged	DC	Date 03 / 12 / 2025
Client	UPG Edmondson Parkland Pty Ltd	Box	1-2 of 2	Checked	SK	Date 29 / 01 / 2026

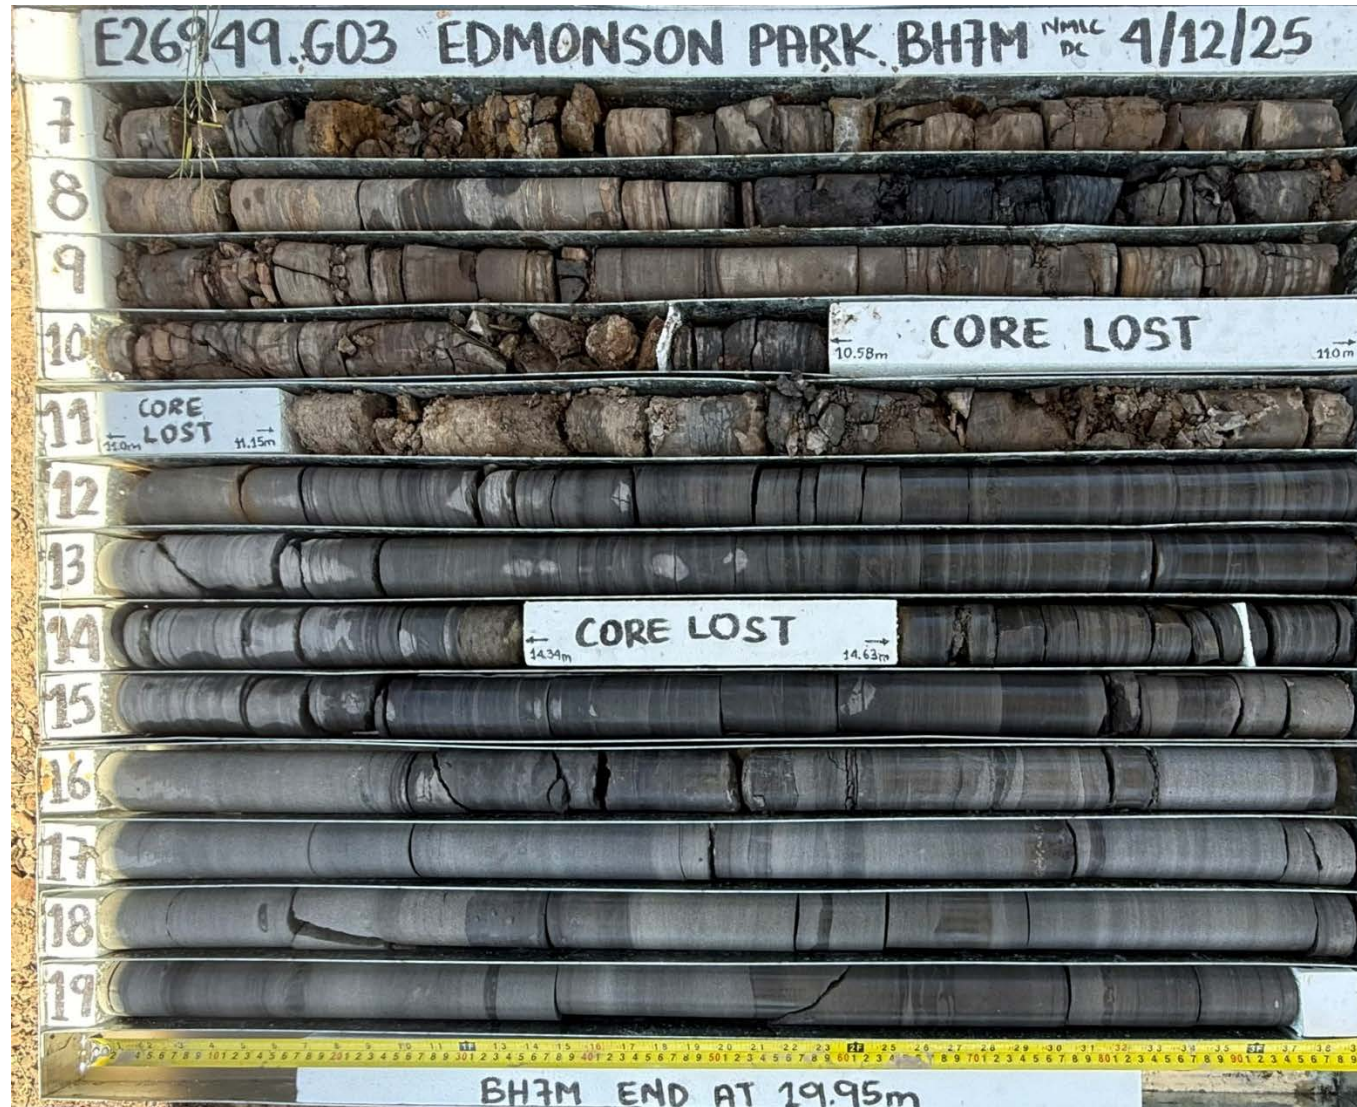
Project	Proposed Development	East	301906.656	Depth Range	7.0m to 19.95m	
Location	Lot 4 to 8 Buchan Avenue, Edmondson Park, NSW	North	6239439.581	Contractor	Geosense Drilling Engineers	
Position	See Figure 2	Surface RL	55.9 mAHD	Drill Rig	Comacchio Geo 205	
Job No.	E26949.G03	Inclination	90°	Logged	DC	Date 04 / 12 / 2025
Client	UPG Edmondson Parkland Pty Ltd	Box	1-3 of 3	Checked	SK	Date 29 / 01 / 2026

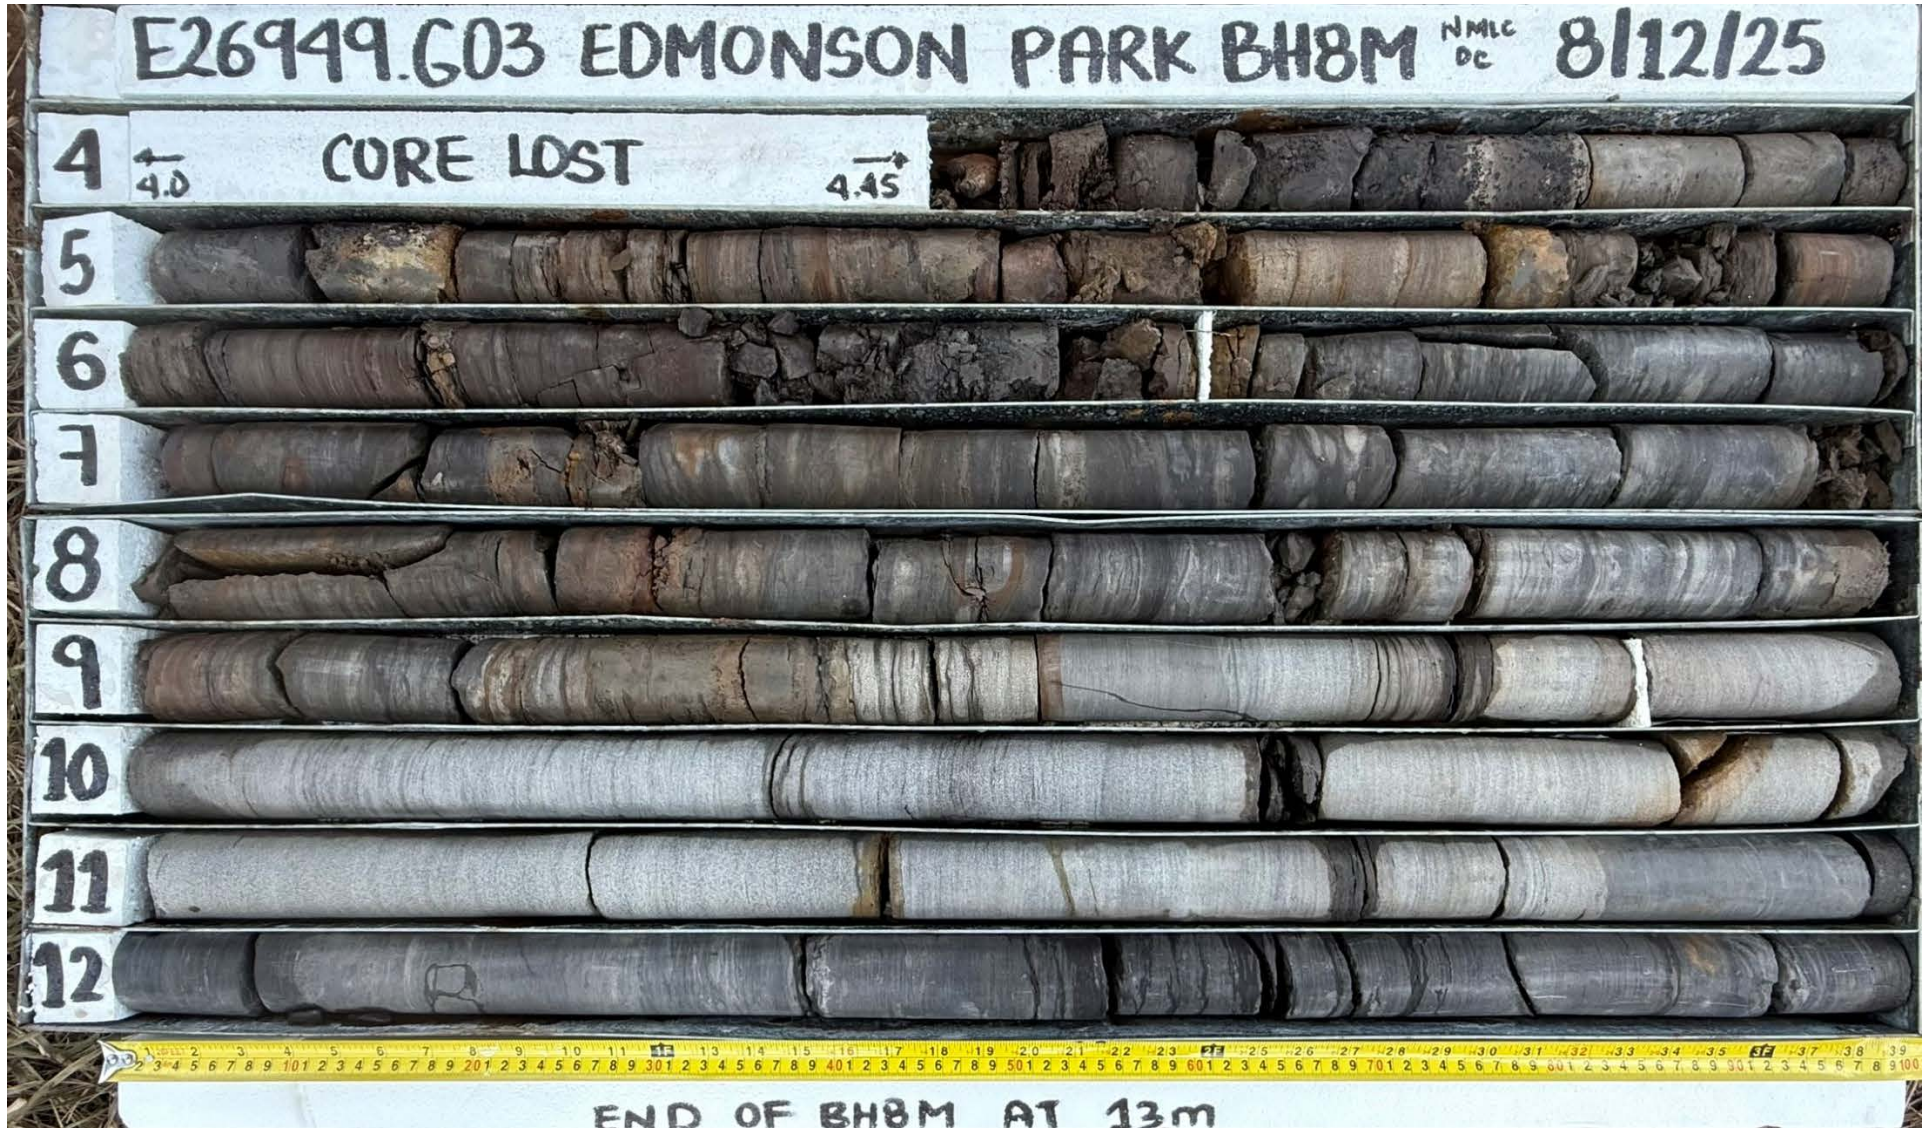
Project	Proposed Development	East	301821.331	Depth Range	4.0m to 13.0m		
Location	Lot 4 to 8 Buchan Avenue, Edmondson Park, NSW	North	6239390.491	Contractor	Geosense Drilling Engineers		
Position	See Figure 2	Surface RL	57.5 mAHD	Drill Rig	Comacchio Geo 205		
Job No.	E26949.G03	Inclination	90°	Logged	DC	Date	08/12/2025
Client	UPG Edmondson Parkland Pty Ltd	Box	1-2 of 2	Checked	SK	Date	29/01/2026

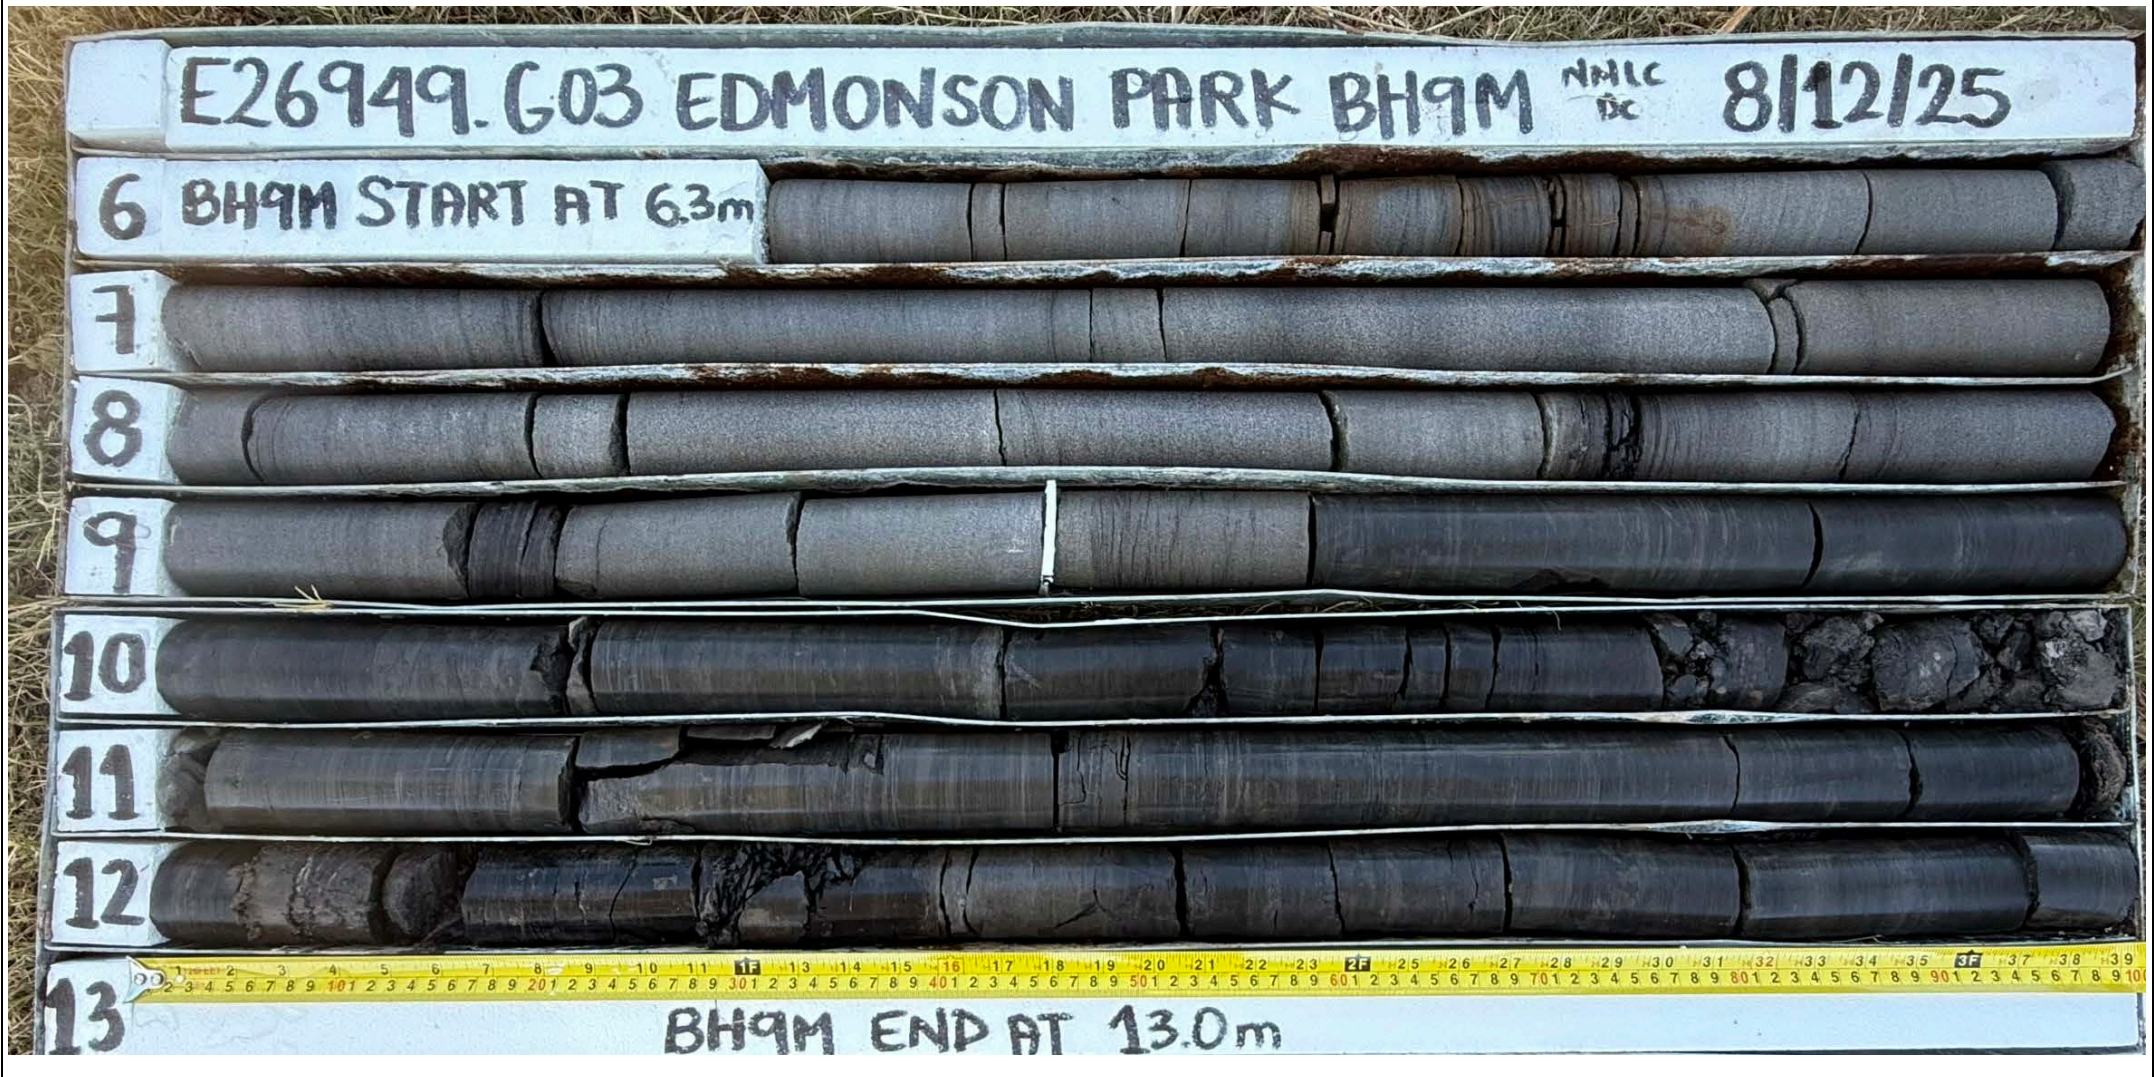
CORE PHOTOGRAPH OF BOREHOLE: BH9M

Project	Proposed Development	East	301835.644	Depth Range	6.3m to 13.0m	
Location	Lot 4 to 8 Buchan Avenue, Edmondson Park, NSW	North	6239301.431	Contractor	Geosense Drilling Engineers	
Position	See Figure 2	Surface RL	58.2 mAHD	Drill Rig	Comacchio Geo 205	
Job No.	E26949.G03	Inclination	90°	Logged	DC	Date 08 / 12 / 2025
Client	UPG Edmondson Parkland Pty Ltd	Box	1- 2 of 2	Checked	SK	Date 29 / 01 / 2026

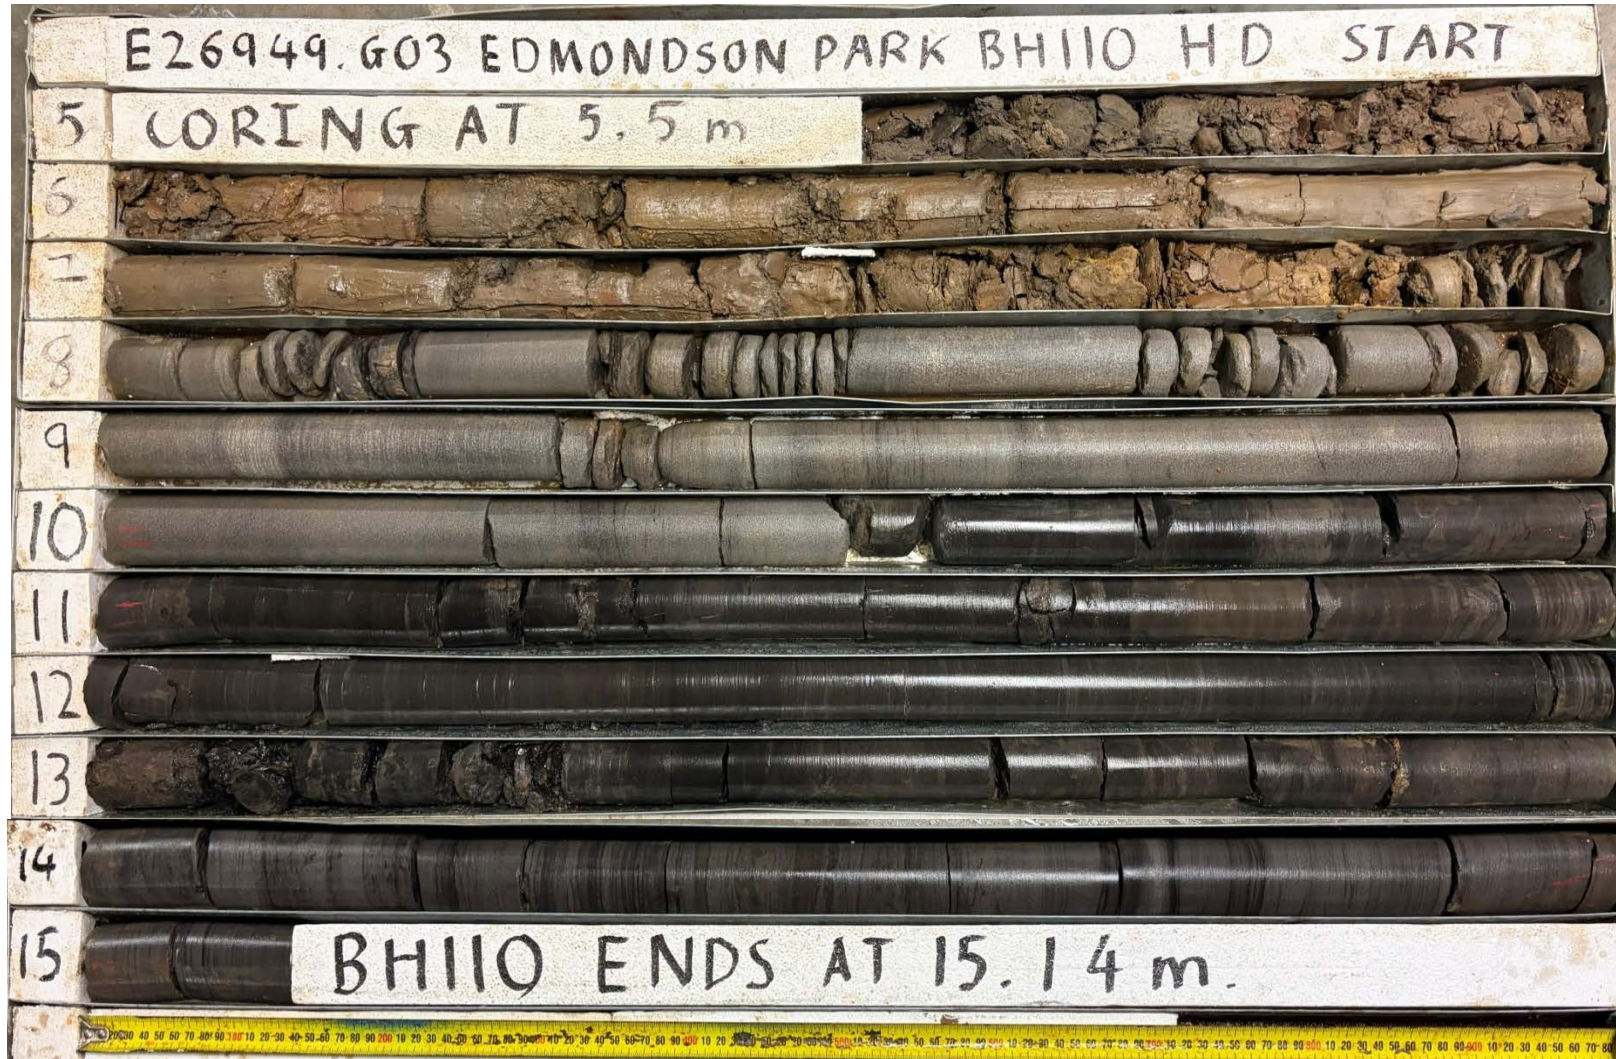
Project	Proposed Development	East	301776.5	Depth Range	5.5m to 15.14m
Location	Lot 4 to 8 Buchan Avenue, Edmondson Park, NSW	North	6239306.5	Contractor	Geosense Drilling Engineers
Position	See Figure 2	Surface RL	59.4 mAHD	Drill Rig	Comacchio Geo 205
Job No.	E26949.G03	Inclination	90°	Logged	HD Date 10 / 12 / 2025
Client	UPG Edmondson Parkland Pty Ltd	Box	1-3 of 3	Checked	SK Date 29 / 01 / 2026
