Remediation Action Plan

Proposed Multi-storey Development

**11 and 15 Kenrick Street and 189 and 195-
197 Union Street, The Junction NSW**

Project 236197.01

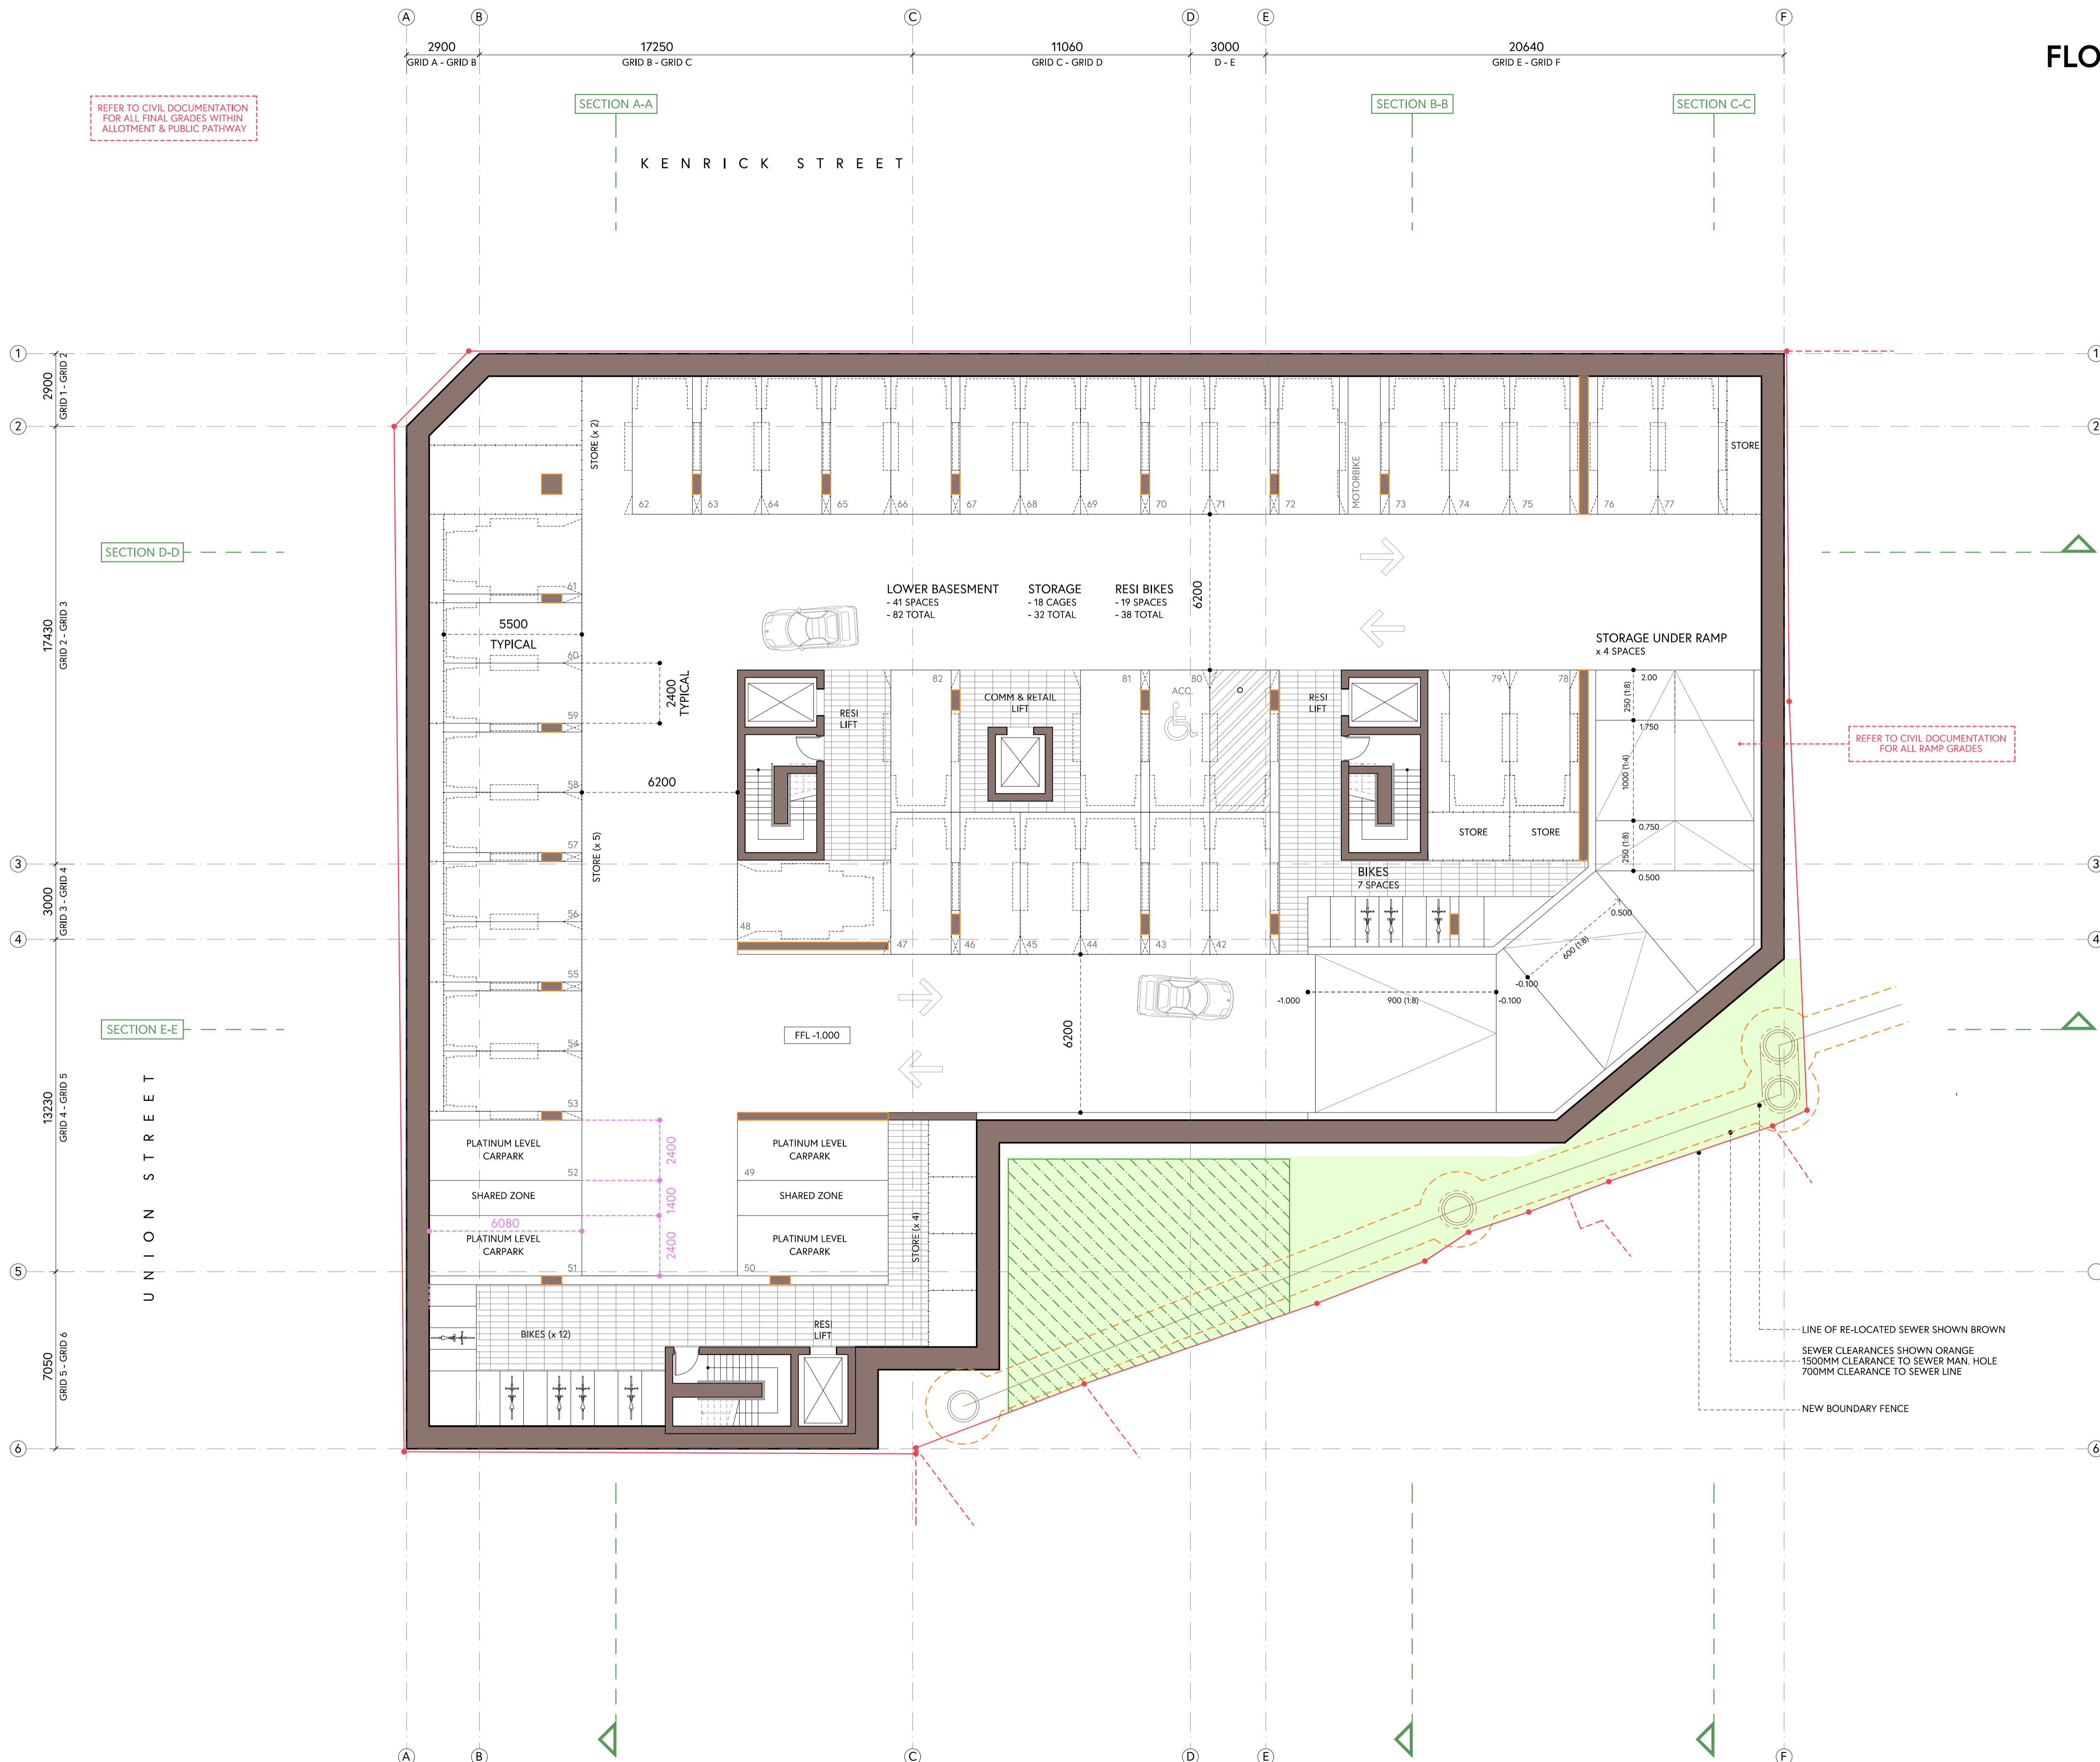
REVISION	R.10 SSDA 04.05.2026
DRAWING	FLOOR PLAN LOWER BASEMENT
NUMBER	A-12

FLOOR PLAN | LOWER BASEMENT

Given the proposed basement excavation for the development, the adopted remediation strategy comprises excavation of the impacted fill followed by validation testing of the underlying soils to confirm removal of impact.

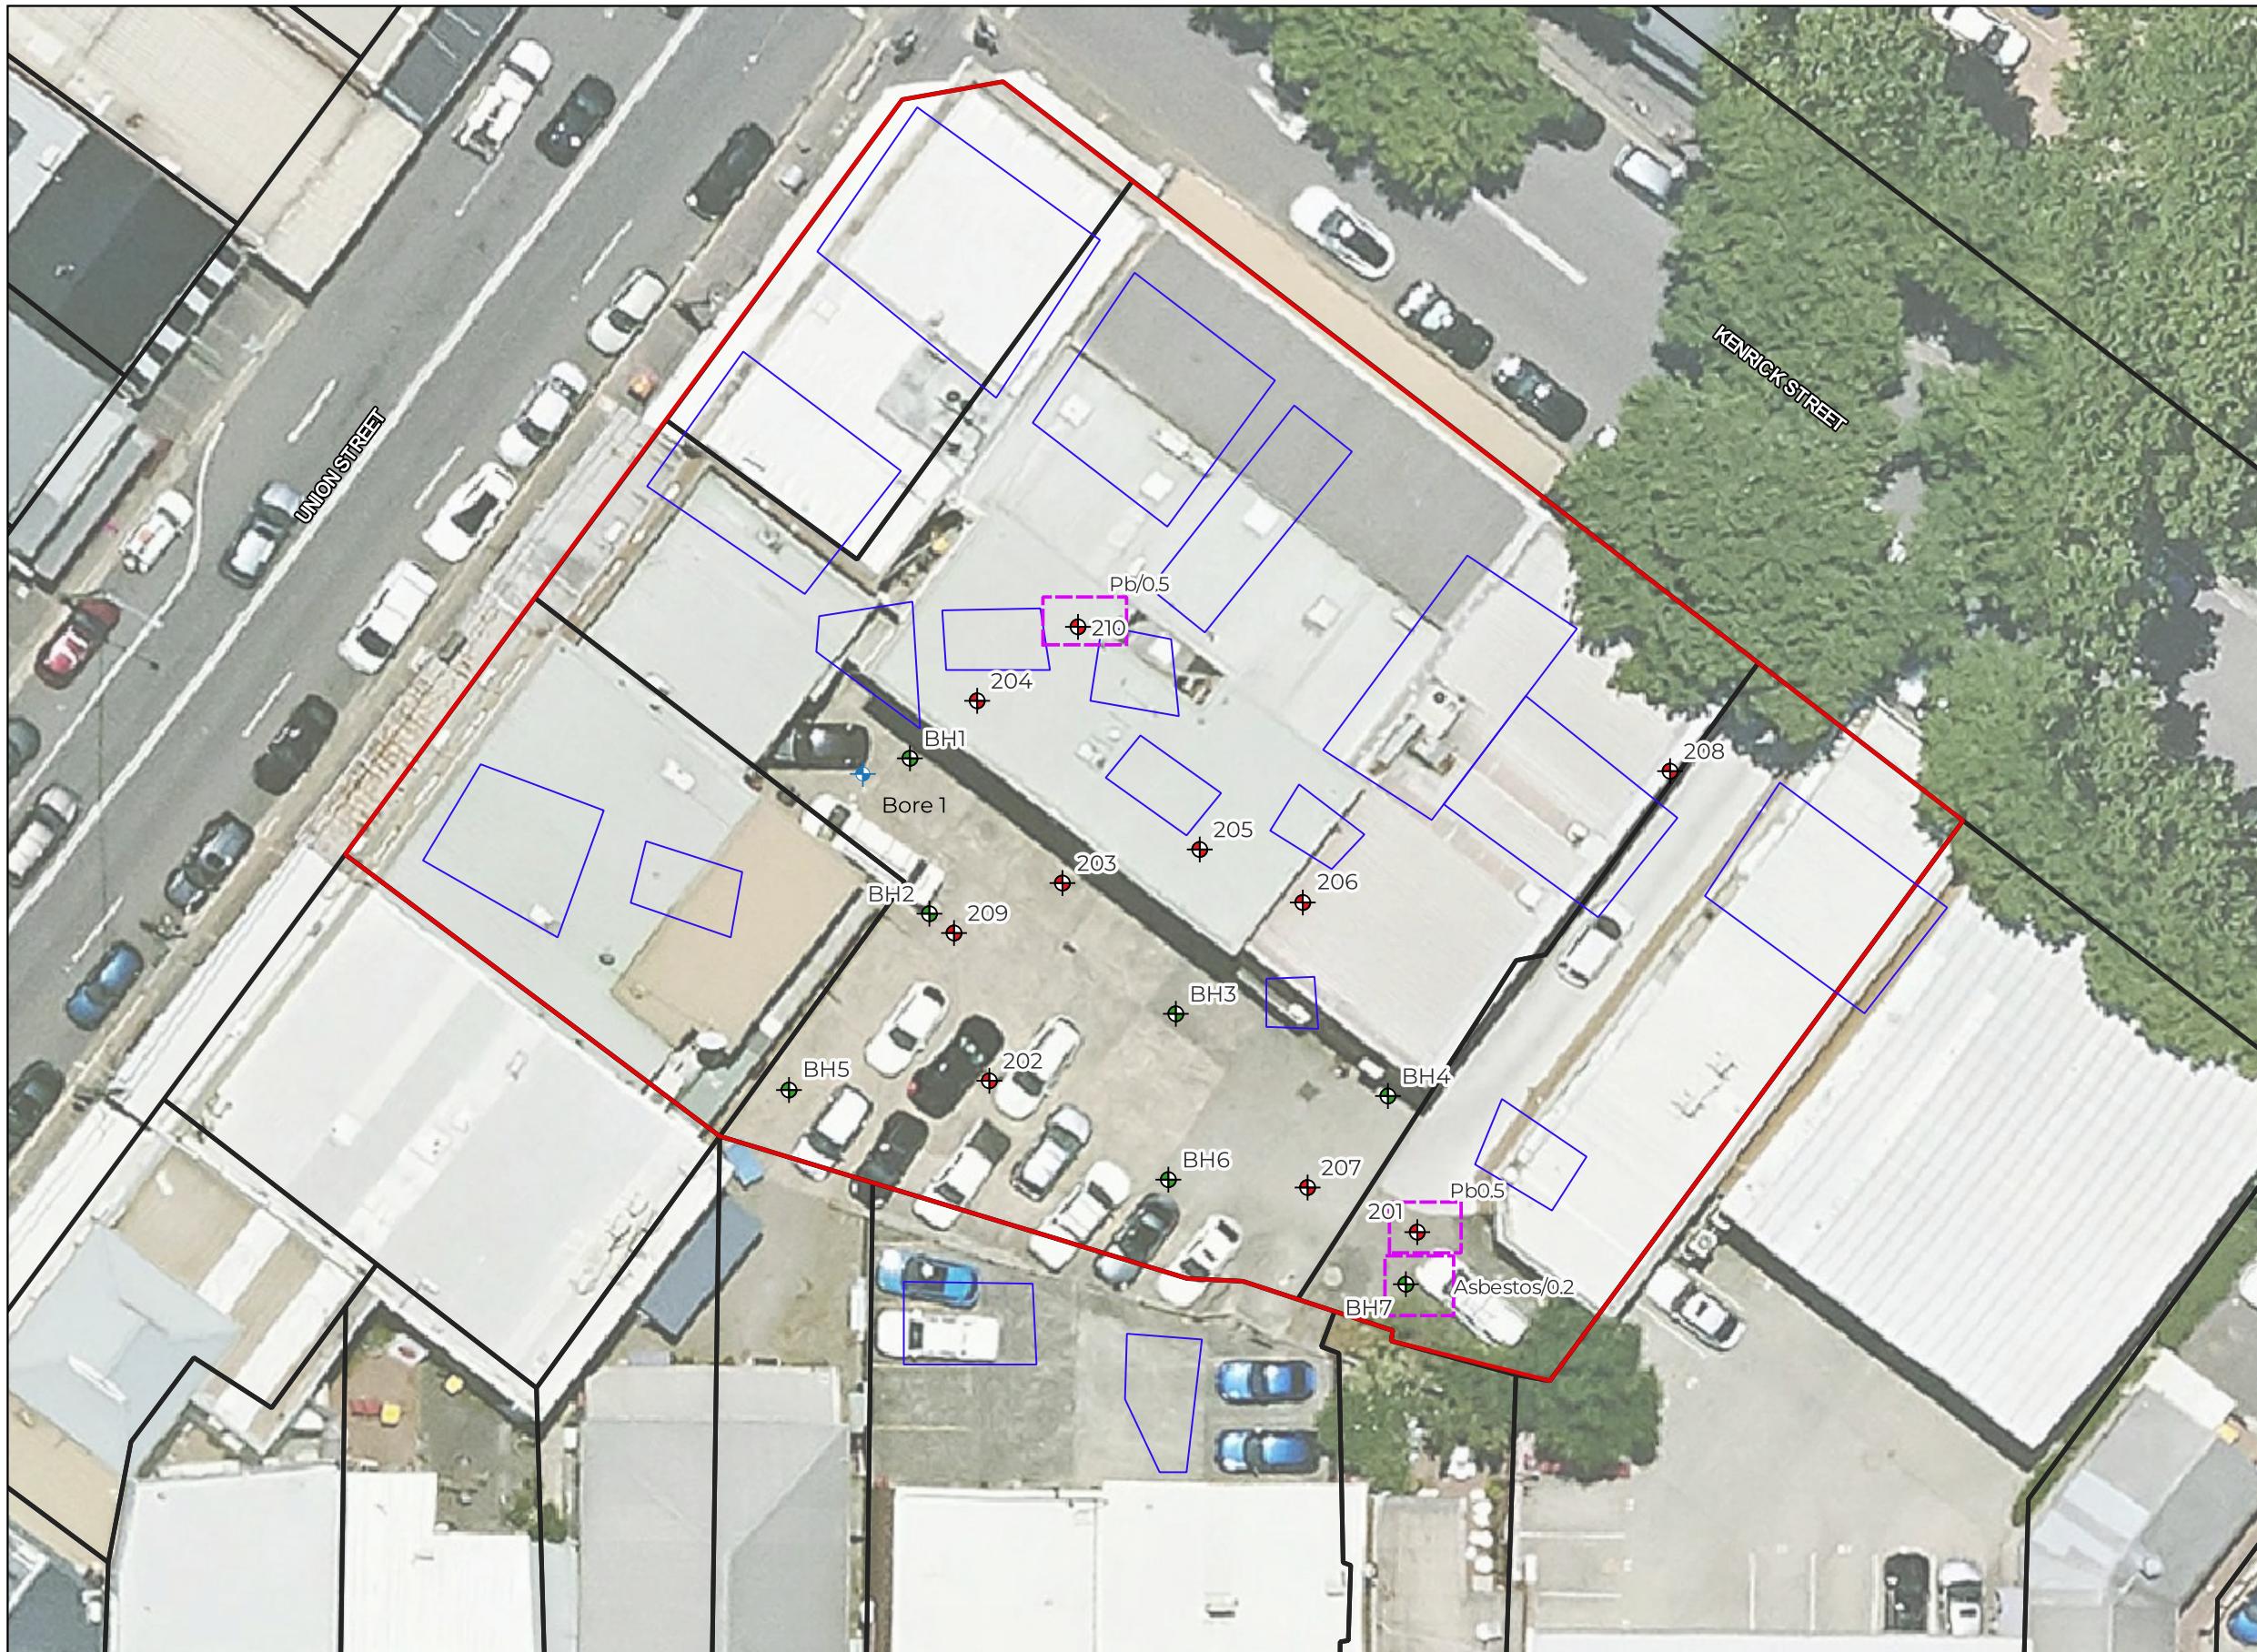
Drawing 1 Test Location Plan from Previous Report(s)

The updated conceptual site model presented in the Douglas DSI (Douglas, 2026a) included additional sources included existing and previous buildings, a jet plane crash on the site and possible hazardous building materials from underground utilities/conduits. The approximate locations of former structures are shown on Drawing 1 (Appendix A).
