# The new Sydney Fish Market: Microbat Management Plan

**Infrastructure NSW**

| Project Number | 17WOL-7553 |

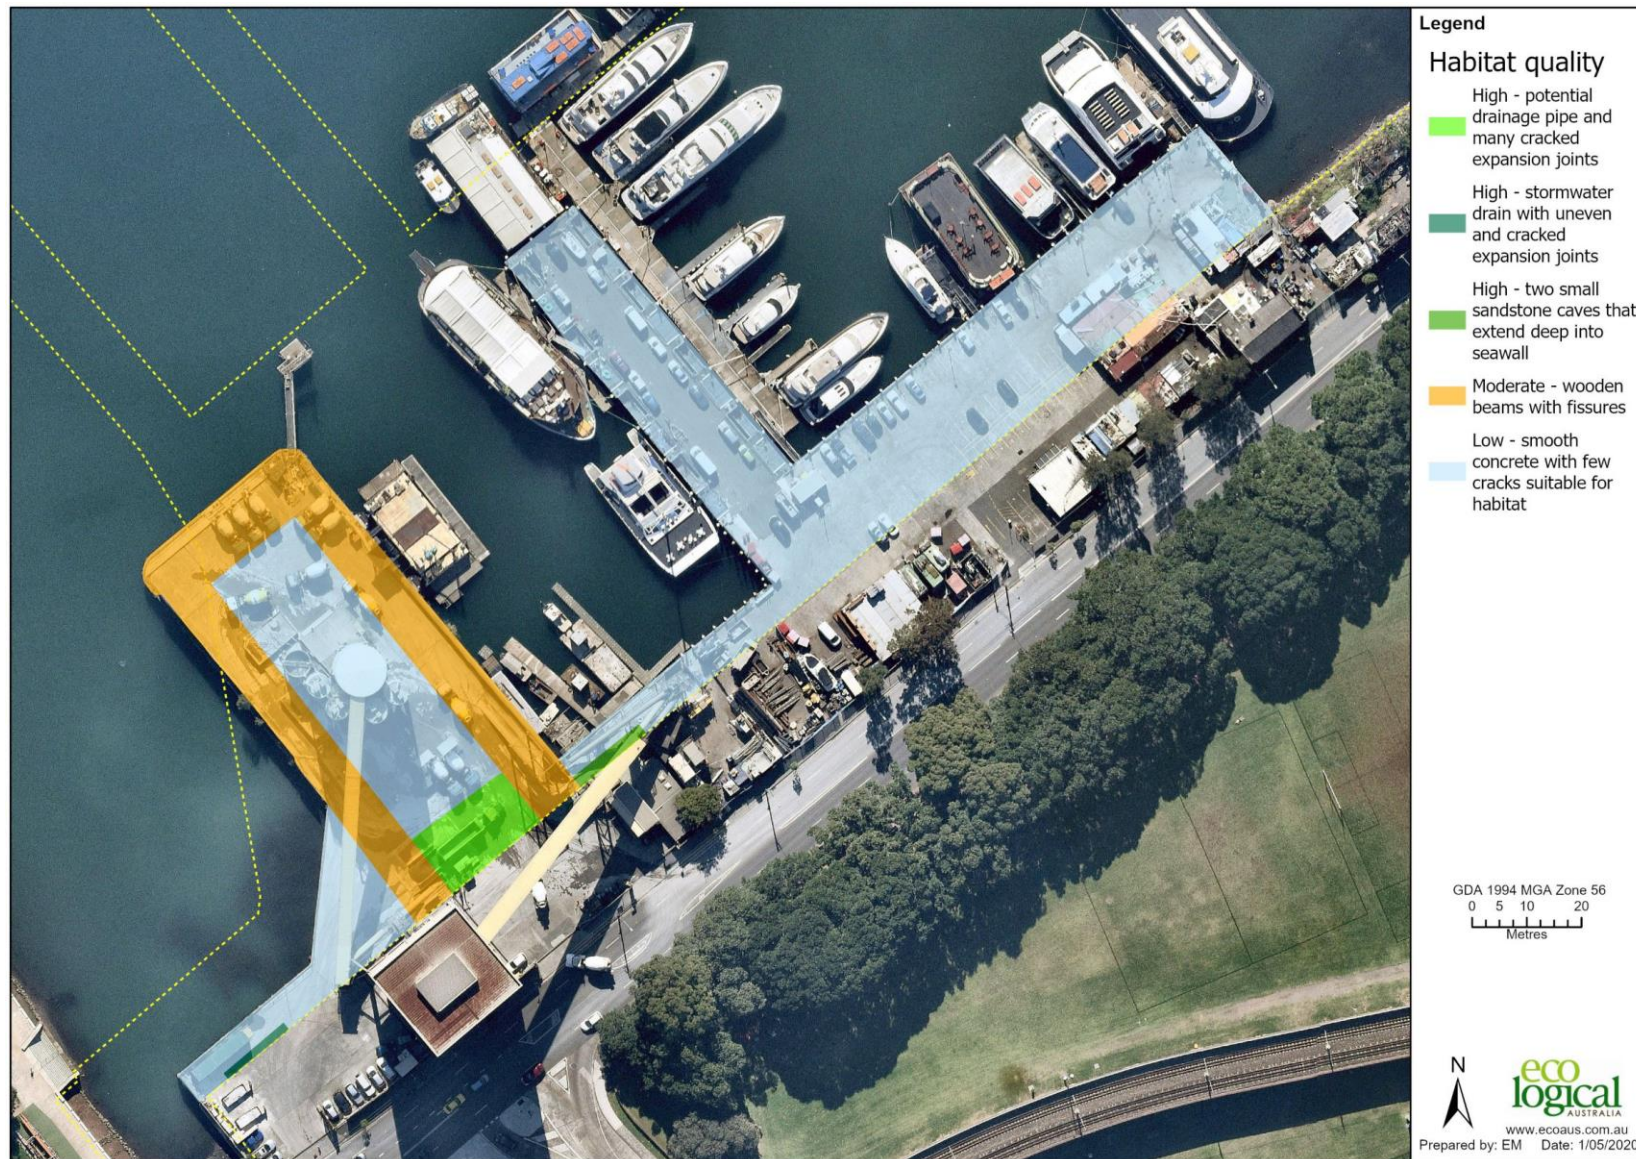
Figure 2: The Subject site and location of the new Sydney Fish Markets, showing location and range of potential microbat habitat on site

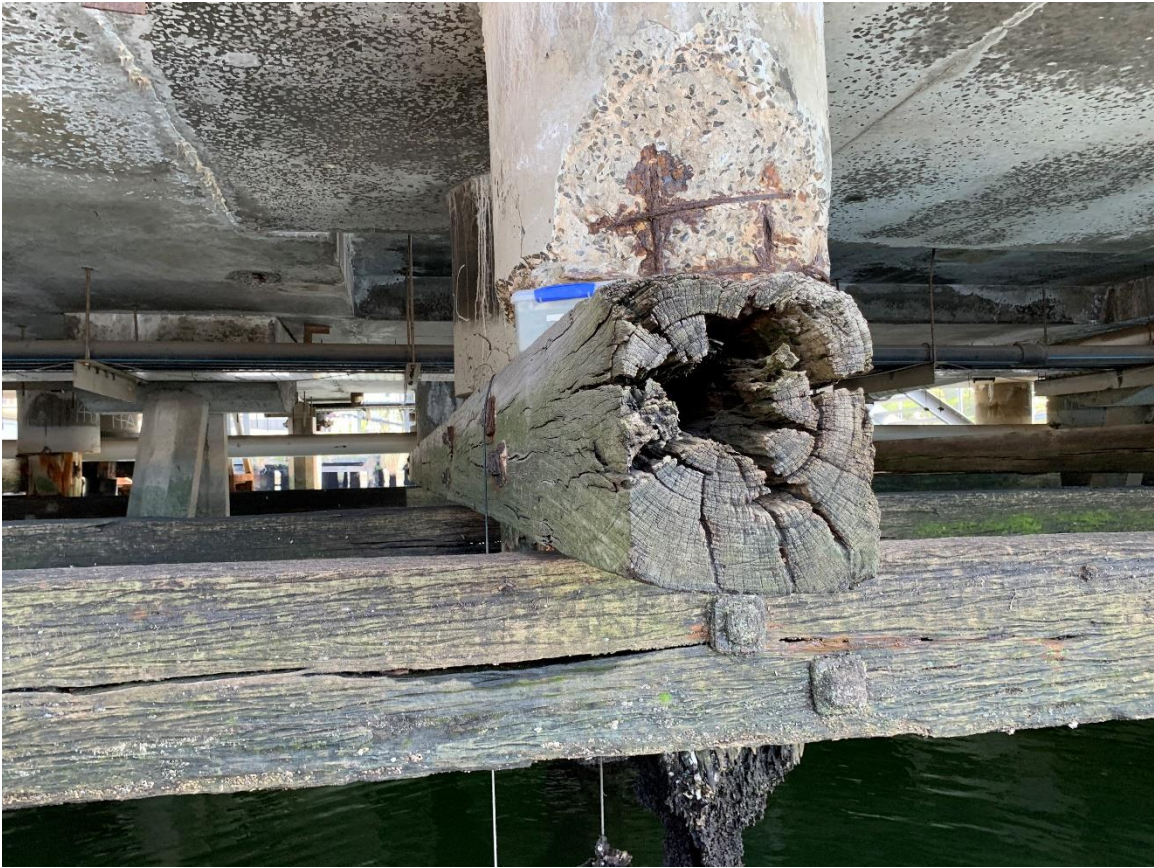
**Figure 5: Degraded timber posts and beams have potential to be roosting habitat for microbats**

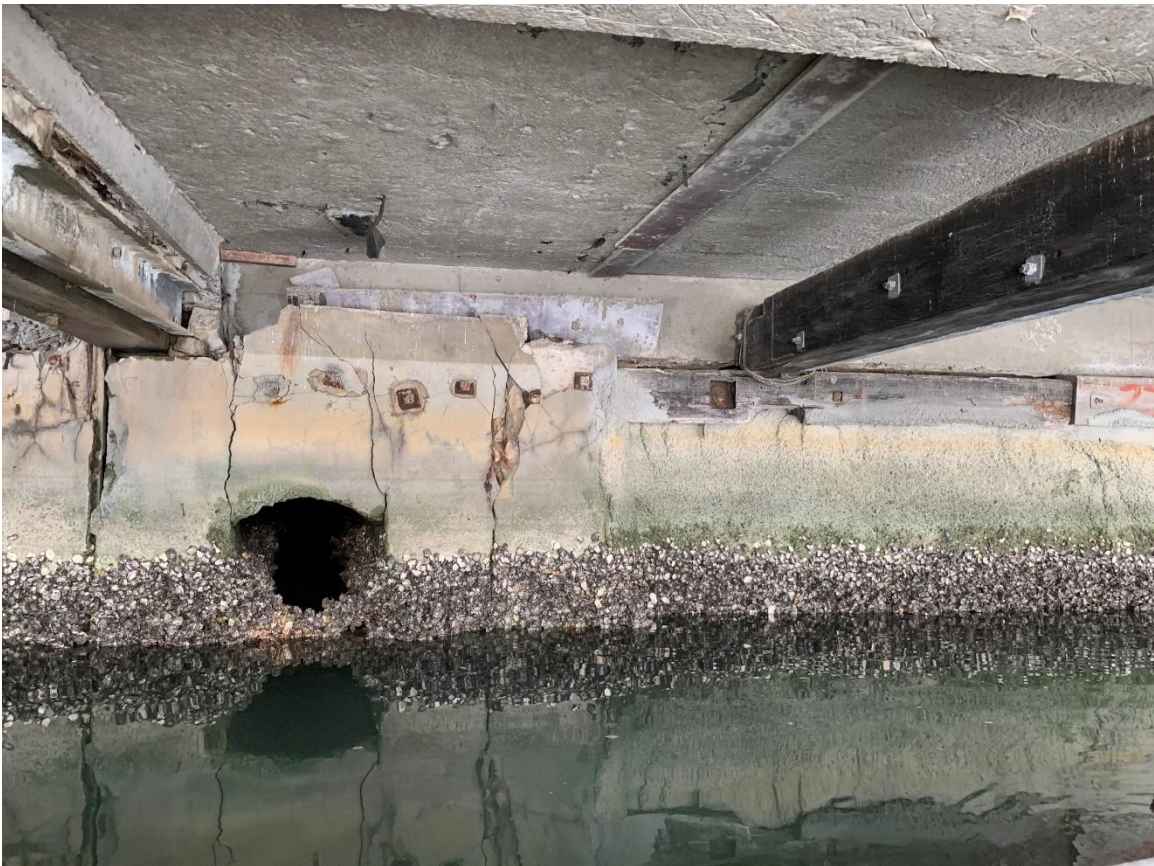
**Figure 6: Some cement culverts and drains within the Subject site have potential to be microbat roosting habitat where the tide levels leave a gap of 1 m or more between the upper tidal limit and the top of the culvert**

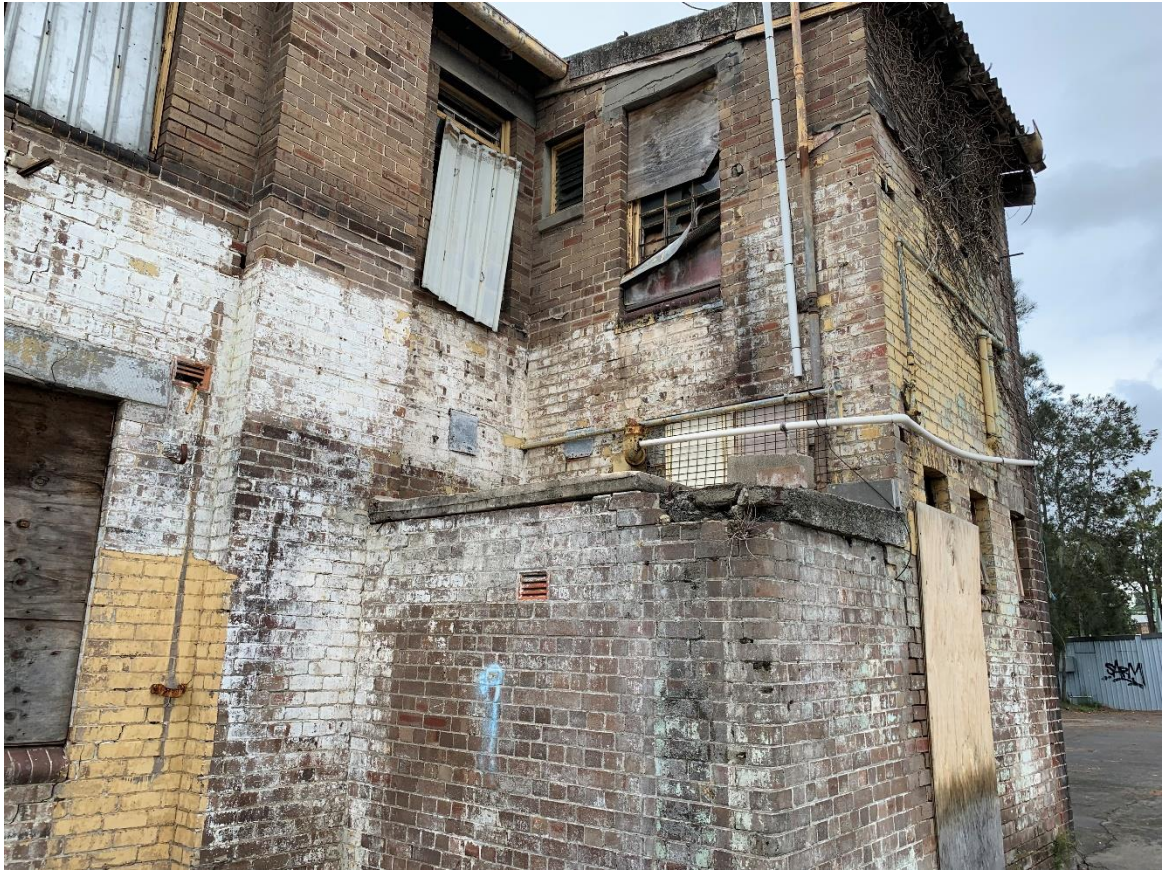
**Figure 7: The derelict building at the northern end of the Subject site showing multiple potential entry / exit points into cavities within the building that could be used as microbat roosting habitat**

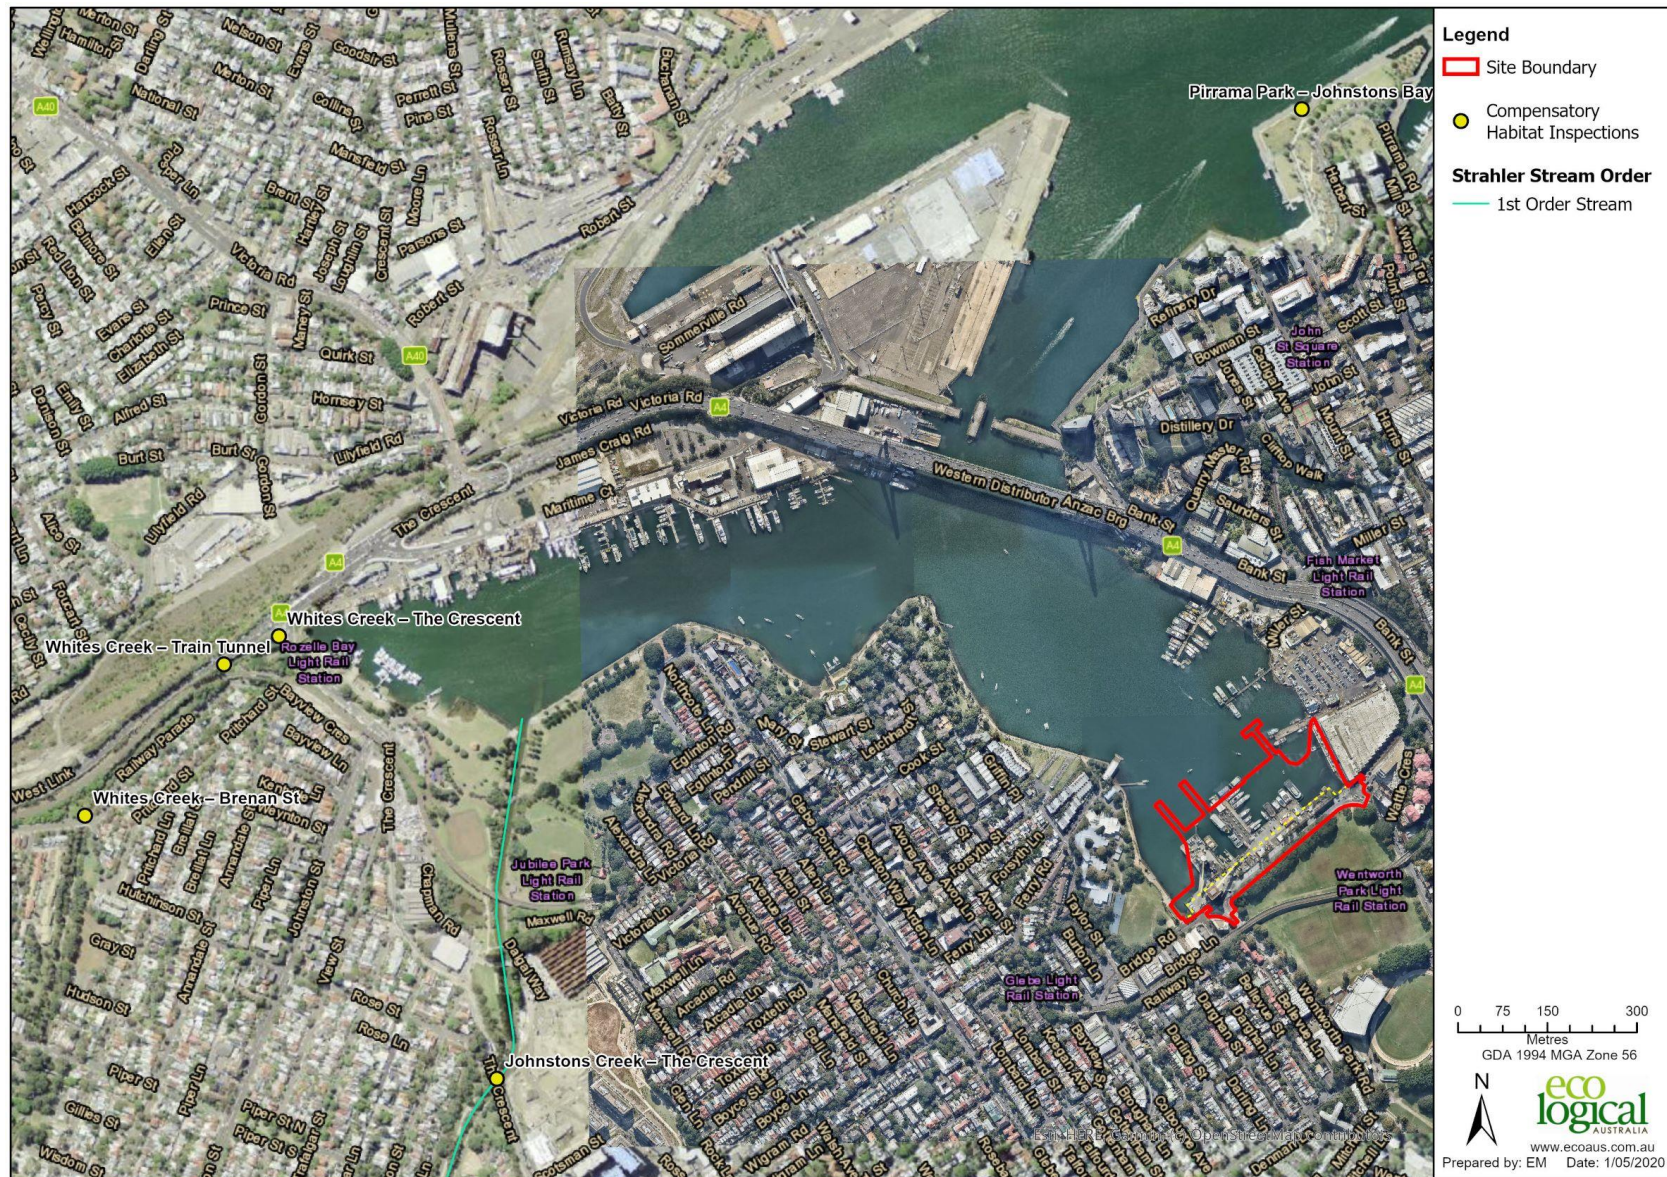
Figure 8: Map showing the locations within 2 km of the Subject site inspected and assessed for their suitability as receptor sites for compensatory roosting habitat in the form of bat boxes

**Table 3: Results of a diurnal land and water-based survey of five potential sites for installation of compensatory habitat within 2 km of the Subject site (see Figure 8 for locations)**

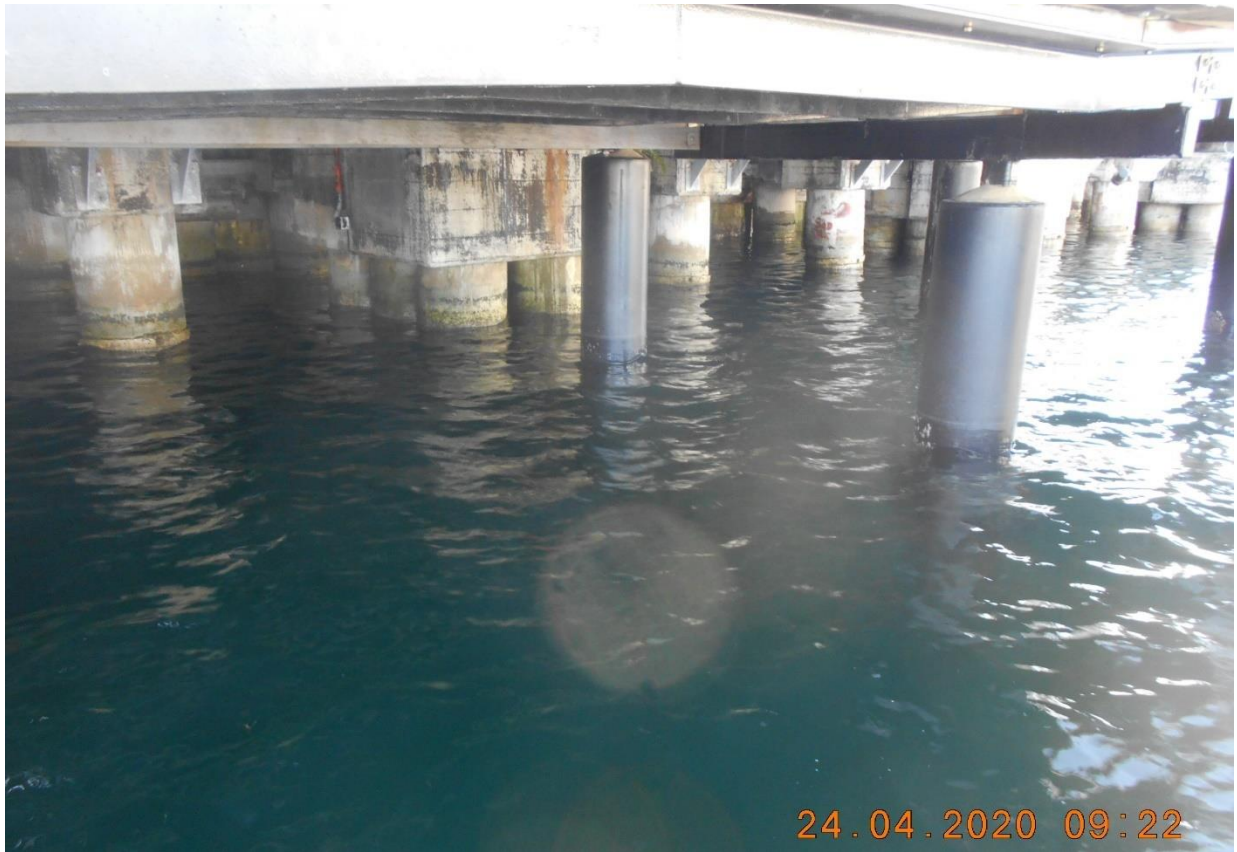
Figure 9: Section of the jetty at Pirrama Park, Johnstons Bay providing an example of a potential receptor site for compensatory bat boxes.

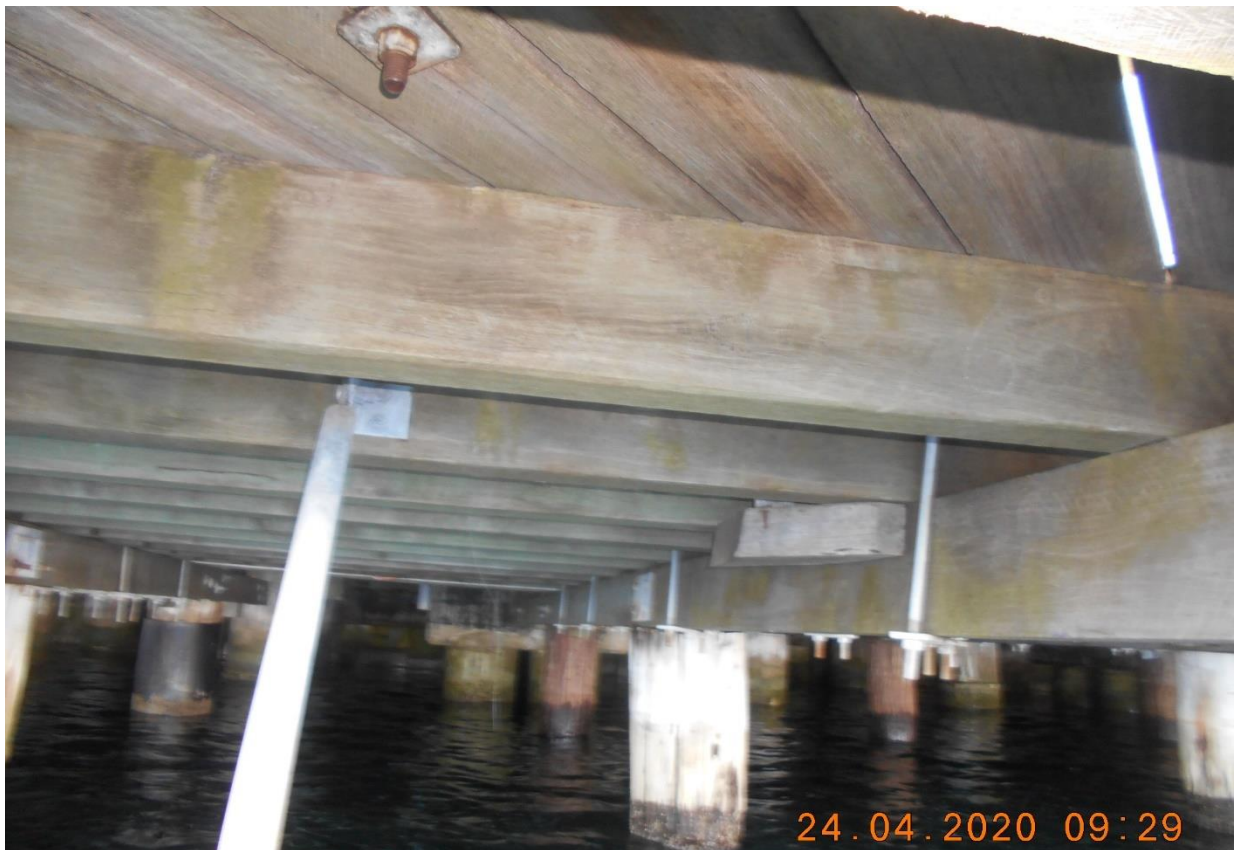
Figure 10: Section of the jetty at Pirrama Park, Johnstons Bay showing the timber elements which could provide a suitable point of attachment for compensatory bat boxes

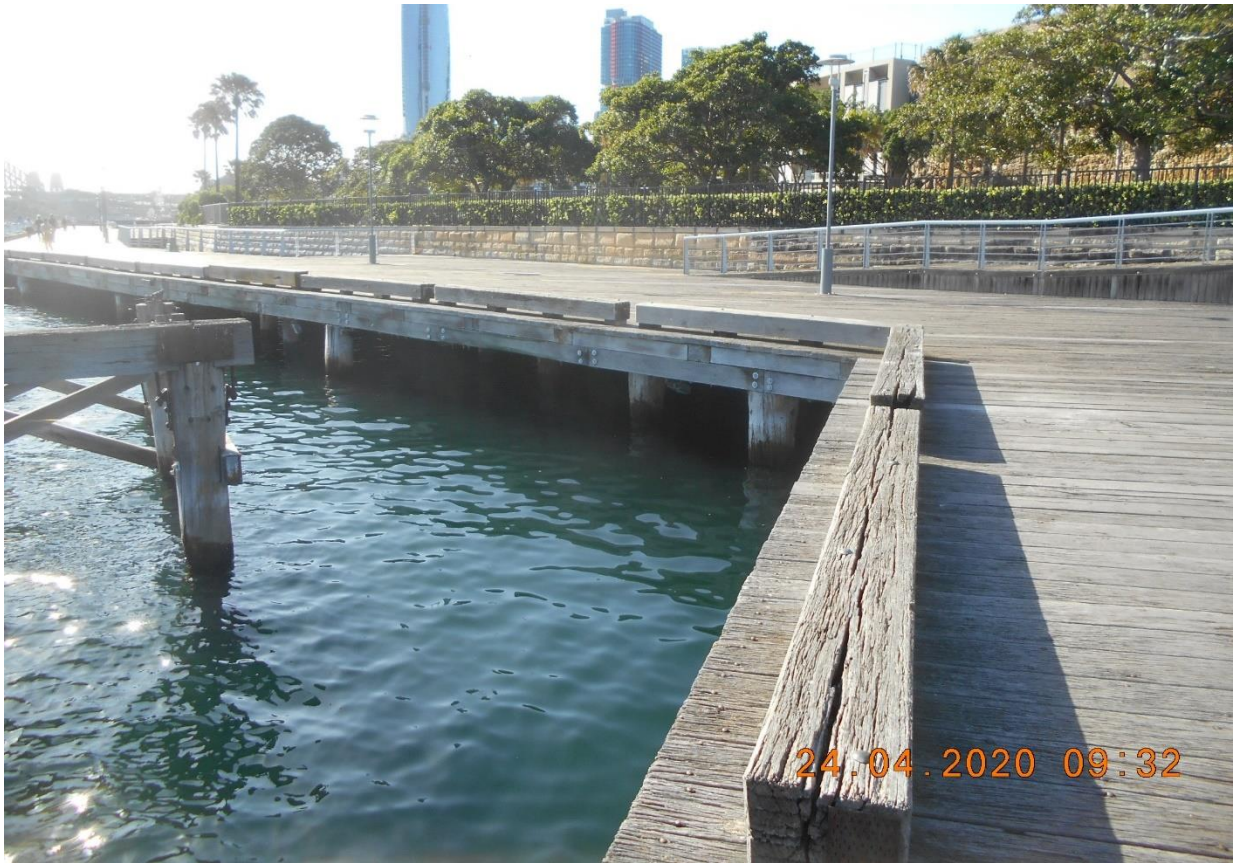
**Figure 11: View of the timber pedestrian jetty encircling Pirrama Park, Johnstons Bay that has been identified as a potential location for installation of compensatory bat boxes.**

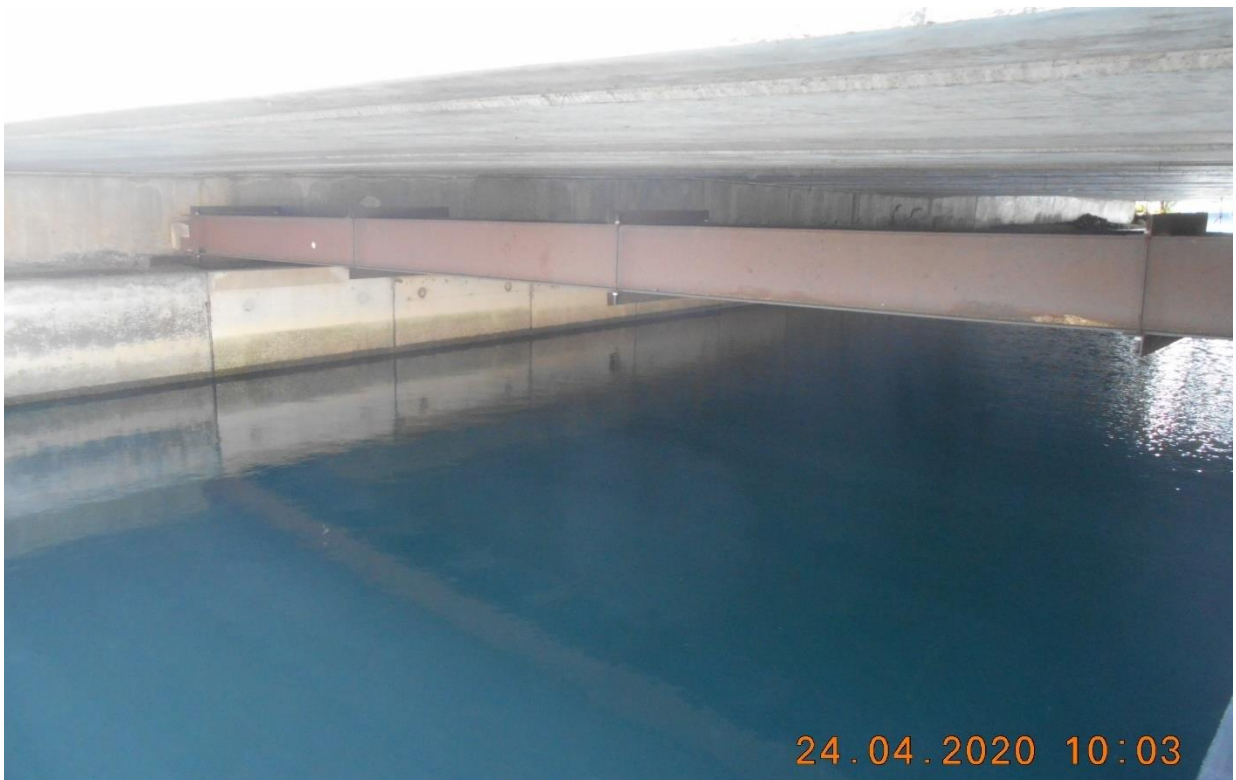
**Figure 12: Concrete bridge over White's Creek beneath The Crescent / City West Link, Rozelle Bay that has been identified as a suitable receptor location for compensatory bat box installation.**

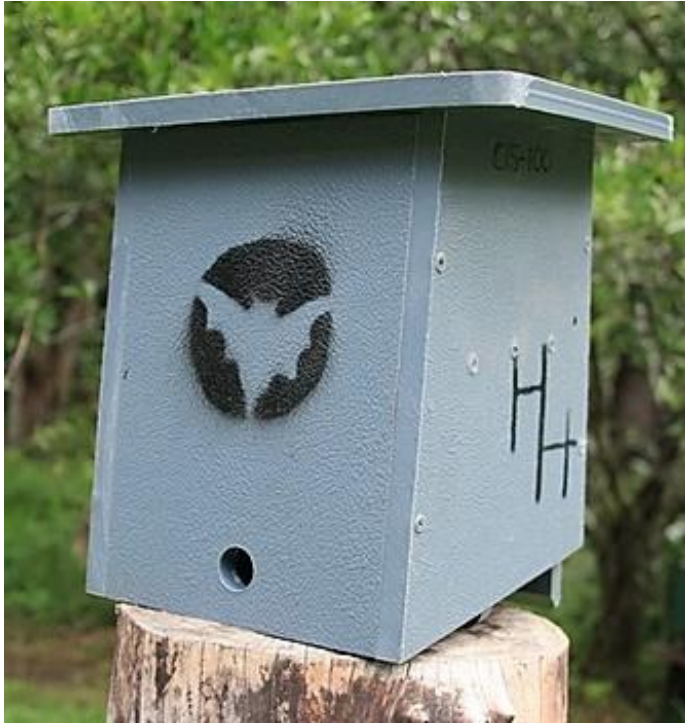
Figure 15: Four chamber microbat box constructed from recycled plastic (Cyplas™) and available from Hollow Log Homes ([www.hollowloghomes.com](http://www.hollowloghomes.com))

Appendix B provides detail of four chambered microbat roosting boxes available from Hollow Log Homes (Figure 15). It is preferable for any bat boxes to be installed on brackets so that they can be temporarily moved when maintenance or repairs to the host structure are required and to allow for future management of the roosting habitat.
