Ramboll Australia Pty Ltd

13 August 2020

SITE AUDIT REPORT

REVISED REMEDIAL ACTION PLAN, THE NEW SYDNEY FISH MARKET, PYRMONT NSW

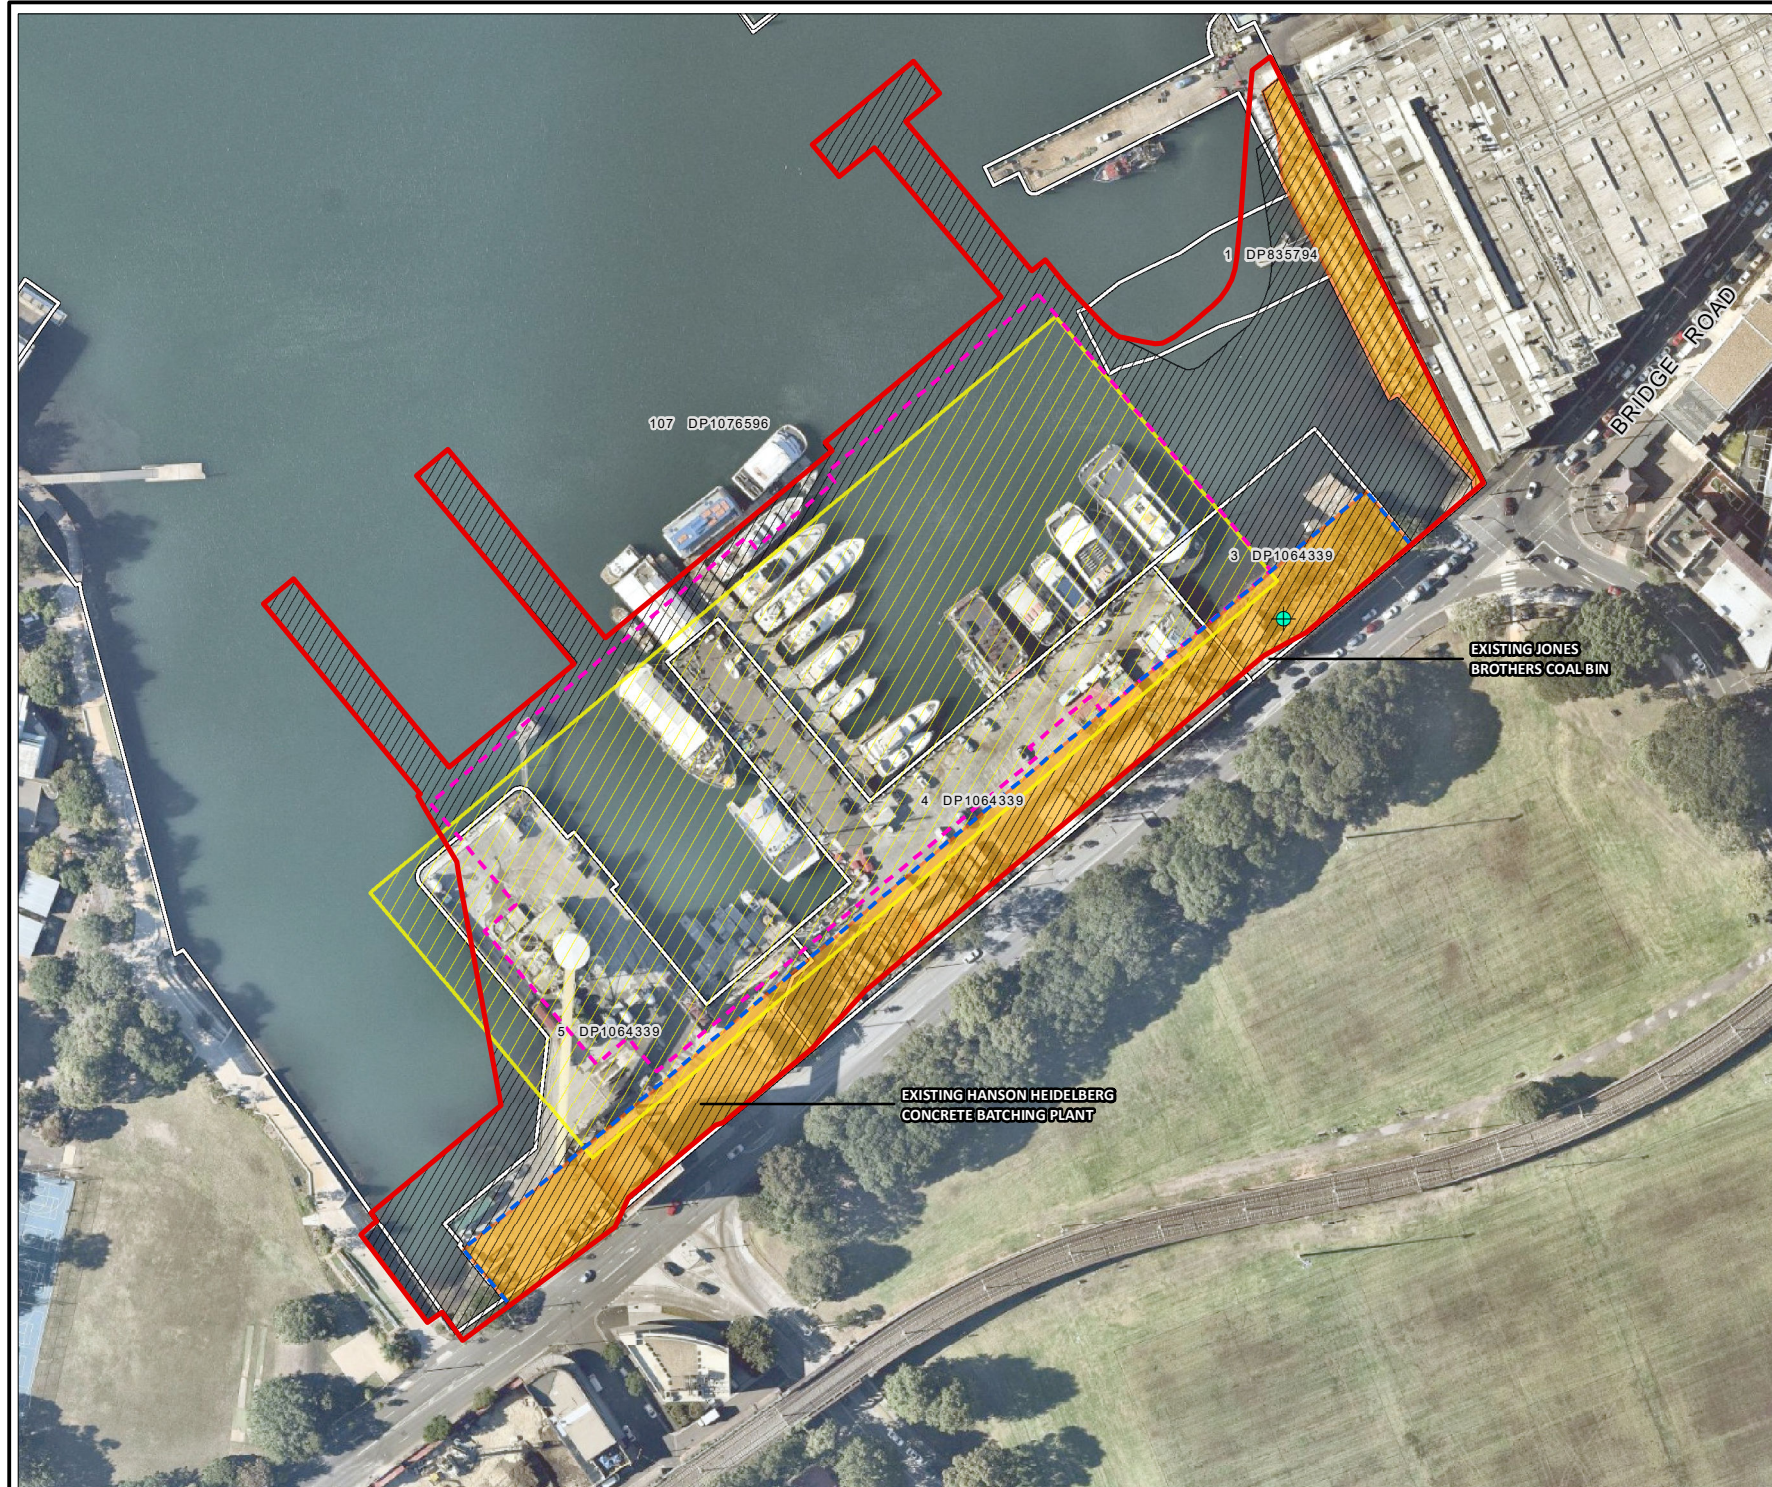
FIGURE 2

The Revised RAP noted that fragments of fibre cement sheeting (suspected ACM) were observed on the ground surface in the eastern portion of the site. No ACM fragments were observed within sampled materials, however it is noted that asbestos quantification was not undertaken and sampling was conducted via boreholes, thereby resulting in limited volumes of drilling spoil for assessment. No asbestos fibres or asbestos fines were reported in five soil samples analysed in the investigation by PB (2009).

SITE LAYOUT

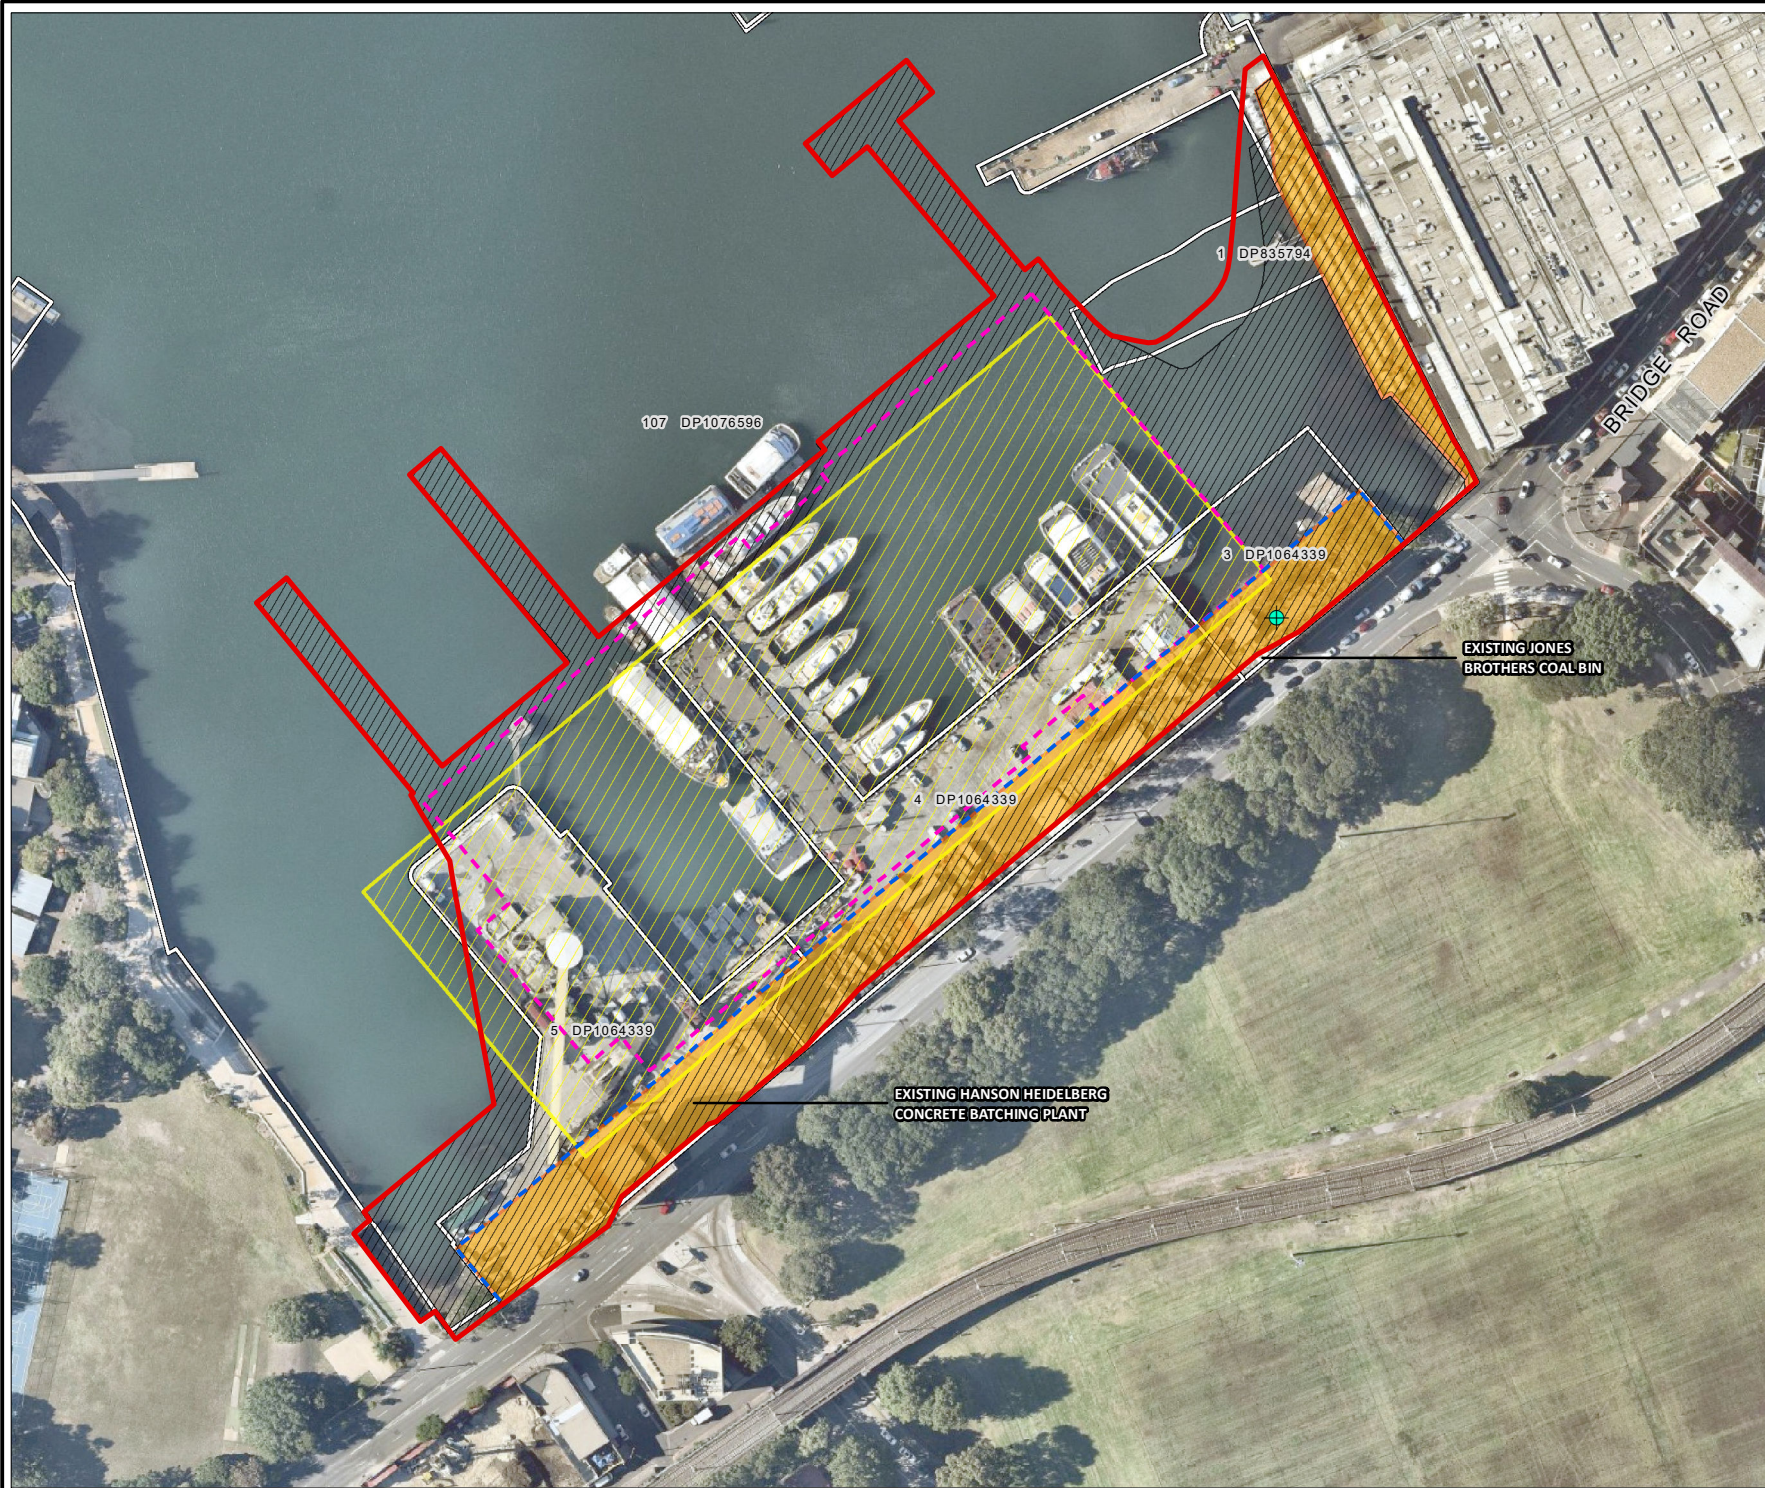
FIGURE 2

- New Sydney Fish Market Development Footprint
- Cadastral Boundary
- Approximate Land Area
- Approximate Seawall Extent
- + ACM Fragments Observed on Ground Surface
