LISMORE HOSPITAL – STAGE 3C HEALTH INFRASTRUCTURE NSW

Structural IFC Design Report

JOHN HOLLAND GROUP LISMORE BASE HOSPITAL–STAGE 3C NORTH TOWER AND NORTH TOWER EXTENSION

Report No RPT-00066/ AA008927-SDDR1-(D)

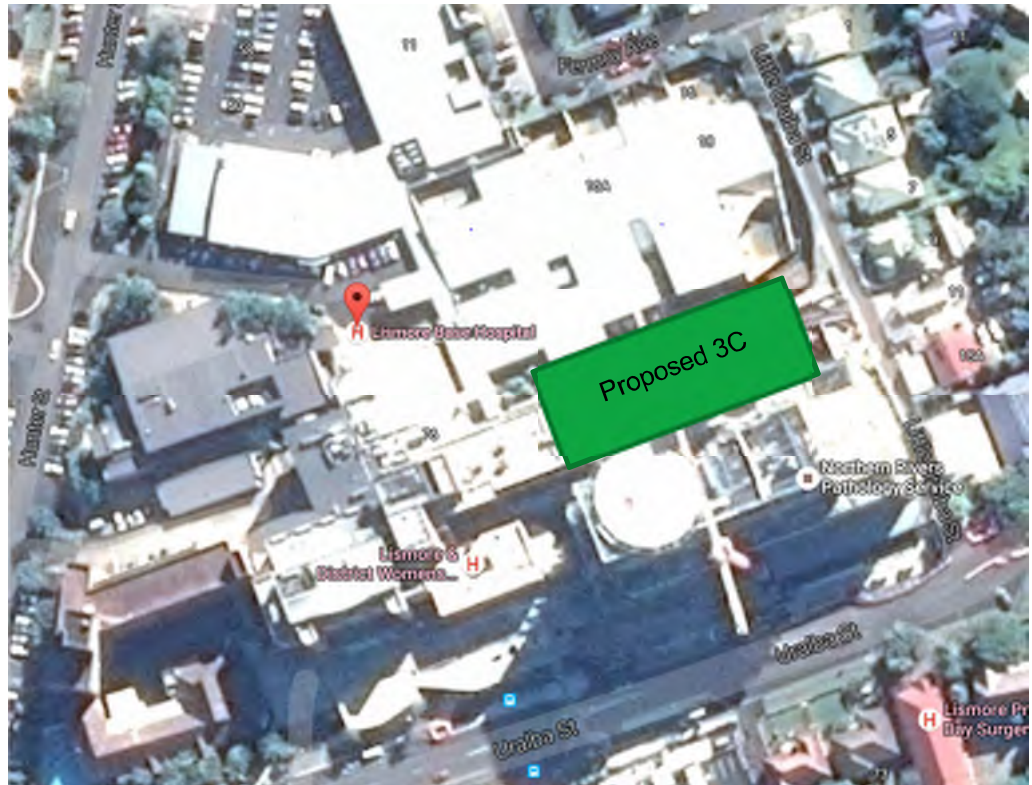
Figure 1 Site Plan

The site for 3C sits directly above and adjacent to the Mental Health building. Refer site plan below. There is a steep batter between these two sites which was created when excavation occurred for the Mental Health building. The retaining system for the batter is a soil nailed structure which was installed during the construction of the Mental Health building around 2006. The capacity of the soil nailed wall to support surcharge loading has been investigated and is addressed in this report. To the south of 3C is the recently constructed 3B1 South Tower building.

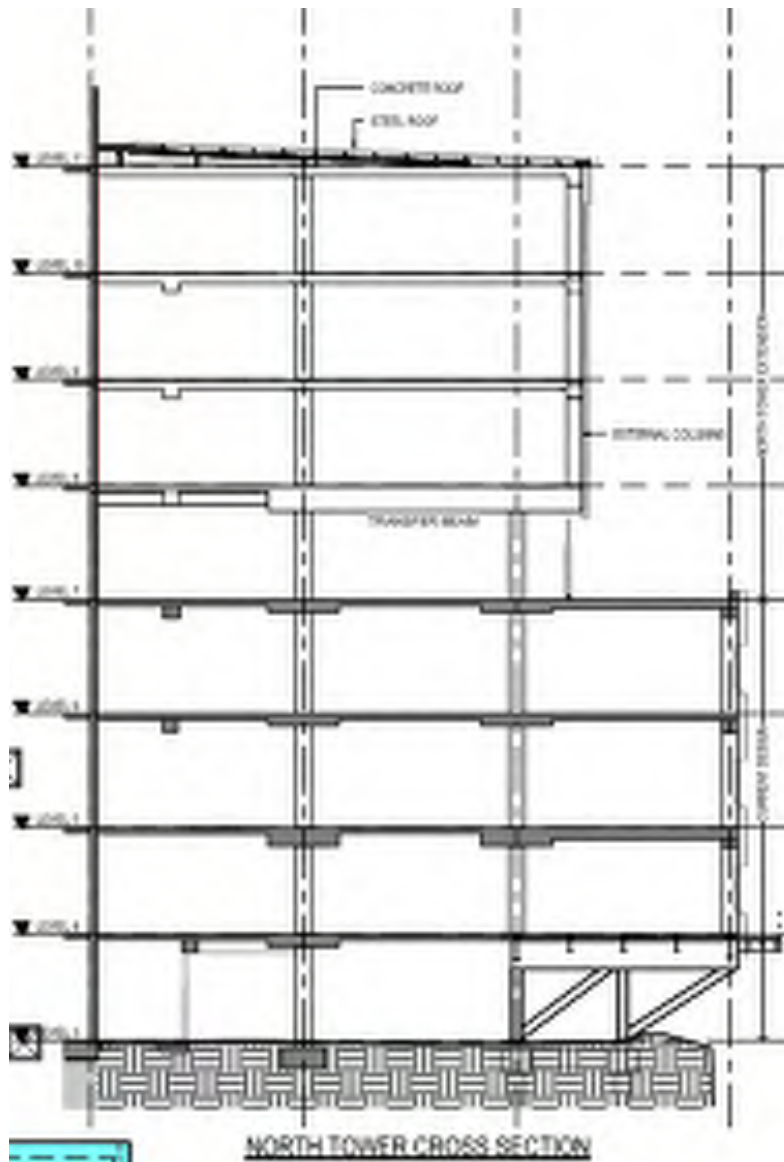
The foundations, columns and lateral resisting elements have been designed for 3 more habitable floors, ie level 7, 8 and 9 as shown below. Future level 9 has a concrete roof with a steel roof over for water tightness. Figure 3 describes the future allowance of additional floor levels.

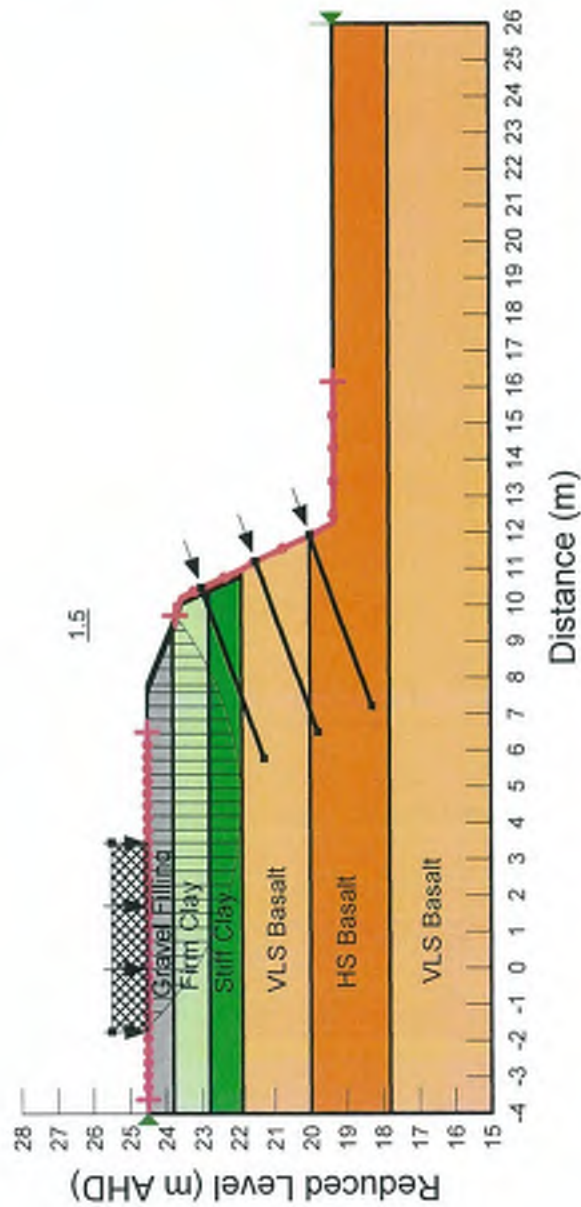
SECTION B - S-LOW

Name: Gravel Filling
Unit Weight: 17 kN/m³
Cohesion: 0 kPa
Phi: 30 °

Name: Firm clay
Unit Weight: 18 kN/m³
Cohesion: 35 kPa

The results of the *SLOPE/W* analysis for the short term conditions are indicated on Figures 1 to 10 attached, and the calculated factors of safety are shown in Table 3 below.

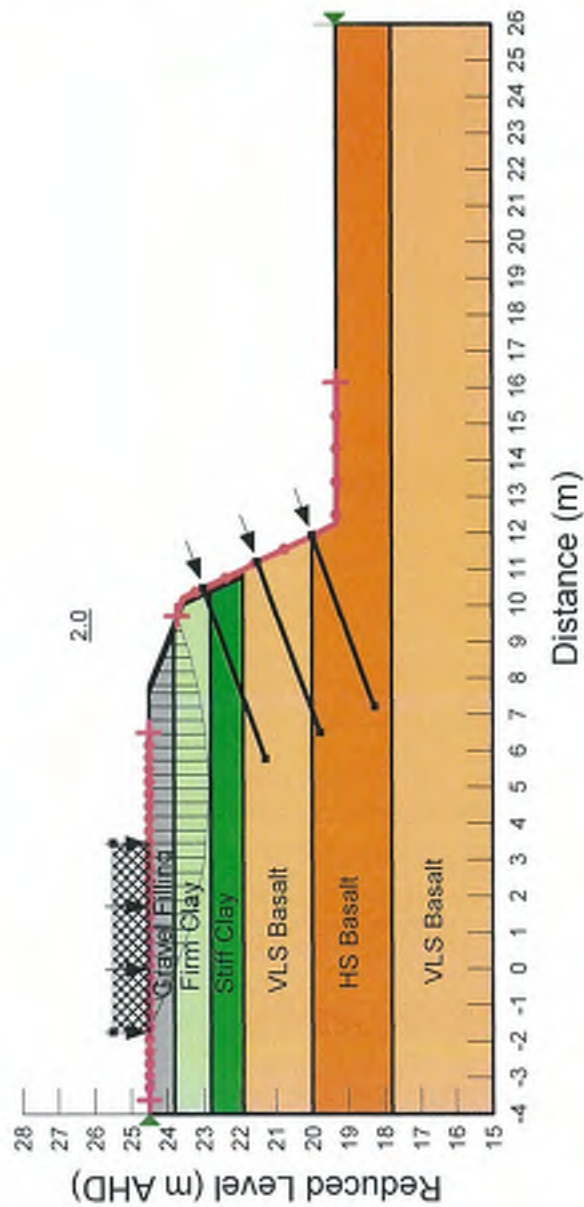
SECTION B - S-HIGH

Name: Gravel Filling
Unit Weight: 17 kN/m³
Cohesion: 0 kPa
Phi: 32 °

Name: Firm clay
Unit Weight: 18 kN/m³
Cohesion: 50 kPa

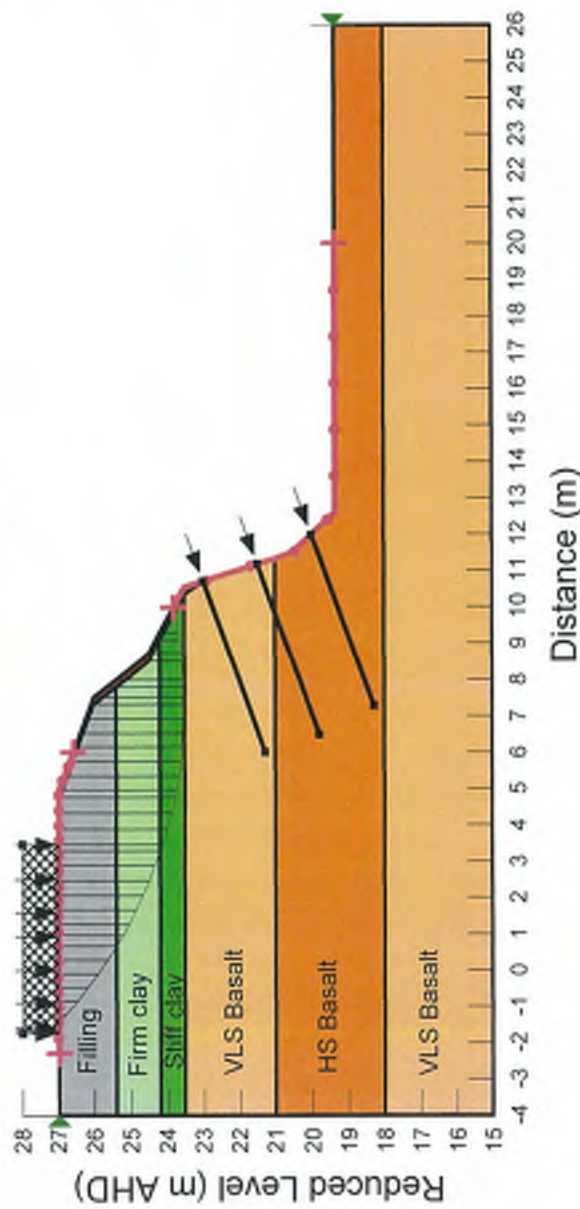
SECTION D - (S-SLOW)

Model: Undrained (Phi=0)
Unit Weight: 21 kN/m³
Cohesion: 200 kPa

Name: Gravel Filling
Model: Mohr-Coulomb
Unit Weight: 17 kN/m³
Cohesion: 0 kPa
Phi: 30 °

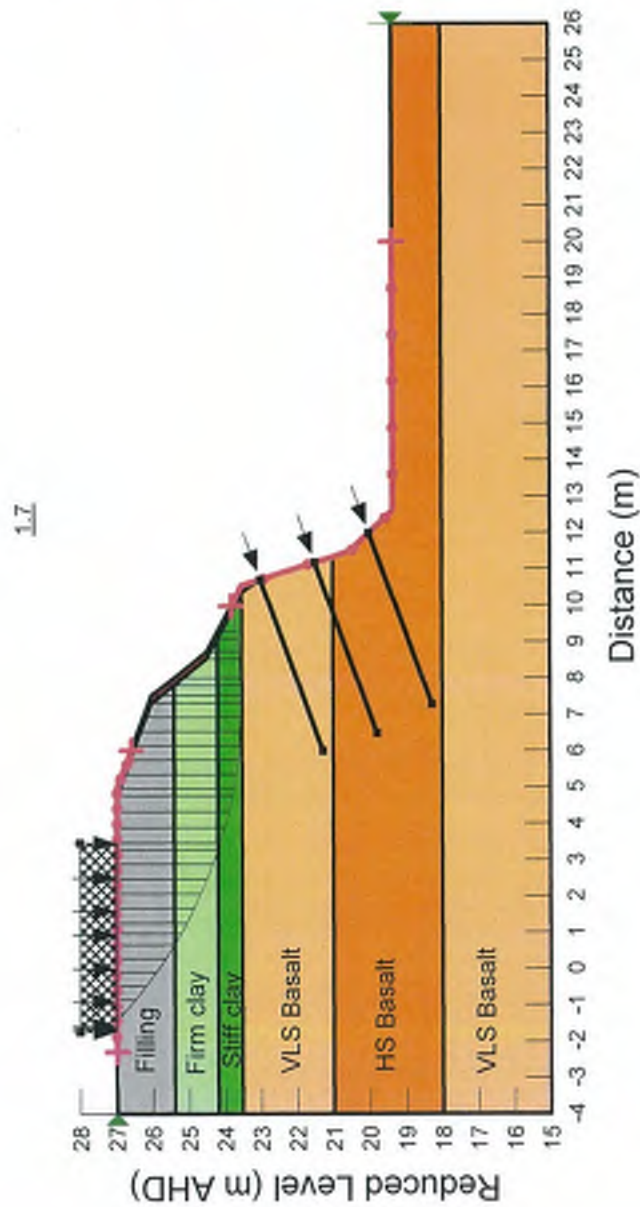
SECTION D - (S-HIGH)

Cohesion: 450 kPa

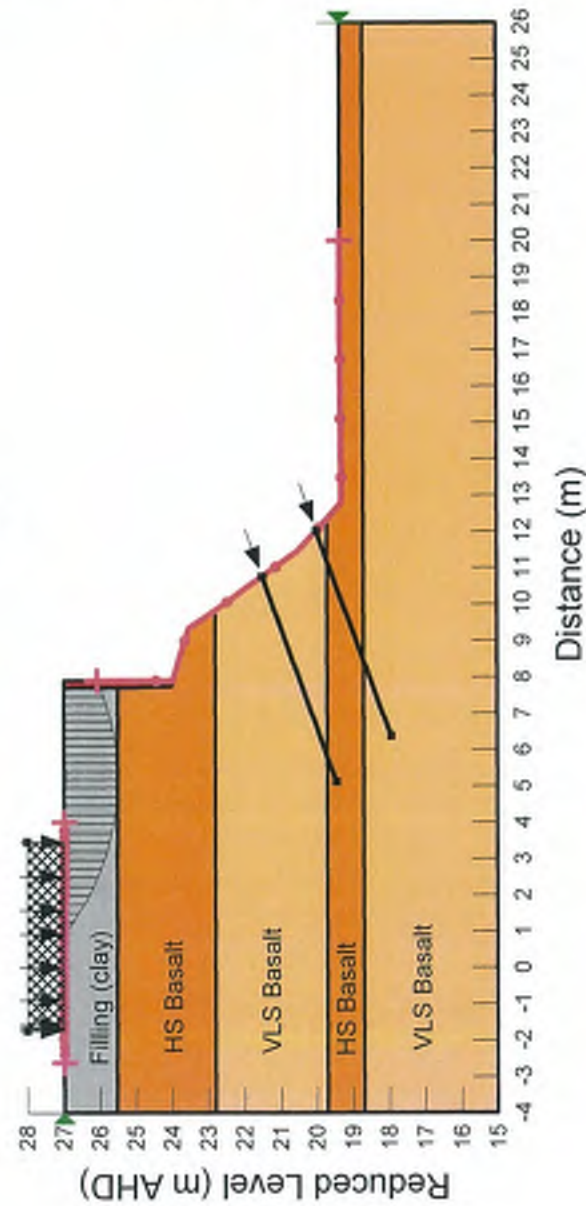
SECTION G - S-LOW

Name: Clay Filling
Model: Undrained (Phi=0)
Unit Weight: 18 kN/m³
Cohesion: 45 kPa

Name: VLS Basalt
Model: Undrained (Phi=0)
Unit Weight: 21 kN/m³
Cohesion: 200 kPa

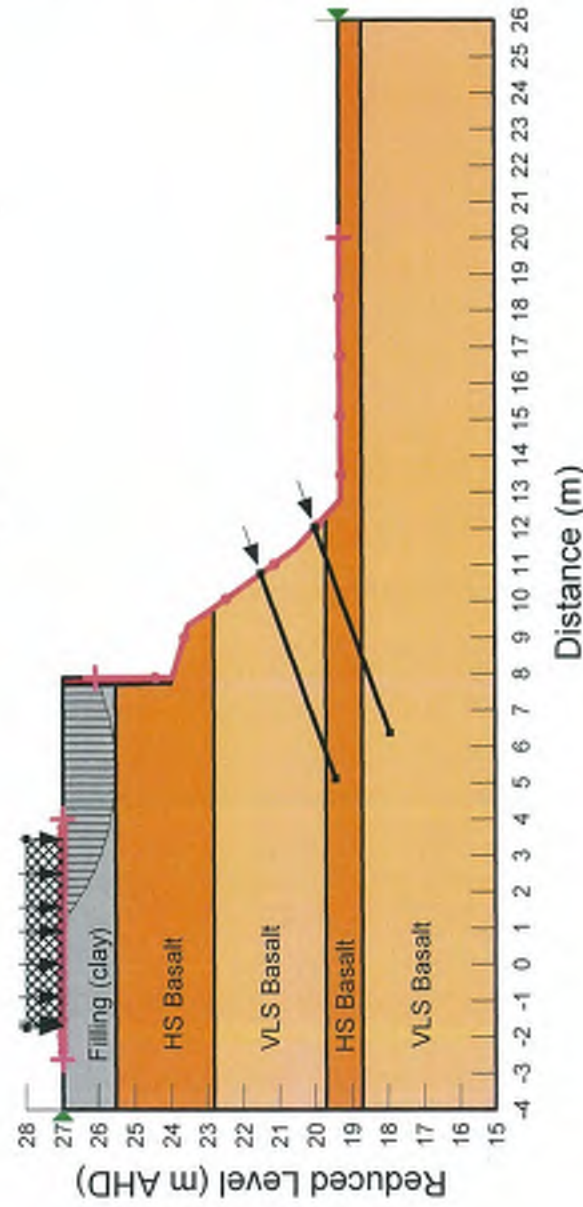
SECTION G - S-HIGH

Name: Clay Filling
Model: Undrained (Phi=0)
Unit Weight: 18 kN/m³
Cohesion: 50 kPa

Name: VLS Basalt
Model: Undrained (Phi=0)
Unit Weight: 21 kN/m³
Cohesion: 450 kPa

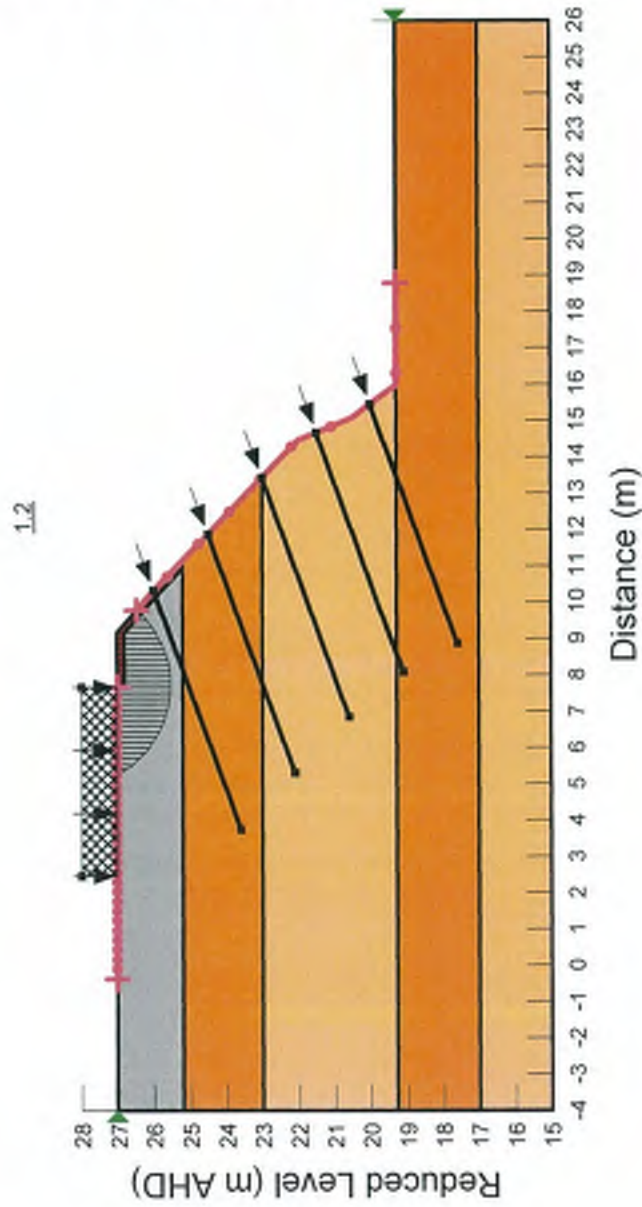
SECTION J - Nails - S-LOW

Name: Filling (clay)
Model: Undrained (Phi=0)
Unit Weight: 18 kN/m³
Cohesion: 45 kPa

Name: VLS Basalt
Model: Undrained (Phi=0)
Unit Weight: 21 kN/m³
Cohesion: 200 kPa

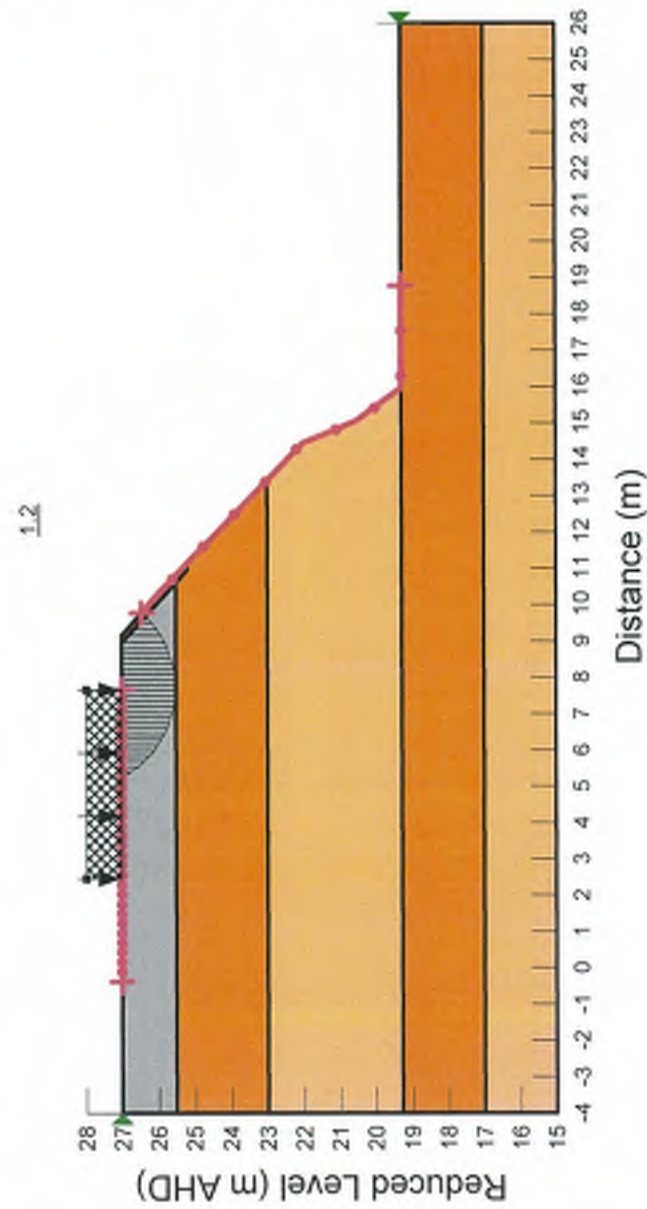
SECTION J - No nails - S-LOW

Name: Filling (clay)
Model: Undrained (Phi=0)
Unit Weight: 18 kN/m³
Cohesion*: 45 kPa

Name: VLS Basalt
Model: Undrained (Phi=0)
Unit Weight: 21 kN/m³
Cohesion*: 200 kPa

- A FoS of 1.2 to 1.3 was achieved where the highest slope cross section at Grid J was modelled with no soil nail support when surcharged by nominated piling rig, in the short term condition.

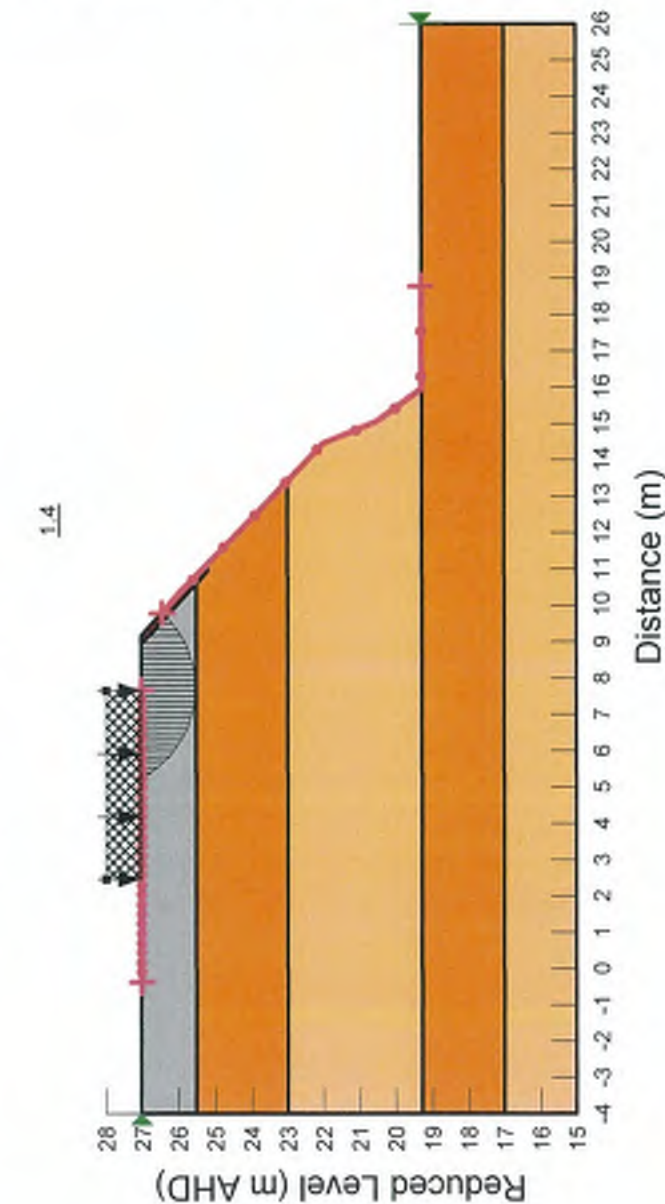
SECTION J - No Nails - S-HIGH

Name: Filling (clay)
 Model: Undrained (Phi=0)
 Unit Weight: 18 kN/m³
 Cohesion: 50 kPa

Name: VLS Basalt
 Model: Undrained (Phi=0)
 Unit Weight: 21 kN/m³
 Cohesion: 450 kPa

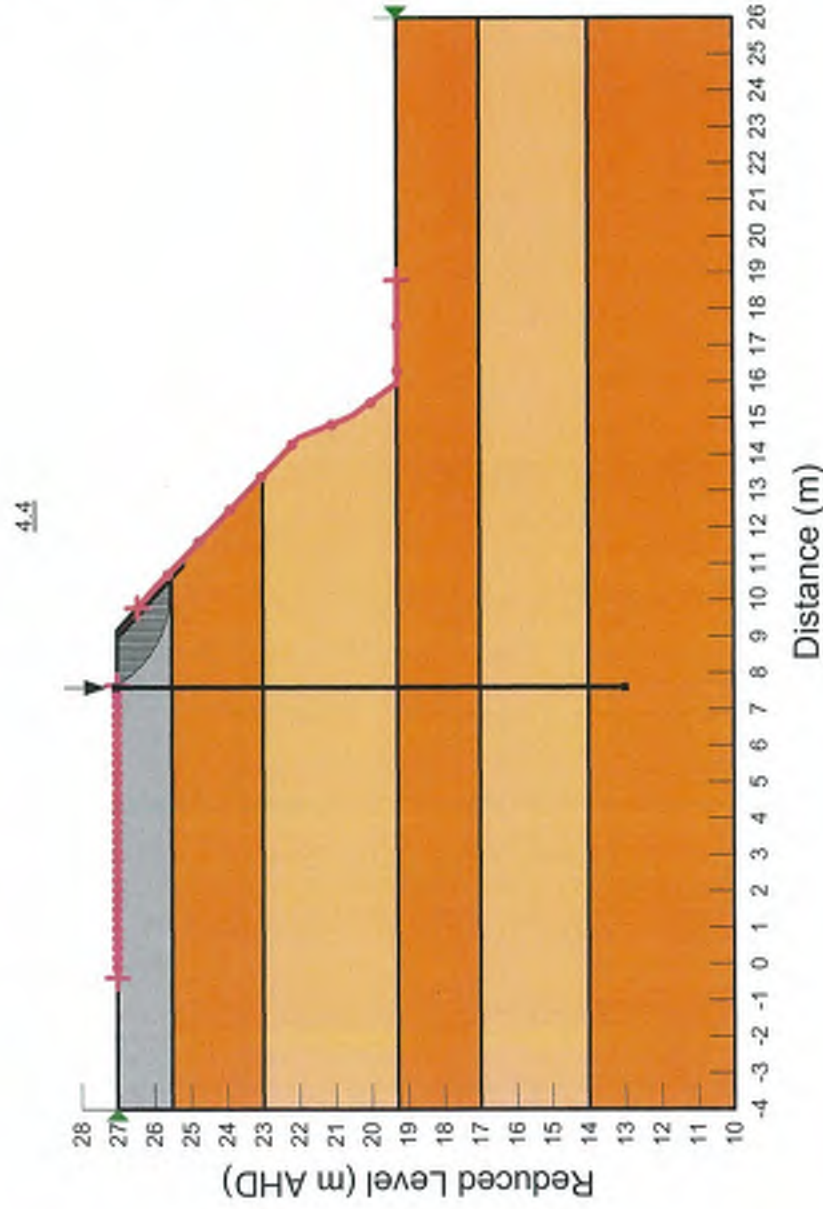
SECTION J - No nails - S-LOW - Pile

Name: VLS Basalt
Cohesion': 1 kPa
Phi': 24 °

The results of the *SLOPEW* analysis for the long term condition are indicated on Figures 11 to 16 attached, and the calculated factors of safety are shown in Table 4 below.

A FOS of 4.4 was achieved where the piles replace the soil nail support at the highest slope cross section at Grid J in the long term (i.e. permanent) condition.

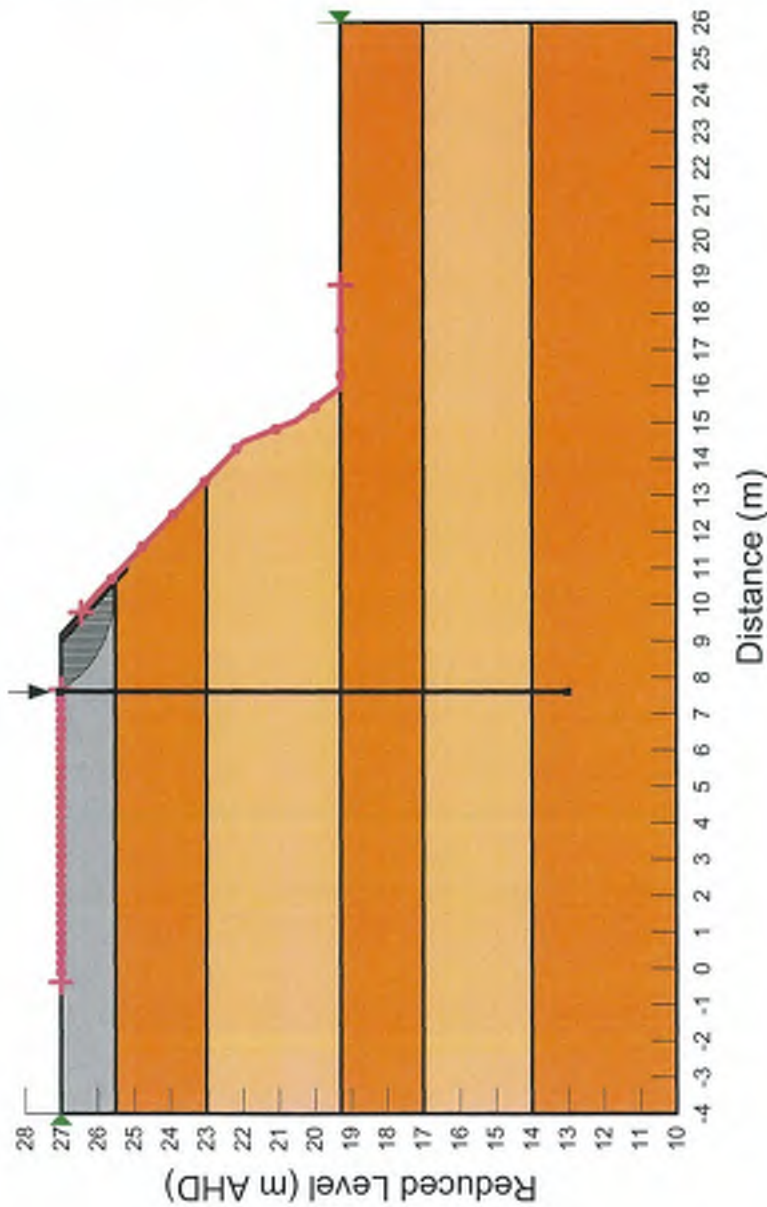
SECTION J - No nails - S-HIGH - Pile

Cohesion': 3 kPa
Phi': 25 °

Name: VLS Basalt
Model: Mohr-Coulomb
Unit Weight: 21 kN/m³
Cohesion': 150 kPa
Phi': 33 °

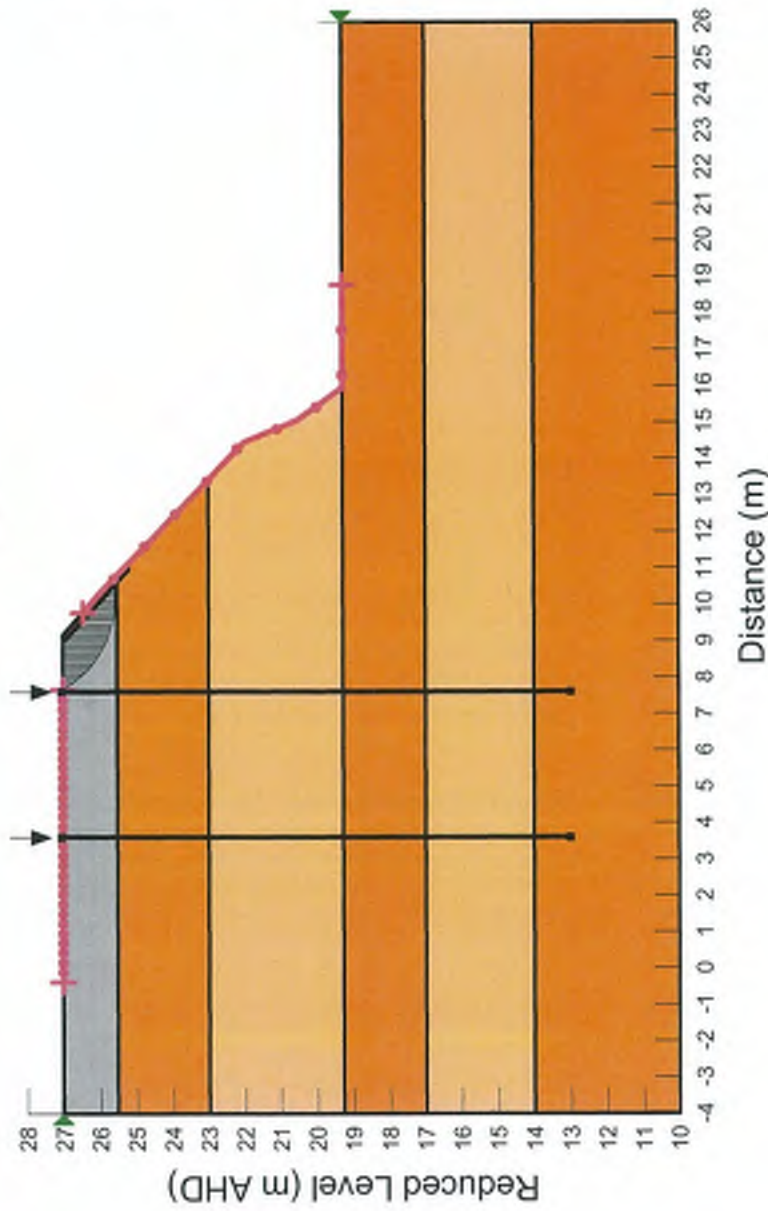
SECTION J - No nails - S-LOW - 2 Pile

Model: Mohr-Coulomb
Unit Weight: 18 kN/m³
Cohesion: 1 kPa
Phi: 24 °

Name: VLS Basalt
Model: Mohr-Coulomb
Unit Weight: 21 kN/m³
Cohesion: 100 kPa
Phi: 31 °

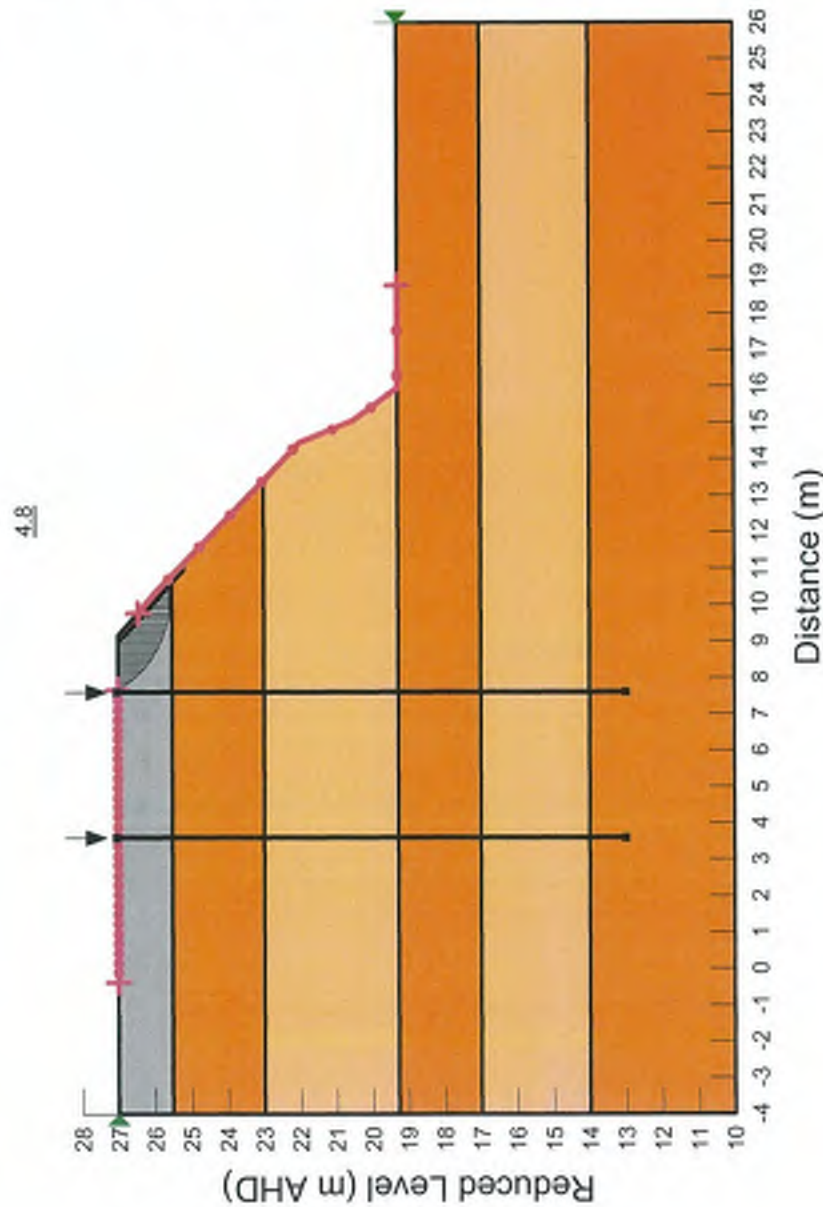
SECTION J - No nails - S-HIGH - 2 Pile

Model: Mohr-Coulomb
Unit Weight: 18 kN/m³
Cohesion: 3 kPa
Phi: 25 °

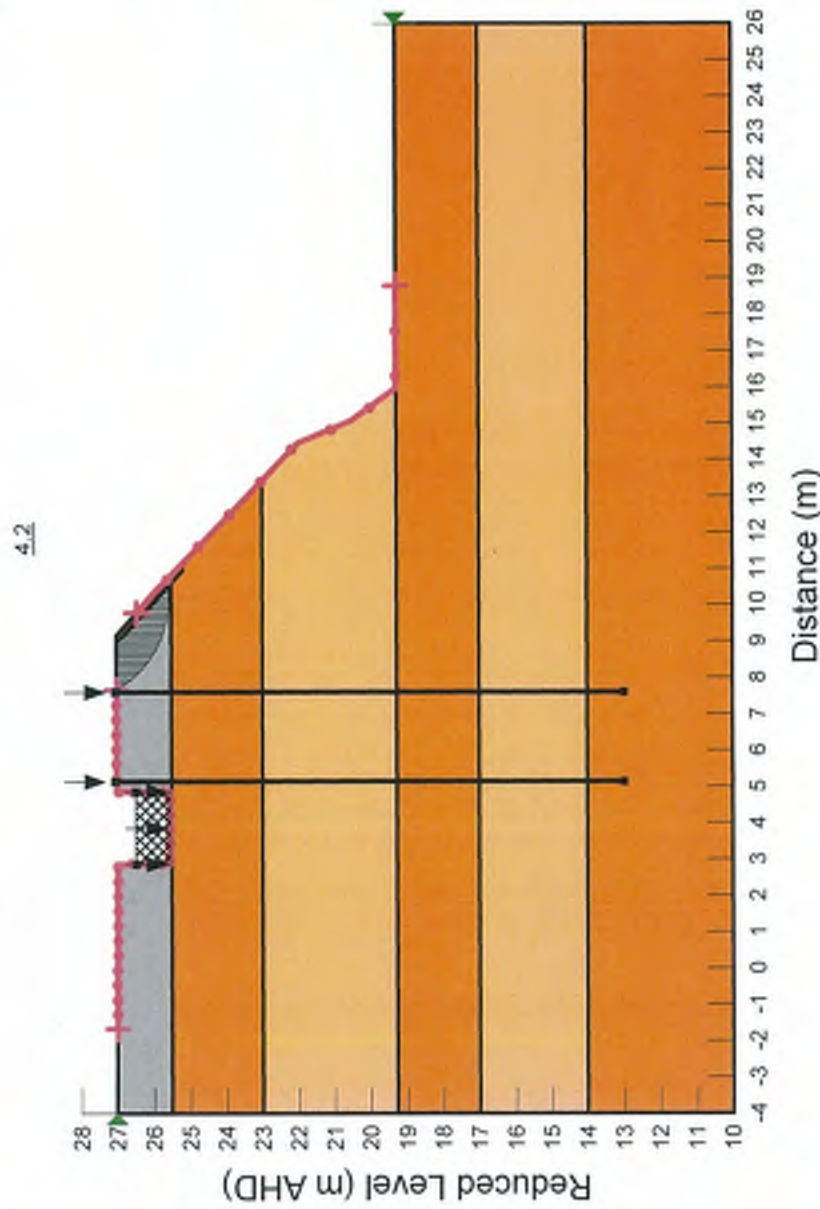
SECTION J - No nails - S-LOW - 2 Pile w/ Footing

Name: VLS Basalt
Model: Mohr-Coulomb
Unit Weight: 21 kN/m³
Cohesion: 100 kPa
Phi: 31 °

Name: HS Basalt
Model: Mohr-Coulomb
Unit Weight: 24 kN/m³
Cohesion: 750 kPa
Phi: 40 °

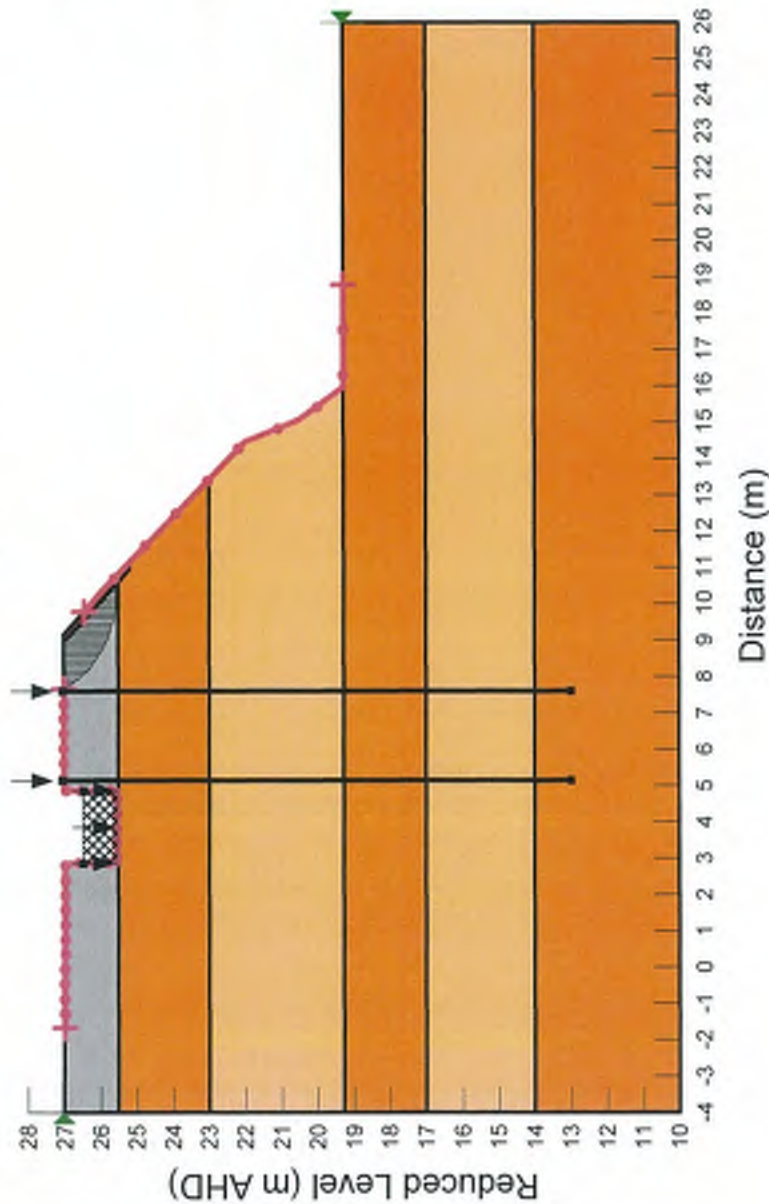
SECTION J - No nails - S-HIGH - 2 Pile w/ Footing

Name: VLS Basalt
Model: Mohr-Coulomb
Unit Weight: 21 kN/m³
Cohesion': 3 kPa
Phi': 25 °

Name: HS Basalt
Model: Mohr-Coulomb
Unit Weight: 24 kN/m³
Cohesion': 150 kPa
Phi': 33 °

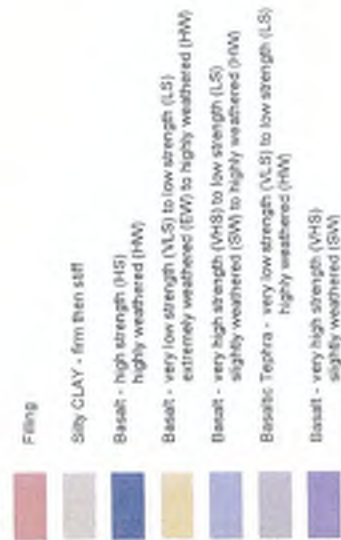
1. Stratum lines are based on interpretation of the subsurface conditions disclosed in the explorations and interpolation between adjacent explorations. Actual conditions could vary from the subsurface condition interpretations presented on this summary cross-section.
2. See report text for descriptions of geological units.
3. For cross-section location see the Site Locality and Test Locations Plan (Drawing 1).
4. Black and white reproduction of this colour original may reduce its effectiveness and lead to incorrect interpretation.

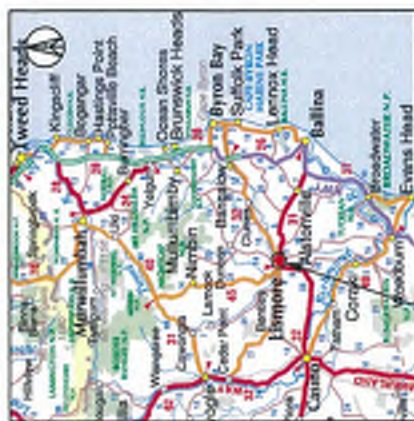
Bores 7 and 8 Designation and Approximate Location. Undertaken by DP June 2016 - Reference 90317.00.

- A lower basalt flow is underlying the tephra layer in both boreholes. It is high strength, becoming very high strength, fresh, slightly fractured. Dark grey basalt was encountered to borehole termination at 20.5m and 18.1m depth in bore 7 and 8 respectively.
