# **Arboricultural Impact Assessment**

## **Physical Education & Sports Precinct Project at St Joseph's College, Hunters Hill**

**Date:** July 2018

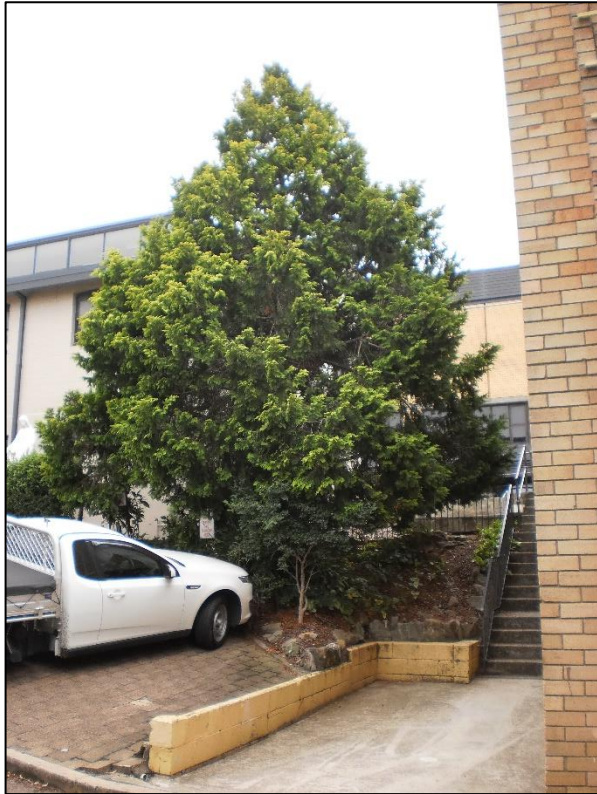
**Photo A:** Tree 1

| Tree Number | Retention Value | Reason for Proposed Removal |
|---|---|---|
| 1 | Medium | Located within the proposed pedestrian entry ramp. |

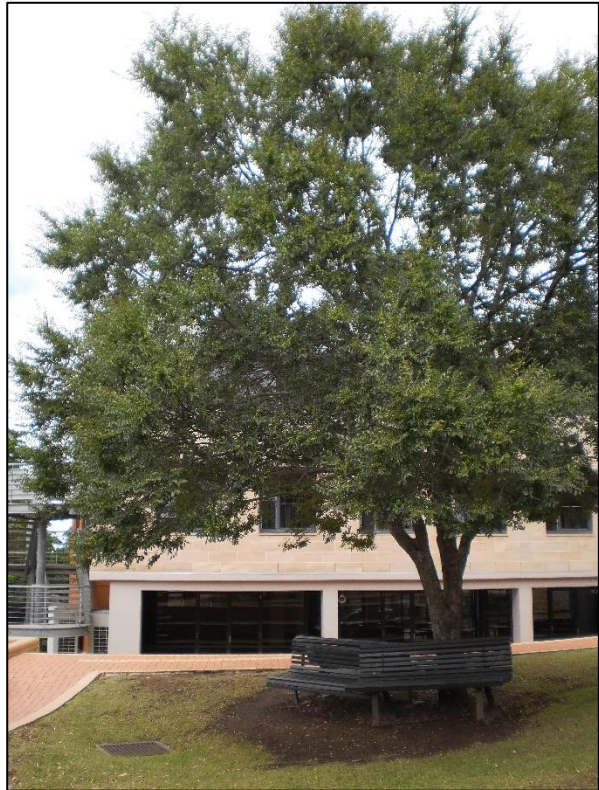
**Photo B:** Tree 2

| Tree Number | Retention Value | Reason for Proposed Removal |
|---|---|---|
| 2 | High | Construction and earthworks are proposed within the Structural Root Zone. Major root loss is expected. |

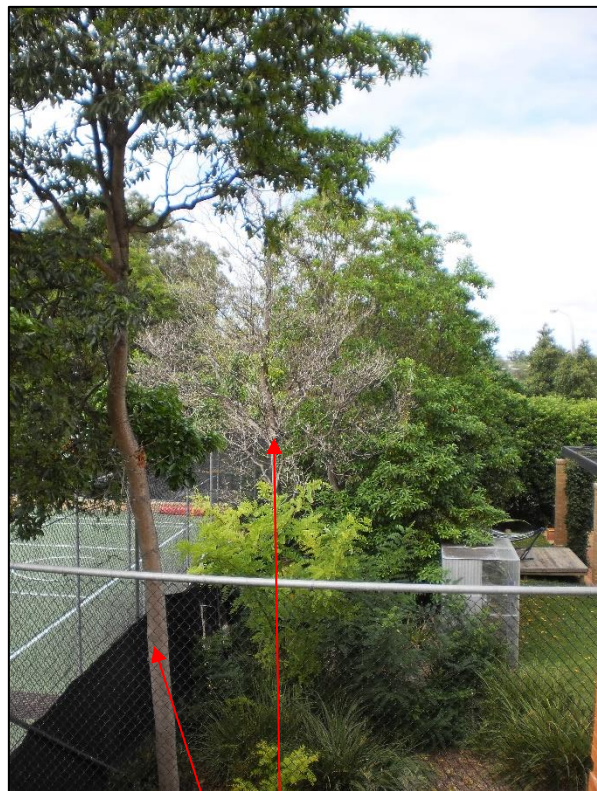
**Photo C:** Trees 3 and 5 (row of 6)

| Tree Number | Retention Value | Reason for Proposed Removal |
|---|---|---|
| 3, 4, 6 | Medium | Within the proposed new driveway. |
| 5<br>(Row of 6) | Low | Within the proposed area of bulk excavation (basement level). |

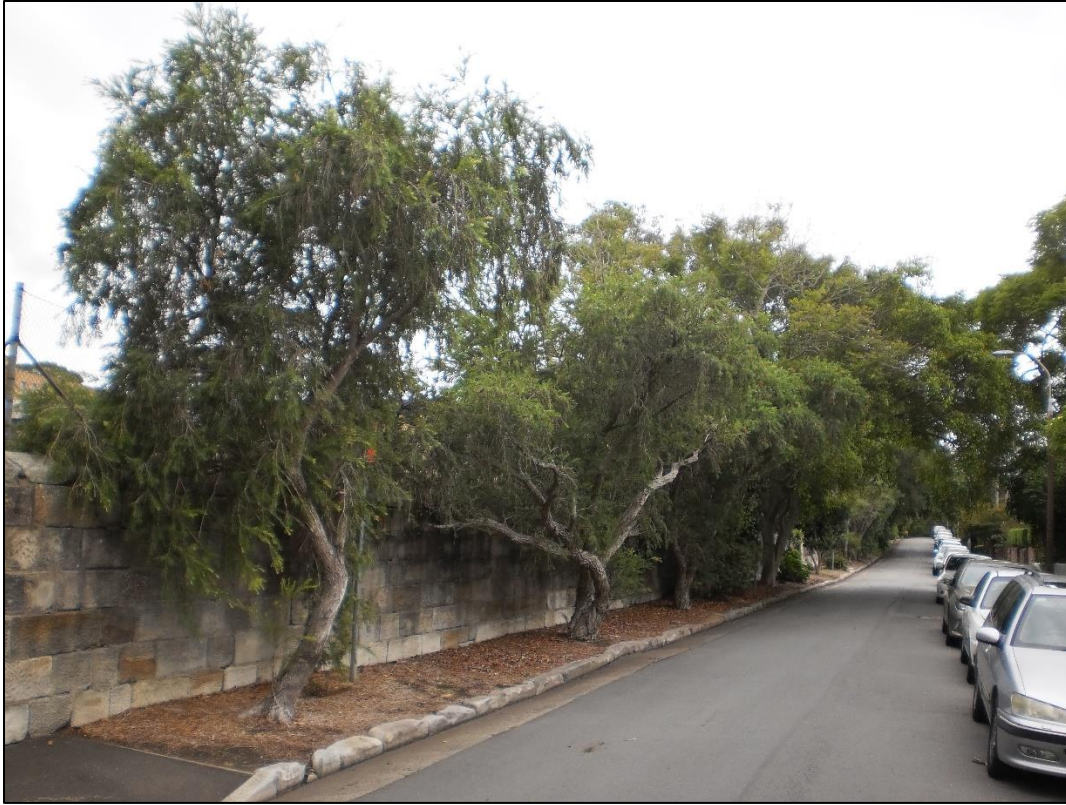
| Tree Number | Retention Value | Reason for Proposed Removal |
|---|---|---|
| 22, 23, 25, 27,<br>35, 37 | Low | The new building scaffold is likely to straddle the boundary wall with supports and hoarding required on the verge. Tree removal will be required to accommodate the scaffolding, supports and hoarding. Some of these trees (Trees 33-35) have the potential to cause damage to the heritage sandstone wall due to their potential size and interaction with wall footings. These trees are proposed to be replaced as outlined in the Landscape Plan. |

**Photo E:** Trees 19-39 located along the Luke Street frontage.

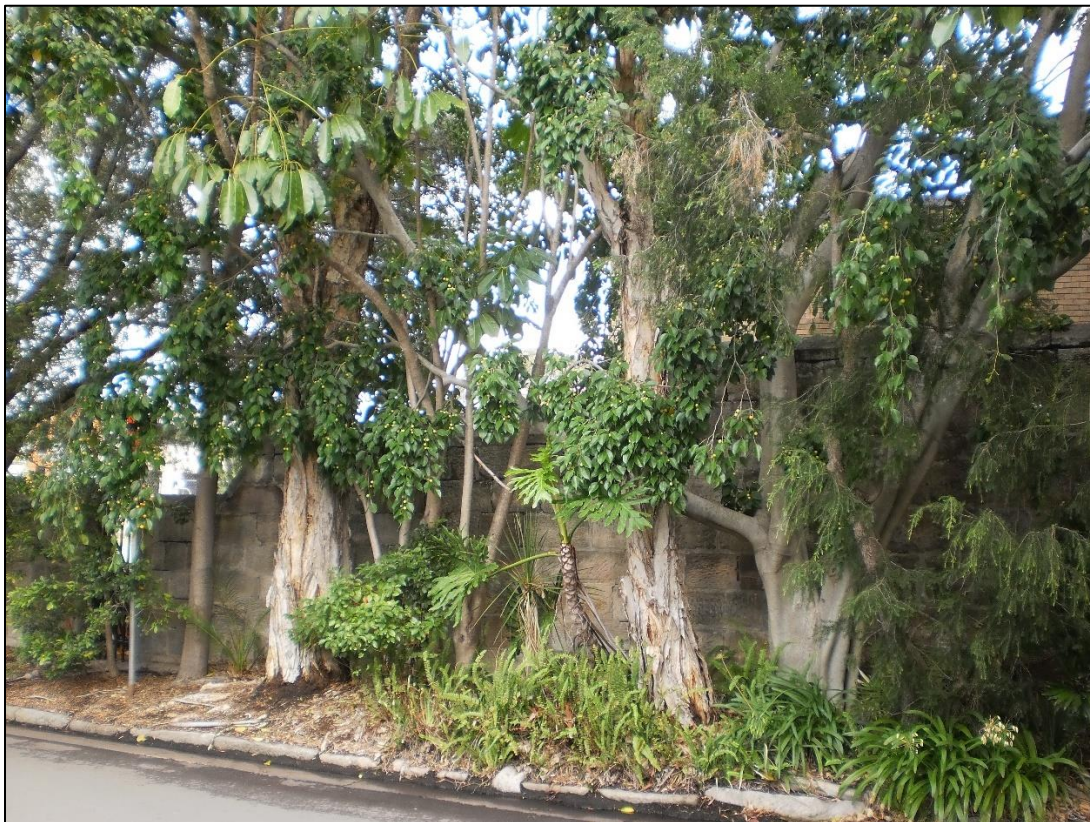
**Photo F:** Trees 33-35. These trees have the potential to damage the heritage sandstone wall.

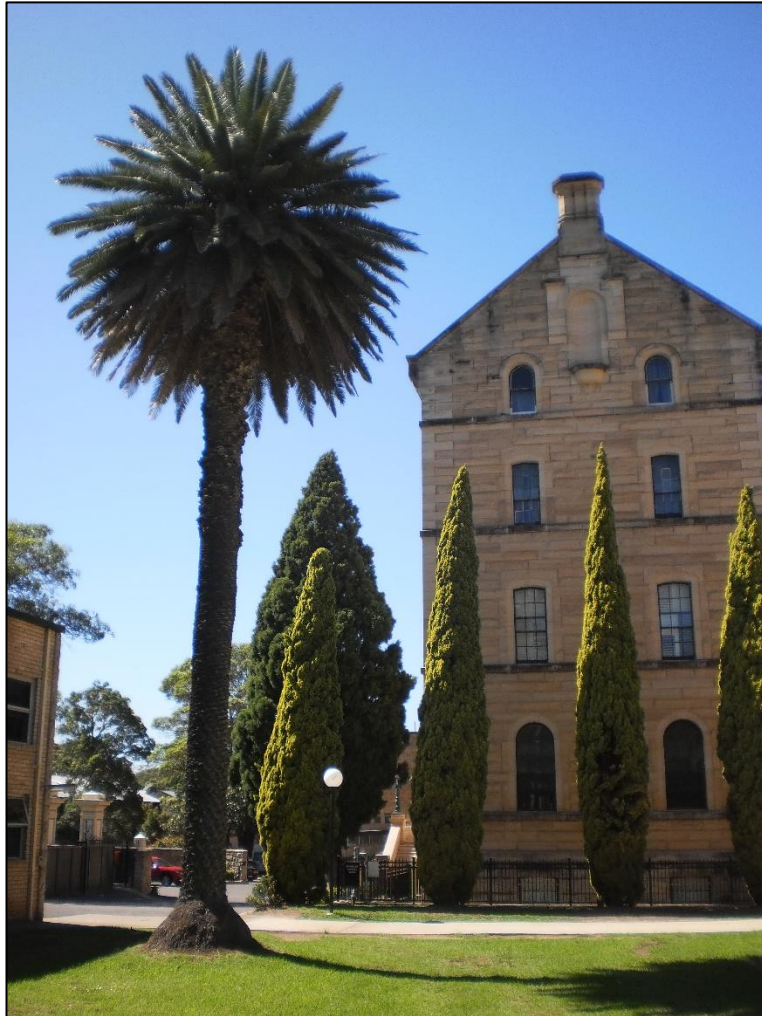
| Tree Number | Retention Value | Reason for Proposed Removal |
|---|---|---|
| 59 | High | Within the proposed Healy Gym footprint. |

**Photo G:** Tree 59. Located within the proposed Healy Gym footprint.

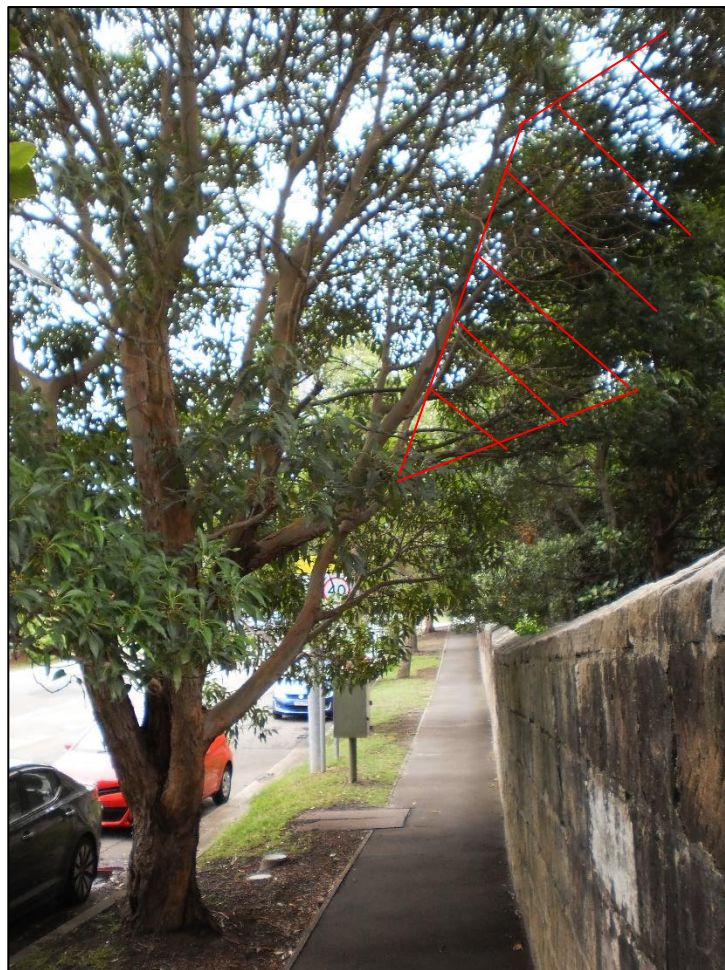
| Tree Number | Retention Value | Works proposed within the Tree Protection Zone (TPZ) |
|---|---|---|
| 16 | High | Canopy pruning will be required to accommodate scaffolding and hoarding during construction. Approximately 10% of the canopy area will require removal. |

**Photo H:** Tree 16 showing the approximate extent of required pruning.

**Canopy Pruning:** The northern side of Trees 16, 17 and 18 are proposed to be pruned to accommodate the scaffolding and hoarding during construction. Canopy pruning should be supervised by the Project Arborist. Canopy pruning must be undertaken in accordance with AS4373-2007-*Pruning of Amenity Trees*, Section 7.2.4 (Selective Pruning).

| Tree Number | Pruning Description | Pruning Limit |
|---|---|---|
| Tree 16 | Canopy pruning should be limited to branches overhanging the property boundary. No other pruning is currently recommended. | 10% |

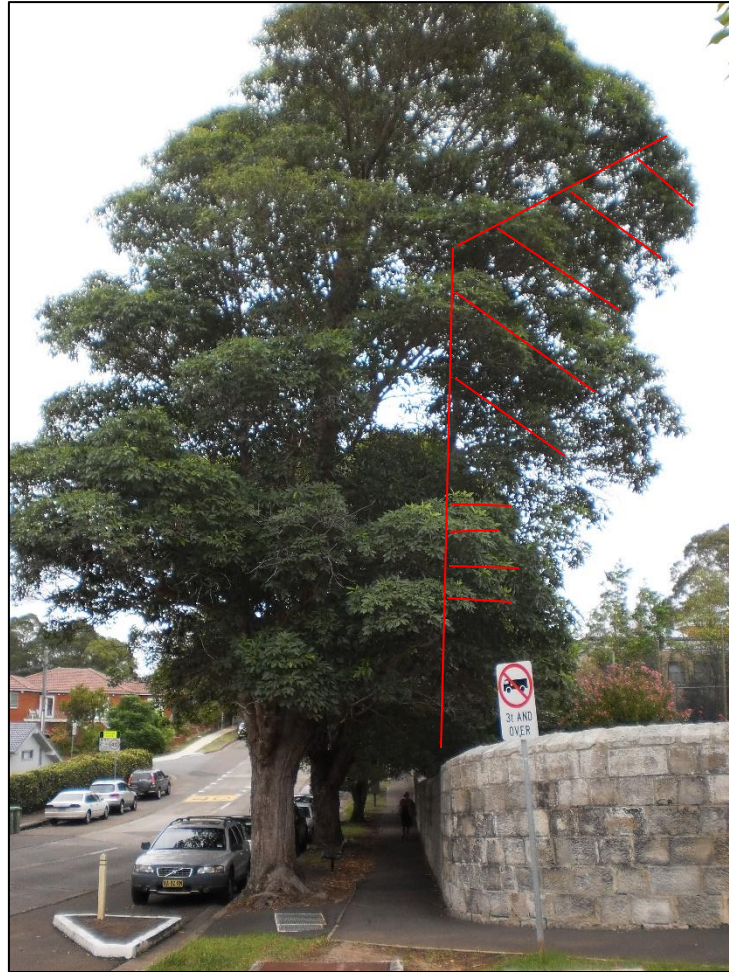
| Tree Number | Retention Value | Works proposed within the Tree Protection Zone (TPZ) |
|---|---|---|
| 17 | High | Canopy pruning will be required to accommodate scaffolding and hoarding during construction. Approximately 15-20% of the canopy area will require removal. |
| 18 | High | Canopy pruning will be required to accommodate scaffolding and hoarding during construction. Approximately 20-25% of the canopy area will require removal. |

**Photo I:** Trees 17 and 18 showing the approximate extent of required pruning.

| Tree Number | Pruning Description | Pruning Limit |
|---|---|---|
| Tree 17 | | 15-20% |
| Tree 18 | | 20-25% |
