REMEDIAL ACTION PLAN

Lot 412 & 413 DP 1063902, Medowie NSW

Prepared for Catholic Diocese of Maitland Newcastle c/- Webber Architects
Prepared by RCA Australia

RCA ref 13156a-401/1 October 2018

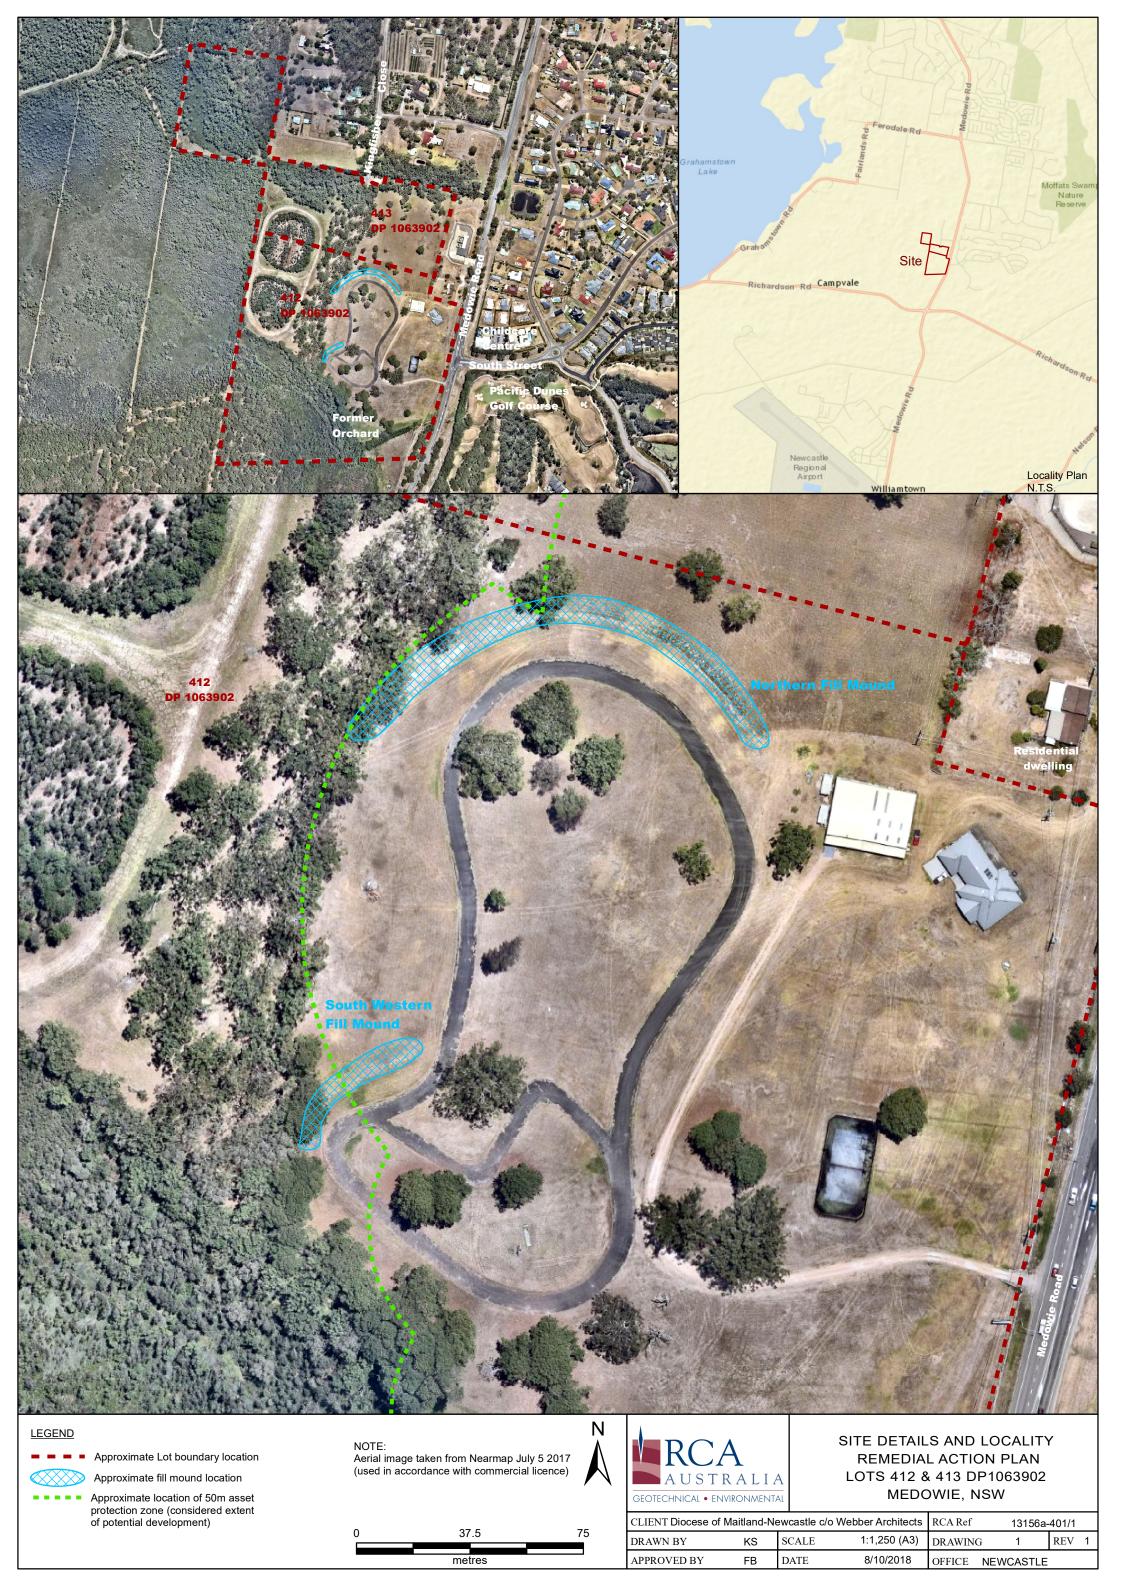
Drawing 1, Appendix A shows the locality and the layout of the site.

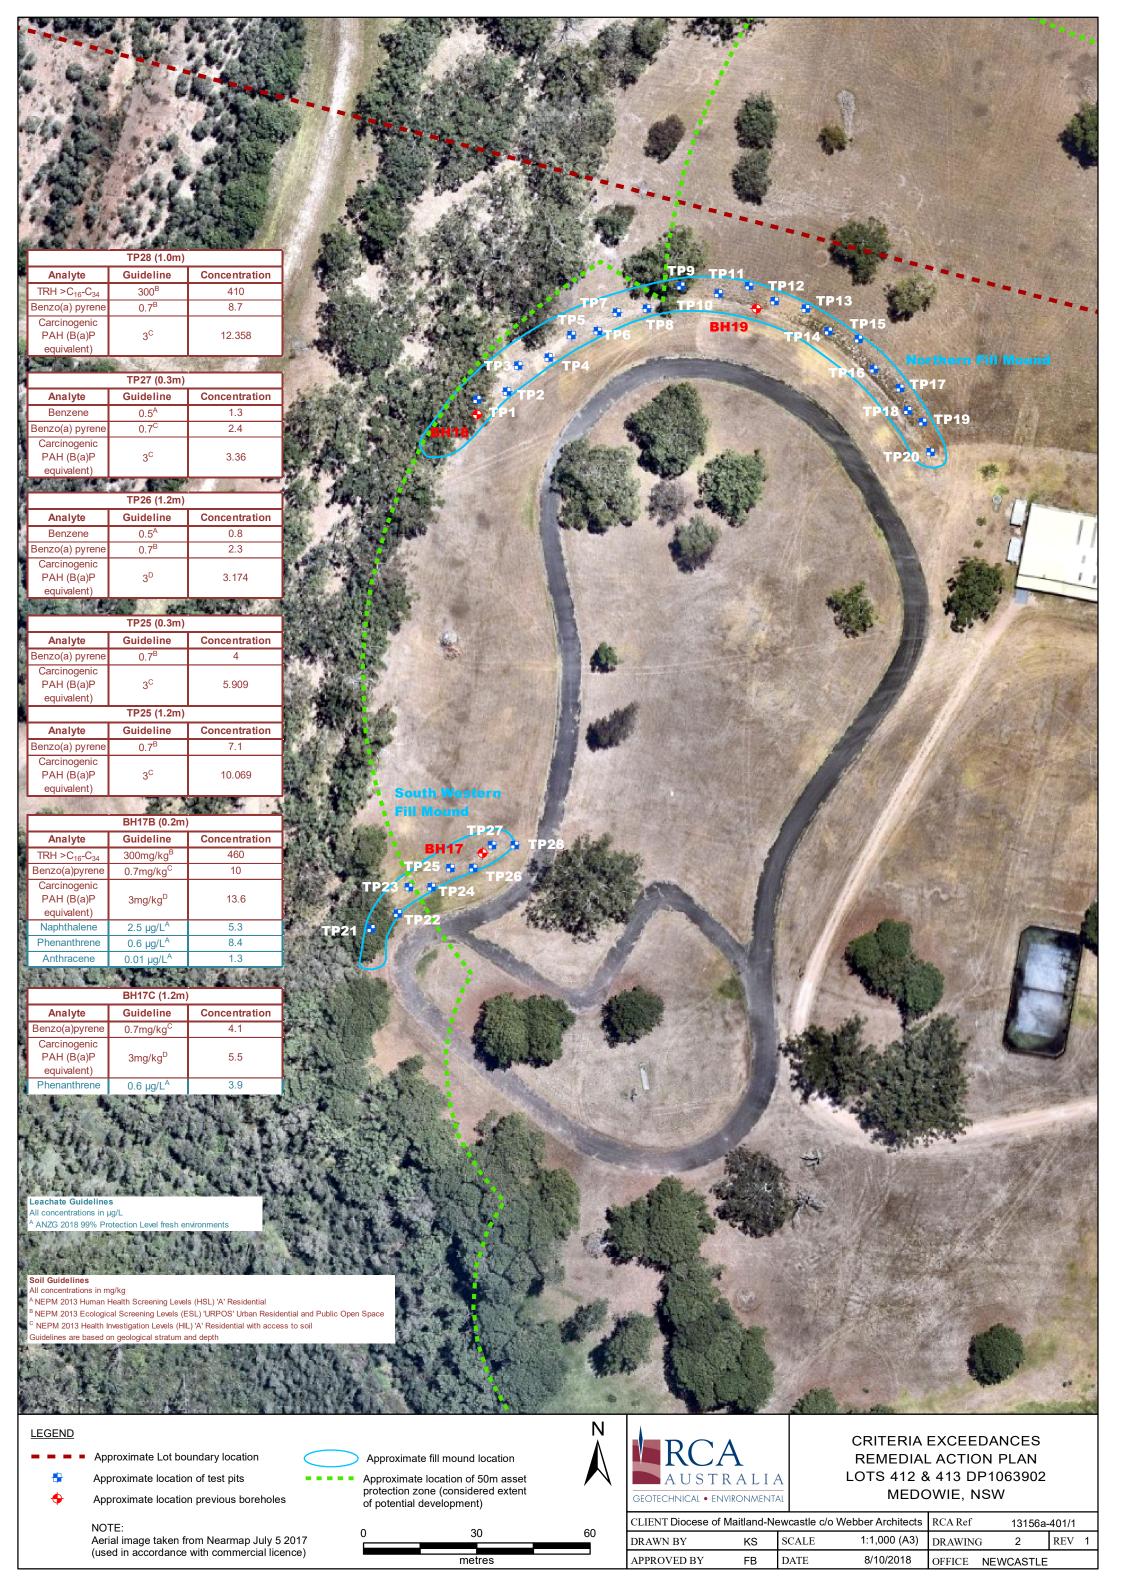
- A site inspection.
- The collection of seventy nine (79) soil samples from twenty eight (28) test pit locations on the fill mounds, as presented on **Drawing 2**, **Appendix A**:

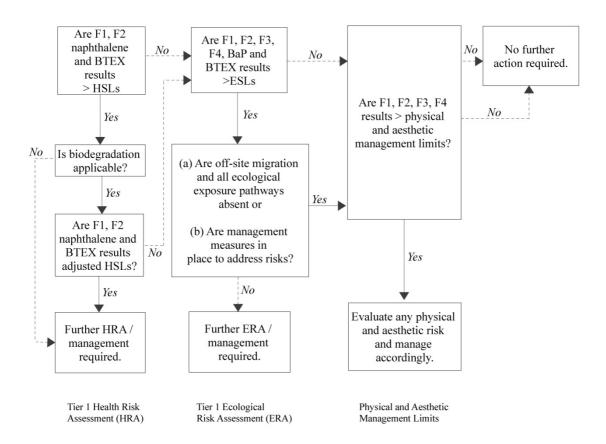
Figure 1 Flowchart for the Tier 1 human and ecological risk assessment of petroleum hydrocarbon contamination – application of HSL and ESL and consideration of management limits

The following figure has been taken from the ASC NEPM (Ref [8]) to illustrate the assessment methodology in regards to petroleum contamination.
