Report on  
Preliminary Site (Contamination) Investigation

2040 Masterplan

SCEGGS Darlington, 215 Forbes Street,  
Darlington

Project 86514.00  
October 2018

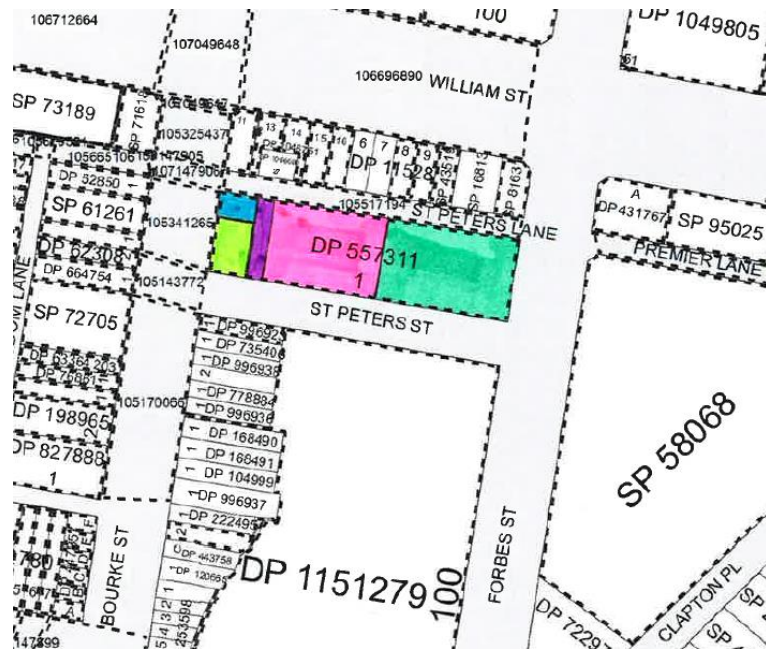
**Figure 1: Breakdown of lots within 159 – 163 Forbes Street, Darlinghurst, currently known as Lot 1 D.P. 557311.**

A summary of the title deeds and possible land uses for the selected lots as show in Figures 1 and 2 are presented in Tables 4 to 7. A full copy of the search, including information on easements and leases is included in Appendix B.

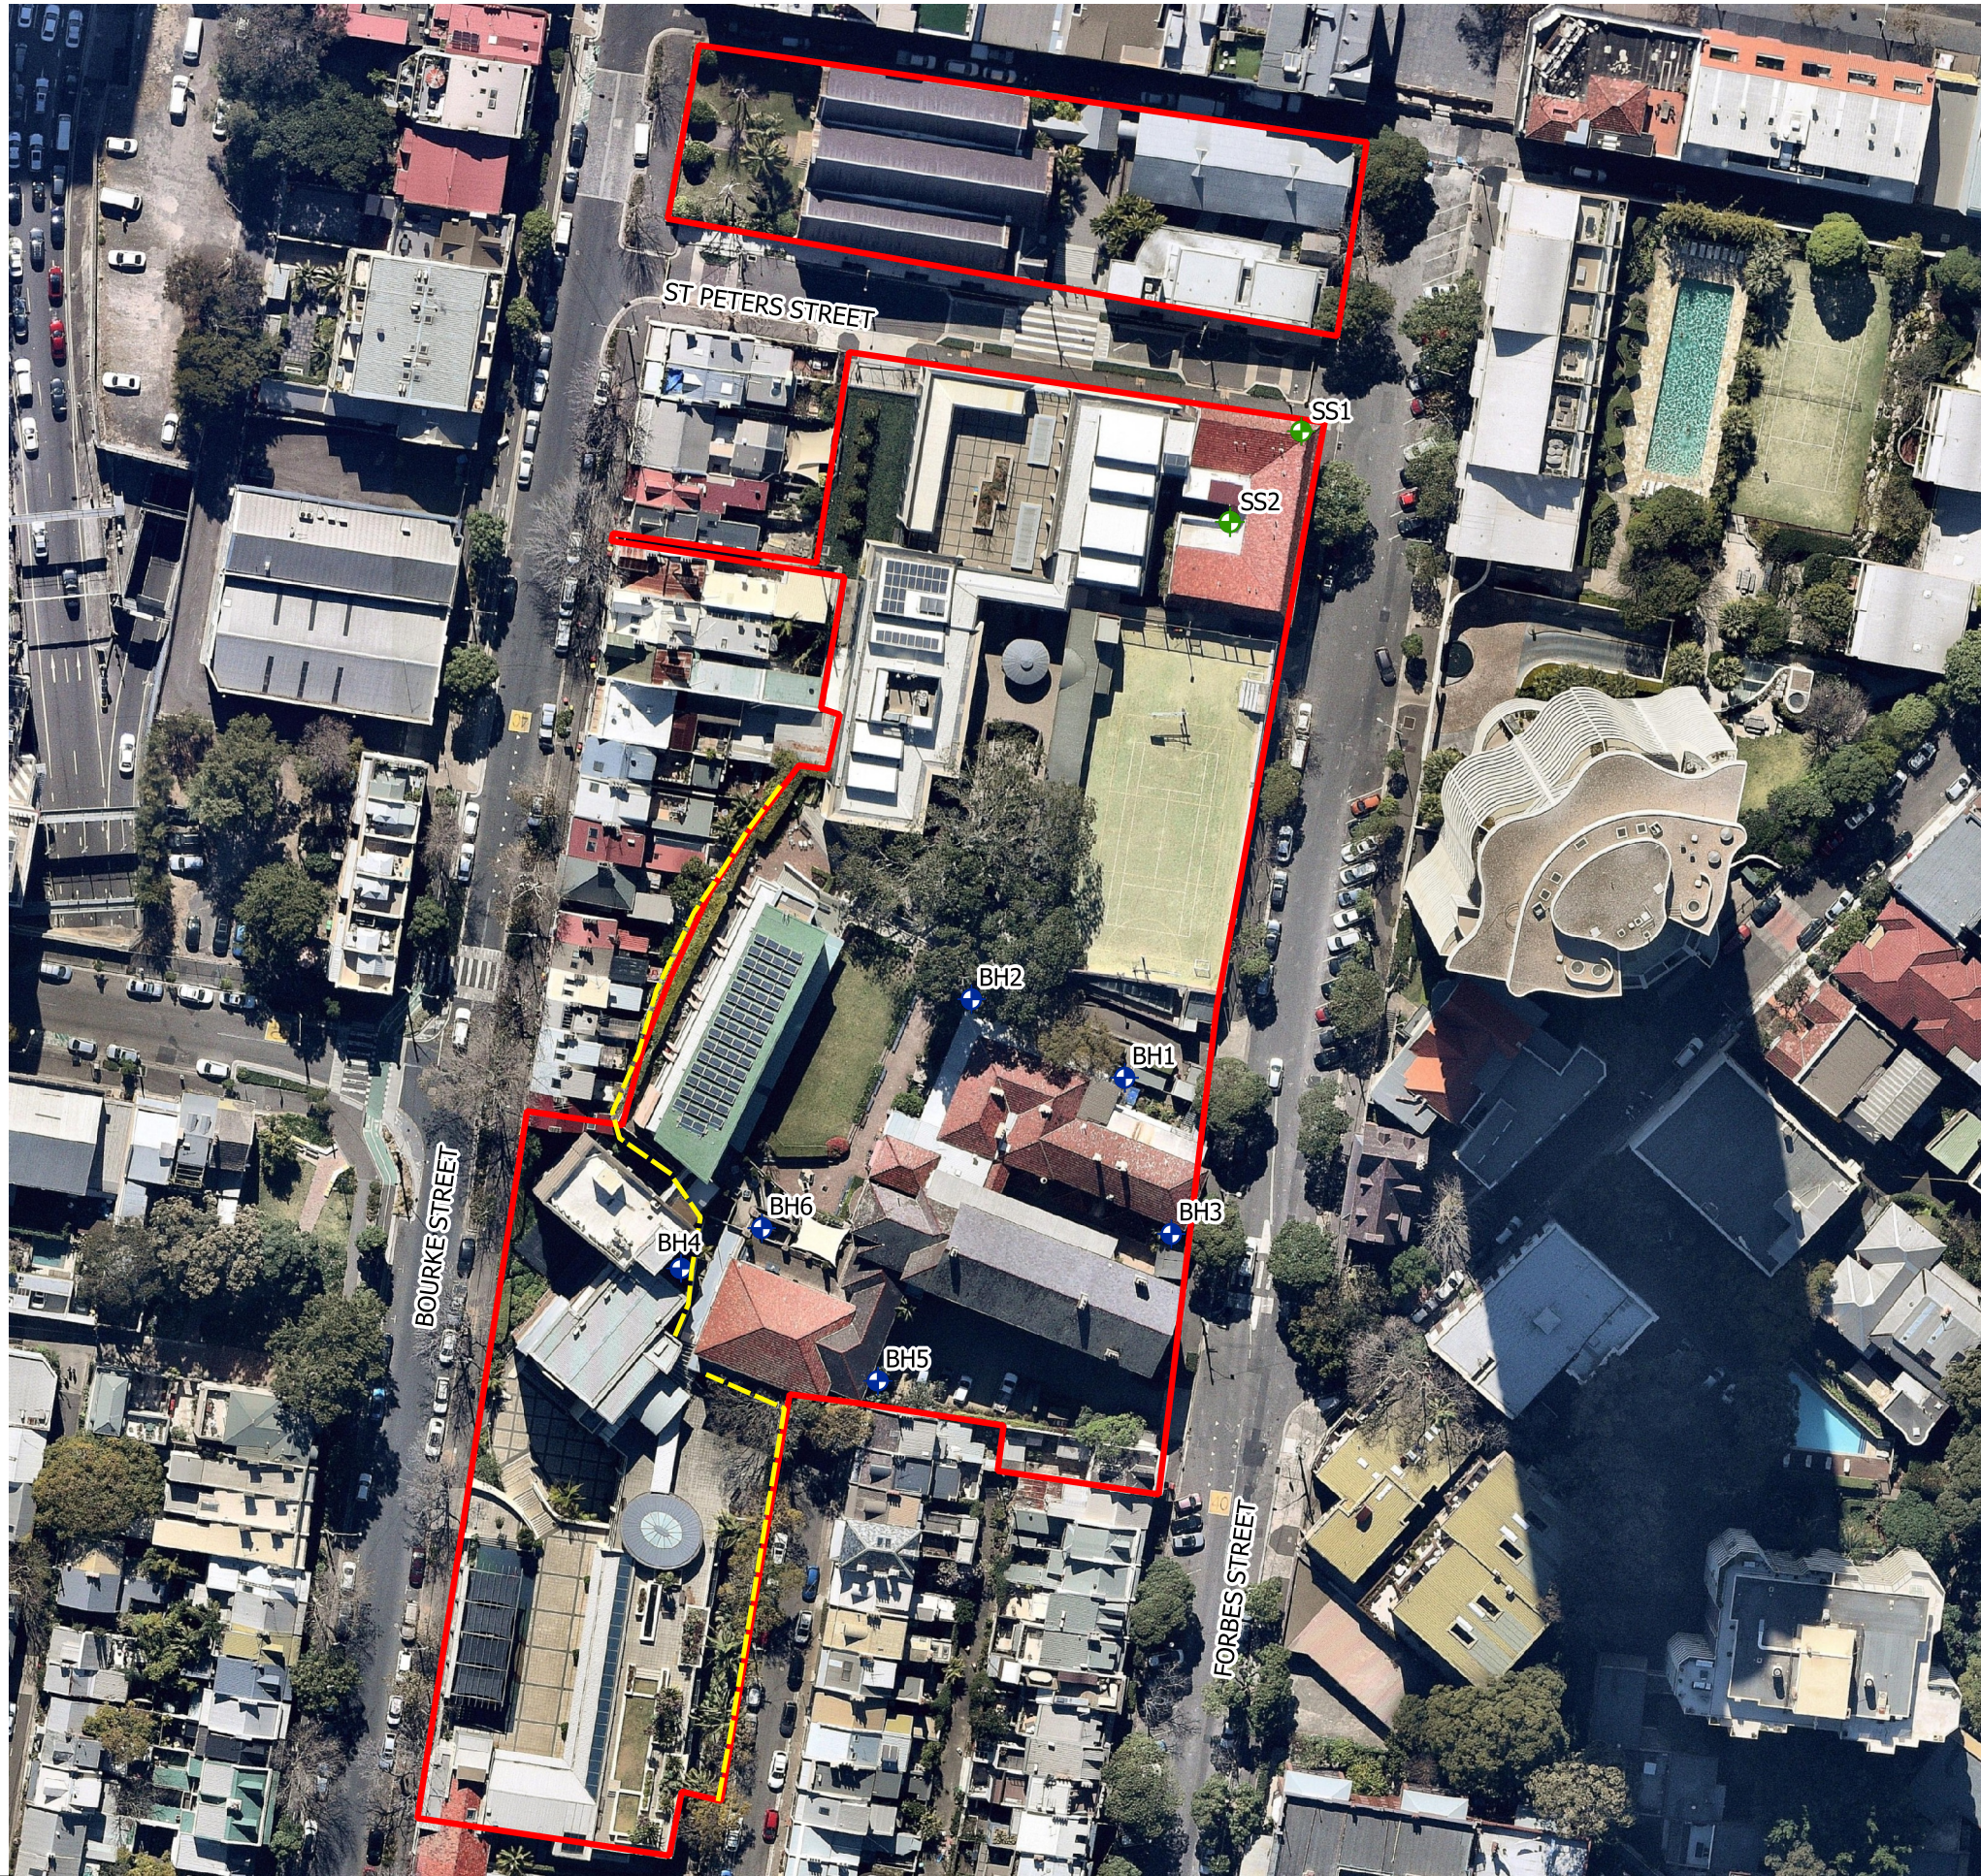
- Site Boundary
- Exposed rock face\*
- Surface Samples
- Boreholes

The bore locations are shown on Drawing 1, Appendix A. The bores were located in readily accessible areas of the site (e.g. in garden beds) to gain a reasonable (albeit preliminary) coverage of the soil profile and contamination status. Particular focus for the investigation was in the vicinity of the proposed new buildings, the grease trap and in areas where building rubble was observed.

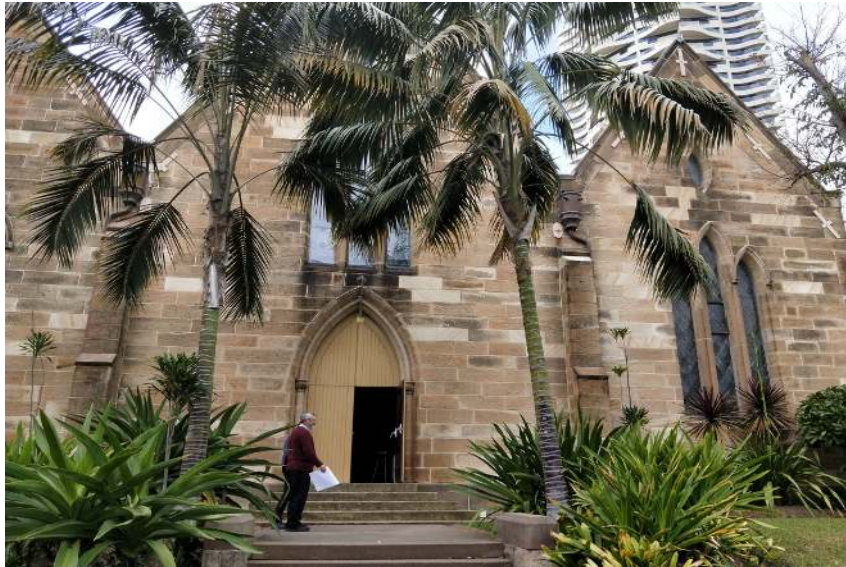
Photo 1 - Old church building repurposed in to the Great Hall, with garden beds out the front.

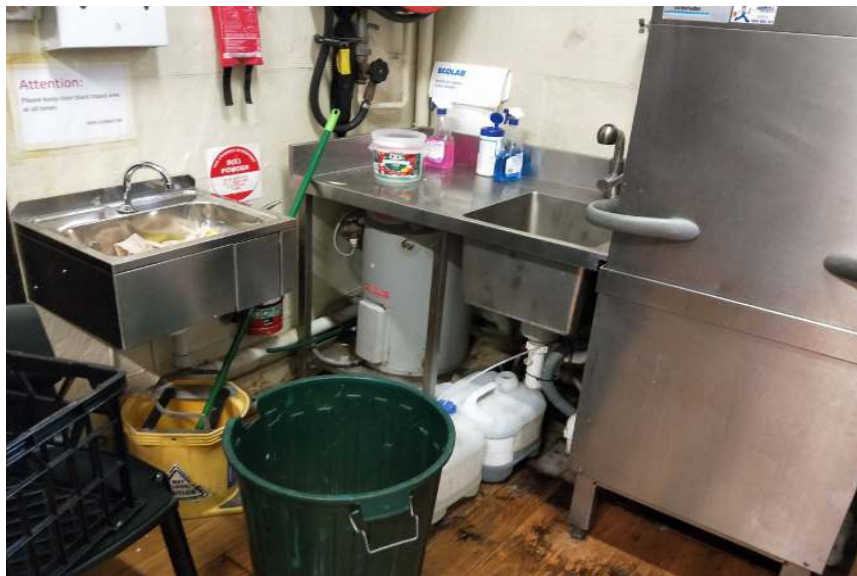
Photo 2 - Commerical kitchen in the Great Hall, with cleaning chemicals stored within it.

renovated and repurposed into educational facilities such as the 'Great Hall' and performing arts facilities. The Great Hall contained a commercial sized kitchen, which had general cleaning chemicals stored in it (Photograph 2). There was no grease trap observed associated with this kitchen. The buildings were in good condition and the foot paths and small garden beds surrounding the buildings were well maintained.

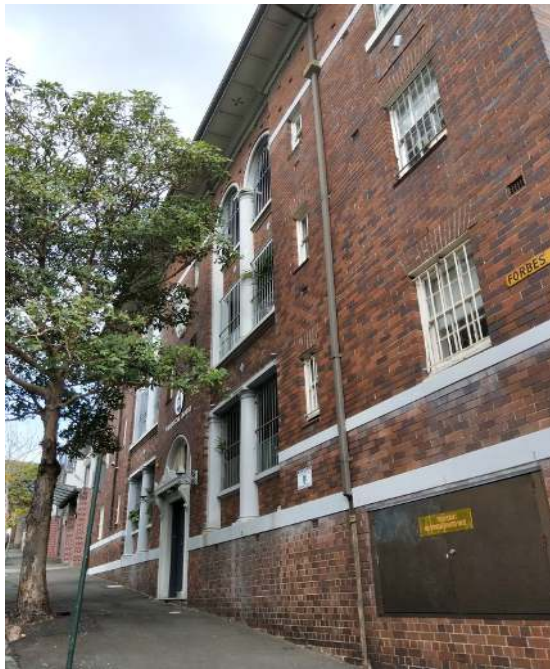
Photo 3 - Wilkinson House, used as the senior study centre, is one of the older buildings onsite.

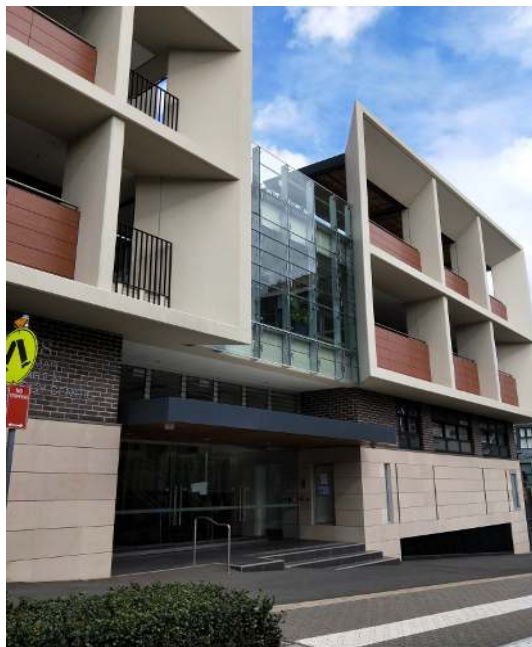
Photo 4 - The new Science, Art and Technology Centre which was constructed in 2010.

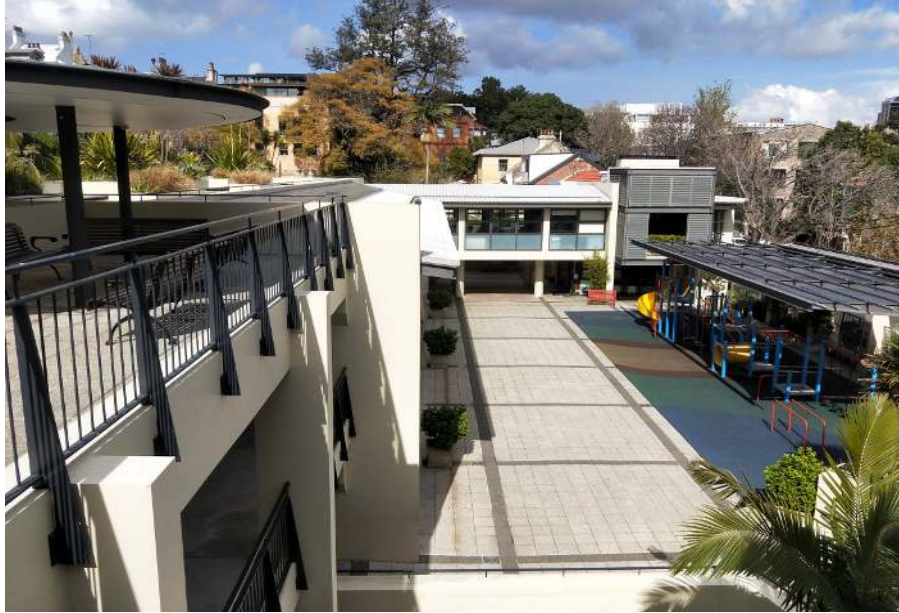
Photo 5 - Newly refurbished primary school with outdoor playground.

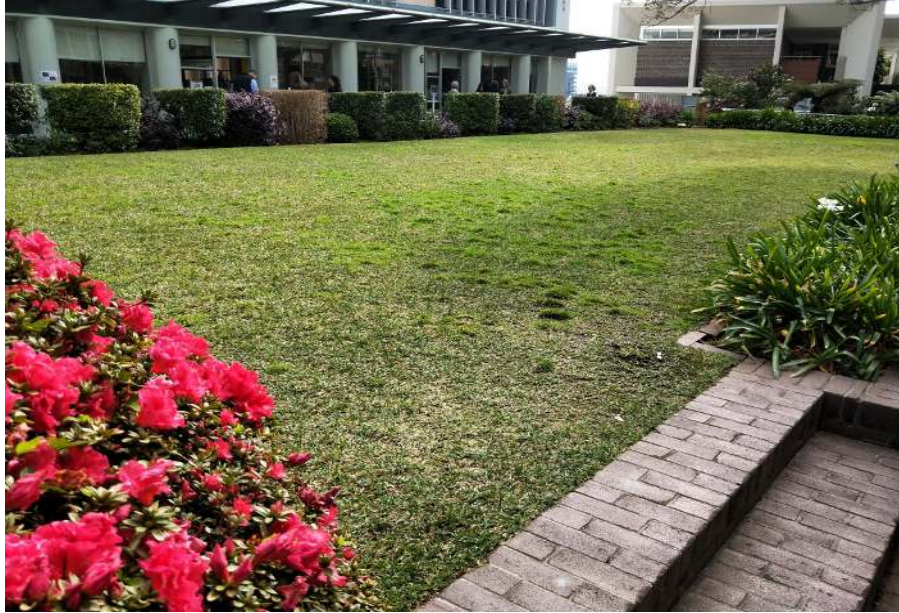
Photo 7 - Lawn and garden beds at the centre of the site.

- The majority of the site was paved or concreted, with the exception of some garden beds and the lawn in the centre of the site (Photograph 7);
- A grease trap was observed adjacent to Barham House and was associated with the commercial kitchen in the building. Waste disposal bins were also stored in this area (Photograph 8);

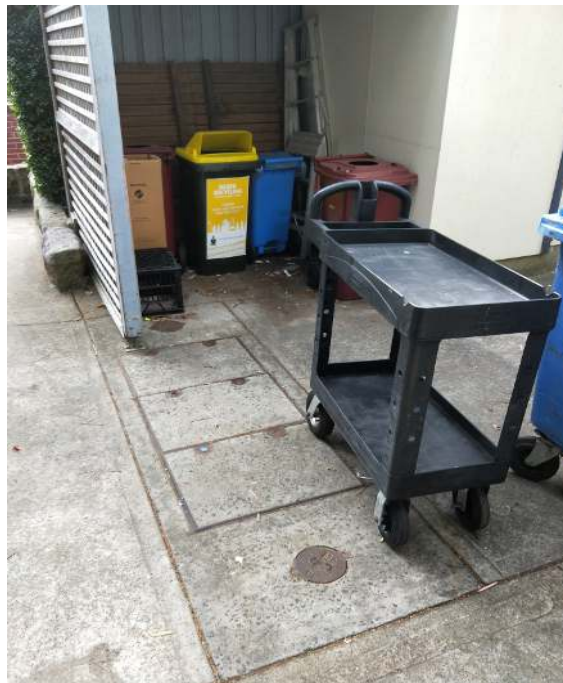
Photo 8 - Grease trap and garbage bins stored near by.

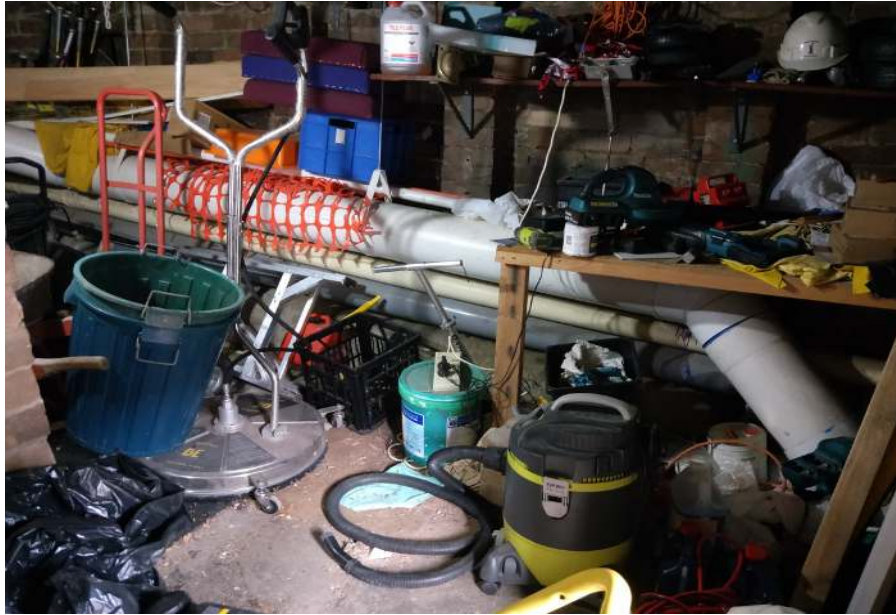
Photo 9 - Storeroom containing maintenance equipment and chemicals beneath Barham House.

- A store room with site maintenance equipment and chemicals was observed in the basement beneath Barham House (accessed off walkway on the western side of the building). The floor of this storeroom was a combination of concrete and sandstone (Photograph 9); and,

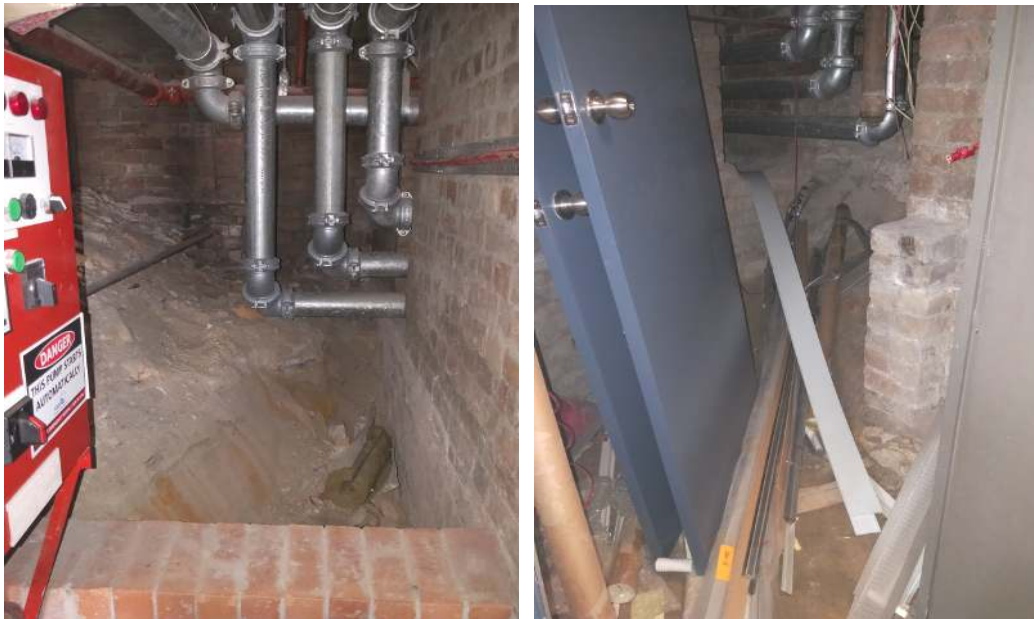
Photo 10 - Sandstone observed in the Pump room (L) and basement (R) of the Wilkinson House.

- Sandstone was observed in the basements of many of the buildings during the site walkover, including the pump room and basement of Wilkinson House (Photograph 10) and along the eastern site boundary along the wall of the basketball court, beneath the tennis court.
