Acid Sulfate Soil Management Plan

Huntington  
35 Honeysuckle Drive, Newcastle

Prepared for  
Lee 4 Pty Ltd

Project 91303.00  
June 2018

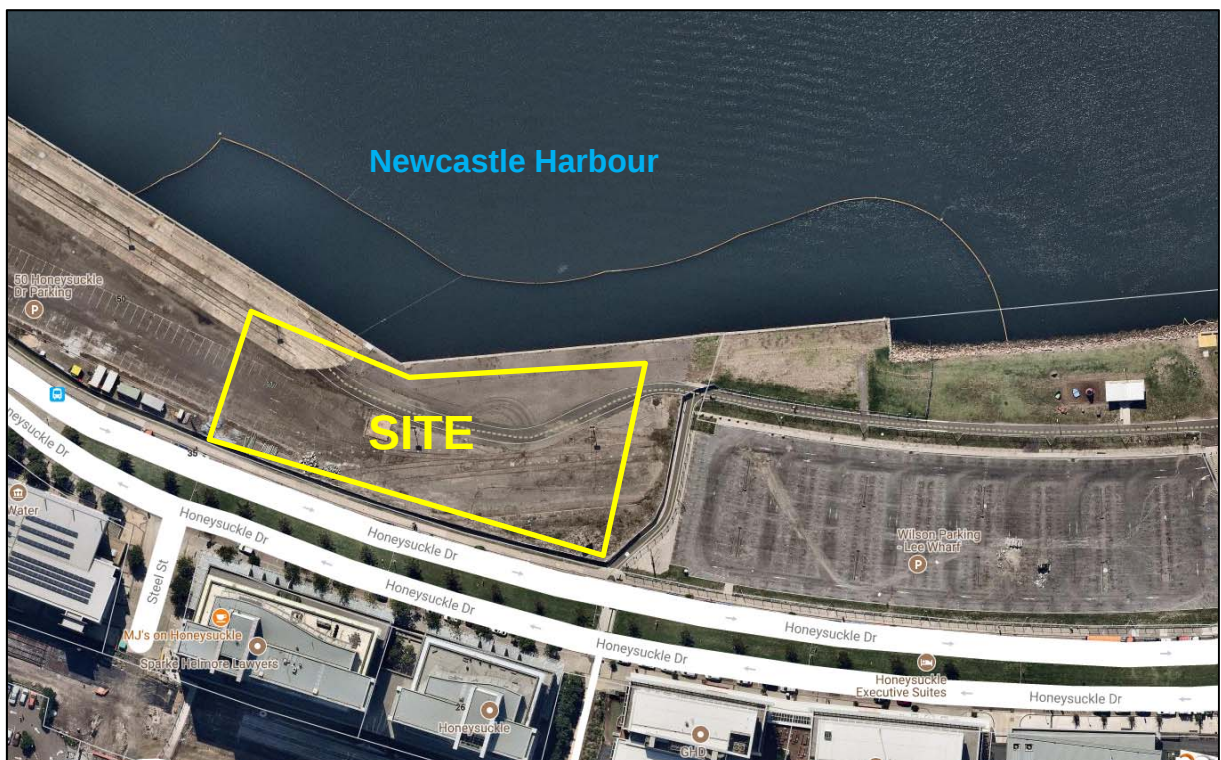
Figure 1: Site Location - 35 Honeysuckle Drive, Newcastle (Photo dated 7 April 2018, nearmap)

It is almost fully occupied by a bitumen-sealed area which is currently disused. The location and aerial view of the site is shown in Figure 1.

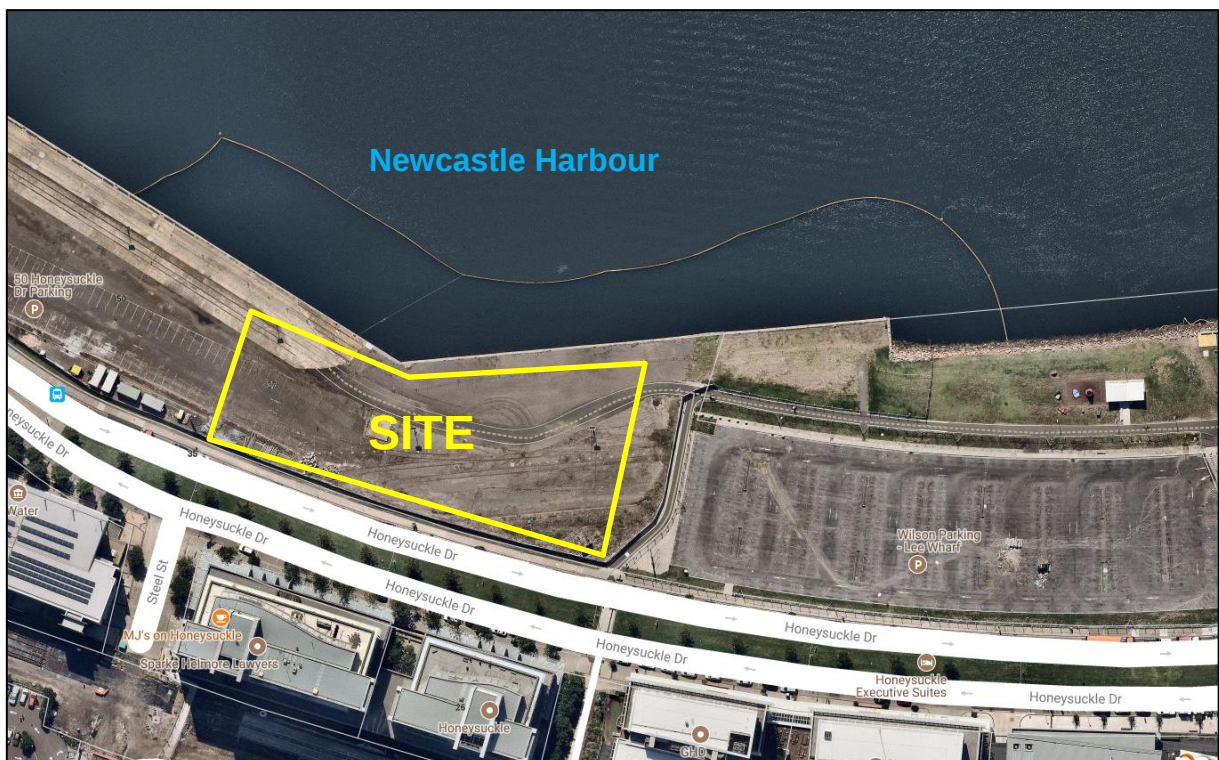
**Figure 1: Site Location - 35 Honeysuckle Drive, Newcastle (Photo dated 7 April 2018, nearmap)**

It is almost fully occupied by a bitumen-sealed area which is currently disused. The location and aerial view of the site is shown in Figure 1.
