# artefact

16 December 2025

**Re: 2-10 Valentine Avenue, Parramatta: Aboriginal Heritage Due Diligence Assessment.**

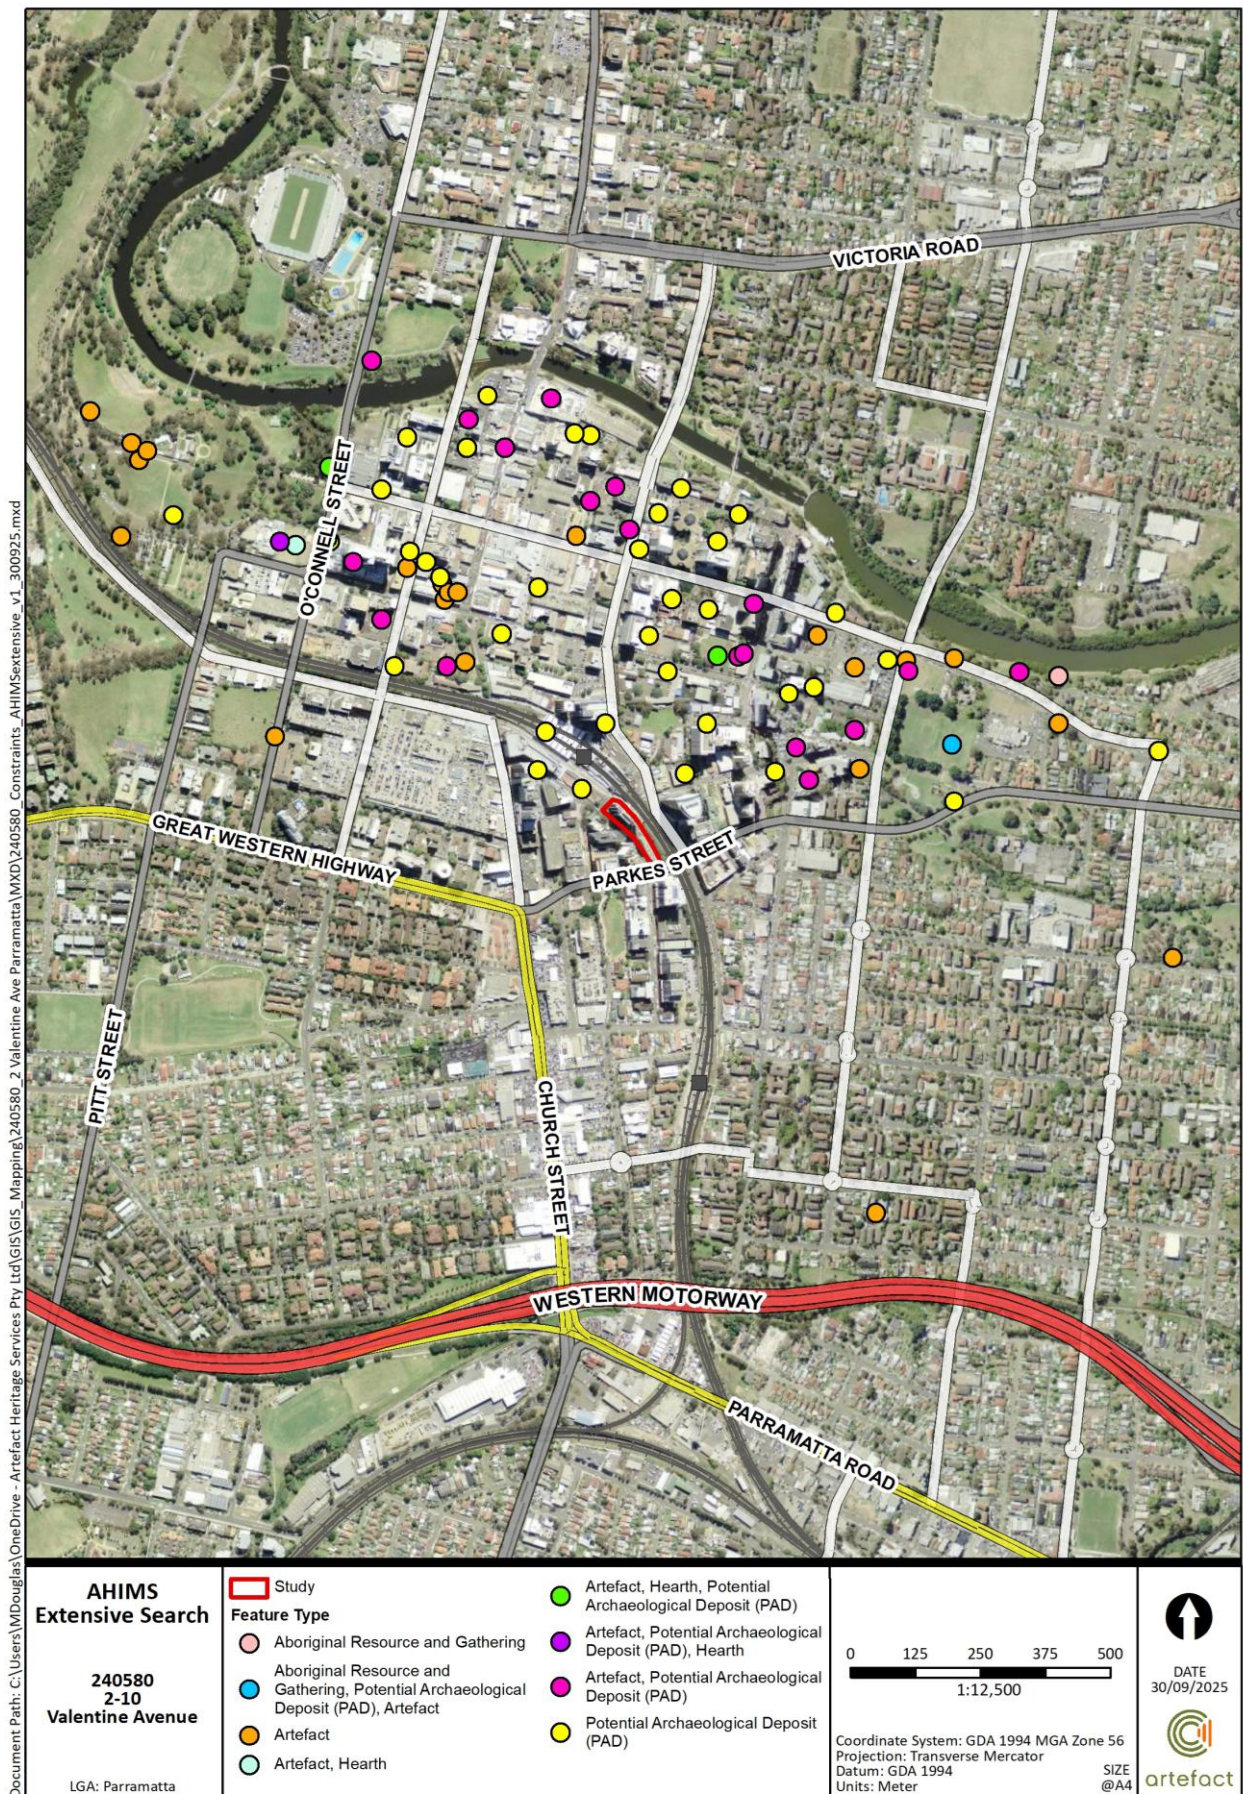
Figure 2: AHIMS extensive search results

The extensive search resulted in a total of 82 registered sites within the wider search area. However, two of these sites were classified as 'Not a site' and have been removed from the total of registered results. As a result, 80 registered sites were identified within the extensive search. No Aboriginal sites were identified within the study area. The closest AHIMS site to the study area is AHIMS ID 45-6-4080 'Potential Archaeological Deposit', in which its centroid is located approximately 55 m northeast of the study area.

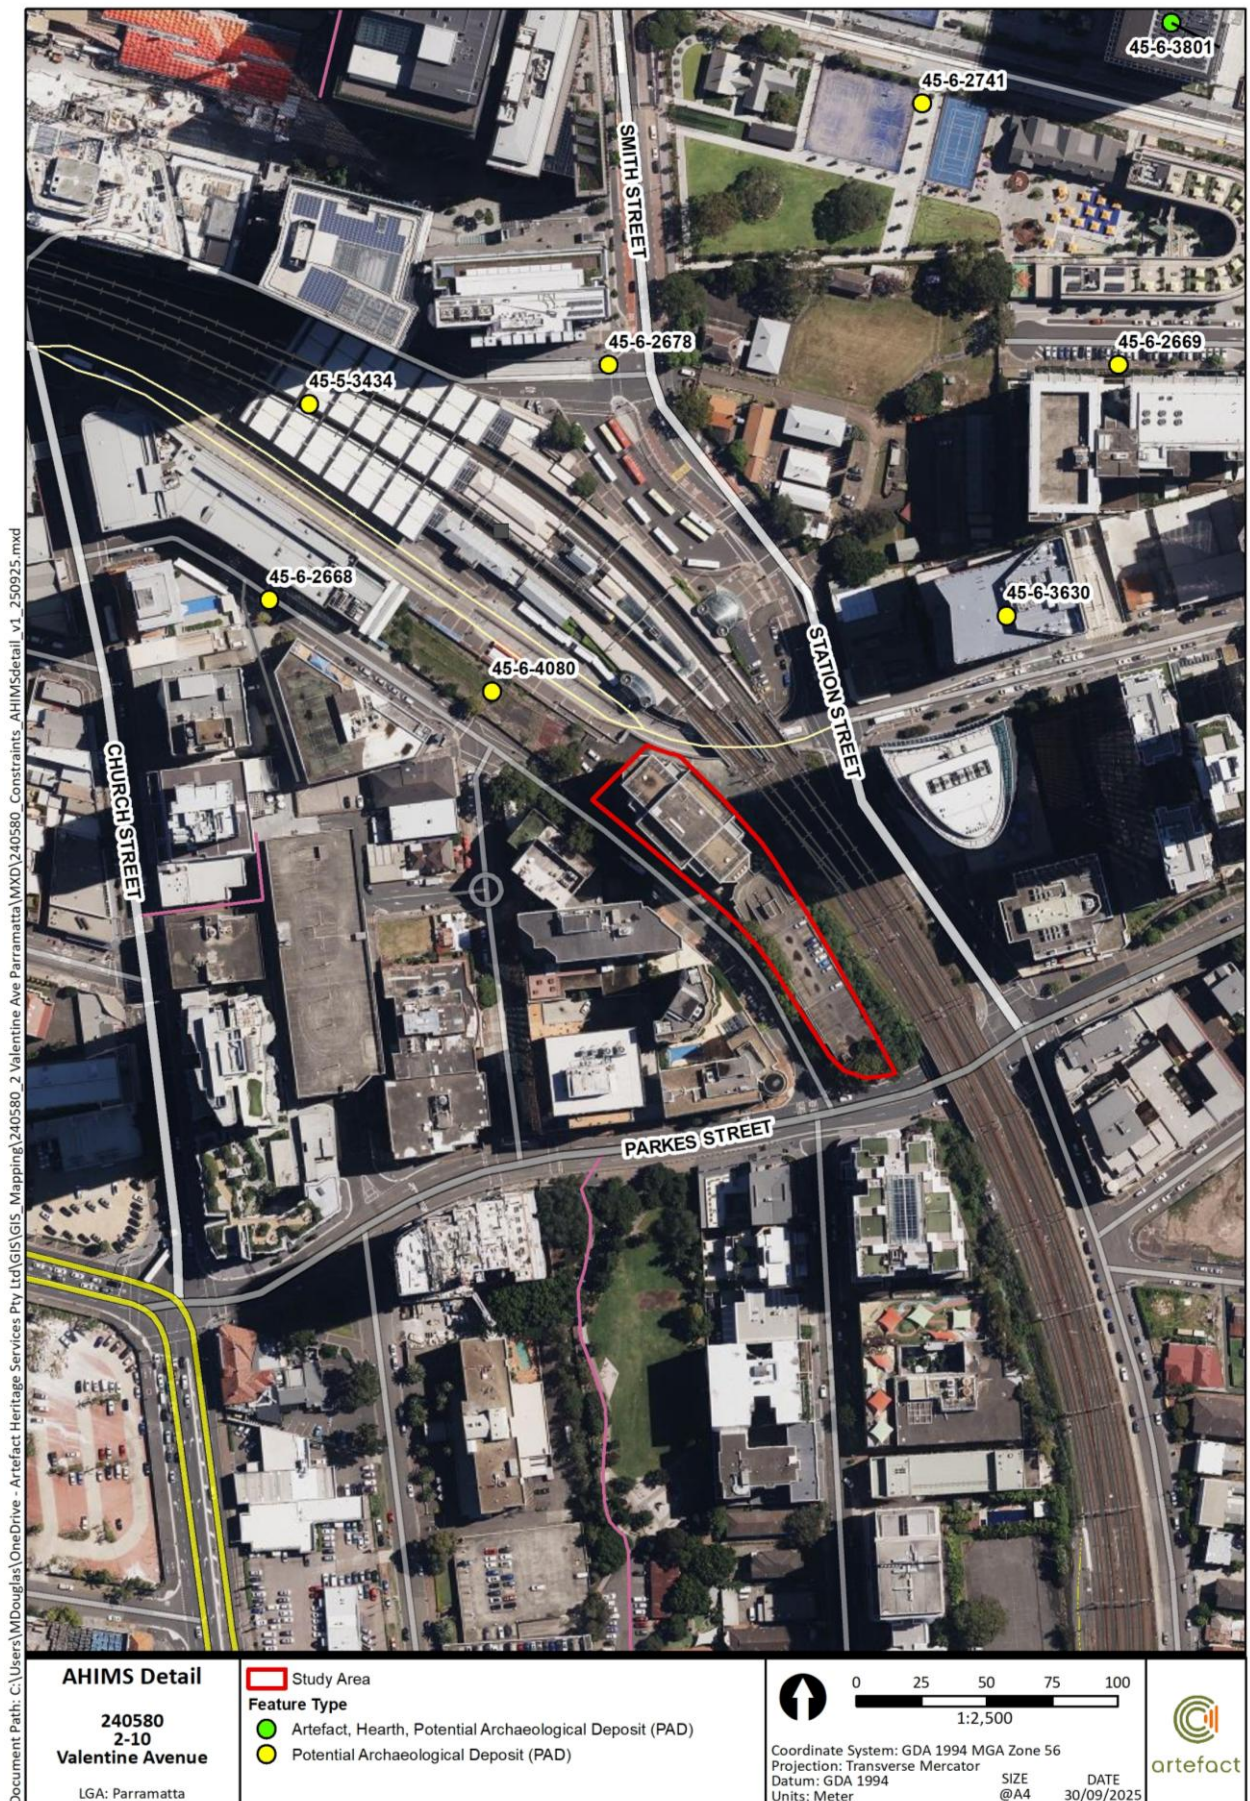
Figure 3: AHIMS detailed search results

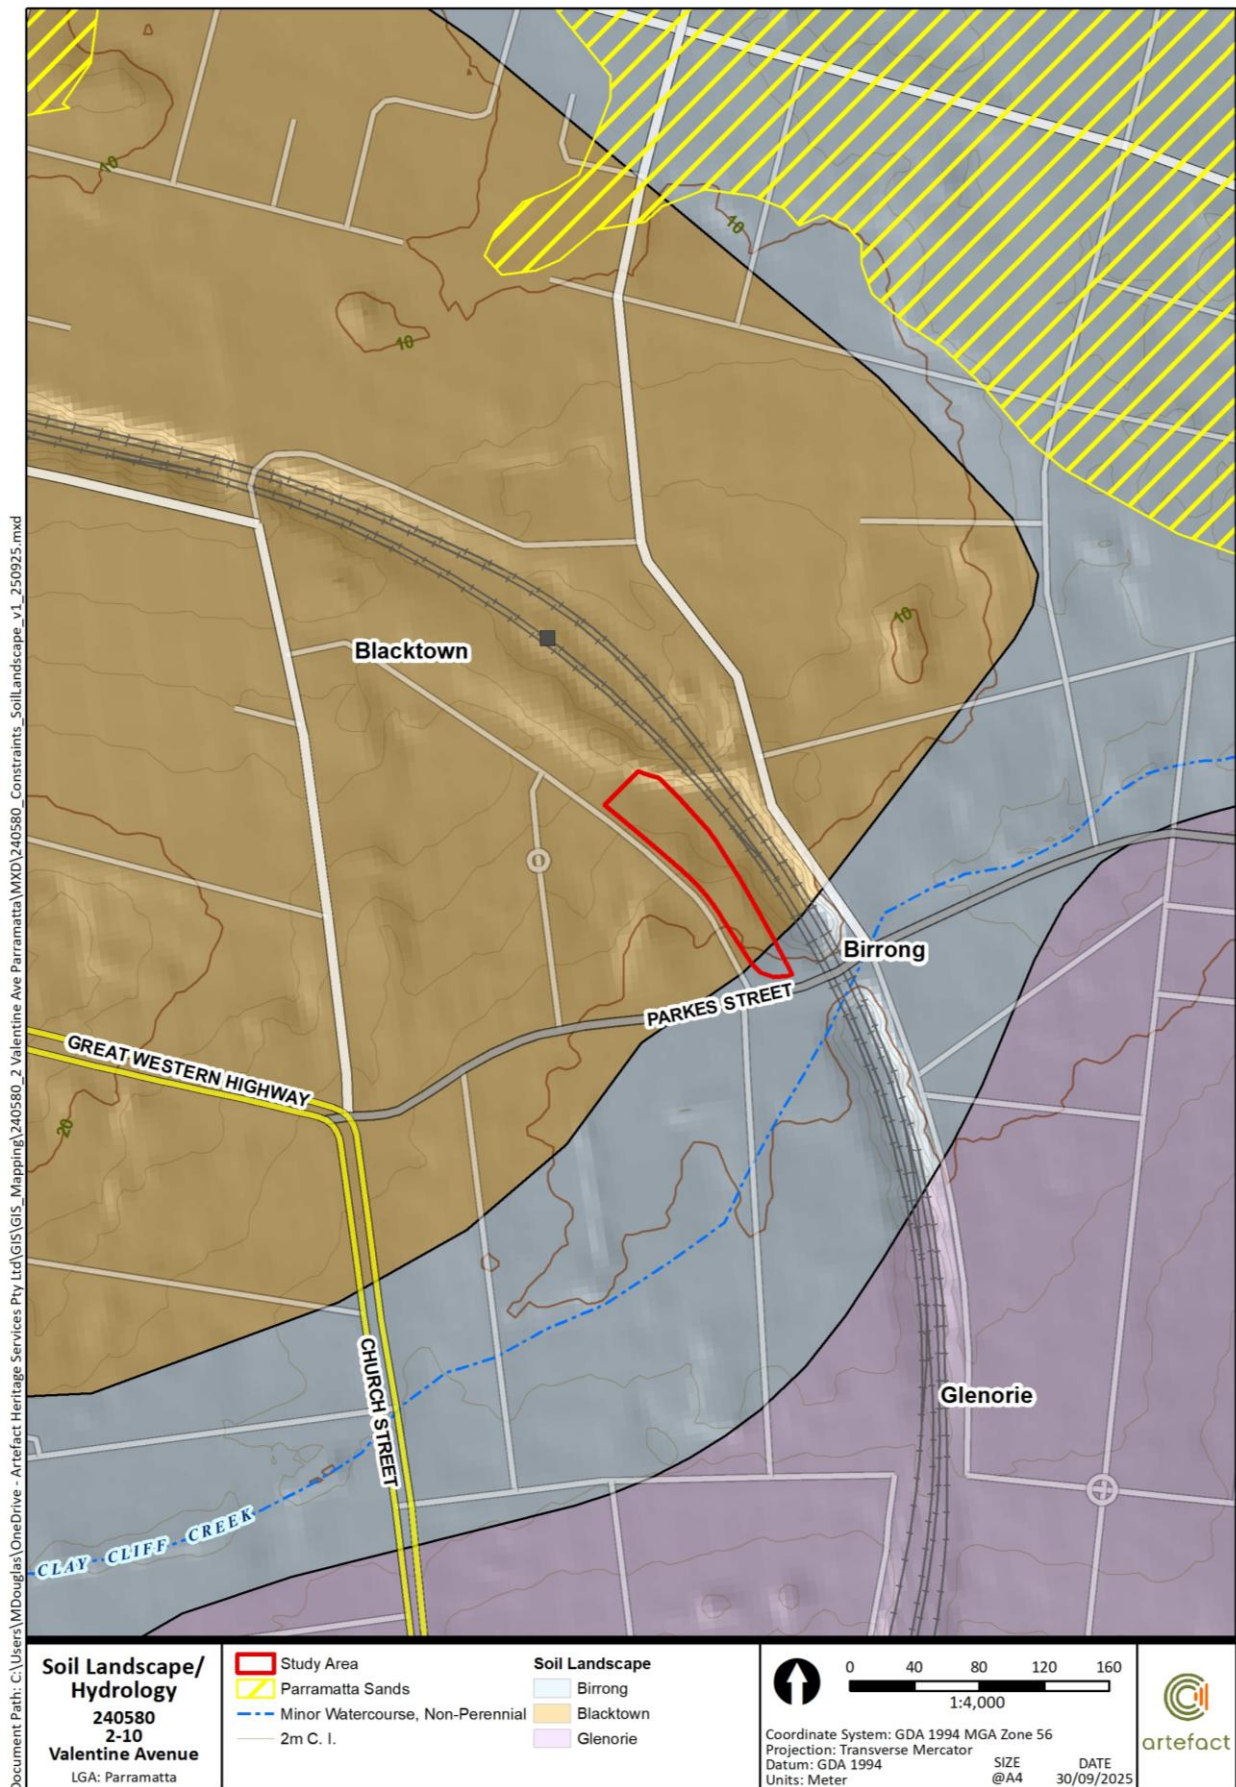
Figure 4: Soil landscape within and surrounding the study area

The study area is situated within the Blacktown soil landscape, which is comprised of shallow to moderately deep (<100cm) Red and Brown Podzolic Soils on crests, upper slopes and well-drained areas, and deep (150-300cm) Yellow Podzolic Soils on lower slopes and in poorly drained areas (eSPADE 2015) (Figure 4). As the study area is spread across the upper to lower portions of a slope, portions of the study area are likely to contain shallow soil profiles that are susceptible to ground disturbance, which may limit the potential for archaeological deposits to be present.

The southern portion of the study area is also in close proximity to the boundary between the Blacktown and Birrong soil landscapes, meaning that some soil mixture between the two landscapes may have occurred within the study area (Figure 4). Soils within the Birrong landscape are generally deeper (>250 cm) and less prone to erosion from ground disturbance (eSPADE 2015).

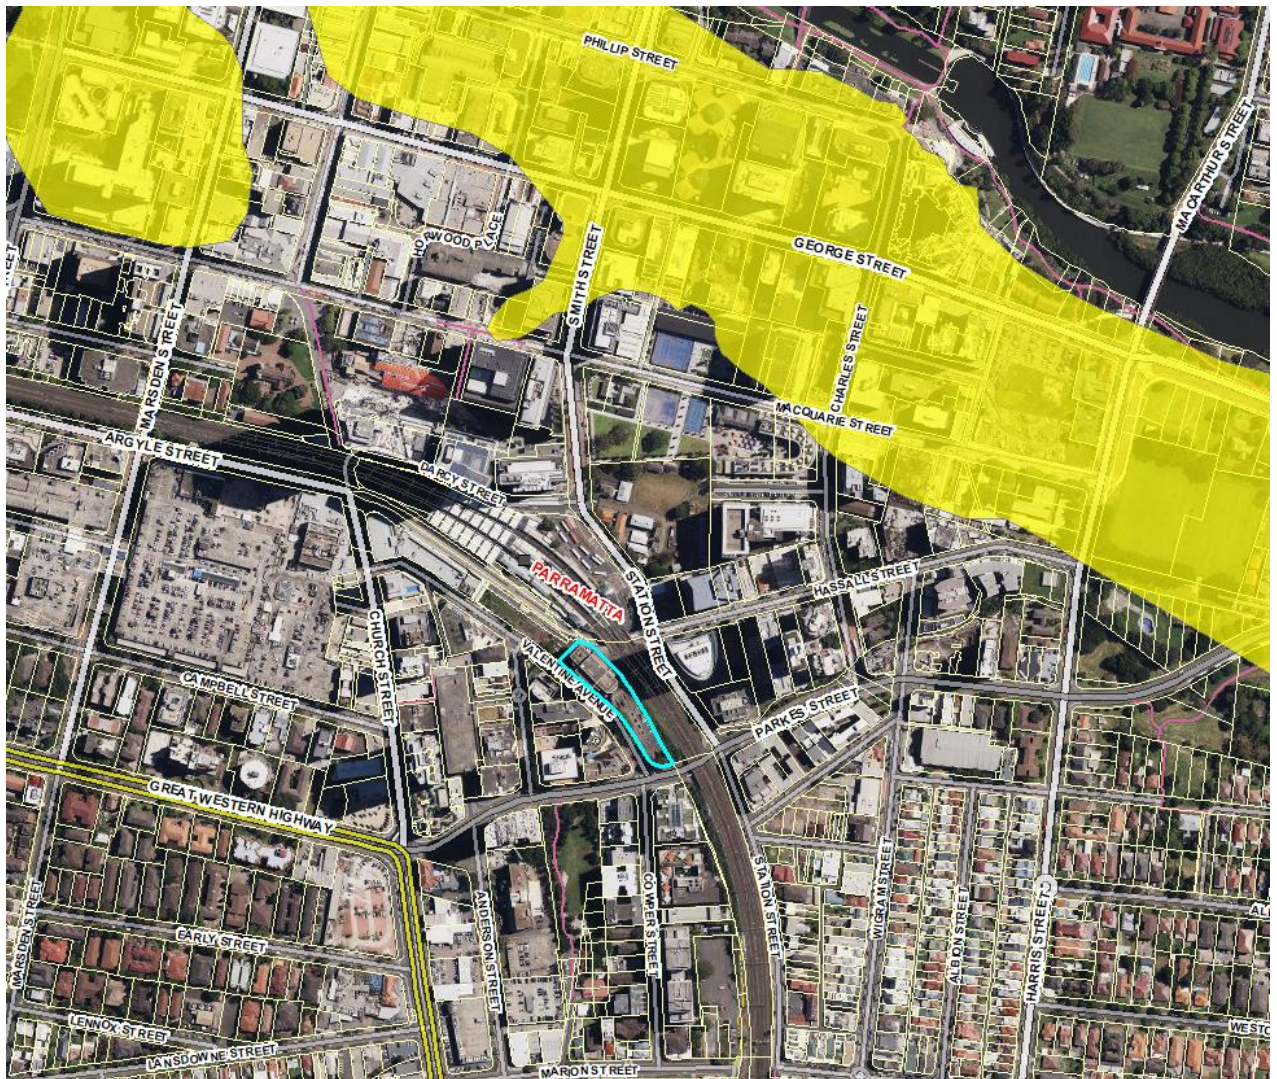
Figure 5: The study area (blue) in relation to the Parramatta Sand Body (shown in yellow)

At its closest point, the study area is also located approximately 250 m southeast of the mapped extent of the Parramatta Sand Body, which is known to possess Aboriginal archaeological sensitivity (Williams and McDonald 2021; Artefact Heritage 2023; Quinn et al. 2023; Williams et al. 2024) (Figure 5). While the sand body has been identified outside its mapped extent, the study area's distance from the confirmed location of the sand body suggests that it is unlikely to appear in the study area.

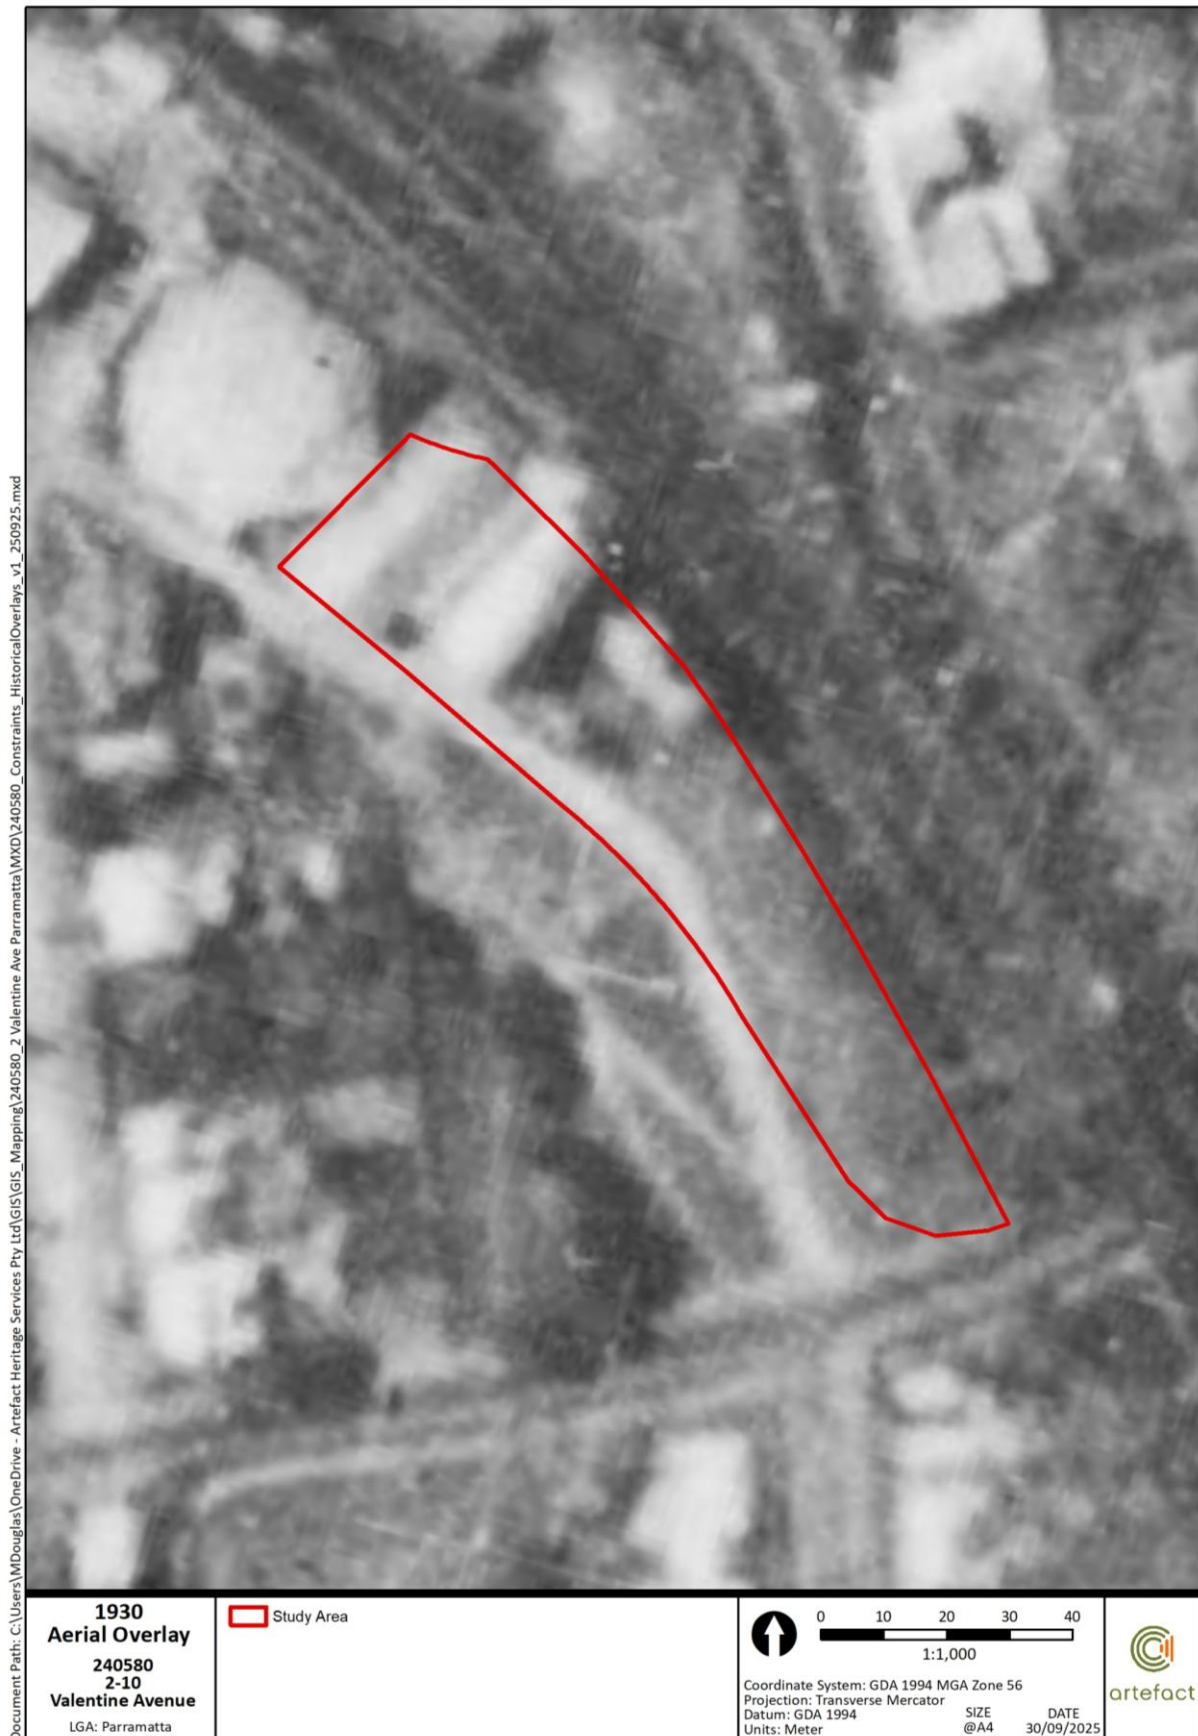
**Figure 6: 1930 aerial overlay showing the study area has cleared from vegetation and the construction of multiple developments and infrastructure around the study area including the rail corridor**

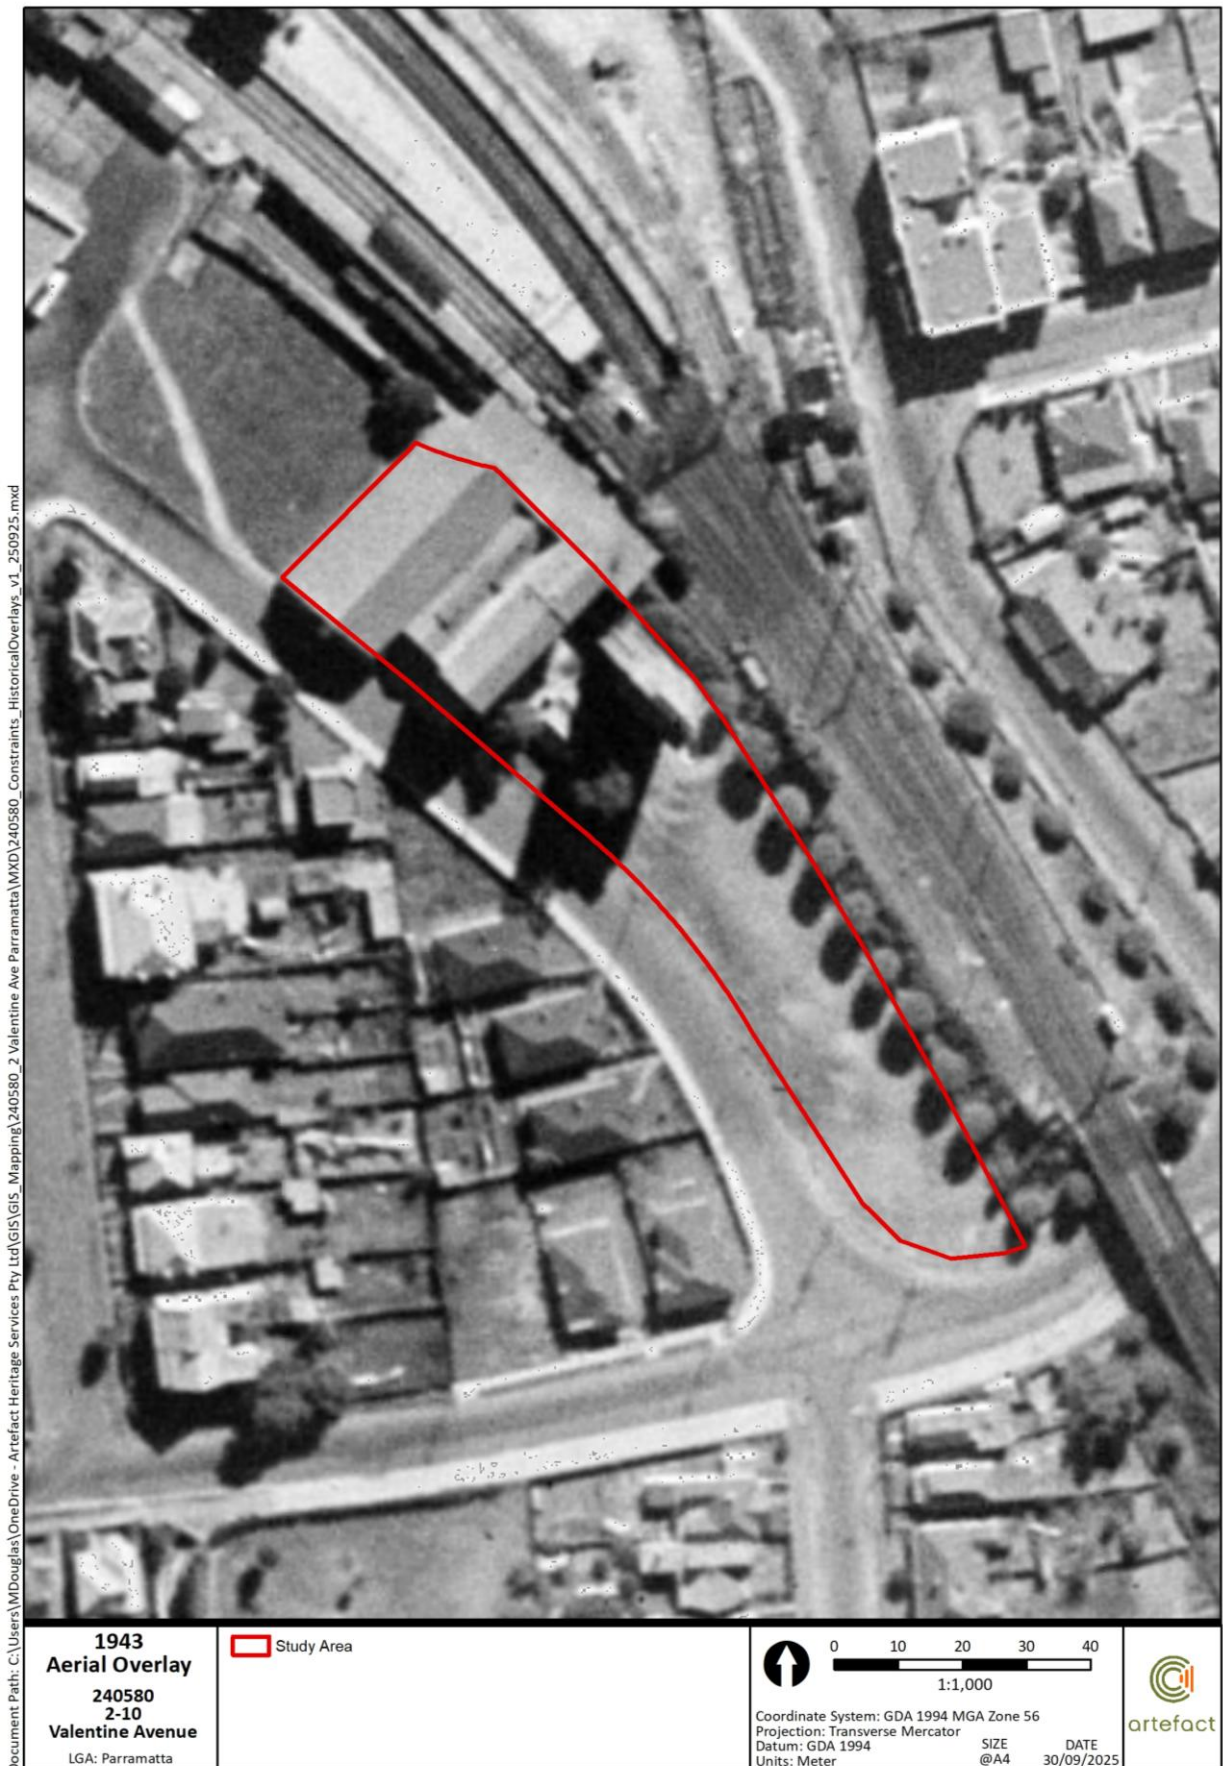
**Figure 7: 1943 aerial overlay showing a large structure within the study area and associated landscaping**

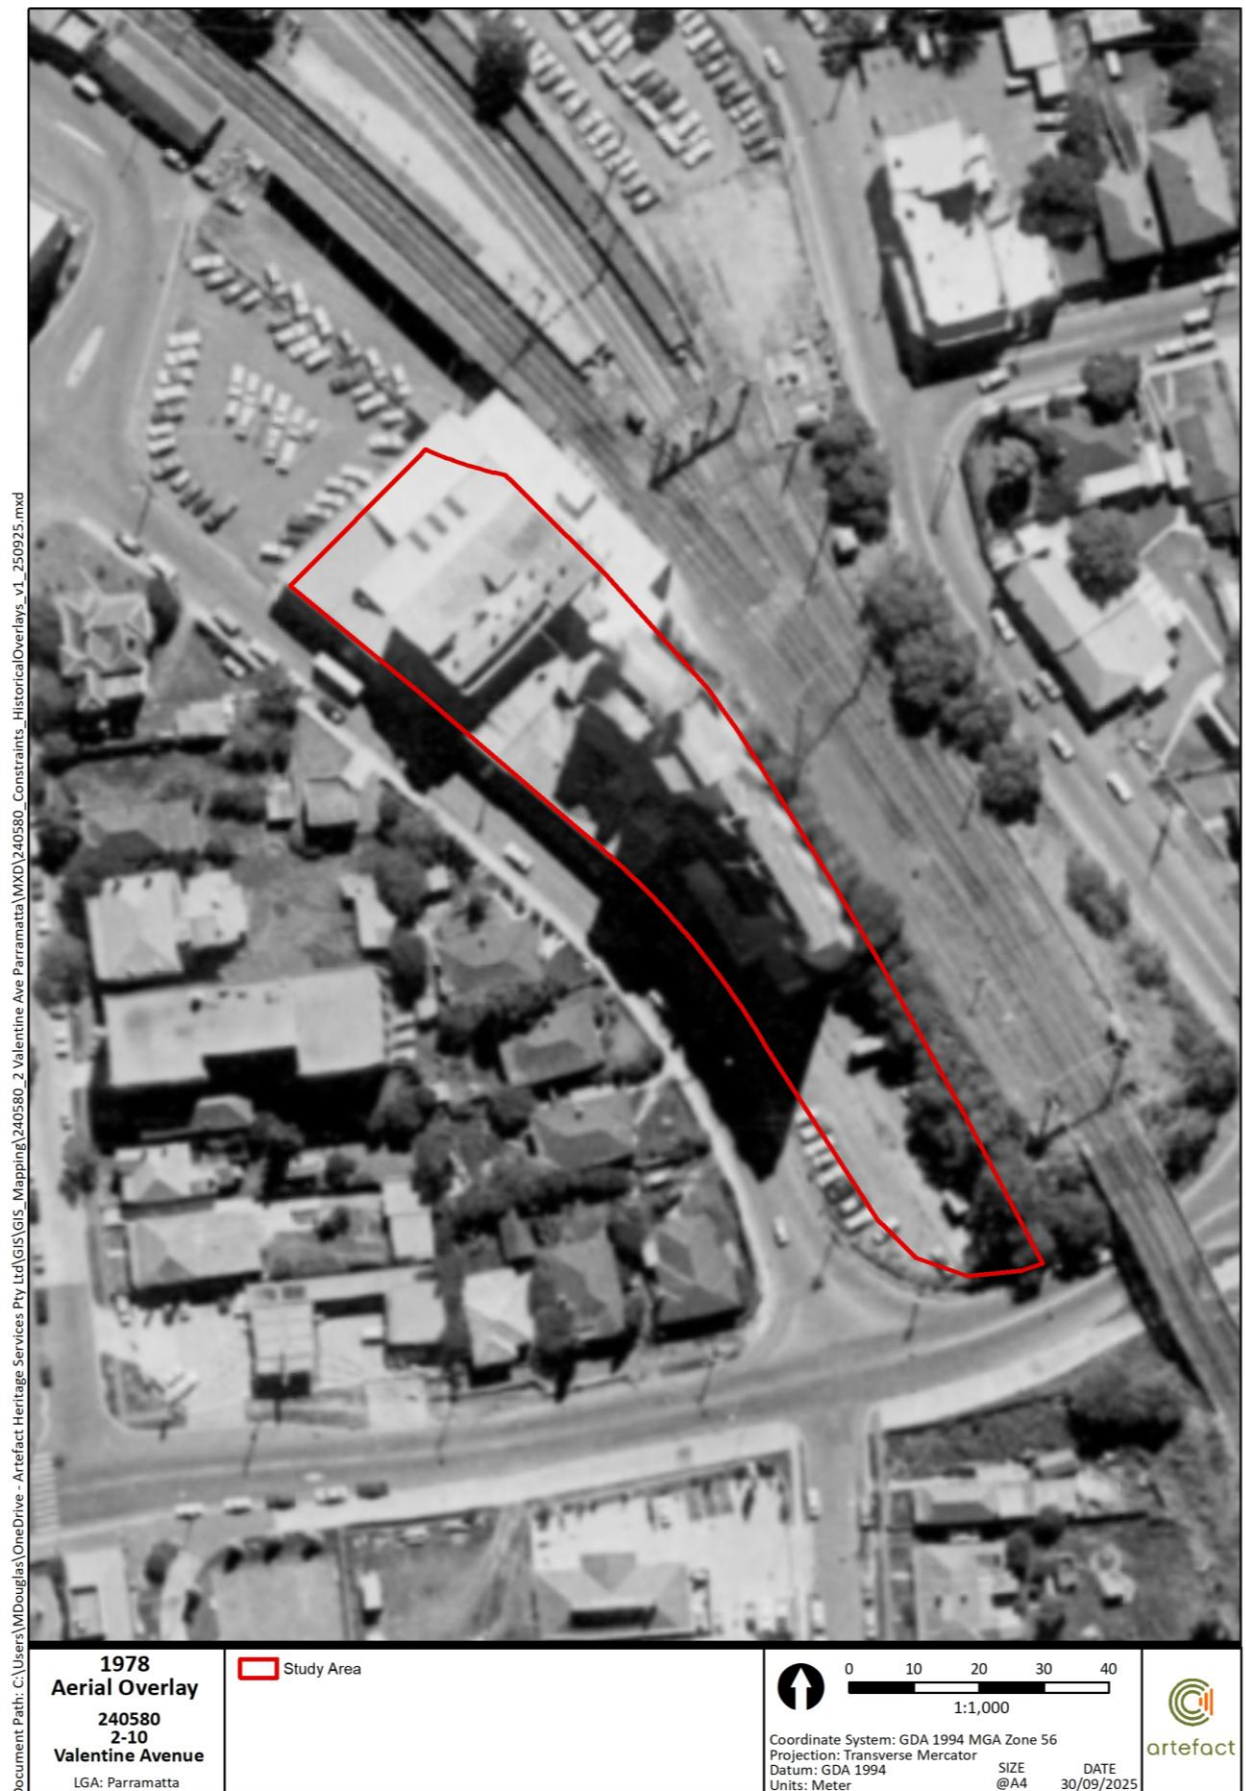
Figure 8: 1978 aerial overlay showing the structure was extended to the southeast

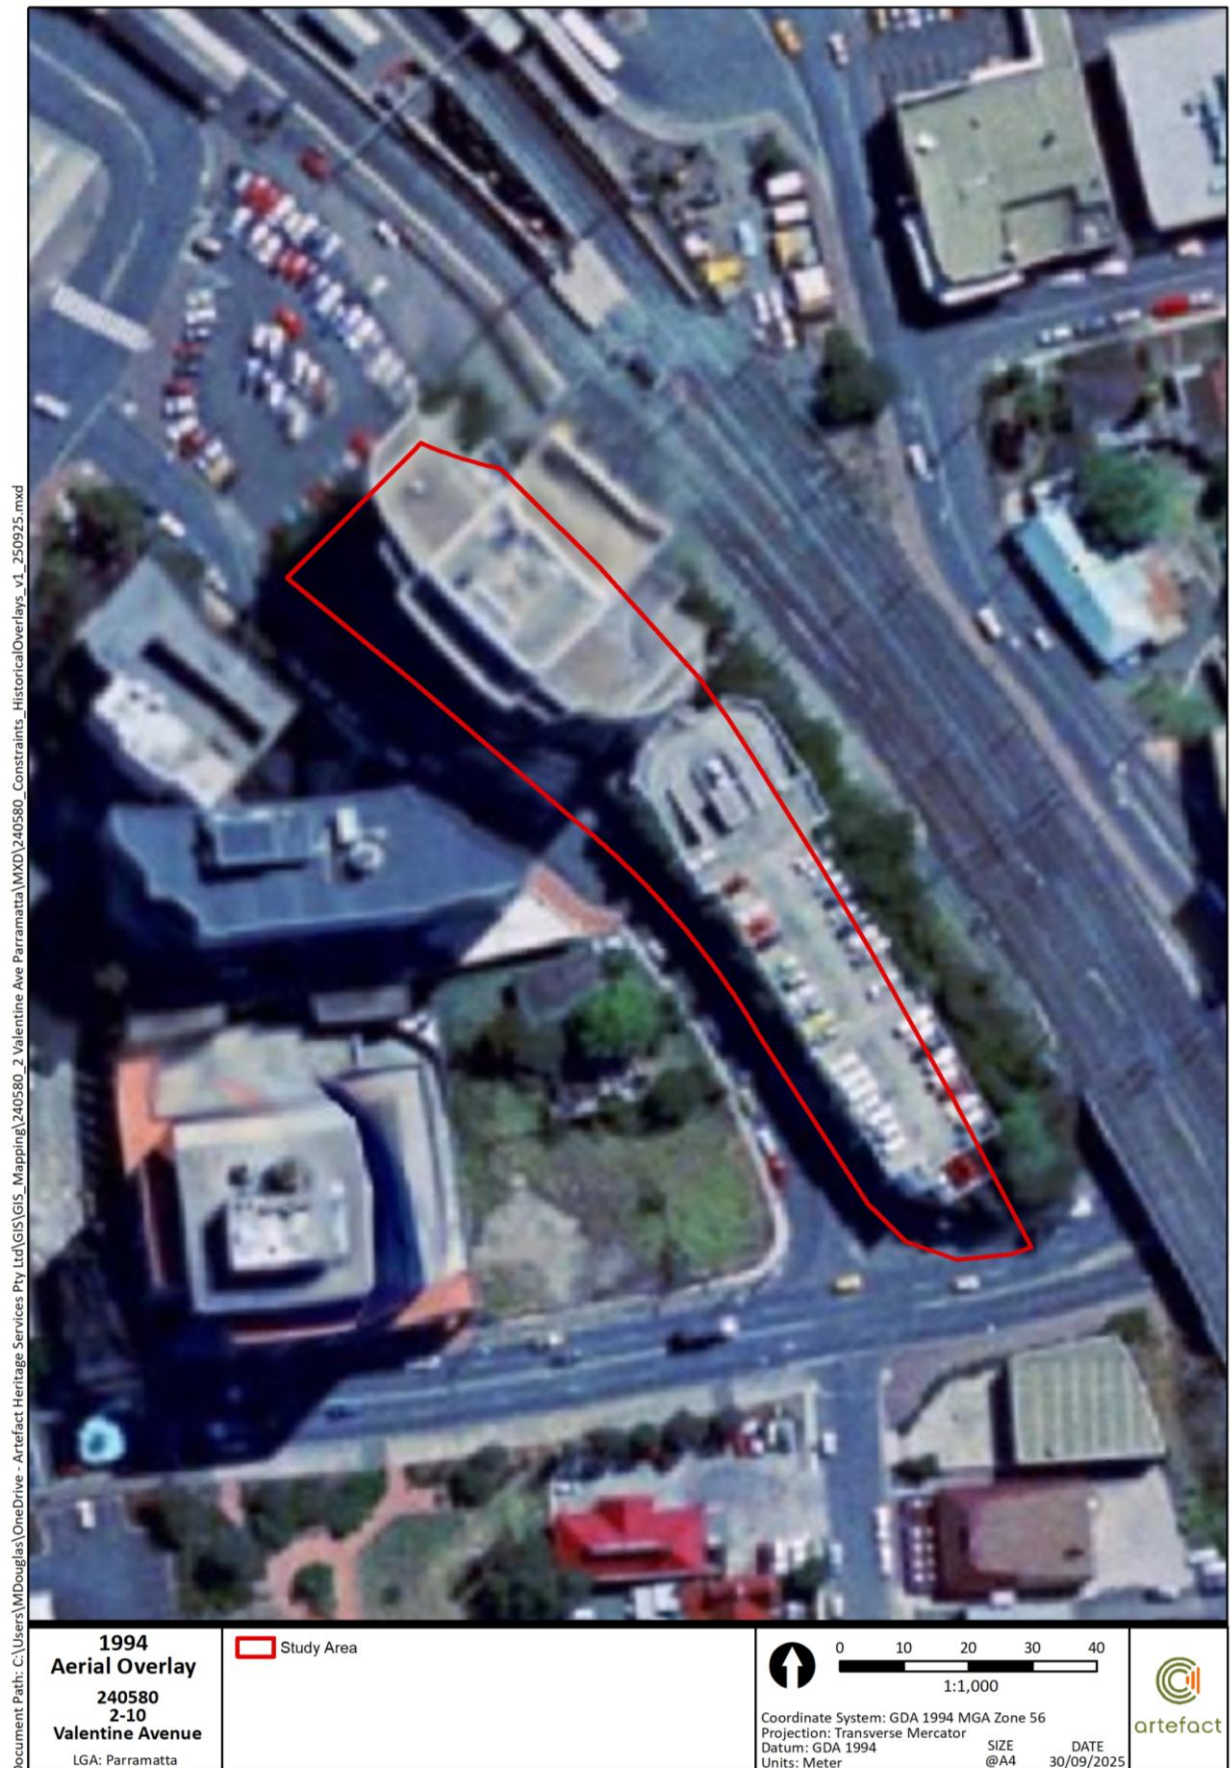
**Figure 9: 1994 aerial overlay showing the majority of the study area occupied by two large structures**

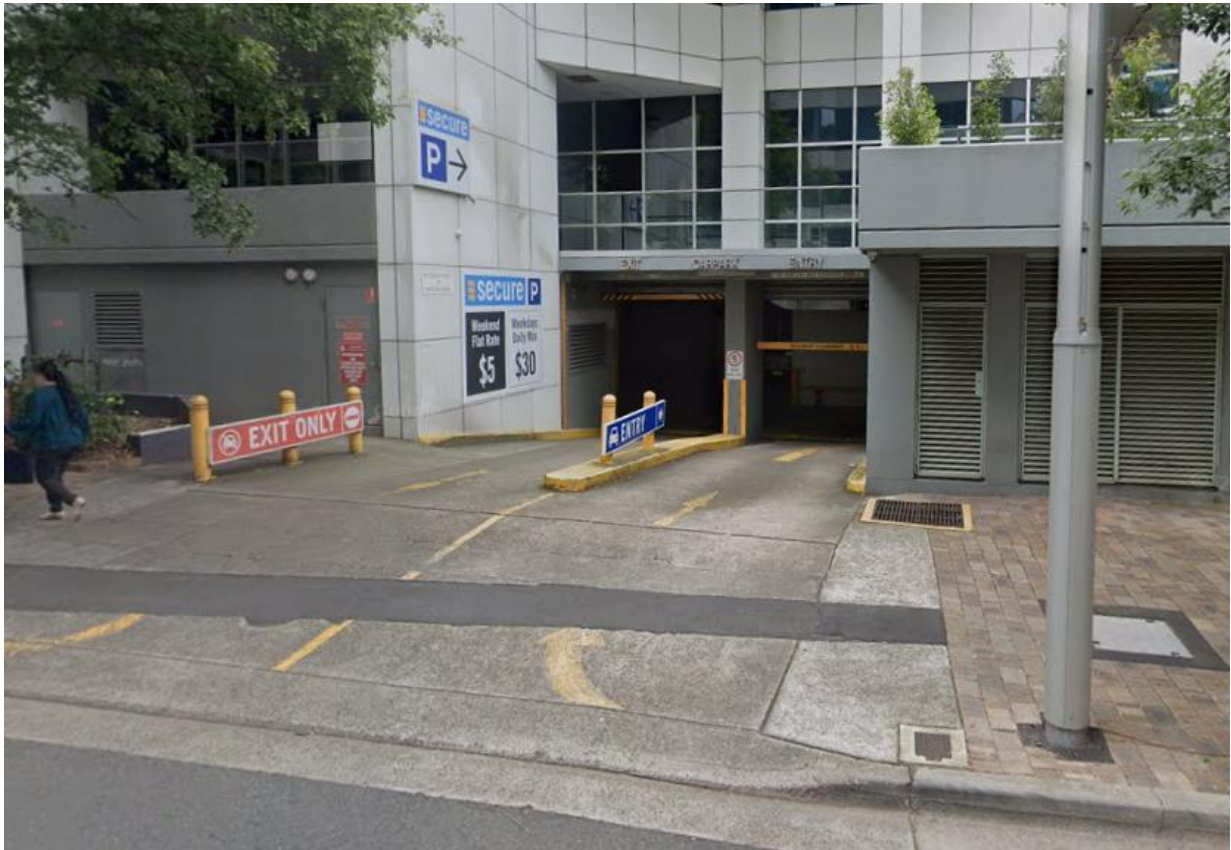
**Figure 10: Evidence of subsurface ground disturbance from basement carparking (Source: Google maps, 2025)**

2 Valentine Avenue demonstrate that deep subsurface excavations had been undertaken for below-ground-surface car parking in both building (Figure 10).

These previous historical disturbances would have required meters of subsurface excavations which would have included the removal/redistribution of soil and importation of fill. These impacts are likely to have significantly disturbed if not destroyed any archaeological remains which may once have been present within the study area.

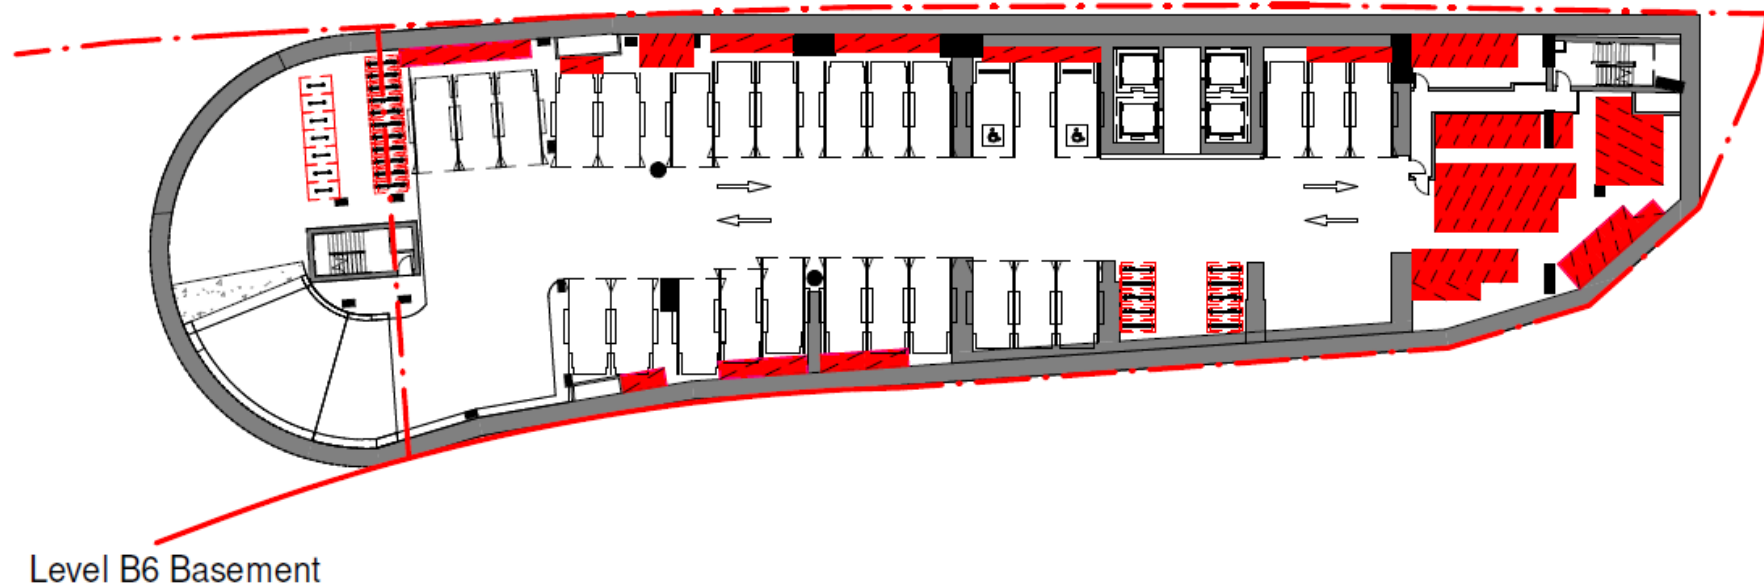
Figure 11: Proposed works – Basement 6 (Source: Buchan Furtado Sullivan, December 2025, Rev C)

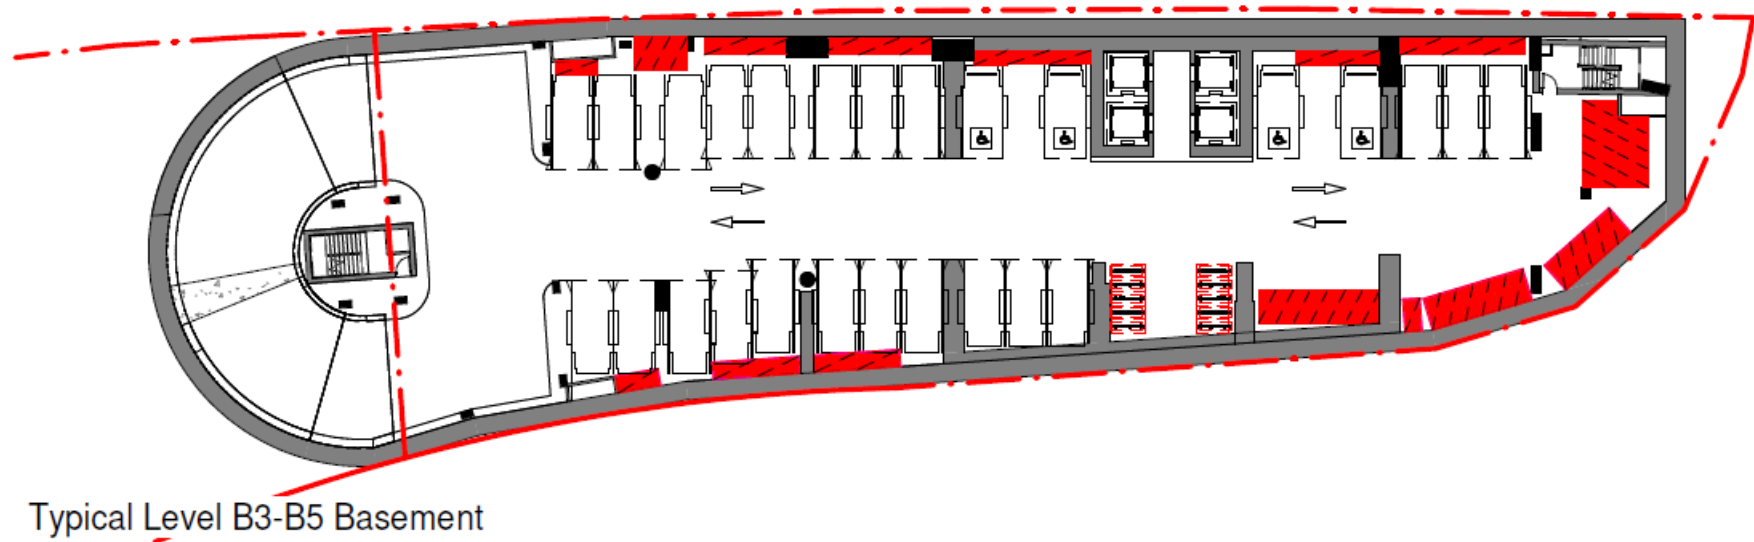
Figure 12: Proposed works – Basements 3-5 (Source: Buchan Furtado Sullivan, December 2025, Rev C)

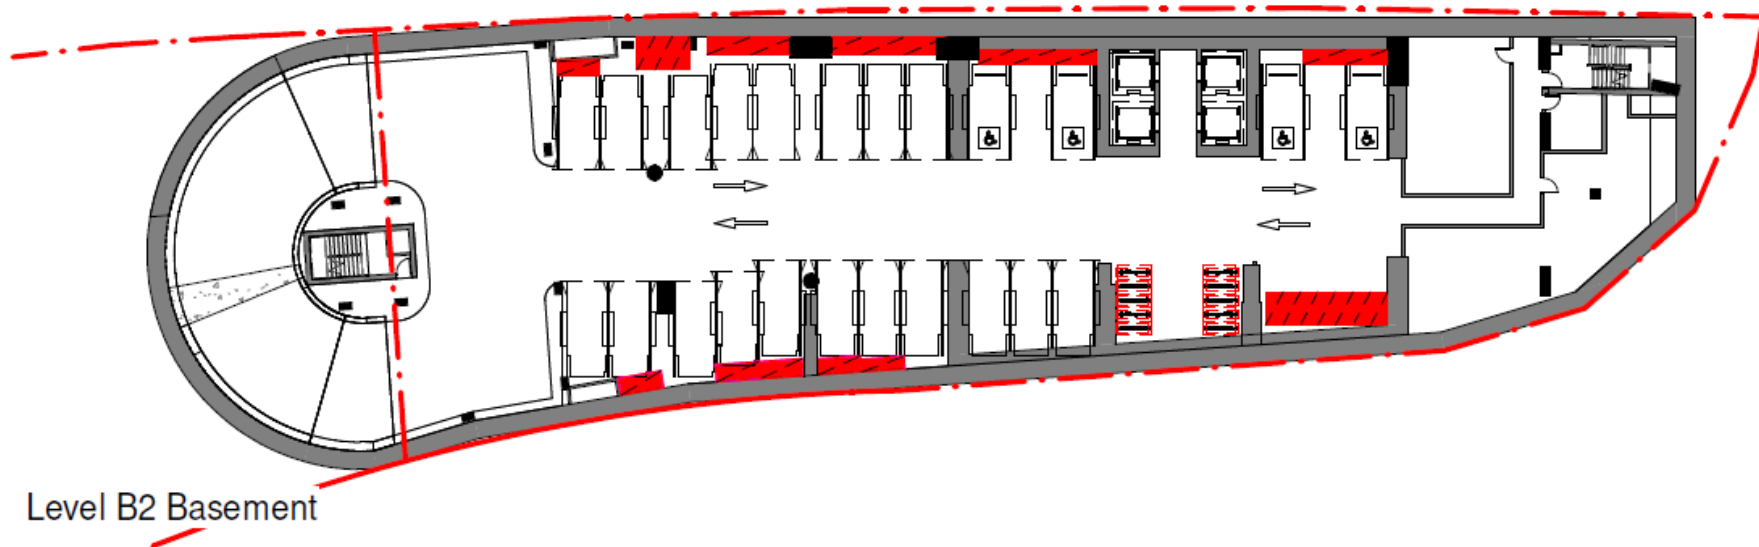
Figure 13: Proposed works – Basement 2 (Source: Buchan Furtado Sullivan, December 2025, Rev C)

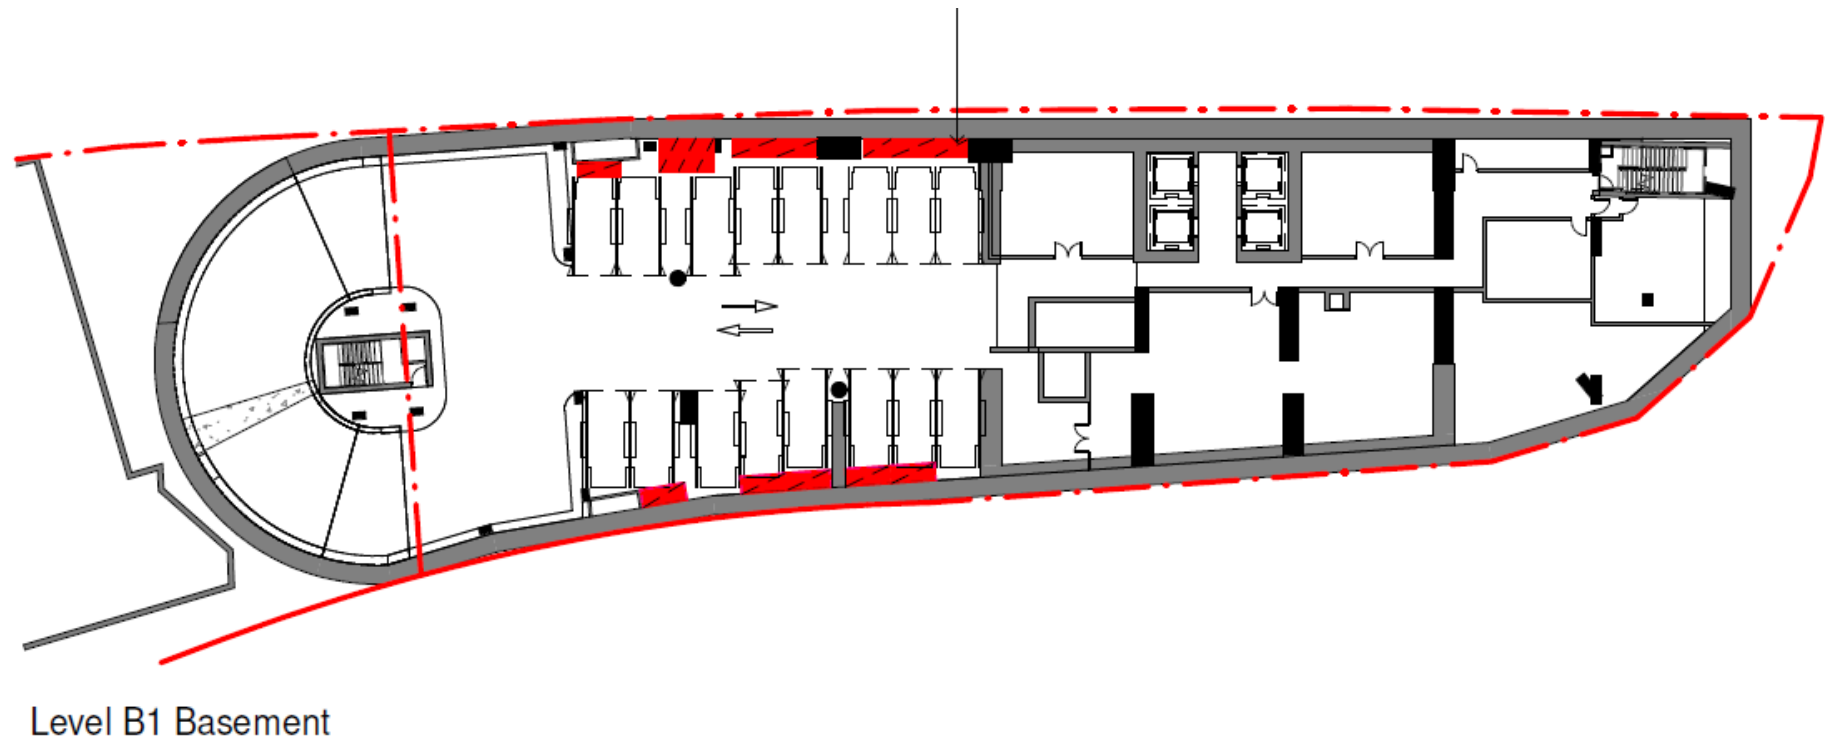
Figure 14: Proposed works – Basement 1 (Source: Buchan Furtado Sullivan, December 2025, Rev C)
