# artefact

16 December 2025

**Re: 2-10 Valentine Avenue, Parramatta: Aboriginal Heritage Due Diligence Assessment.**

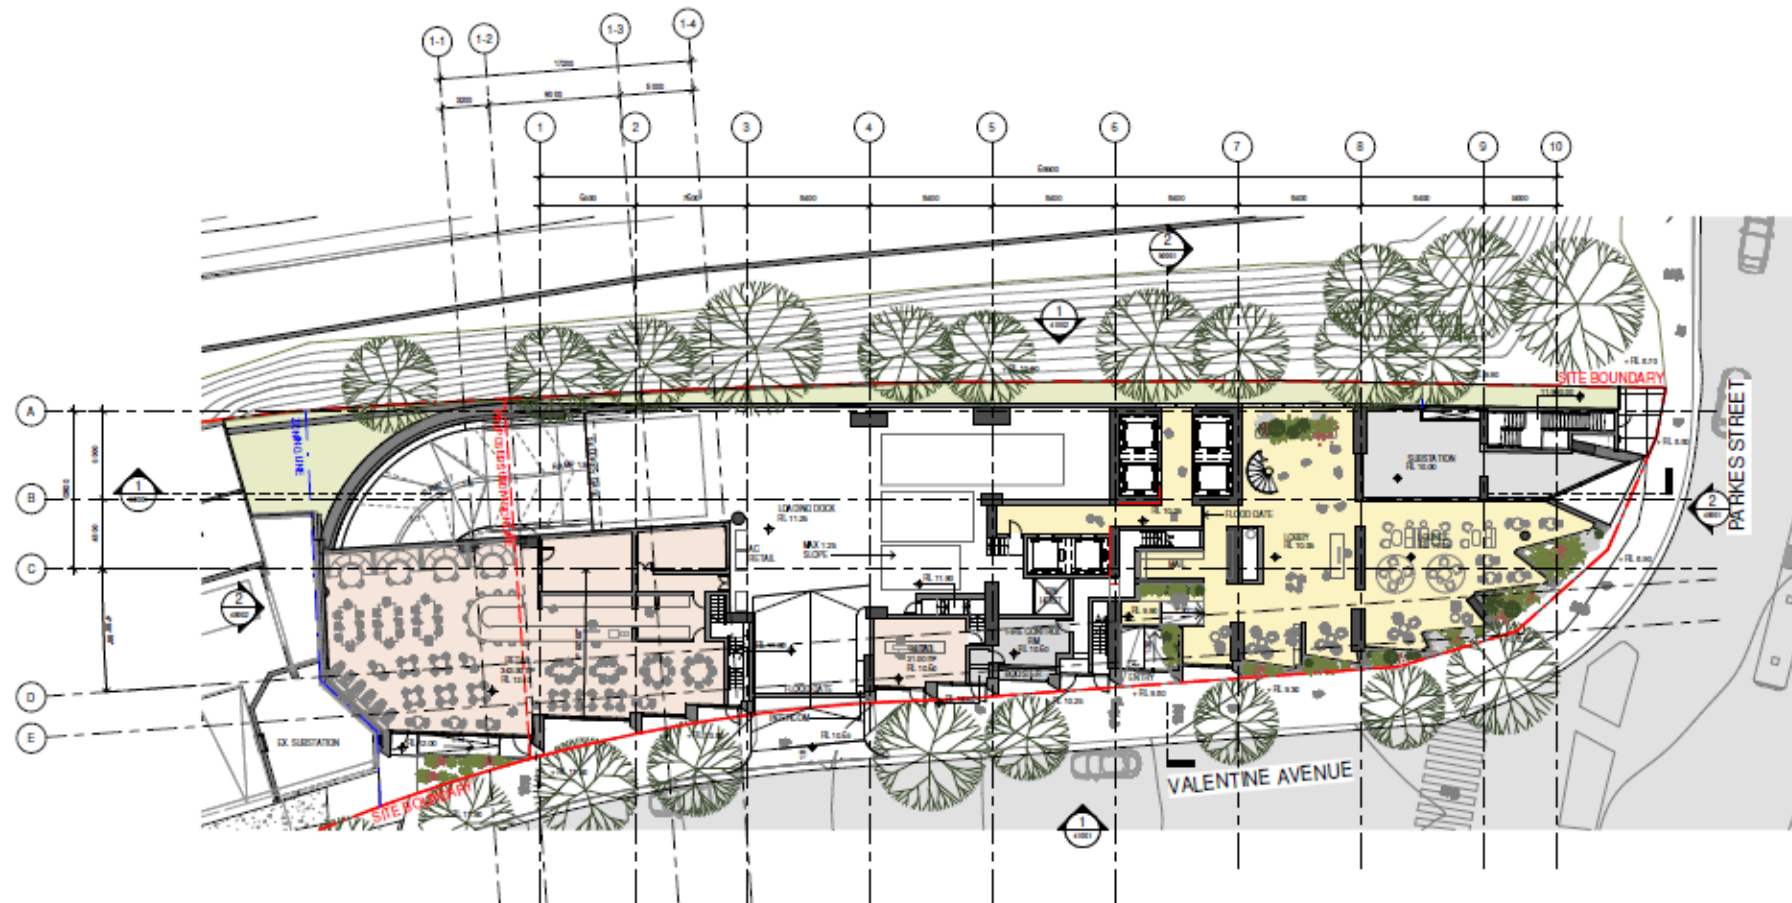
Figure 15: Proposed works – Ground Floor Plan (Source: Buchan Furtado Sullivan, December 2025, Rev C)
