### **Report on Detailed Geotechnical Investigation**

#### **Eastlakes Town Centre**

**19A Evans Avenue, Eastlakes NSW**

**Project 236760.01**

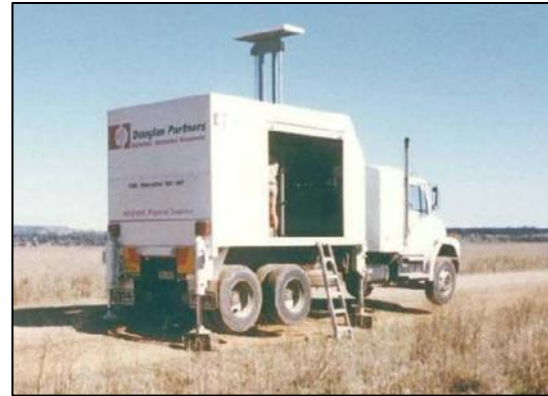
Figure 2: Purpose built CPT rig

The cone is thrust into the ground at a steady rate of about 20 mm/sec, usually using the hydraulic rams of a purpose built CPT rig, or a drilling rig. The testing is carried out in accordance with the Australian Standard AS1289 Test 6.5.1.

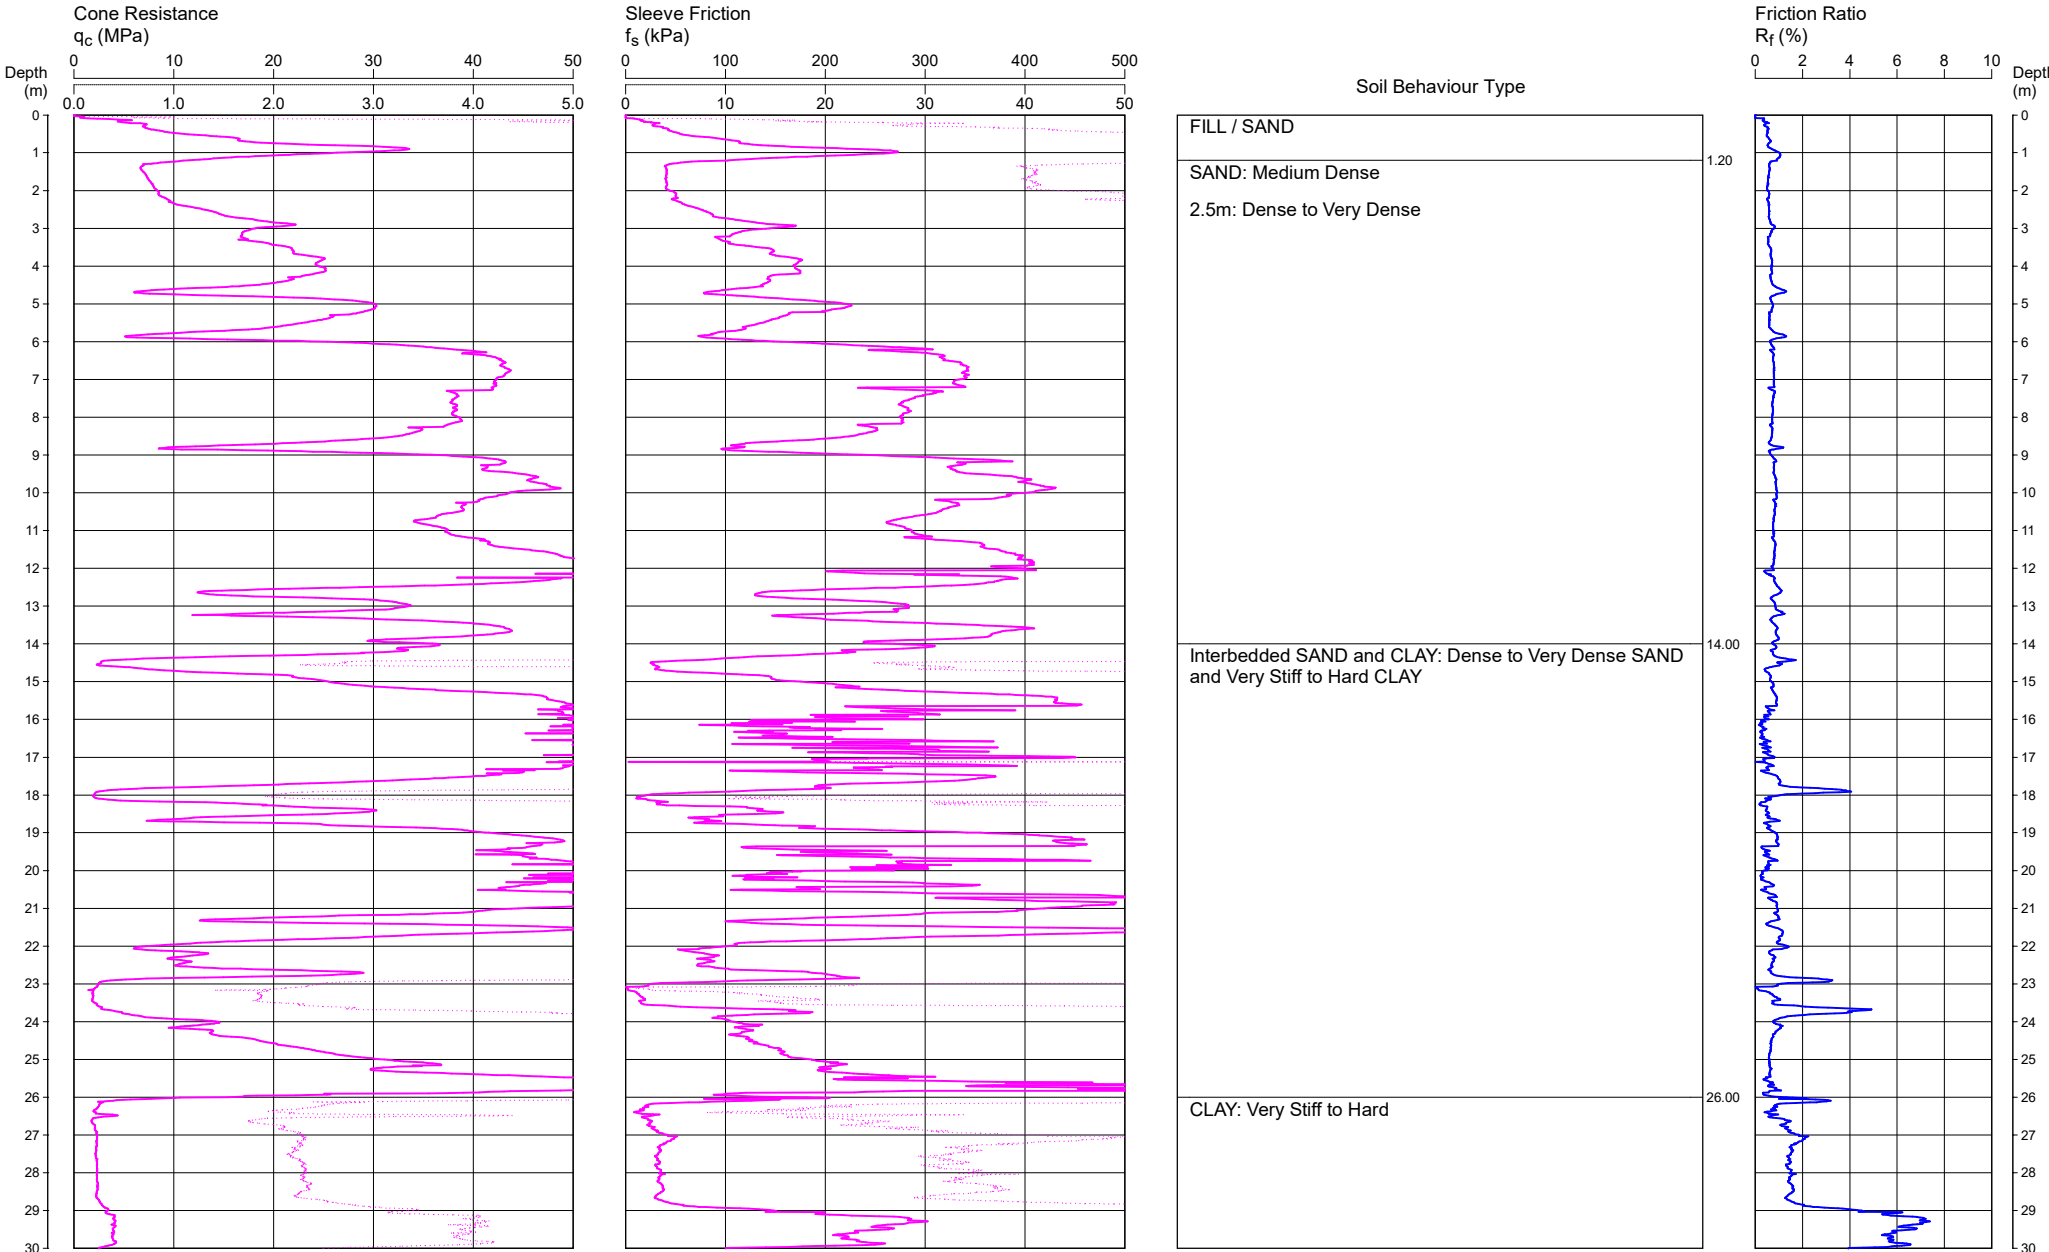
REMARKS: TEST DISCONTINUED DUE TO REFUSAL ON (or NEAR) INFERRED WEATHERED ROCK. GROUNDWATER OBSERVED AT 1.7m AFTER WITHDRAWAL OF RODS.
