SERS
Site Environmental and
Remediation Services

Addendum 2 to Remediation and Validation Report

Part Lot 1, Section 49 in DP75082

(ARMIDALE HIGH SCHOOL, BUTLER STREET, ARMIDALE NSW 2350)

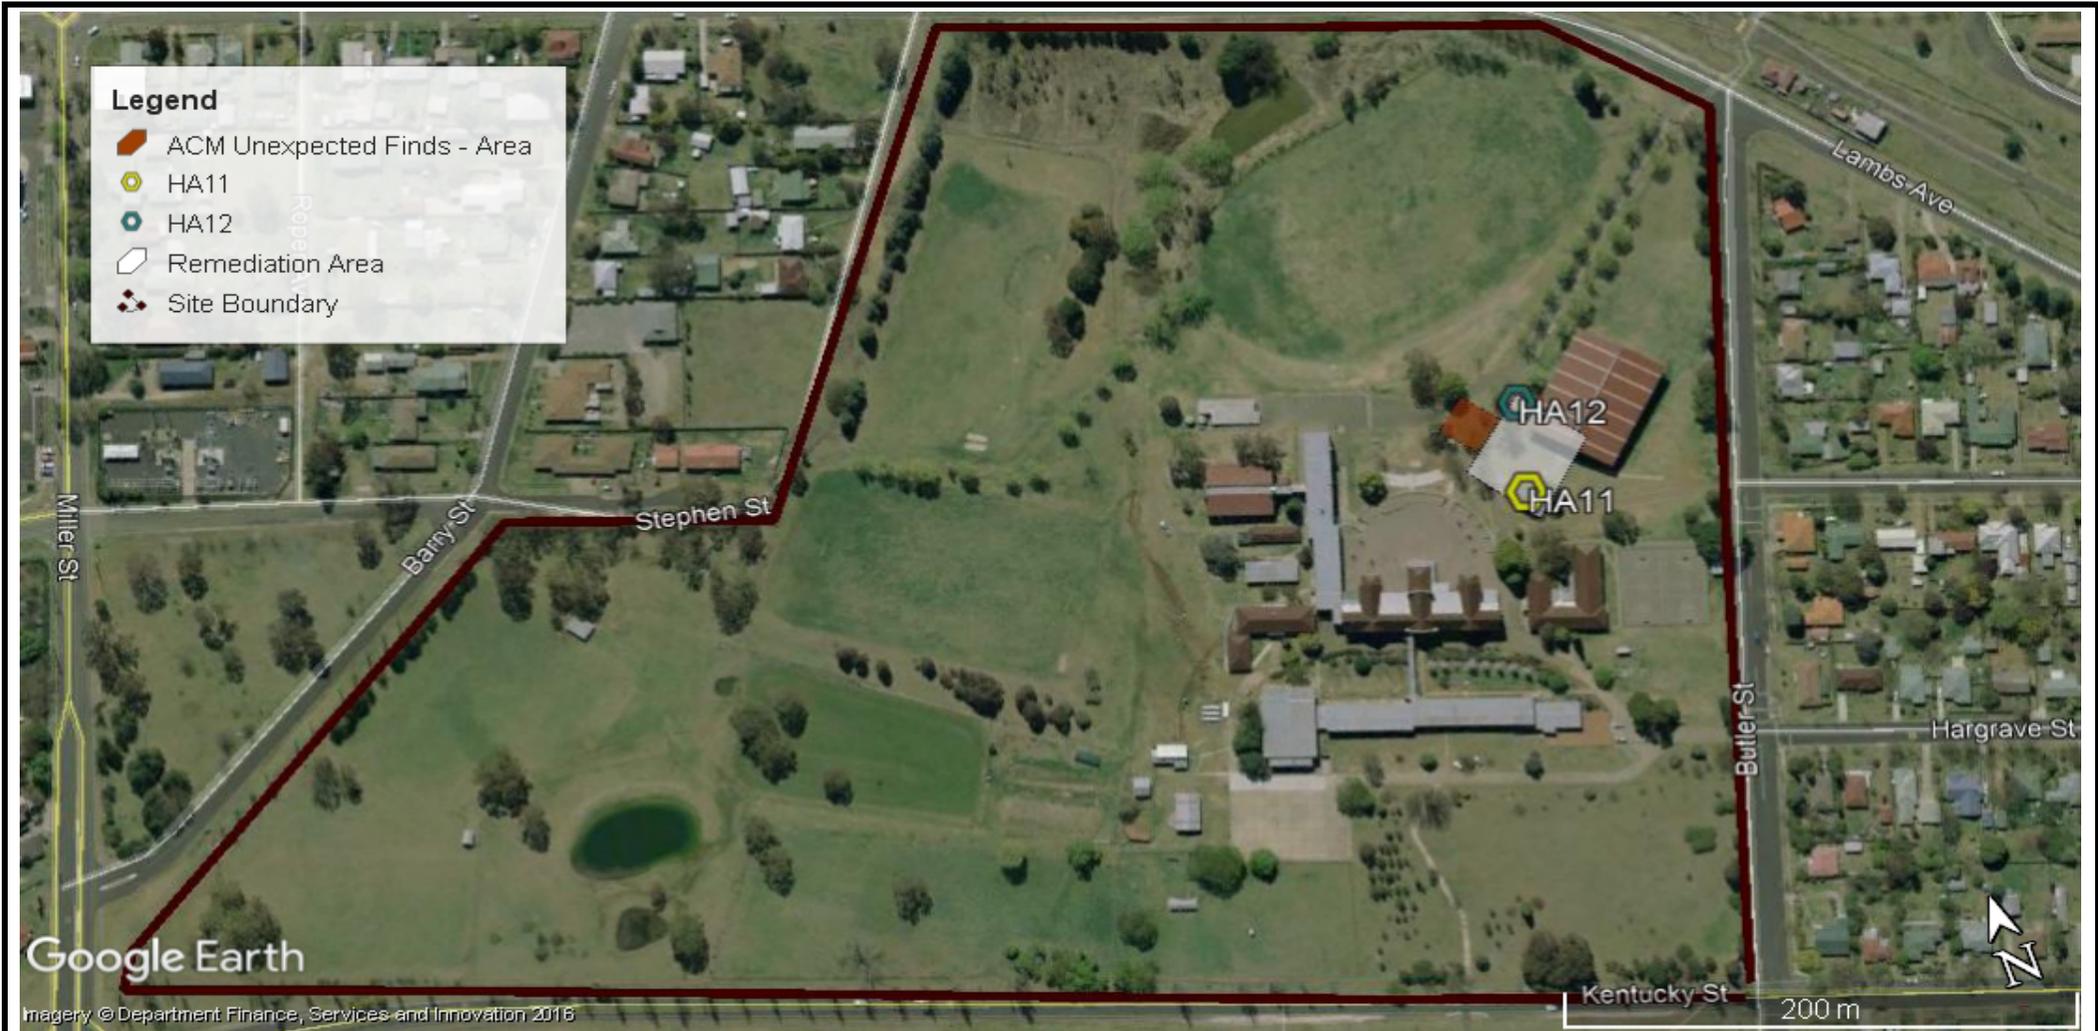
<p>SERS Site Environmental and Remediation Services</p> <p>Site Environmental & Remediation Services (SERS) Tel: 1300 320 696 Fax: +61(0) 8 9220 2010 http://sers.net.au</p>	TITLE: Figure 2: Soil Remediation Area		Key:

Excavations were extended to the practical lateral and vertical extent of contamination as indicated within the SAQP (May 2019) and the UFA. Soils in the vicinity of the following sample points were previously identified in the RAP as requiring excavation to a minimum depth of **0.2mbgl** or natural soil on Lot 1 section 49 in DP758032:

- HA11 - asbestos

All soils were removed in the vicinity of these sample points using an excavator. Most locations within the Site that had identified contamination were scraped to a minimum depth of approximately 0.2mbgl.

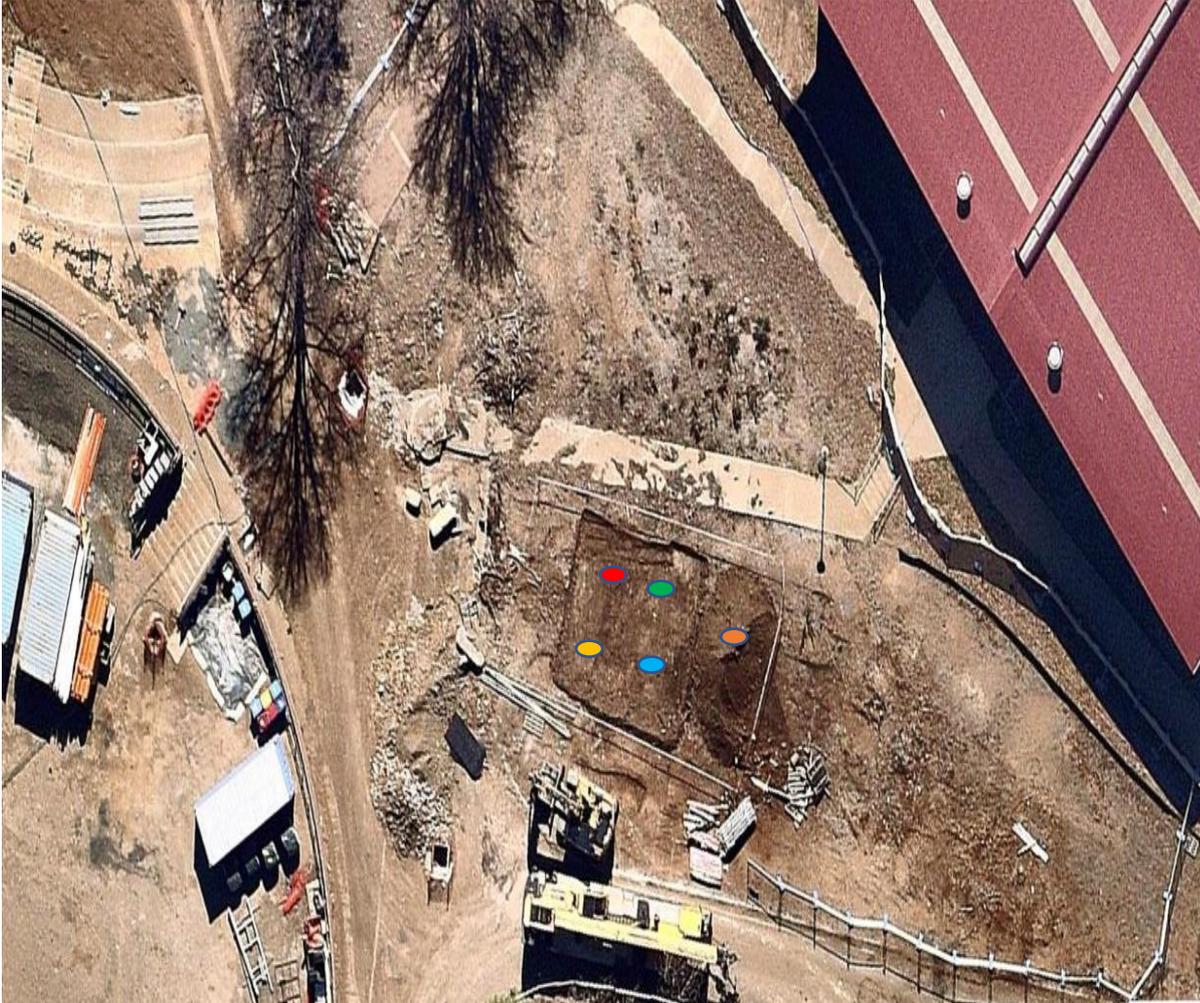
FIGURE

Following identification of asbestos to surface soils adjacent area HA11 during construction works, the SERS scientist supervised the excavation of impacted soils in the area to a depth of 0.2mbgl. Upon completion, validation sampling was undertaken on newly exposed soils across the area at a density of 4 x sample points to ensure that the remaining contamination within the UFA had been removed to a sufficient depth. All samples taken in this area comprised appropriate laboratory supplied soil bags.

Samples 2-SE and 3-NW yielded concentrations above the site assessment criteria for asbestos only and based on this exceedance, further excavations were undertaken to depths of 0.2mbgl. This has been addressed in section 3.2 below.

Following exceedance of the adopted site assessment criteria for asbestos only after the first round of validation as mentioned in section 3.1 above, further excavations were undertaken to depths of 0.2mbgl across a 5m radius in sample points 2-SE and 3-NW. The impacted materials excavated from the aforementioned areas were removed onto a tandem tipper and appropriately disposed of off-site at a licensed waste facility. Four (4) further soil samples (159239_SS_03022020 - Samples 1-4) were obtained underneath the former stockpile area and sent to a NATA accredited laboratory for analysis. All samples yielded results below the site assessment criteria (Asbestos Only).

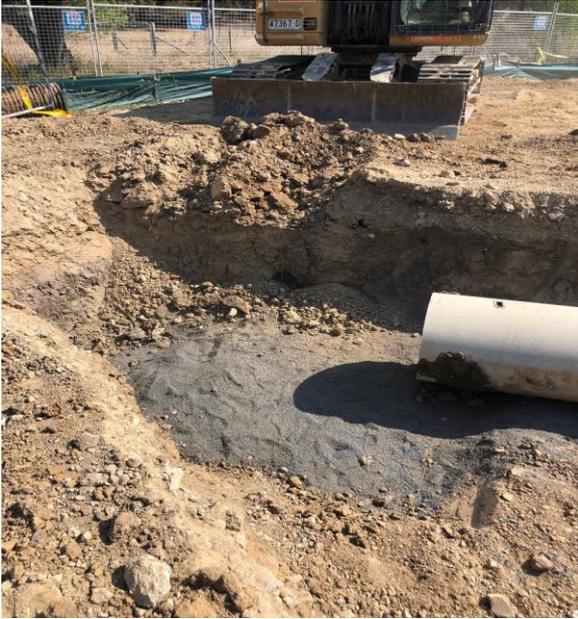
Plate 1: Location of proposed excavation

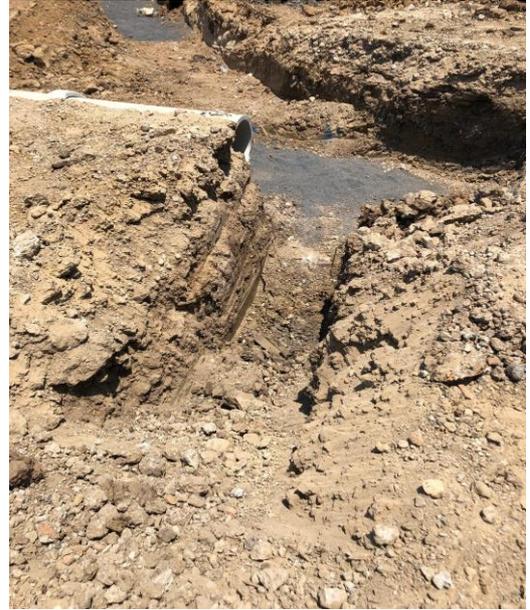
Plate 2: Extent of excavation

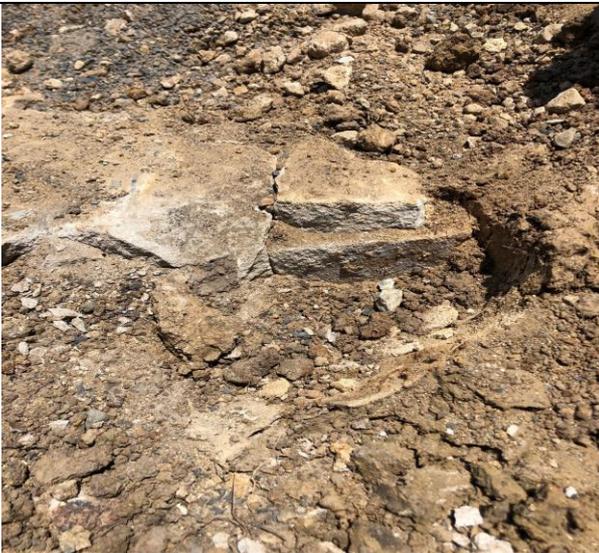
Plate 3: Concrete footing of old sump

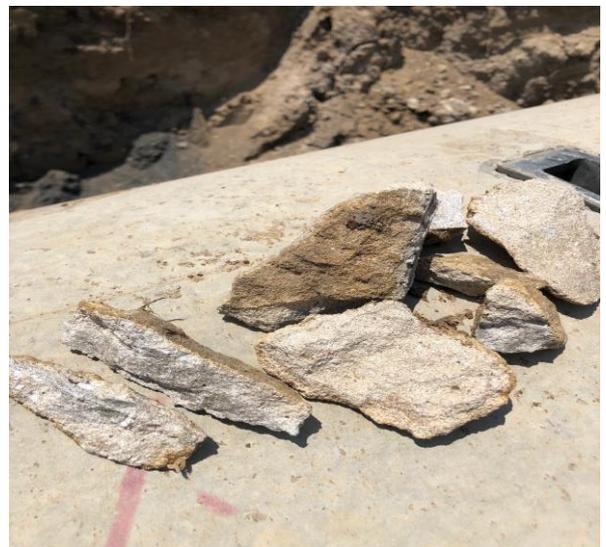
Plate 4: Close up of concrete Fragments

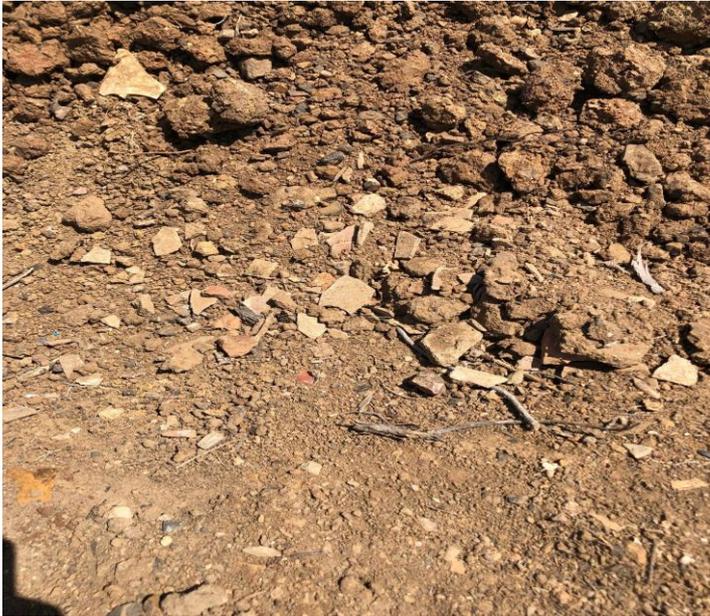
Plate 1: Confirmed ACM fragments

SERS recommends that a further 200mm soil scrape is undertaken across the contaminated area to removal the contaminated soils.

SERS recommends that following the removal of this additional material, further soil samples are collected to confirm that no ACM remain within the soil profiles

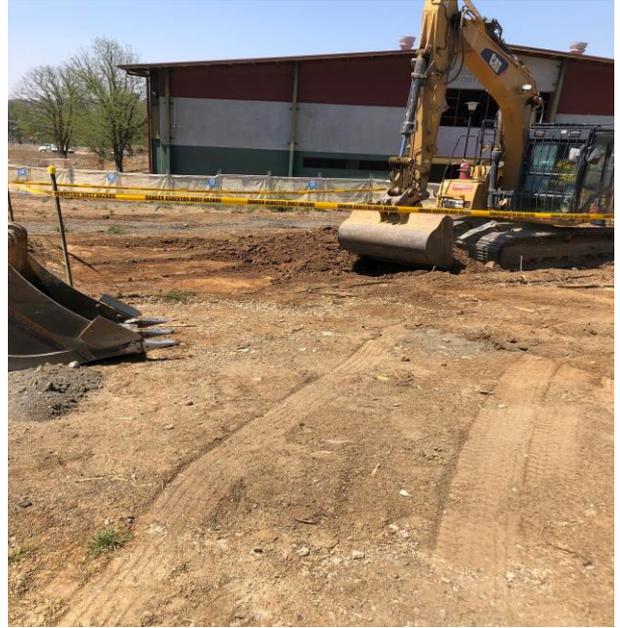
Plate 2: Commencement of excavation

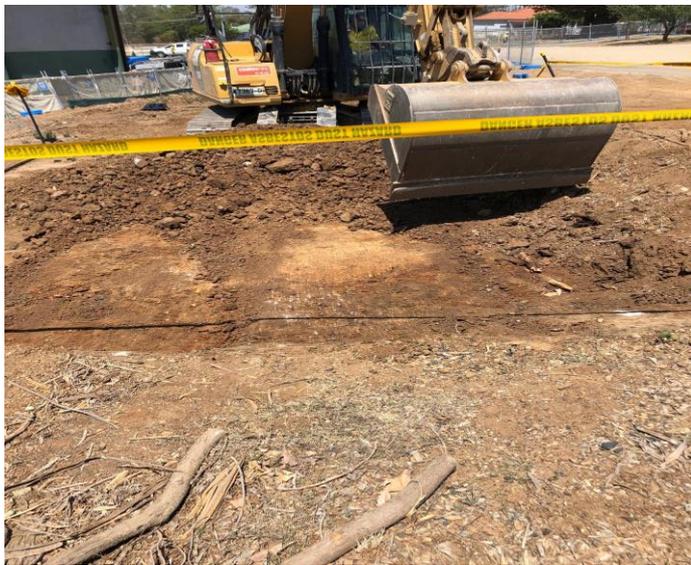
Plate 3: Commencement of excavation

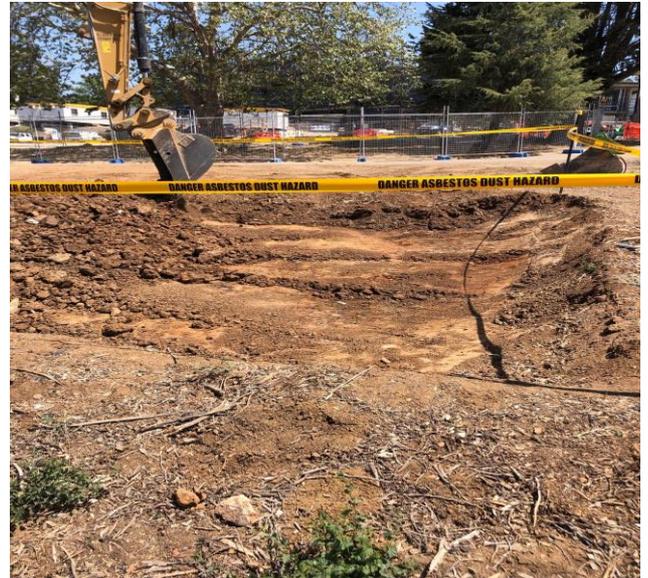
Plate 4: Soils under excavation

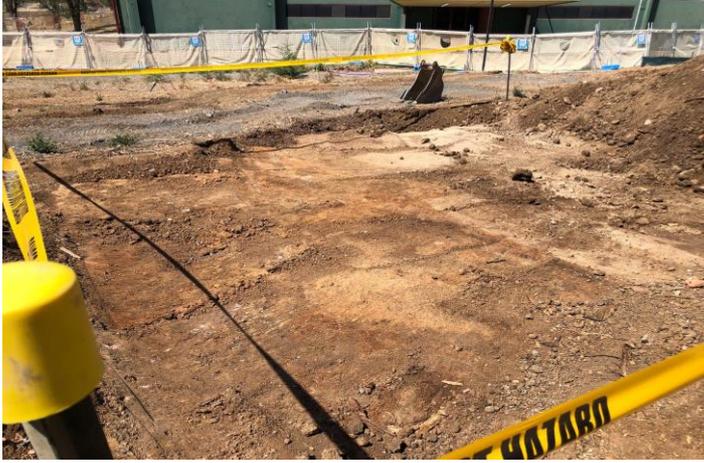
Plate 5: Area at completion of excavation

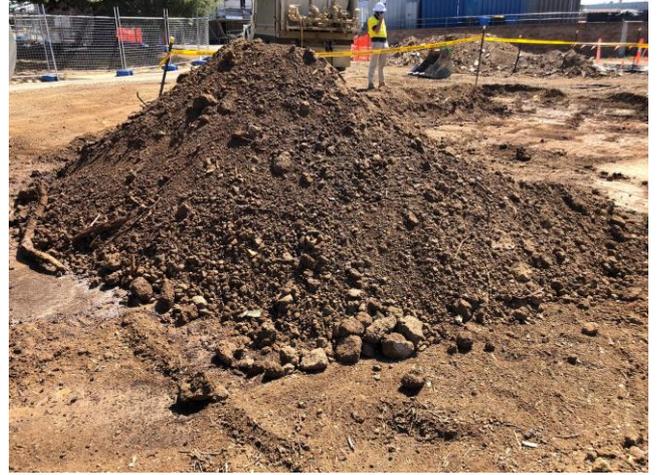
Plate 6: Stockpiled material from excavation

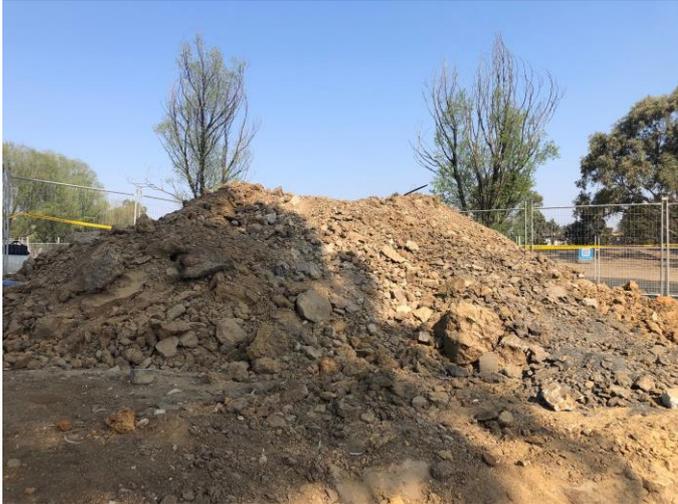
During the inspection SERS observed Asbestos fragments on the surface of the stockpile as per the below photos.

Plate 1: Stockpile

It is SERS's recommendation that the entire stockpile material be disposed of as asbestos contaminated material including the material beneath the stockpile to a depth of 200mm.

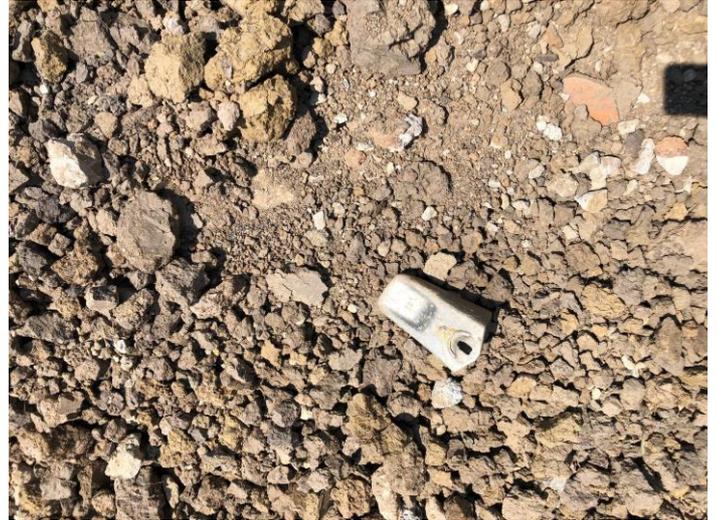
Plate 2: Location of ACM fragment on stockpile surface

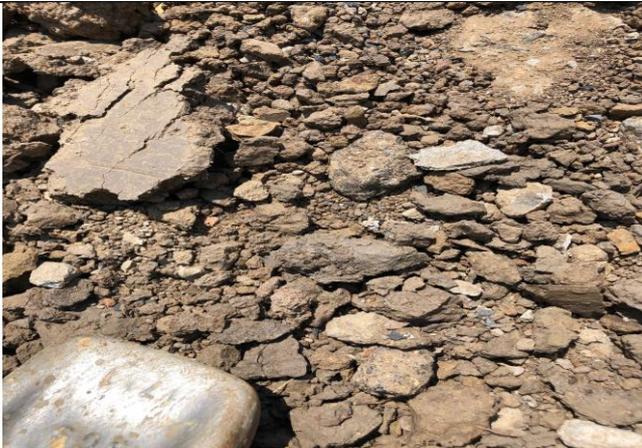
Plate 3: ACM fragment on surface

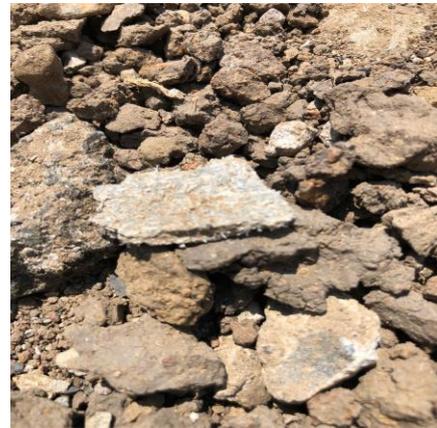
Plate 4: Close up of ACM Fragment

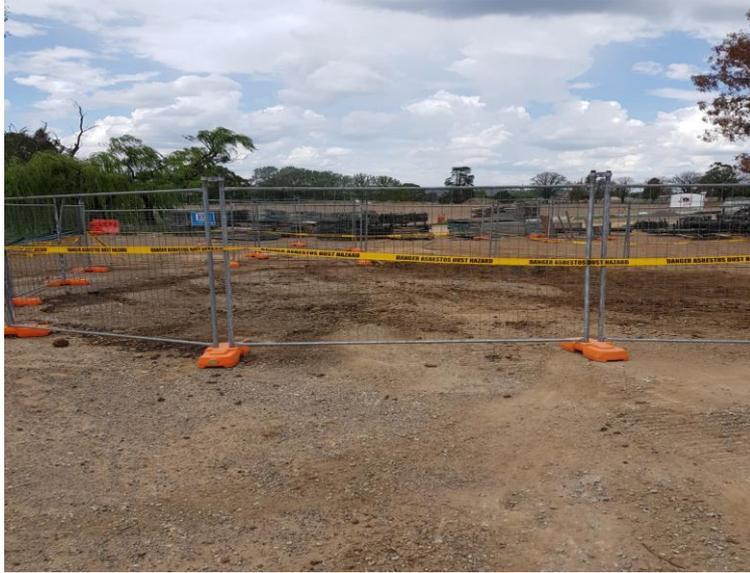
Overview of work area:

No ACM or debris visible.

Asbestos contaminated soil removed

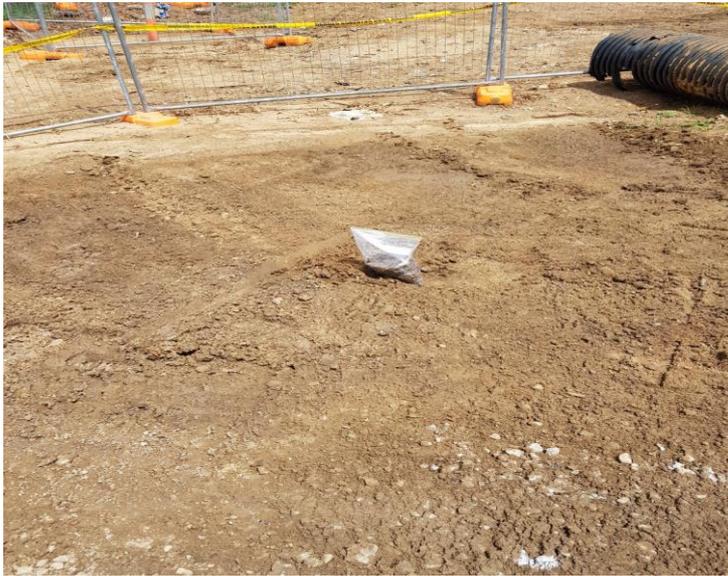
Overview of work area:

No ACM or debris visible.

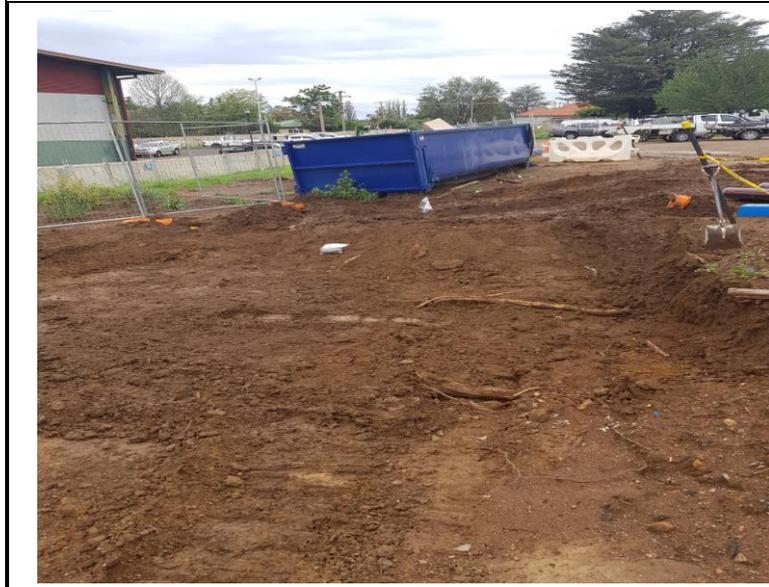
Overview of work area:

No ACM or debris visible.

Asbestos contaminated soil removed

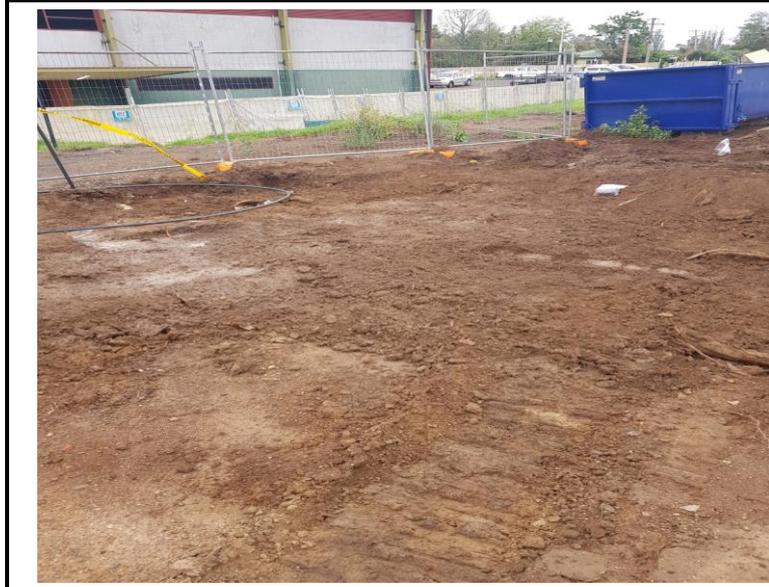
Overview of work area:

No ACM or debris visible.
