# Surface Water and Groundwater Impact Assessment

## **Proposed Mixed Use Development**

CCQ2, 26-30 Mann Street, Gosford NSW 2250

**Project No. 25304**  
Version 1

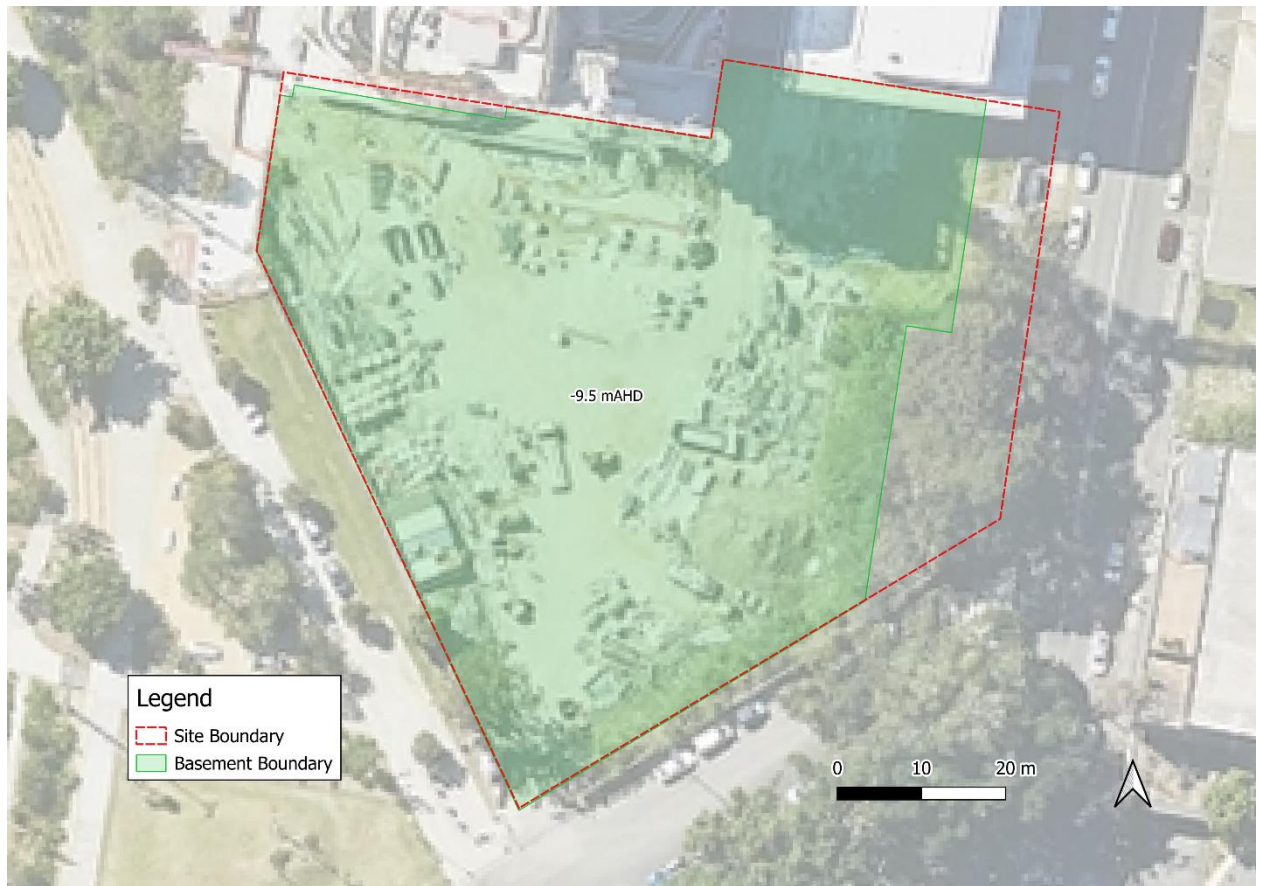
**Figure 6** Basement layout and BEL

| ITEM | DESCRIPTIONS |
|---|---|
| <b>Bulk Excavation Level (BEL)</b> | <u>Basement Carpark Level 4</u> : RL -9.5 mAHD |

<sup>1</sup> Determined from DKO Furtado Sullivan (2025) Drawing Basement 4 Capping Beam and Shoring Plan

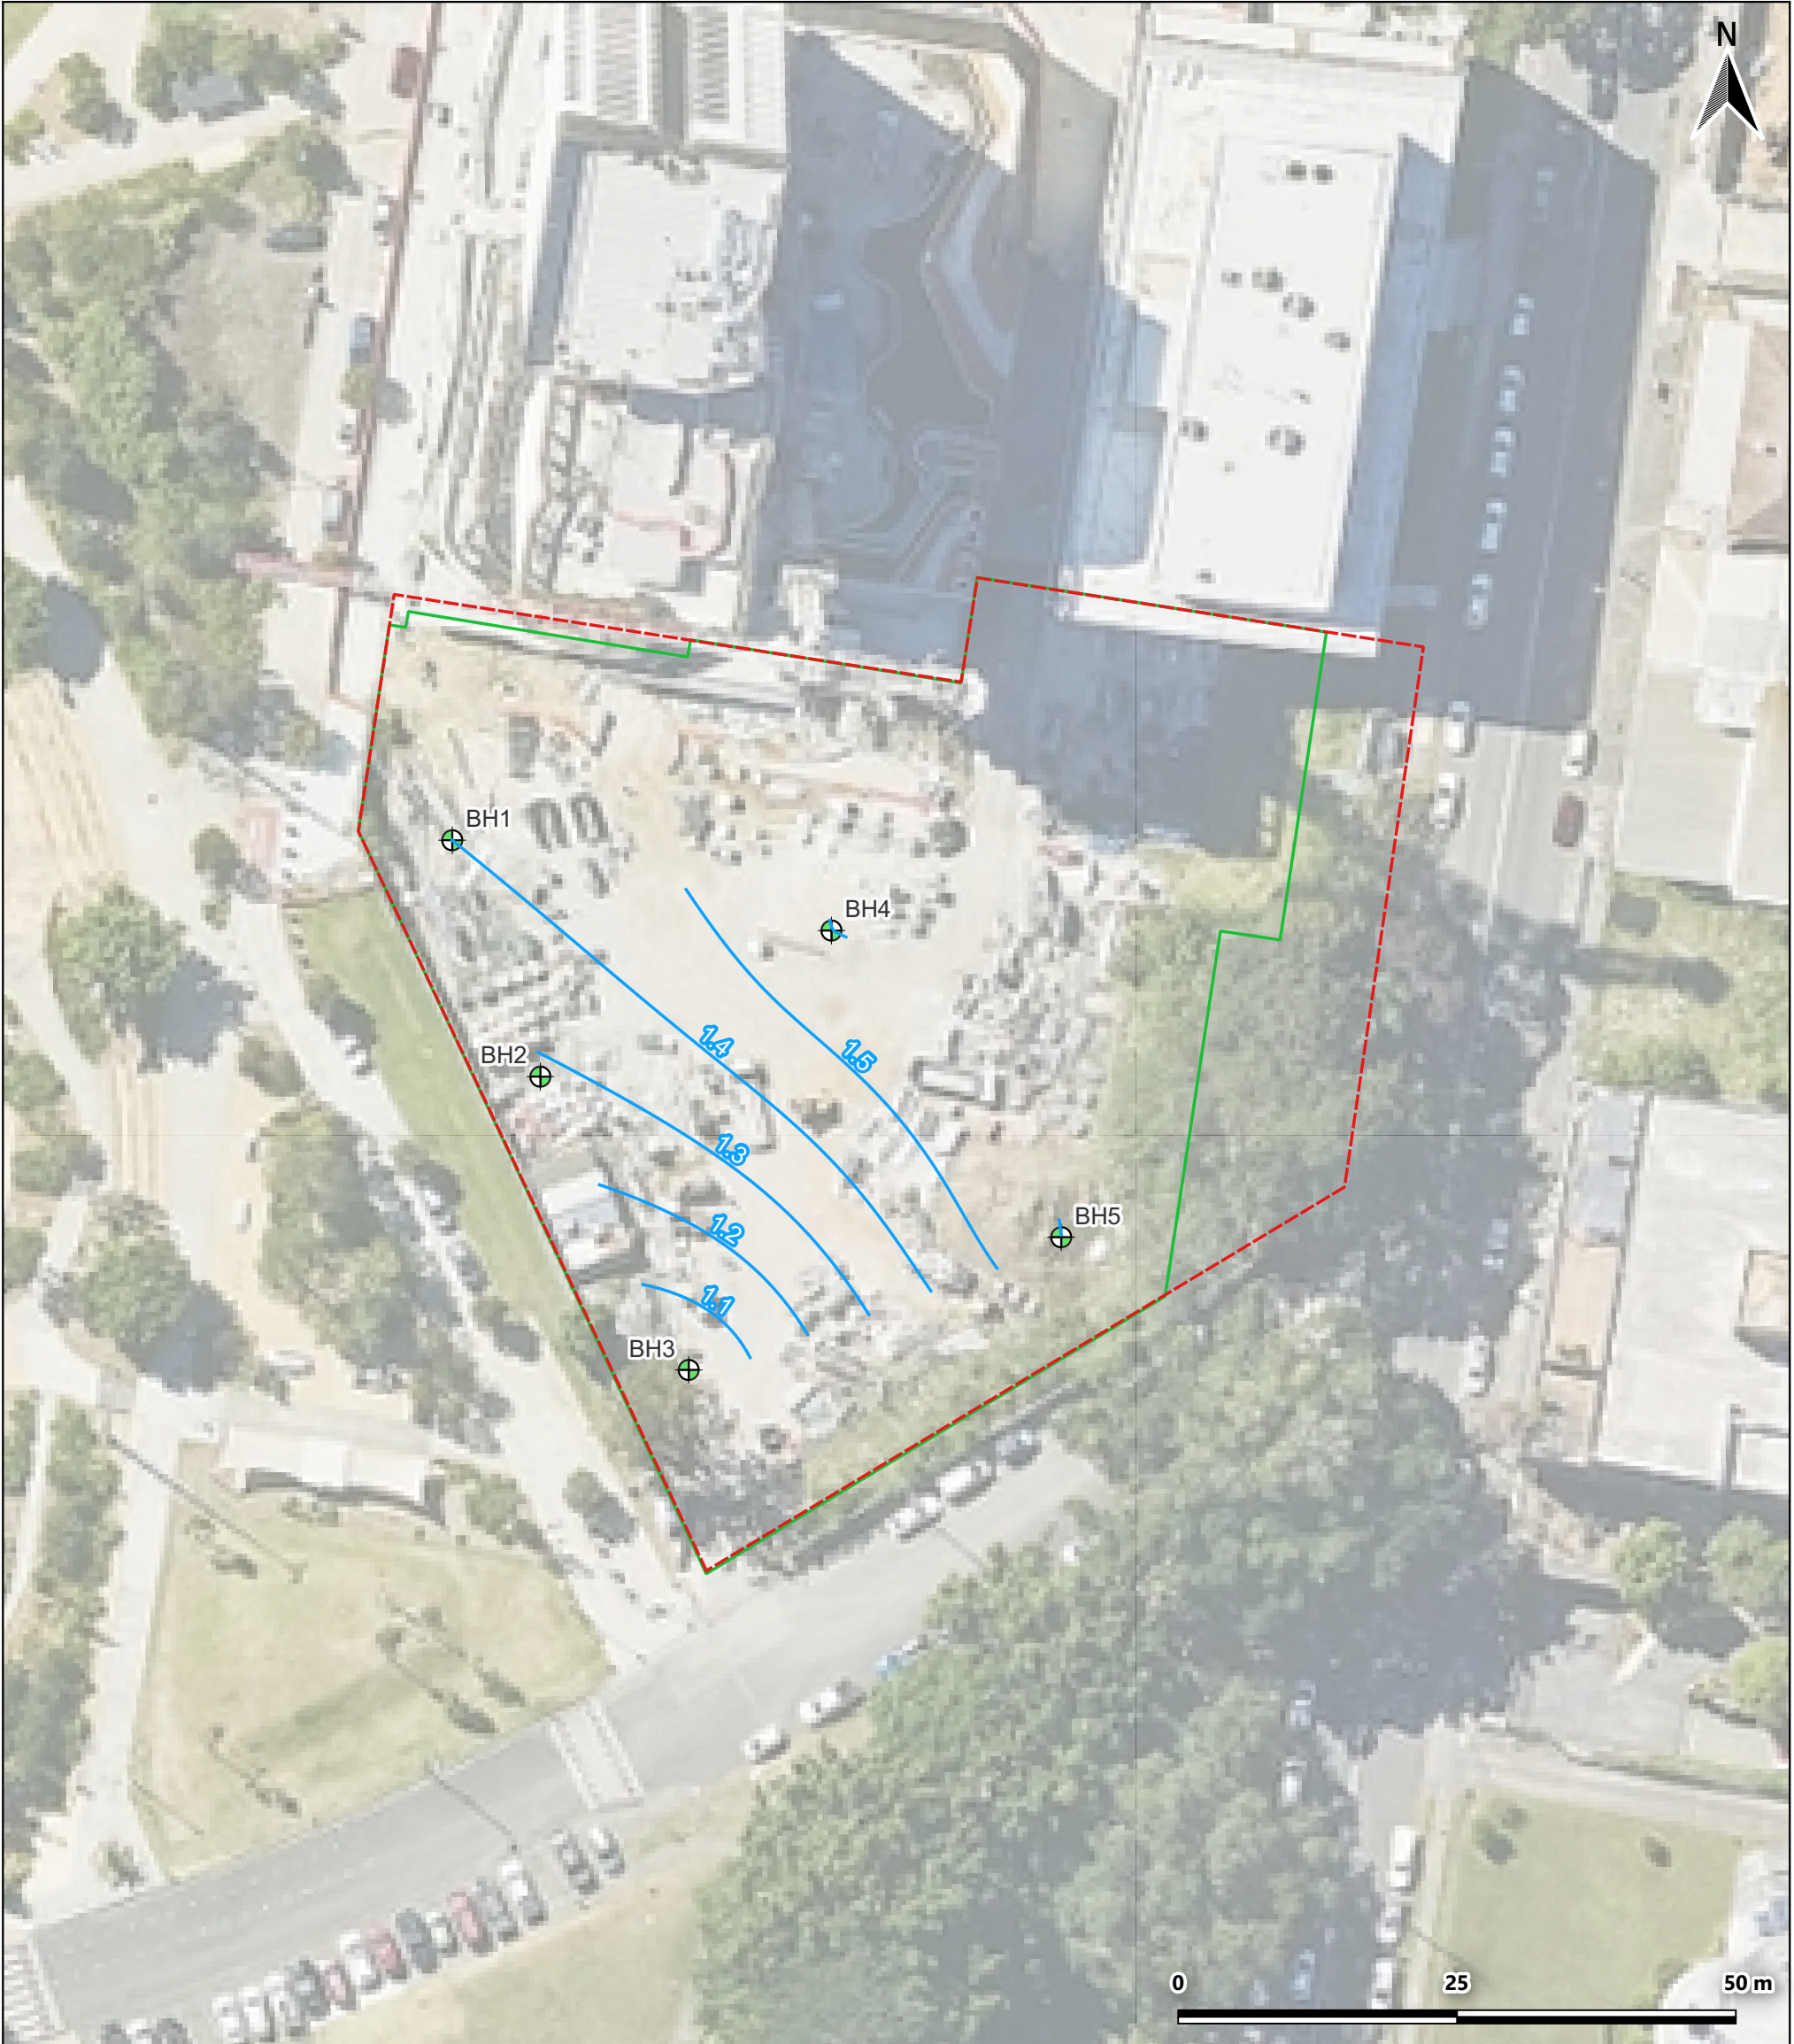
| <div>Map</div> <div>25304_rp02_f06_v01</div> | | <div>Legend</div> <div><div><div></div>Site Boundary</div><div><div></div>Basement Boundary</div><div><div></div>Groundwater Elevation Contours (mAHd)</div></div> <div><div>Boreholes</div><div><div></div>JK (2025)</div></div> | <div>Figure 5 - Groundwater Elevation Contours</div> | |

The groundwater flow contours indicate that groundwater at the site is expected to move south-west towards Brisbane Water, which discharges to Broken Bay and the Pacific Ocean, approximately 11.5 km south of the site.
