**SPECIALIST ADVICE TO
URBAN PROPERTY GROUP**

**ON
GEOTECHNICAL INVESTIGATION**

**FOR
PROPOSED MIXED-USE DEVELOPMENT – CCQ2**

**AT
26-30 MANN STREET, GOSFORD, NSW**

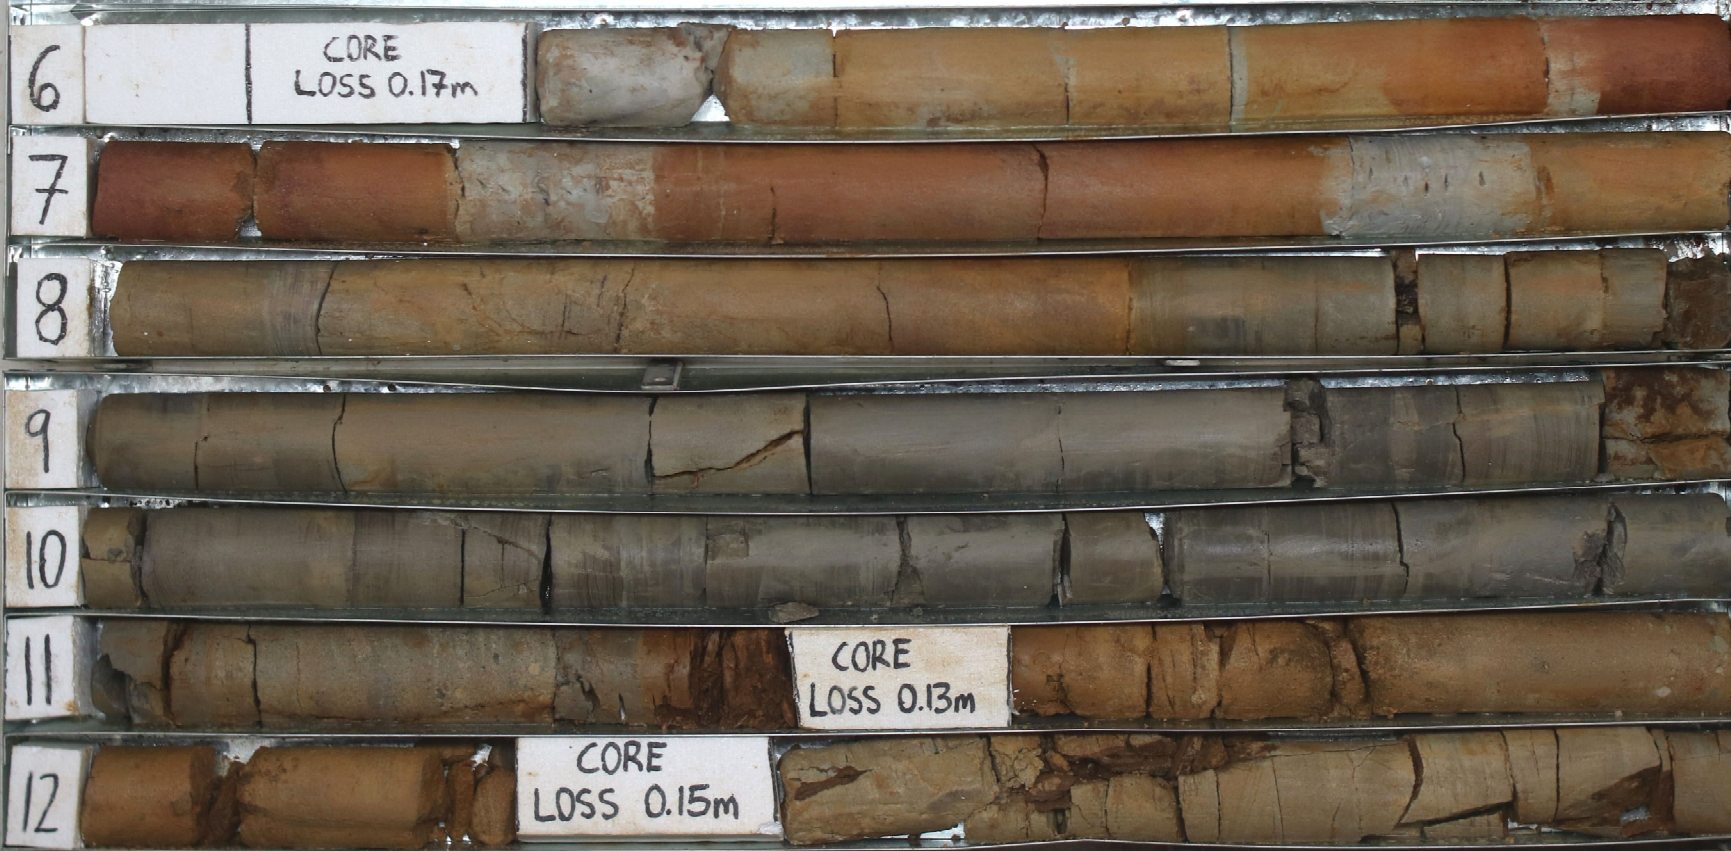
37790P BH4 START CORING AT 6.10m

The bedrock conditions in several of the boreholes are relatively uniform, however the rock conditions in BH4, just below BEL in BH1 and just above BEL in BH2 are quite poor with lower rock strength, greater fracturing and continuous near vertical joints.

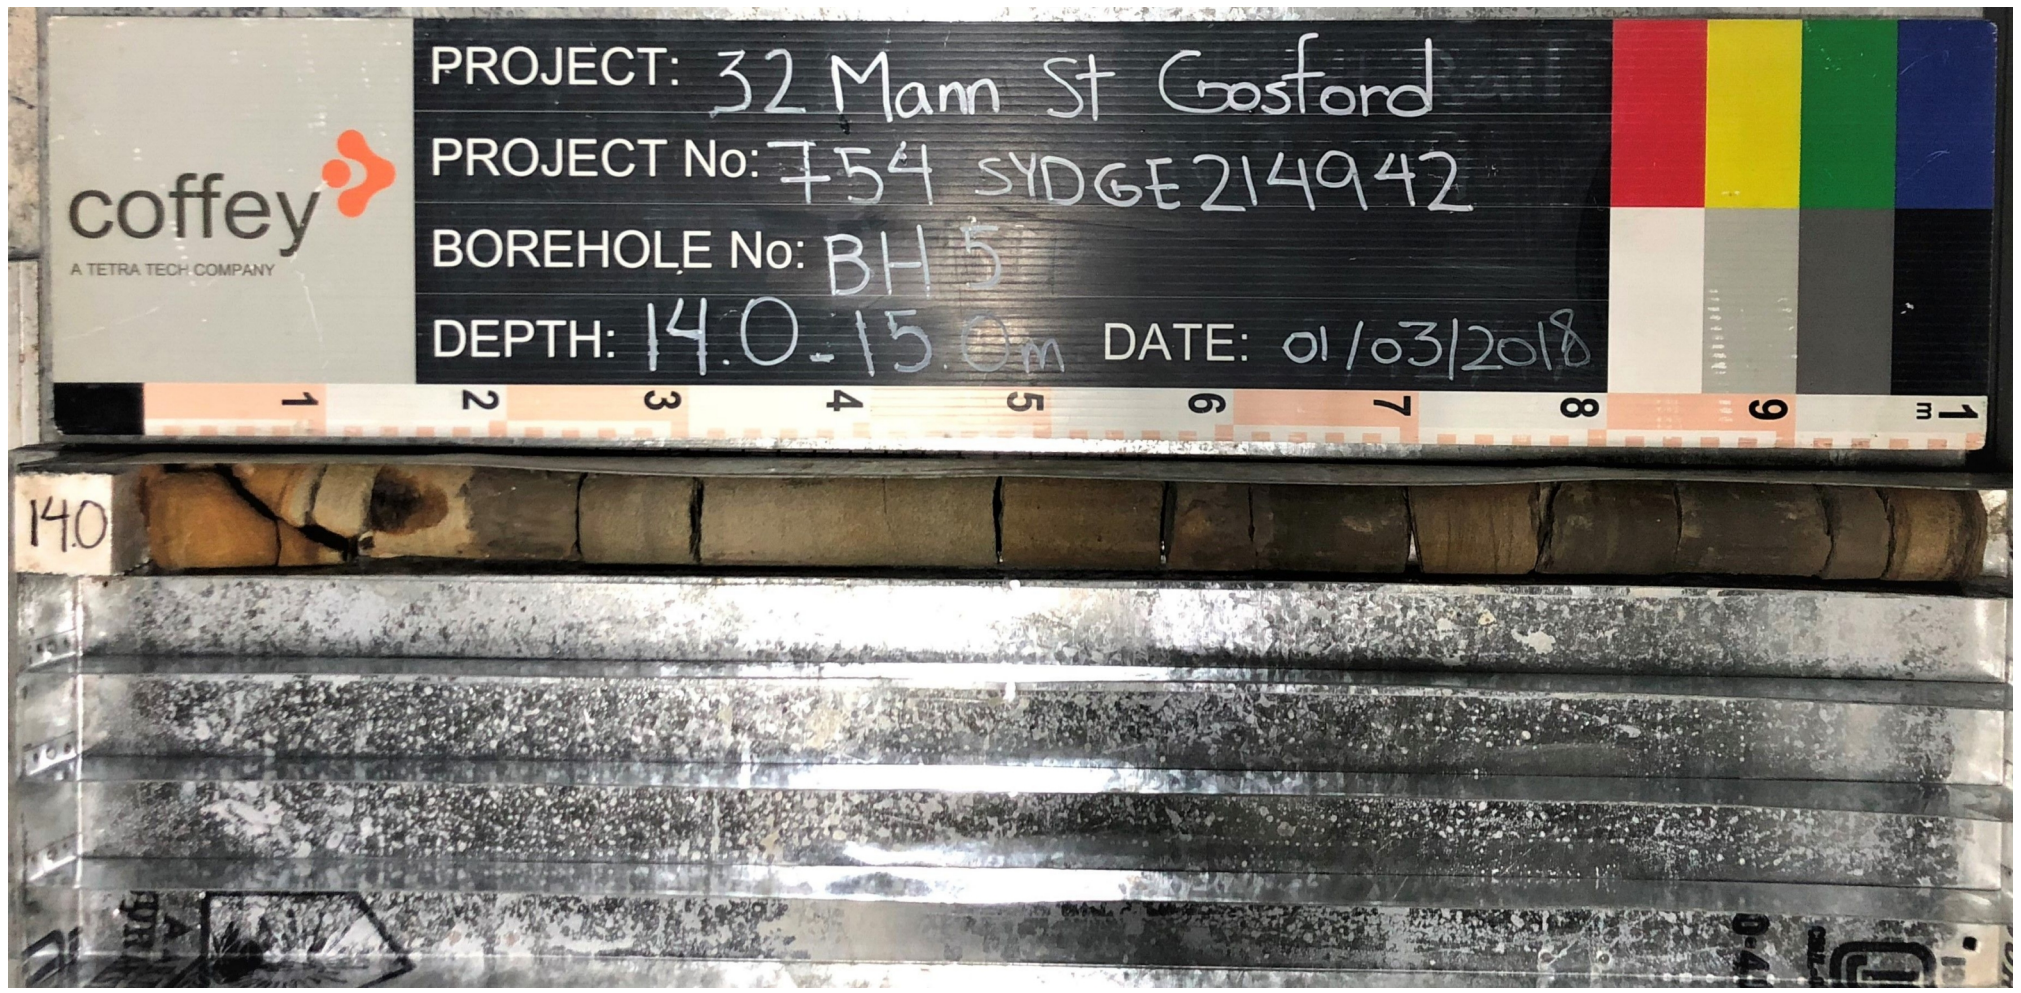
client:	St Hilliers		
approved	AM		project:	Geotechnical and Environmental Assessment 32 Mann Street, Gosford, nsw		
date	22/03/2018		title:	CORE PHOTOGRAPH BH5		
scale	N.T.S.		project no:	SYDGE214942	fig no:	FIGURE 2
original size	A4		rev:

BH5 14.00 - 15.00 m

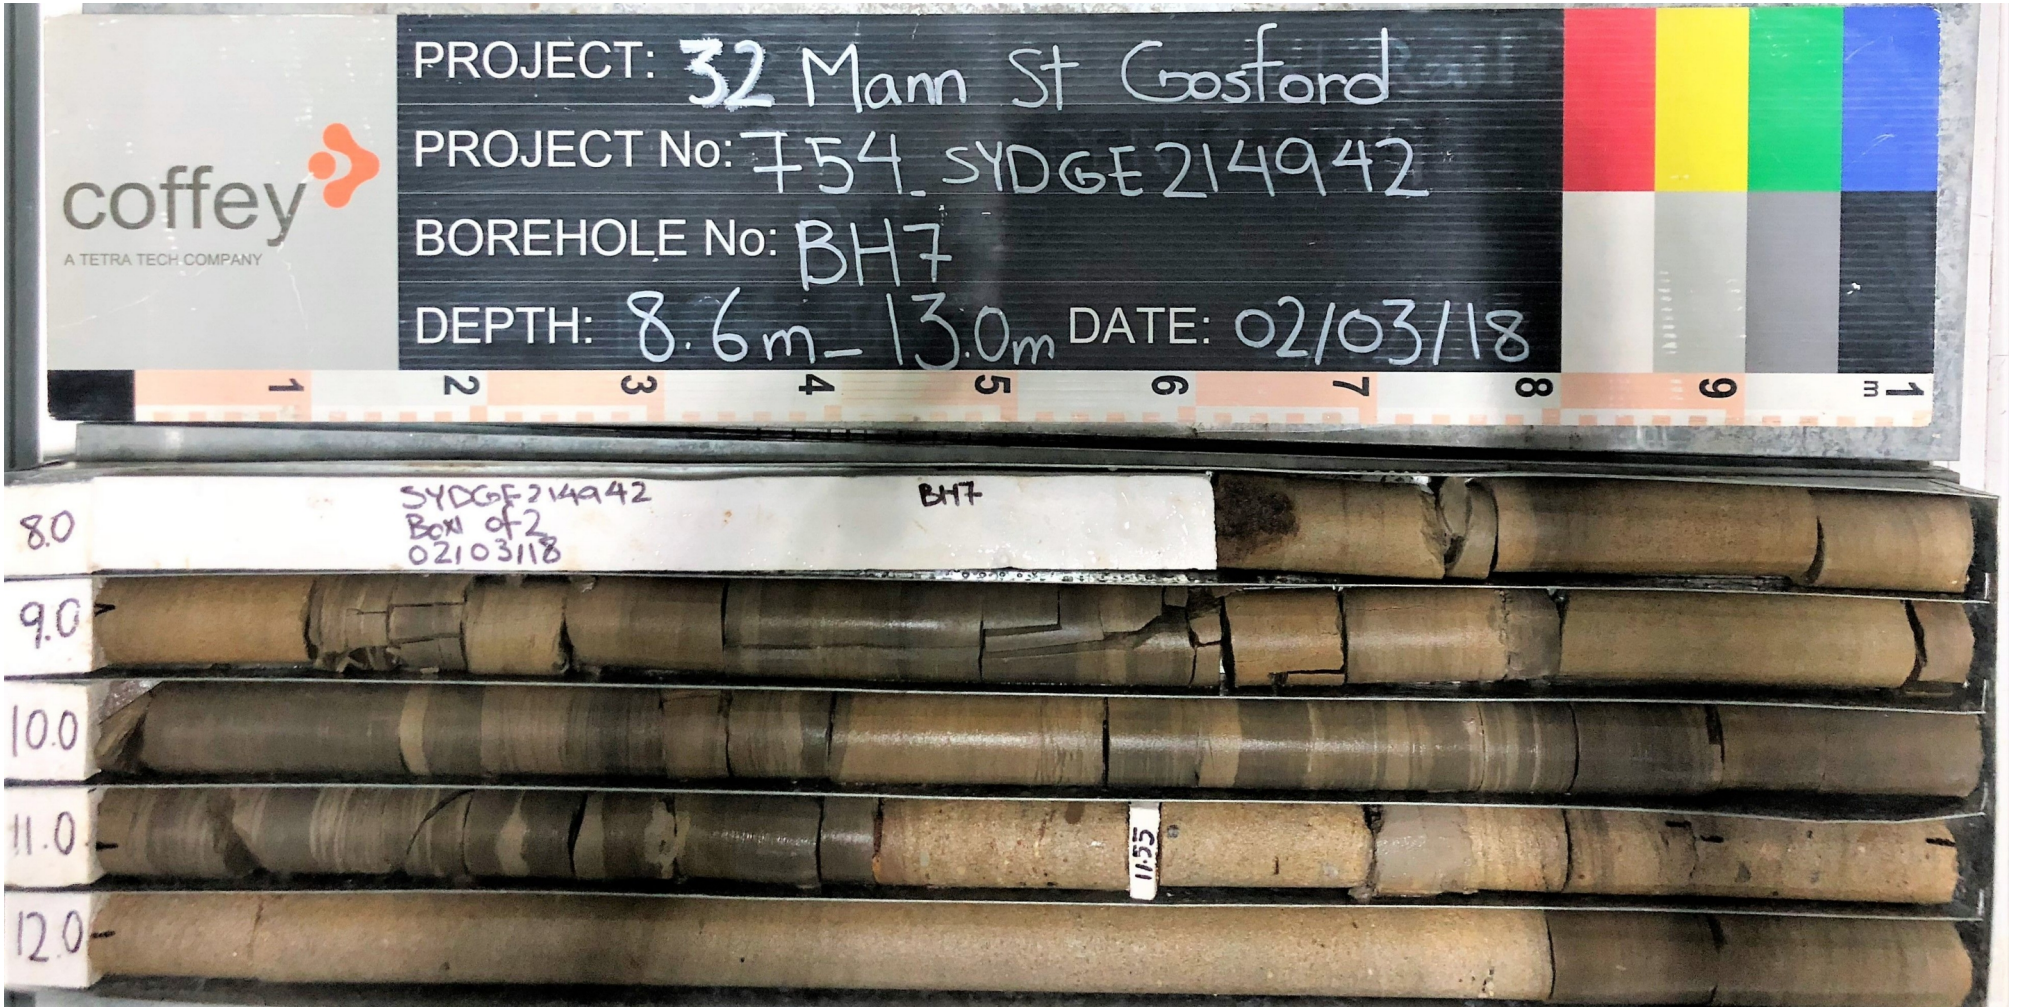
A TETRA TECH COMPANY	client: St Hilliers		
approved	AM		project: Geotechnical and Environmental Assessment 32 Mann Street, Gosford, nsw		
date	22/03/2018		title: CORE PHOTOGRAPH BH7		
scale	N.T.S.		project no: SYDGE214942	fig no: FIGURE 1	rev:
original size	A4

BH7 8.60 - 13.00 m

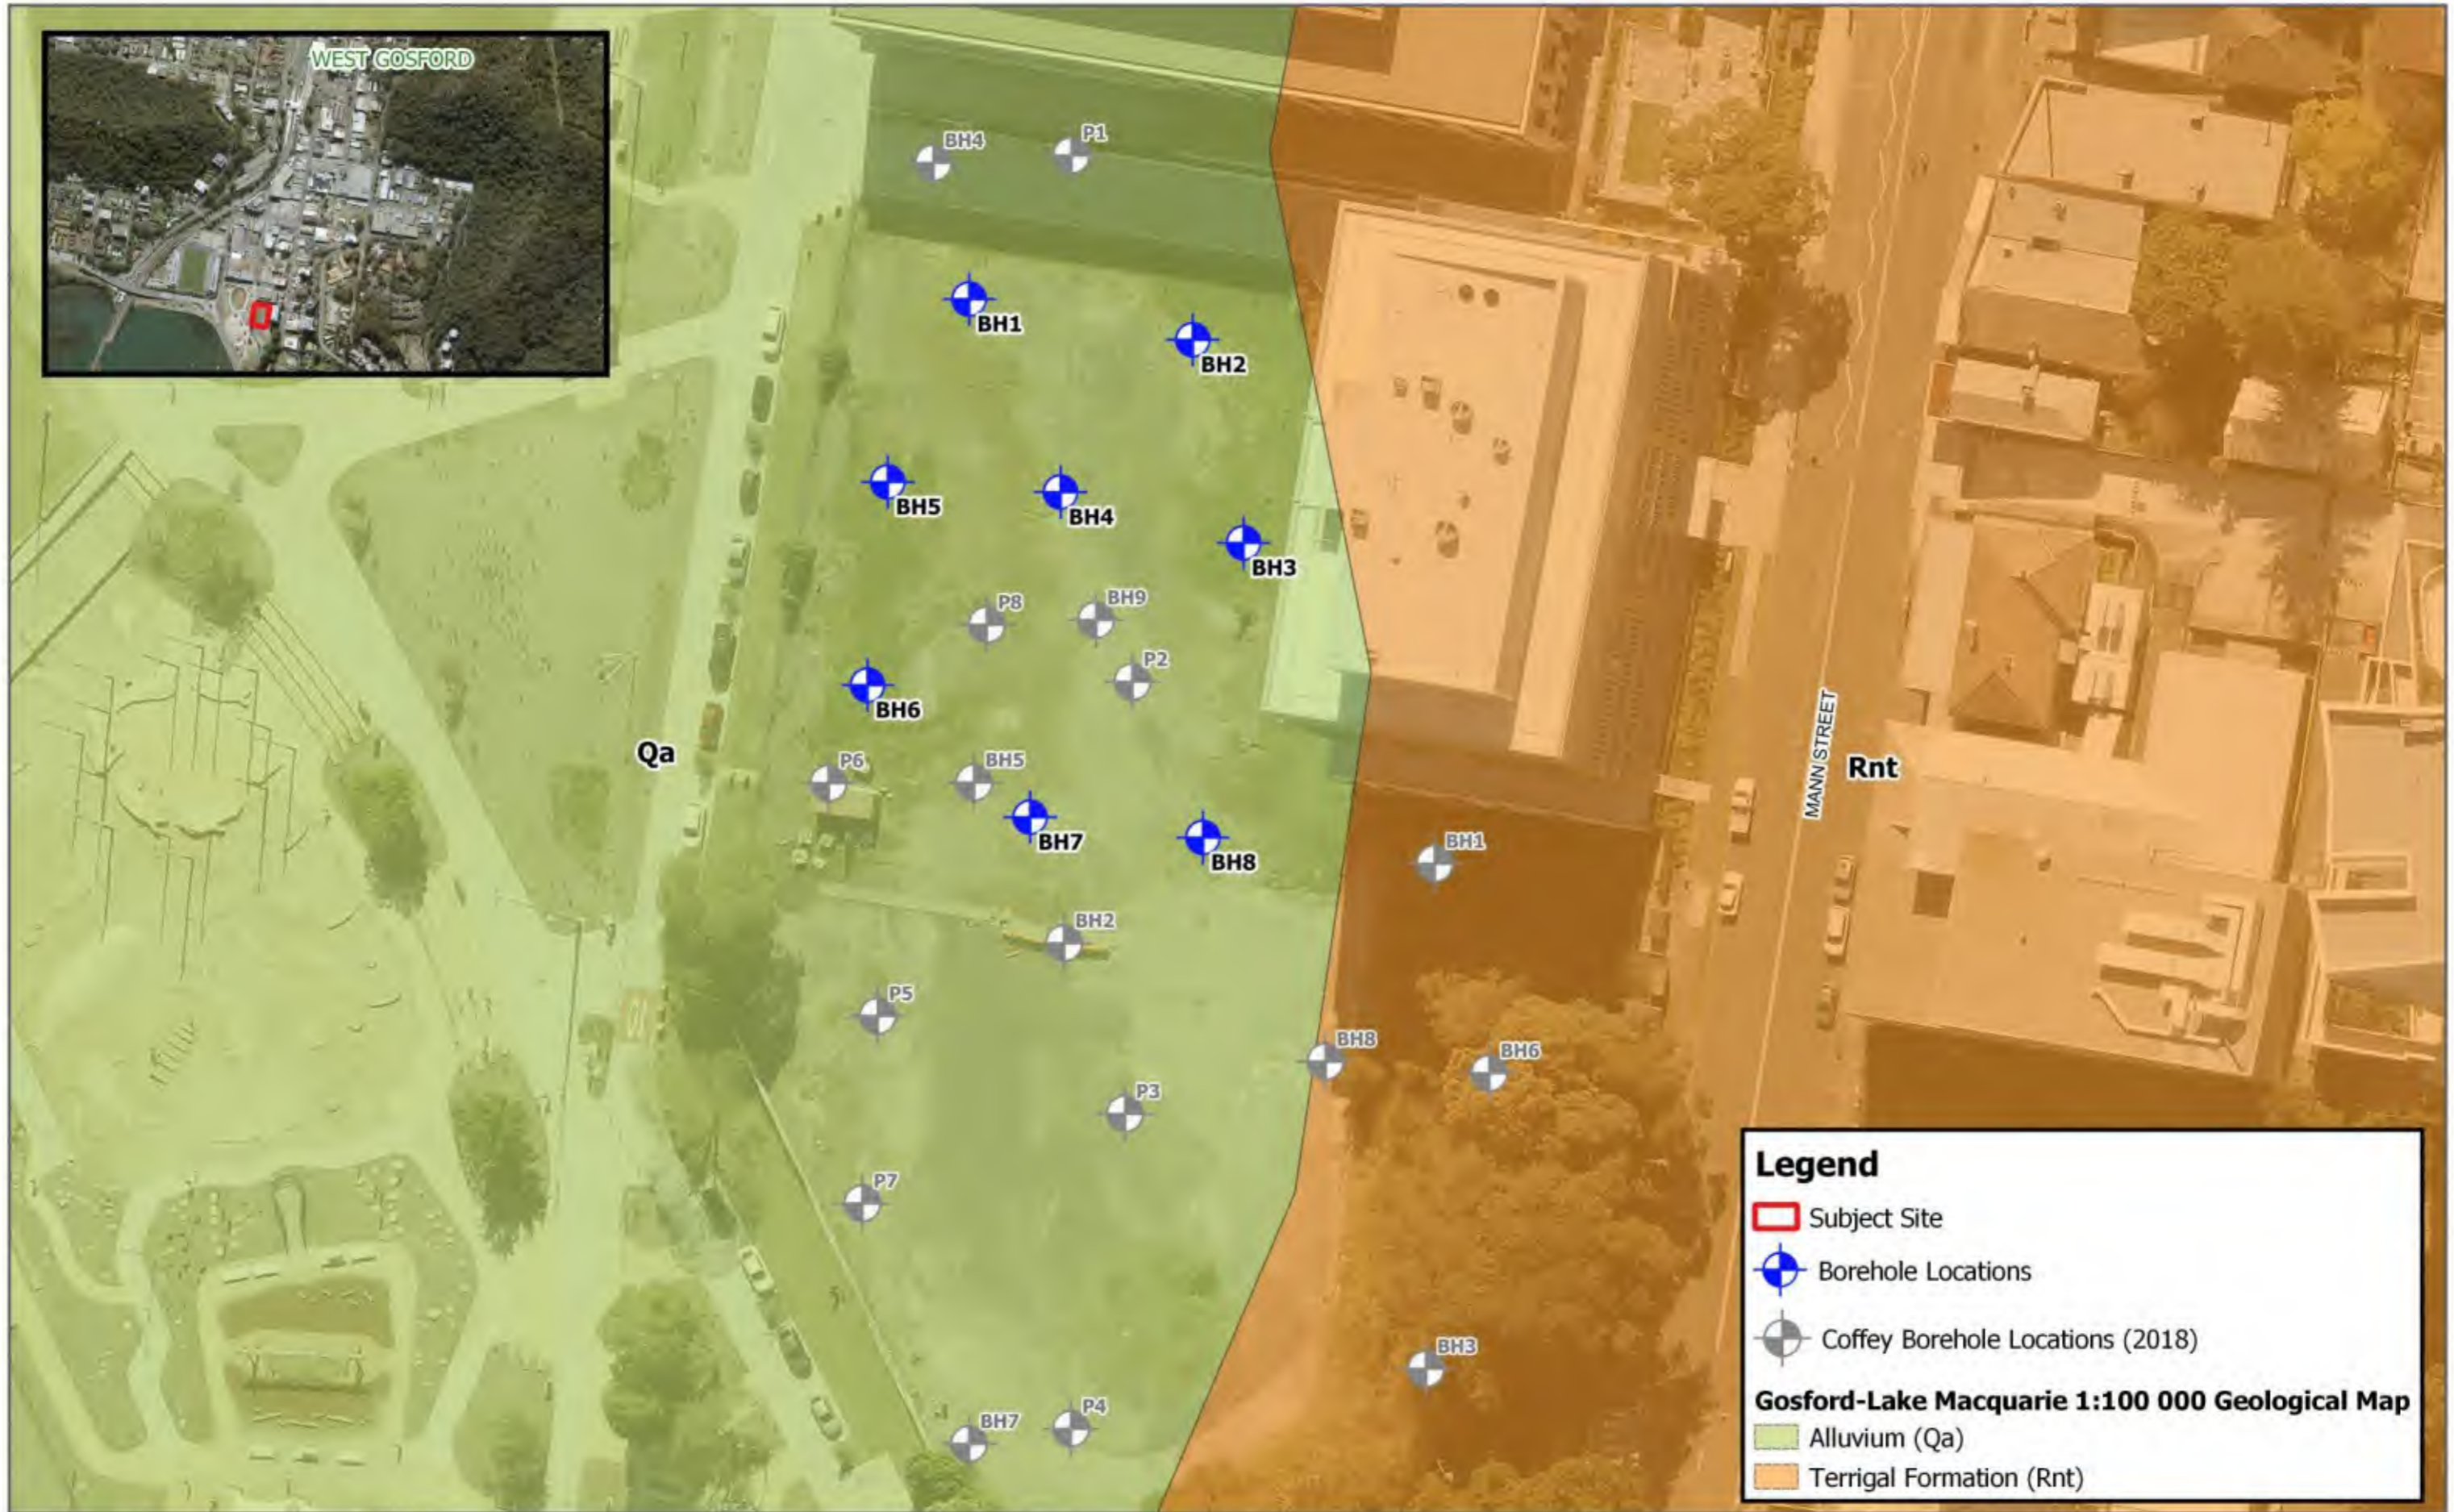
- Subject Site
- ⊕ Borehole Locations
- ⊕ Coffey Borehole Locations (2018)
